I. PROJECT FUNDAMENTALS									
I.1 General									
(1) Code Number	: 33010020-22			(7) Number of Farmers	: 10,638				
(2) Name of Irrigation Scheme	: Jragung			(8) Water Resource River	: Jragung

Scheme	Jragung	District	Demak
Technical Level	Technical	Registered Area	4,597 ha

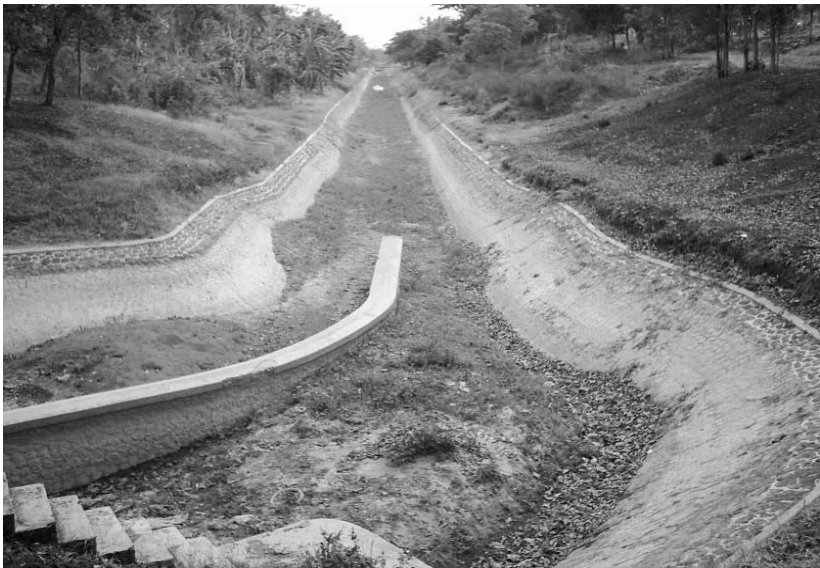
<u>Category</u> Irrigation (Main Canal)	
		<u>Structure</u> Settling Basin and Masonry Lined Canal	
		<u>Condition</u> <input type="checkbox"/> A <input type="checkbox"/> B <input checked="" type="checkbox"/> C <input type="checkbox"/> D	
		<u>Problems</u> Require removal of sediment and provision of inspection road

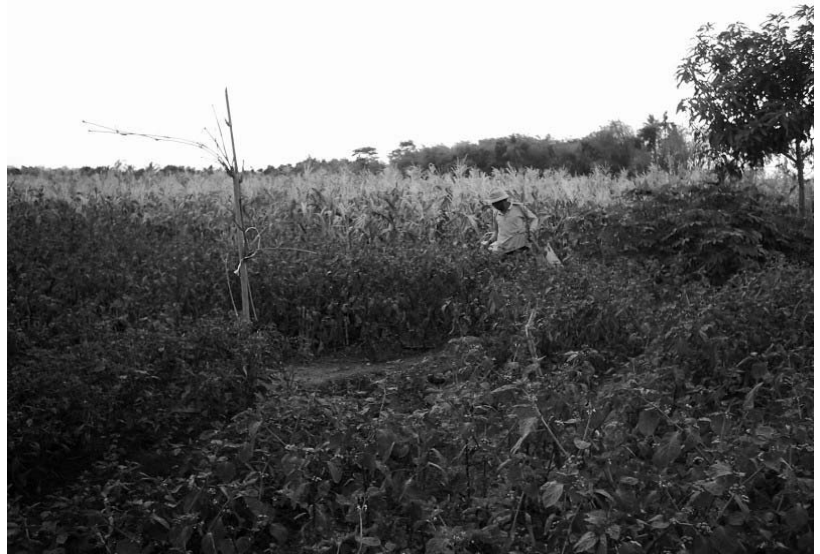
<u>Category</u> Irrigation (Paddy field)	
		<u>Structure</u> Paddy field	
		<u>Condition</u> <input type="checkbox"/> A <input type="checkbox"/> B <input checked="" type="checkbox"/> C <input type="checkbox"/> D	
		<u>Problems</u> Require farm road and ditch

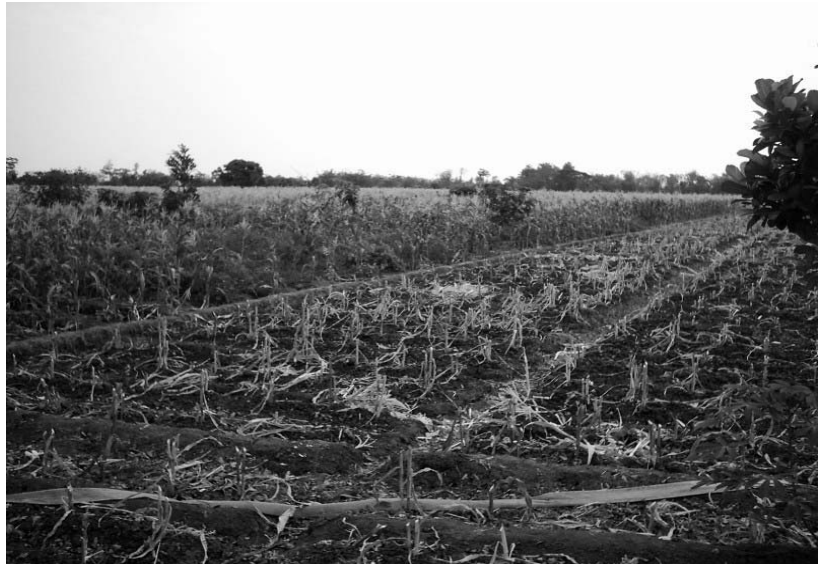
<u>Category</u> Irrigation (Paddy field)	
		<u>Structure</u> Paddy field	
		<u>Condition</u> <input type="checkbox"/> A <input type="checkbox"/> B <input checked="" type="checkbox"/> C <input type="checkbox"/> D

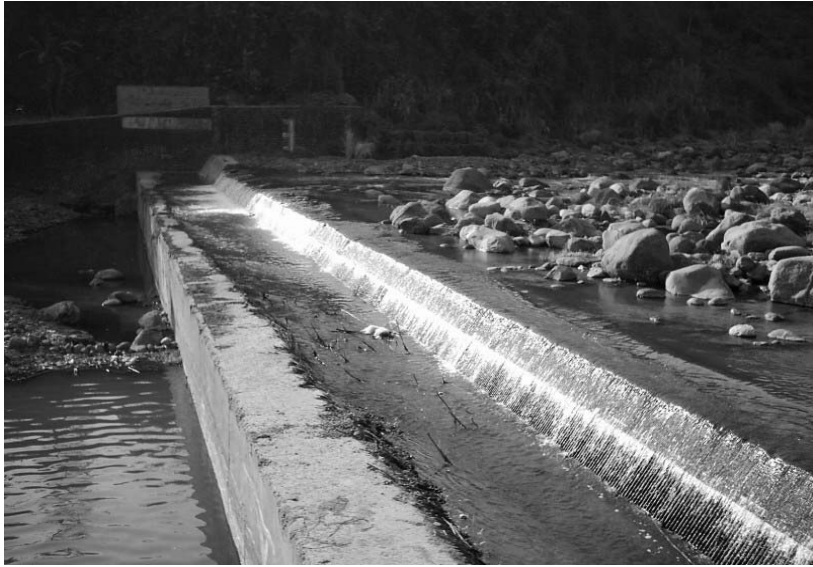
<u>Category</u> Irrigation (Headworks)			
		<u>Structure</u> Fixed Weir, Bar-screen Type			
		<u>Condition</u> <input type="checkbox"/> A <input type="checkbox"/> B <input checked="" type="checkbox"/> C <input type="checkbox"/> D			
		<u>Problems</u> Require total repair of weir body

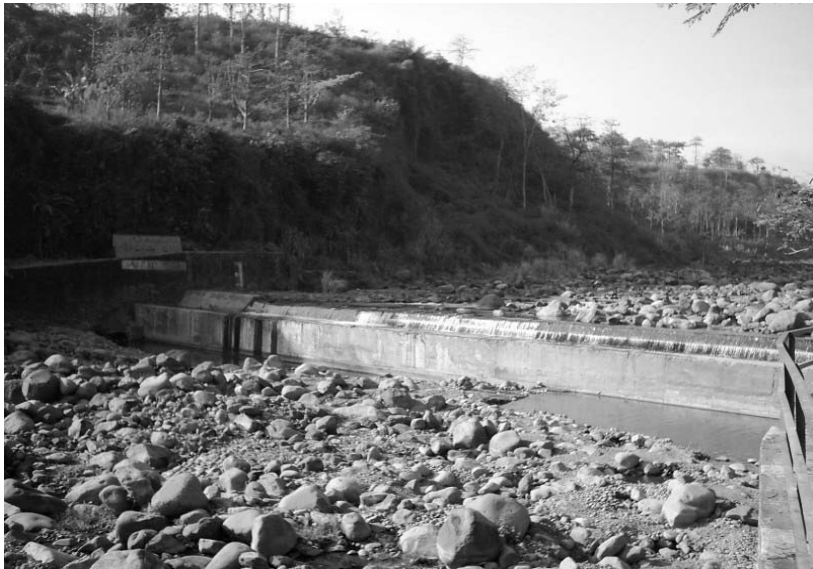
<u>Category</u> Irrigation (Headworks)			
		<u>Structure</u> Fixed Weir, Bar-screen Type			
		<u>Condition</u> <input type="checkbox"/> A <input type="checkbox"/> B <input checked="" type="checkbox"/> C <input type="checkbox"/> D			
		<u>Problems</u> Require total repair of weir body
