The Study on Comprehensive Recovery Program of Irrigation Agriculture
Japan International Cooperation Agency

Location Map of Irrigation Schemes in Pekalongan District

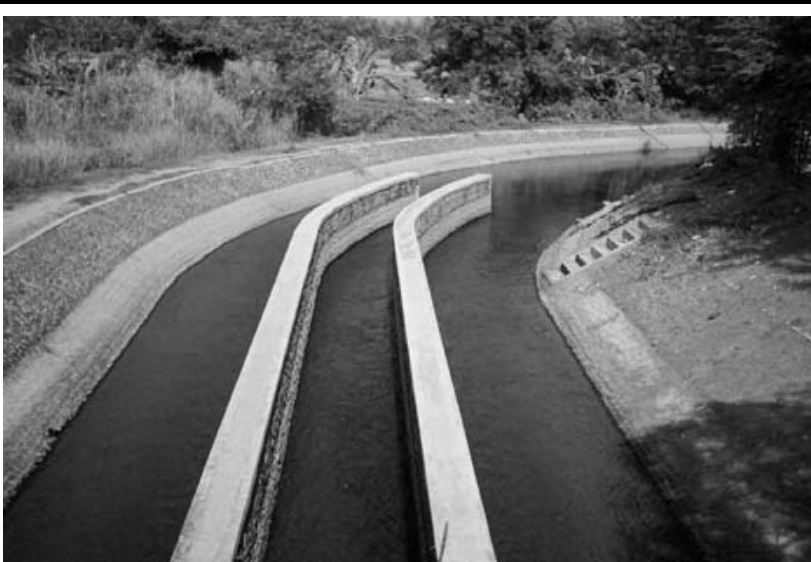
<p><u>Category</u> Irrigation (Headworks)</p>	
		<p><u>Structure</u> Settling Basin</p>	
		<p><u>Condition</u> <input type="checkbox"/> A <input checked="" type="checkbox"/> B <input type="checkbox"/> C <input type="checkbox"/> D</p>

<p><u>Problems</u> Require provision of inspection road along basin</p>

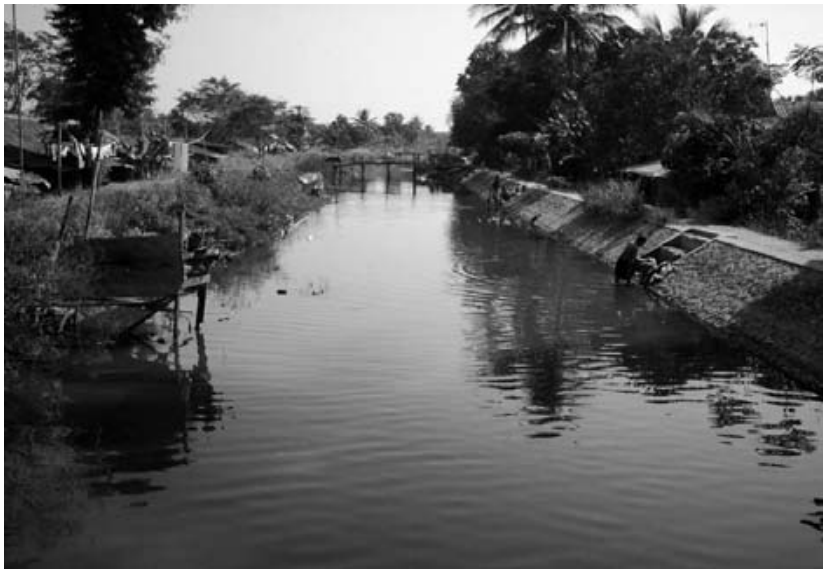
<i>Category</i> Irrigation (Main Canal)	
		<i>Structure</i> Masonry Lined Canal	
		<i>Condition</i> <input type="checkbox"/> A <input type="checkbox"/> B <input checked="" type="checkbox"/> C <input type="checkbox"/> D	
		<i>Problems</i> Require removal of sediments and repair of lining

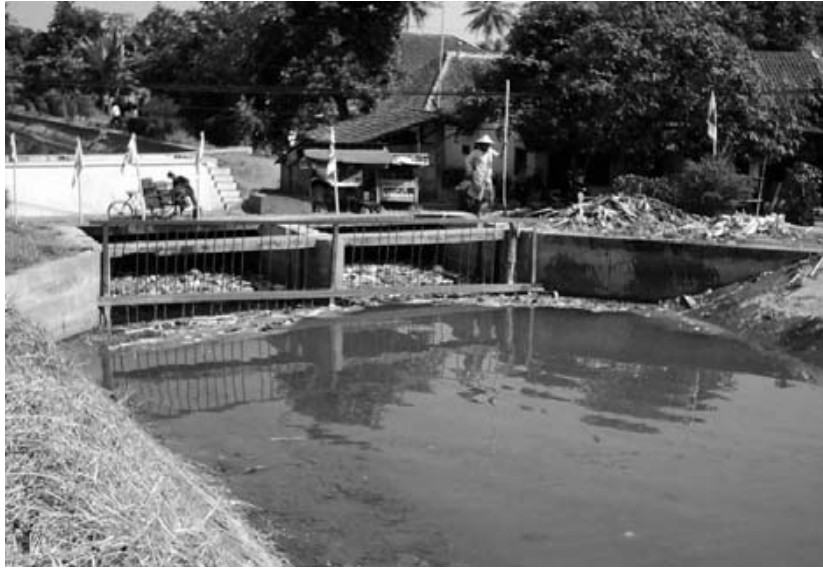
<i>Category</i> Irrigation (Main Canal)	
		<i>Structure</i> Canal and Bridge	
		<i>Condition</i> <input type="checkbox"/> A <input type="checkbox"/> B <input checked="" type="checkbox"/> C <input type="checkbox"/> D	
		<i>Problems</i> Require removal of sediments and repair of lining

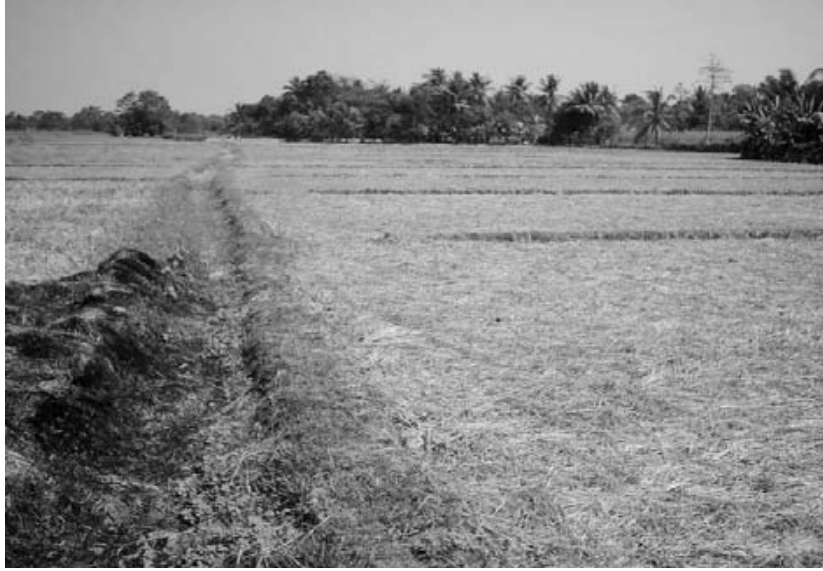
<i>Category</i> Irrigation (Paddy Field)	
		<i>Structure</i> Field Canal and Paddy Field	
		<i>Condition</i> <input type="checkbox"/> A <input type="checkbox"/> B <input checked="" type="checkbox"/> C <input type="checkbox"/> D

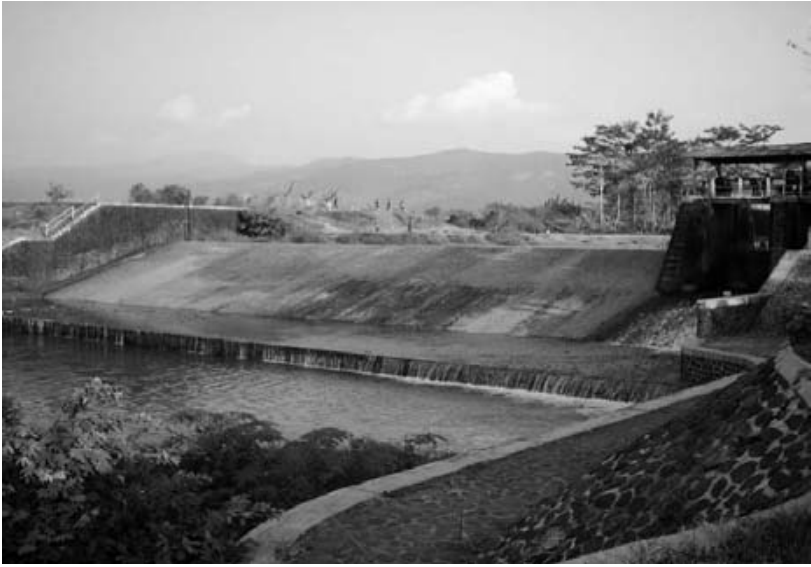
<i>Category</i> Irrigation (Headworks)			
		<i>Structure</i> Fixed Weir, Downstream View			
		<i>Condition</i> <input type="checkbox"/> A <input checked="" type="checkbox"/> B <input type="checkbox"/> C <input type="checkbox"/> D			
		<i>Problems</i> Require repair / provision of stilling

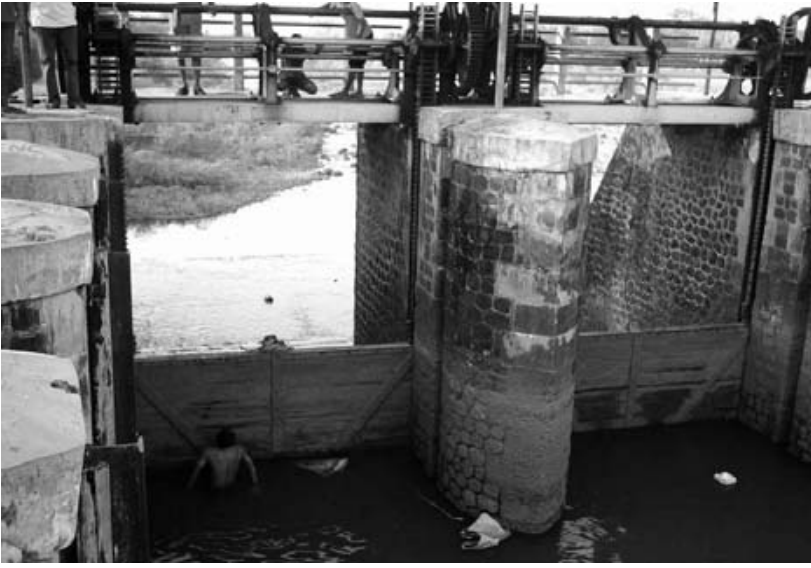
<i>Category</i> Irrigation (Headworks)			
		<i>Structure</i> Intake Gate			
		<i>Condition</i> <input type="checkbox"/> A <input type="checkbox"/> B <input type="checkbox"/> C <input checked="" type="checkbox"/> D			
		<i>Problems</i> Require replacement of intake gate from wooden to steel

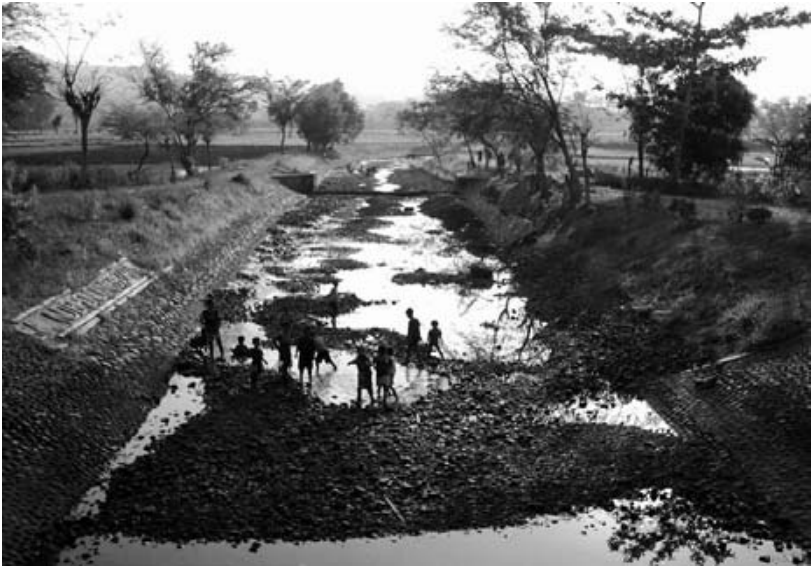
<i>Category</i> Irrigation (Main Canal)			
		<i>Structure</i> Masonry Lined Canal			
		<i>Condition</i> <input type="checkbox"/> A <input type="checkbox"/> B <input checked="" type="checkbox"/> C <input type="checkbox"/> D

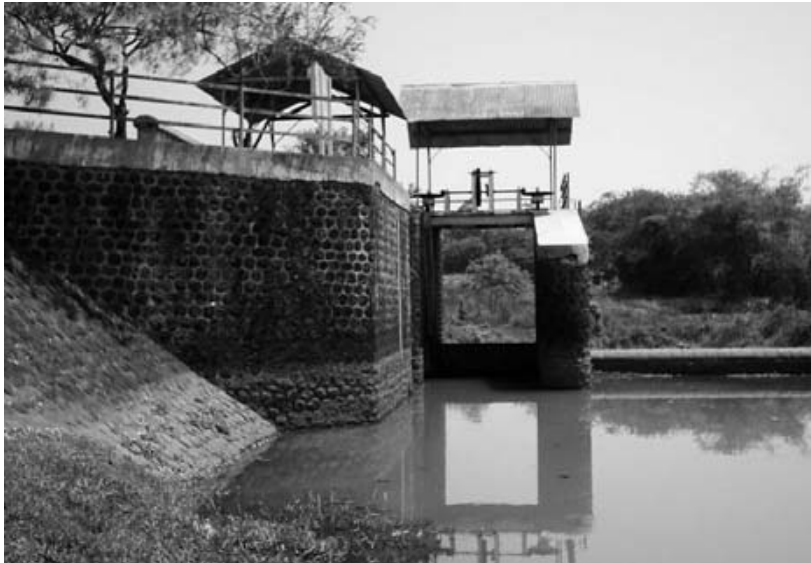
<u>Category</u> Irrigation (Headworks)		
		<u>Structure</u> Fixed Weir, Upstream		
		<u>Condition</u> <input type="checkbox"/> A <input type="checkbox"/> B <input checked="" type="checkbox"/> C <input type="checkbox"/> D		
		<u>Problems</u> Require major repair of weir body and gate works, removal of debris and sediment

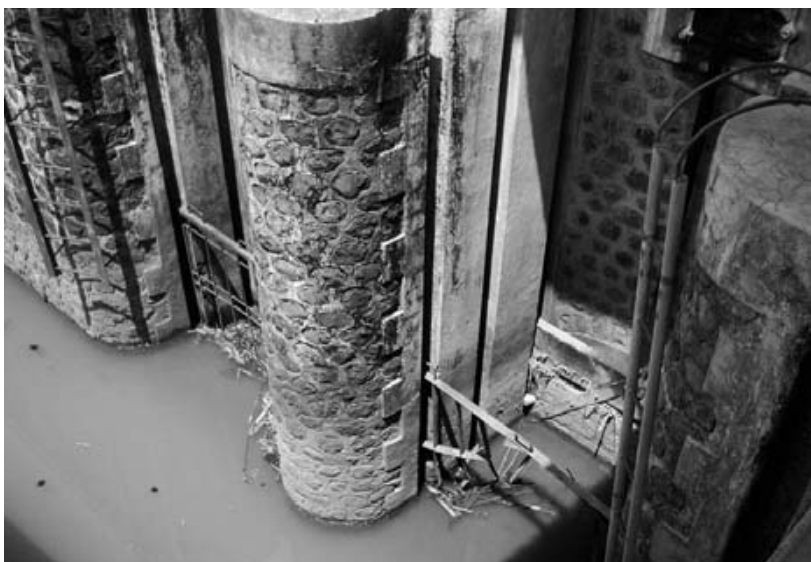
<u>Category</u> Irrigation (Headworks)		
		<u>Structure</u> Intake Gate		
		<u>Condition</u> <input type="checkbox"/> A <input type="checkbox"/> B <input type="checkbox"/> C <input checked="" type="checkbox"/> D		
		<u>Problems</u> Require replacement totally from wooden to steel

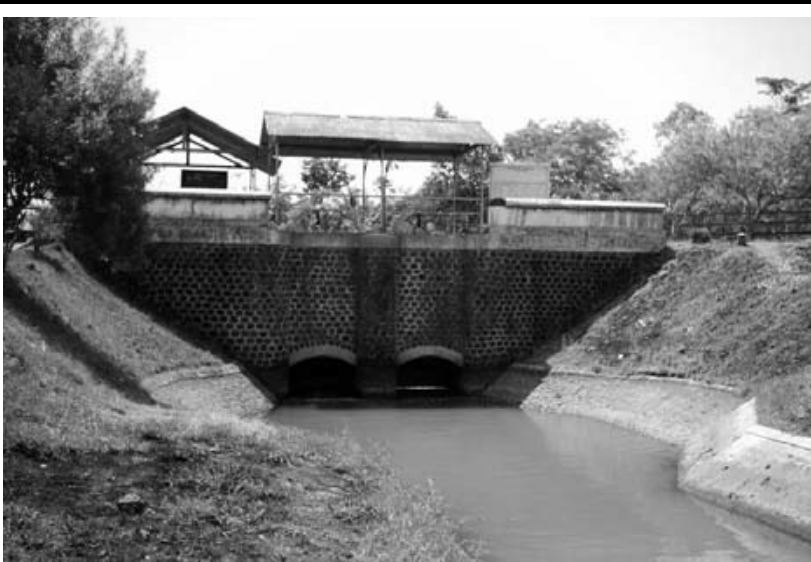
<u>Category</u> Irrigation (Headworks)		
		<u>Structure</u> Intake, Rear View		
		<u>Condition</u> <input type="checkbox"/> A <input type="checkbox"/> B <input checked="" type="checkbox"/> C <input type="checkbox"/> D

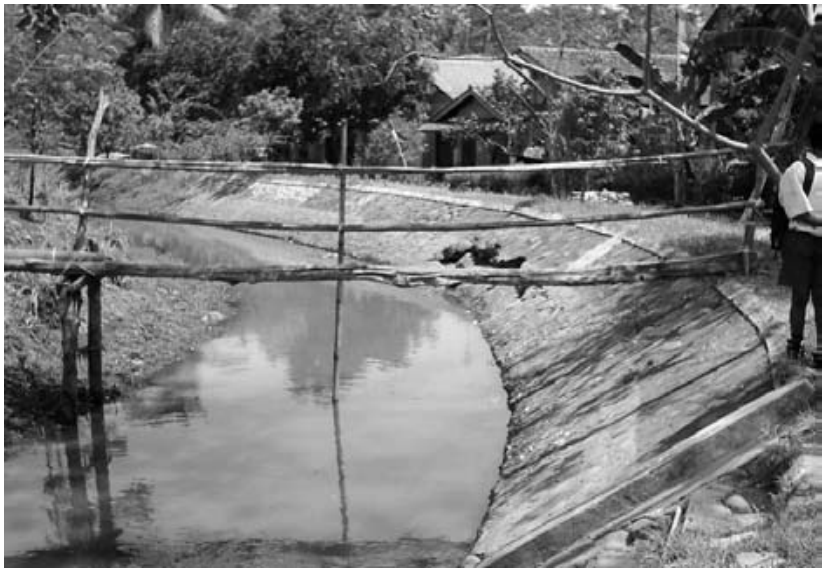
<p><u>Category</u> Irrigation (Secondary Canal)</p>			
		<p><u>Structure</u> Masonry Lined Canal</p>			
		<p><u>Condition</u> <input type="checkbox"/> A <input type="checkbox"/> B <input checked="" type="checkbox"/> C <input type="checkbox"/> D</p>			
		<p><u>Problems</u> Require major repair of canal lining and provision of inspection road</p>

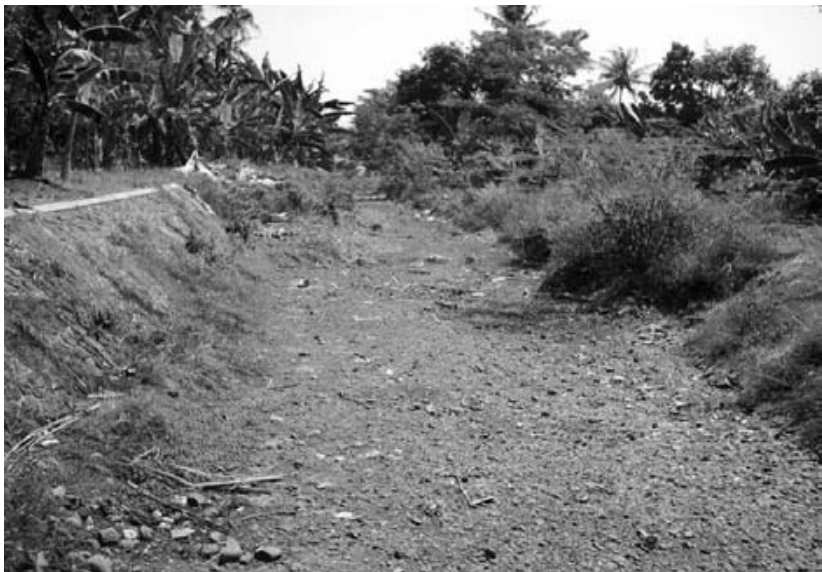
<p><u>Category</u> Irrigation (Secondary Canal)</p>			
		<p><u>Structure</u> Canal</p>			
		<p><u>Condition</u> <input type="checkbox"/> A <input type="checkbox"/> B <input checked="" type="checkbox"/> C <input type="checkbox"/> D</p>			
		<p><u>Problems</u> Require major repair of canal lining and provision of inspection road</p>

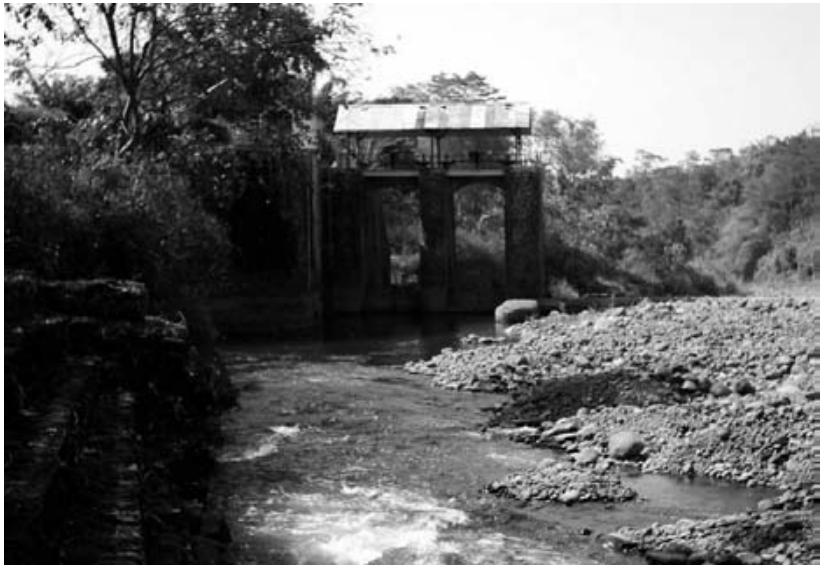
<i>Category</i> Irrigation (Headworks)			
		<i>Structure</i> Fixed Weir, Upstream View			
		<i>Condition</i> <input type="checkbox"/> A <input type="checkbox"/> B <input type="checkbox"/> C <input checked="" type="checkbox"/> D			
		<i>Problems</i> Require new construction (nearly 100 years after construction)

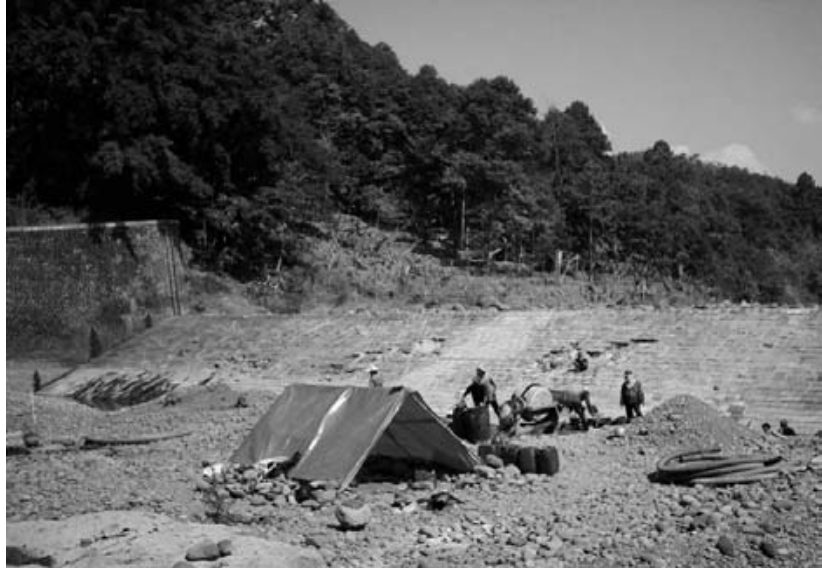
<i>Category</i> Irrigation (Headworks)			
		<i>Structure</i> Fixed Weir, Downstream View			
		<i>Condition</i> <input type="checkbox"/> A <input type="checkbox"/> B <input type="checkbox"/> C <input checked="" type="checkbox"/> D			
		<i>Problems</i> Require new construction (nearly 100 years after construction)

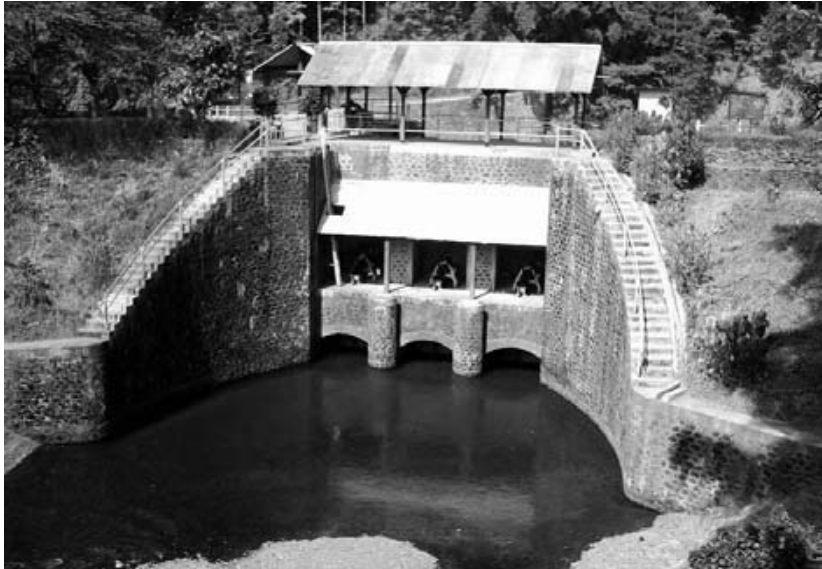
<i>Category</i> Irrigation (Headworks)			
		<i>Structure</i> Intake, Rear View			
		<i>Condition</i> <input type="checkbox"/> A <input type="checkbox"/> B <input type="checkbox"/> C <input checked="" type="checkbox"/> D

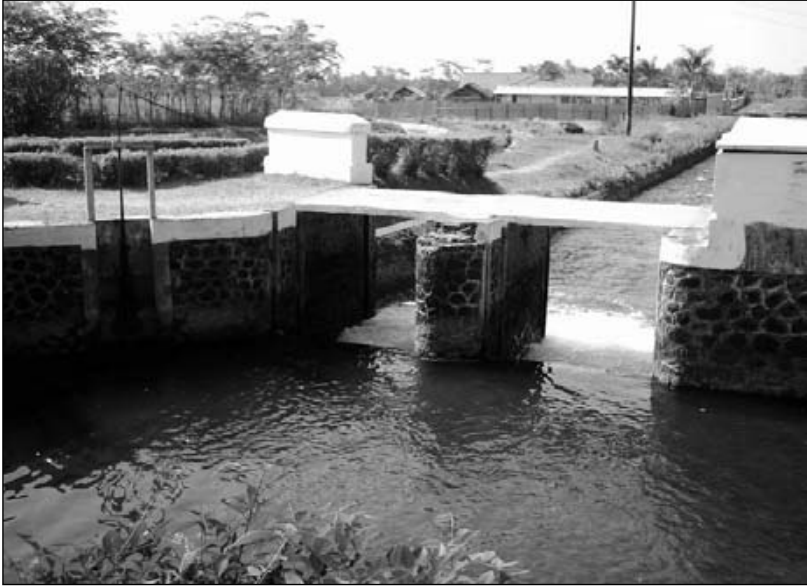
<p><u>Category</u> Irrigation (Main Canal)</p>			
		<p><u>Structure</u> Division Structure</p>			
		<p><u>Condition</u> <input type="checkbox"/> A <input type="checkbox"/> B <input checked="" type="checkbox"/> C <input type="checkbox"/> D</p>			
		<p><u>Problems</u> Require major repair of civil works and provision of steel gates</p>

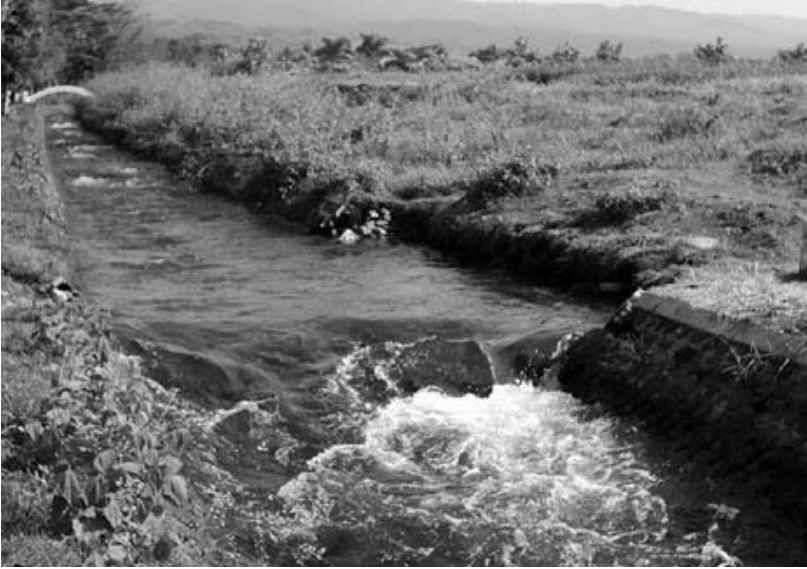
<p><u>Category</u> Irrigation (Secondary Canal)</p>			
		<p><u>Structure</u> Canal</p>			
		<p><u>Condition</u> <input type="checkbox"/> A <input type="checkbox"/> B <input type="checkbox"/> C <input checked="" type="checkbox"/> D</p>			
		<p><u>Problems</u> Require total repair of lining and provision of inspection road</p>

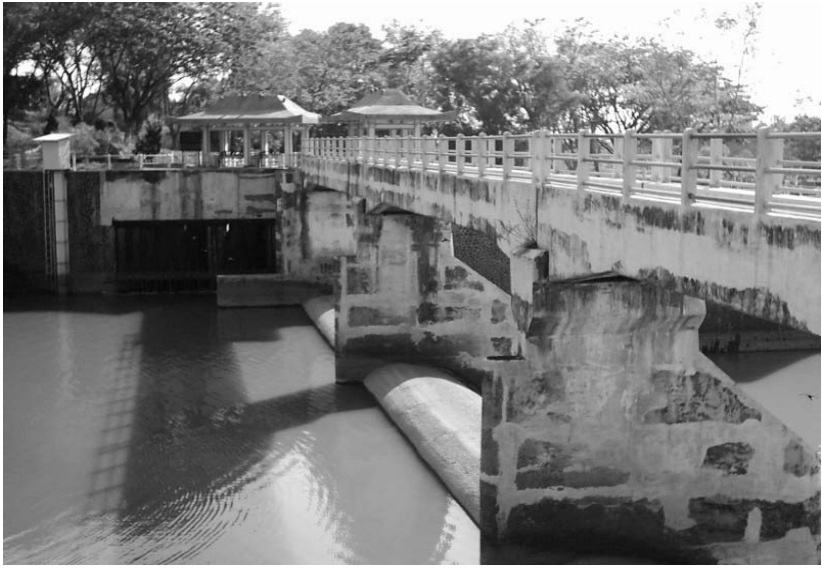
<p><u>Category</u> Irrigation (Headworks)</p>		
		<p><u>Structure</u> Fixed Weir, Upstream View</p>		
		<p><u>Condition</u> <input type="checkbox"/> A <input type="checkbox"/> B <input checked="" type="checkbox"/> C <input type="checkbox"/> D</p>		
		<p><u>Problems</u> Require repair for civil and gate works and widening of inspection bridge</p>

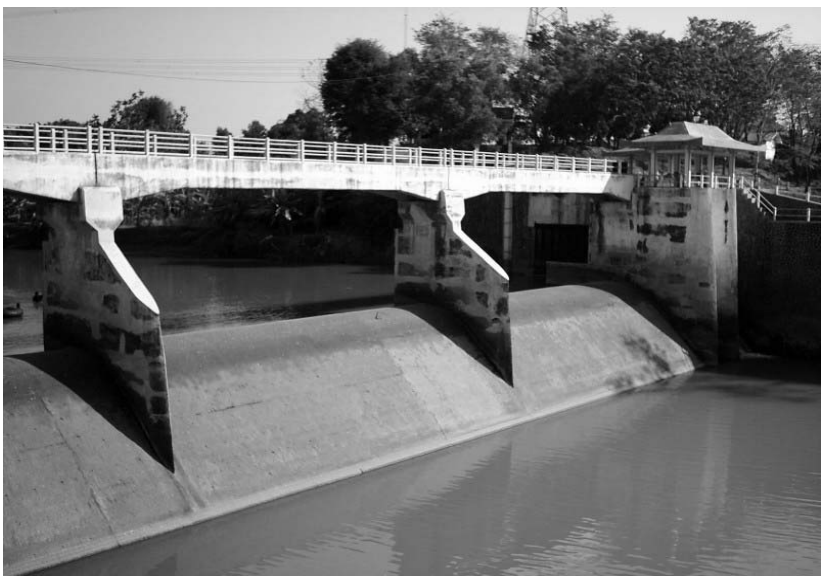
<p><u>Category</u> Irrigation (Headworks)</p>		
		<p><u>Structure</u> Fixed Weir, Downstream View</p>		
		<p><u>Condition</u> <input type="checkbox"/> A <input type="checkbox"/> B <input checked="" type="checkbox"/> C <input type="checkbox"/> D</p>		
		<p><u>Problems</u> Require repair for civil ad gate works and widening of inspection bridge</p>

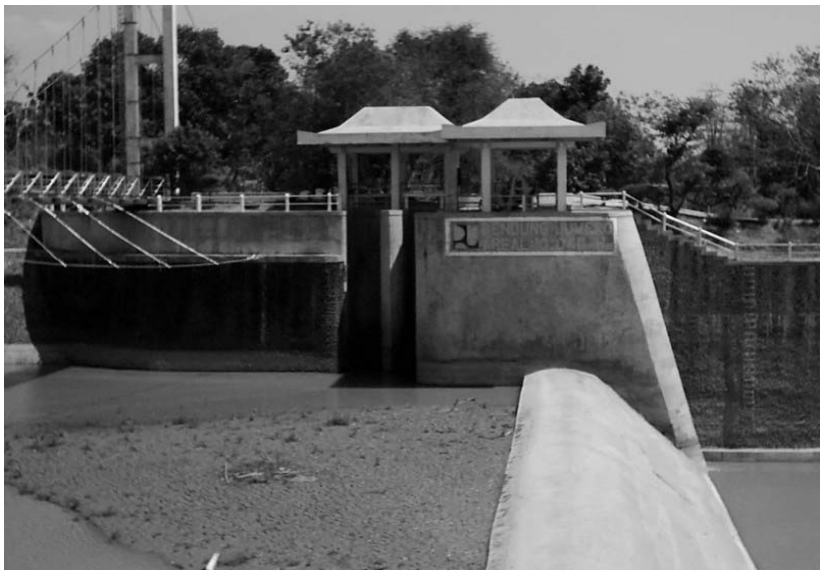
<i>Category</i> Irrigation (Headworks)		
		<i>Structure</i> Fixed Weir and Intake		
		<i>Condition</i> <input type="checkbox"/> A <input type="checkbox"/> B <input checked="" type="checkbox"/> C <input type="checkbox"/> D		
		<i>Problems</i> Require removal of sediment in front of intake, require repair of civil and gate works

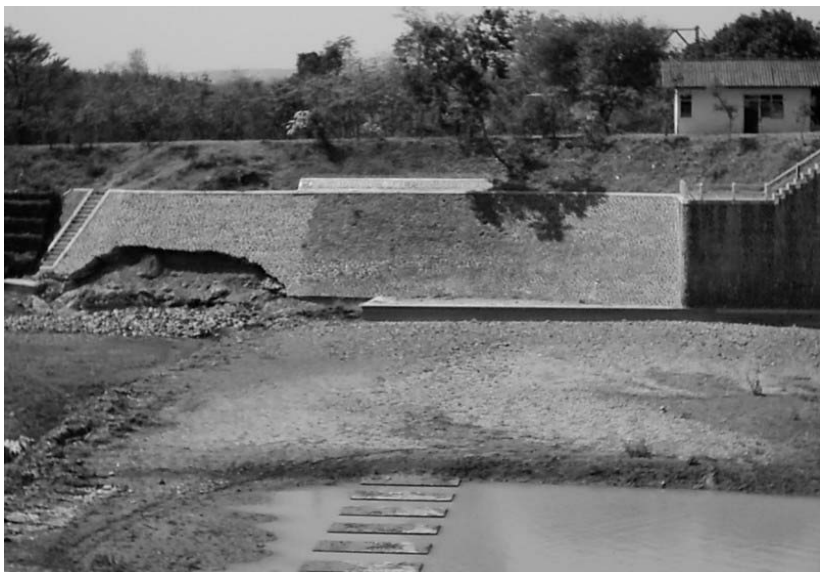
<i>Category</i> Irrigation (Headworks)		
		<i>Structure</i> Fixed Weir, Retaining Wall		
		<i>Condition</i> <input type="checkbox"/> A <input type="checkbox"/> B <input checked="" type="checkbox"/> C <input type="checkbox"/> D		
		<i>Problems</i> Require repair of retaining wall

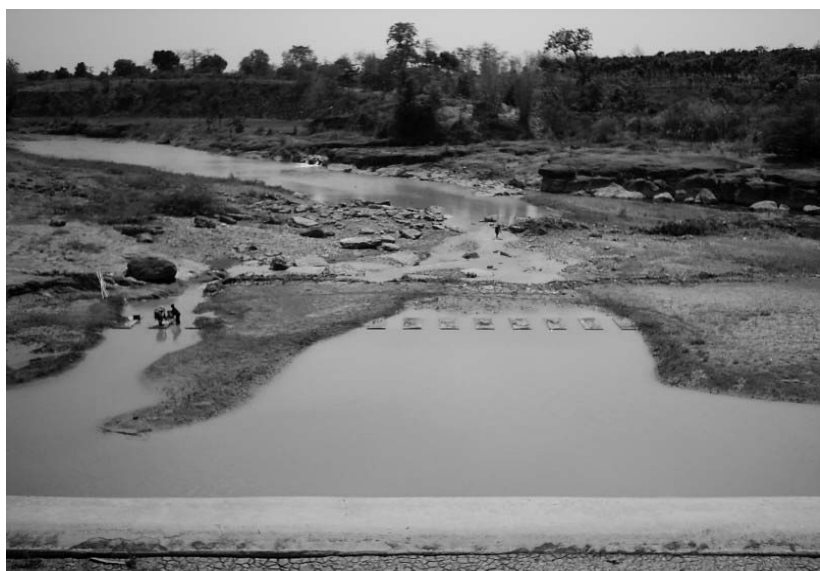
<i>Category</i> Irrigation (Headworks)		
		<i>Structure</i> Fixed Weir, Downstream View		
		<i>Condition</i> <input type="checkbox"/> A <input type="checkbox"/> B <input type="checkbox"/> C <input checked="" type="checkbox"/> D

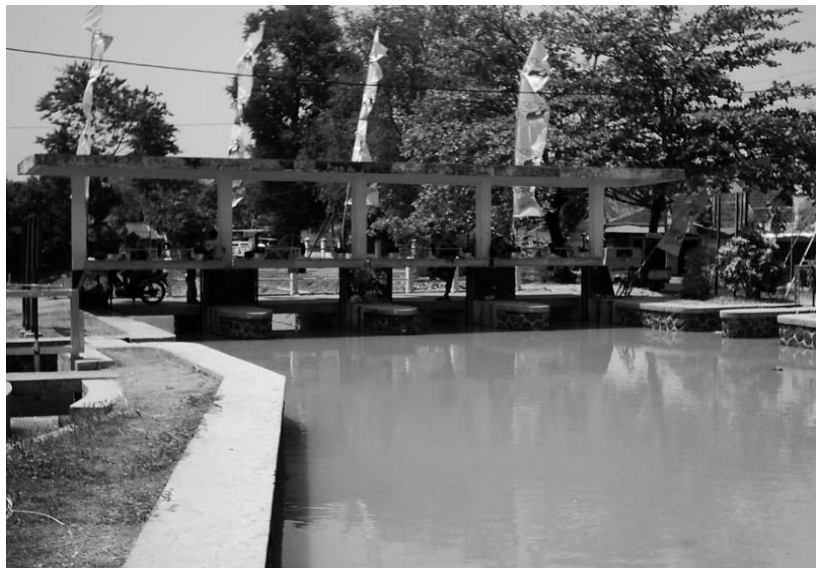
<i>Category</i> Irrigation (Headworks)			
		<i>Structure</i> Movable Weir, Upstream View			
		<i>Condition</i> <input type="checkbox"/> A <input type="checkbox"/> B <input checked="" type="checkbox"/> C <input type="checkbox"/> D			
		<i>Problems</i> Require major repair for civil and gate works

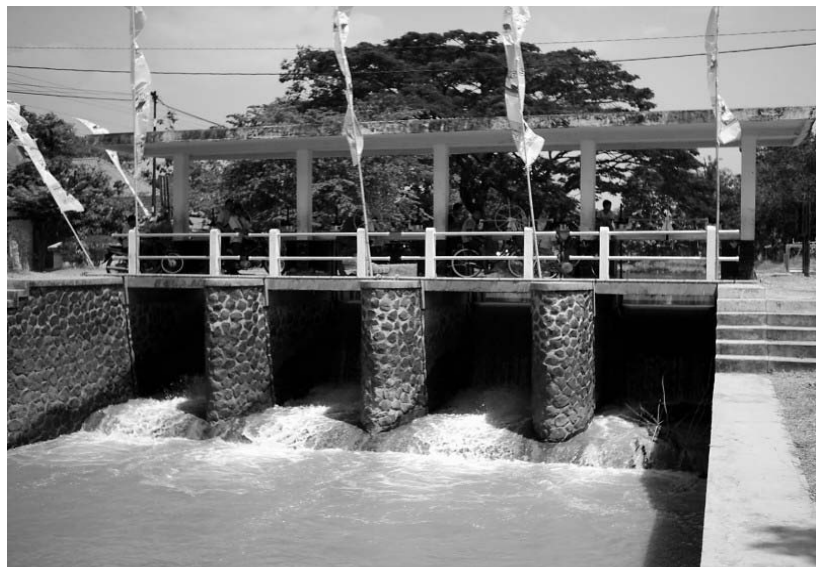
<i>Category</i> Irrigation (Headworks)			
		<i>Structure</i> Movable Weir, Rear View			
		<i>Condition</i> <input type="checkbox"/> A <input type="checkbox"/> B <input checked="" type="checkbox"/> C <input type="checkbox"/> D			
		<i>Problems</i> Require major repair for civil and gate works

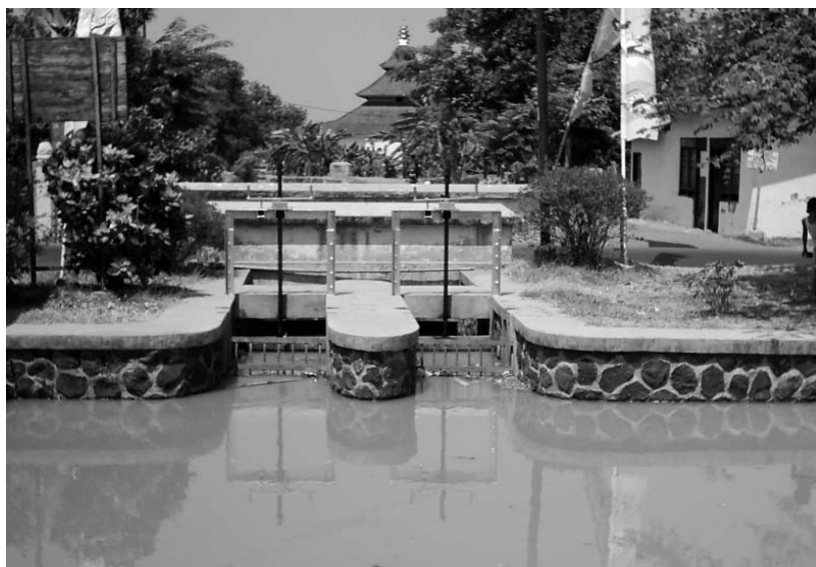
<i>Category</i> Irrigation (Main Canal)			
		<i>Structure</i> Off-take Structure			
		<i>Condition</i> <input type="checkbox"/> A <input type="checkbox"/> B <input checked="" type="checkbox"/> C <input type="checkbox"/> D

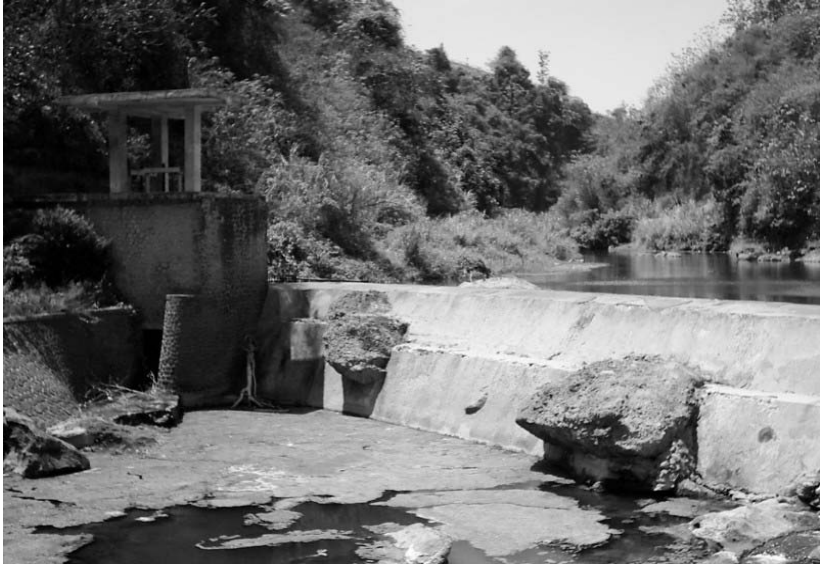
<i>Category</i> Irrigation (Headworks)	
		<i>Structure</i> Fixed Weir, Downstream View	
		<i>Condition</i> <input type="checkbox"/> A <input type="checkbox"/> B <input type="checkbox"/> C <input checked="" type="checkbox"/> D	
		<i>Problems</i> Require new construction

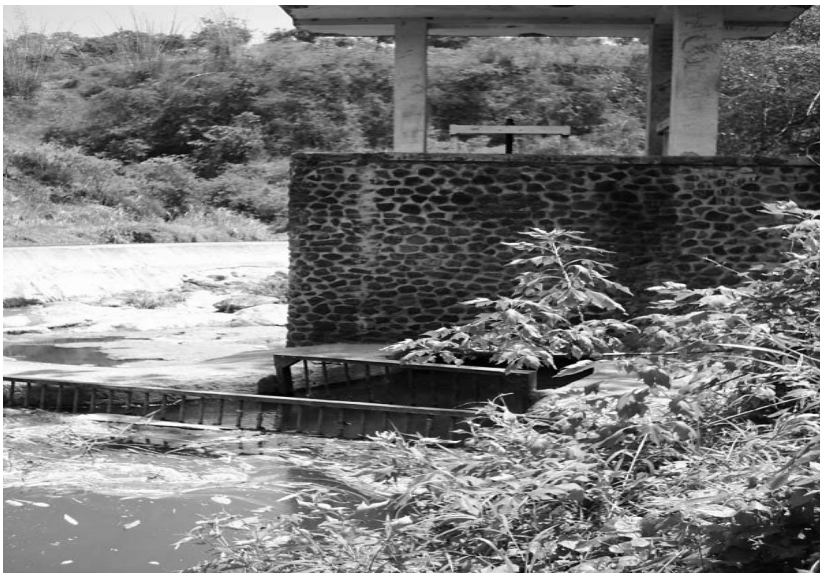
<i>Category</i> Irrigation (Headworks)	
		<i>Structure</i> Fixed Weir, Intake	
		<i>Condition</i> <input type="checkbox"/> A <input type="checkbox"/> B <input type="checkbox"/> C <input checked="" type="checkbox"/> D	
		<i>Problems</i> Require new construction

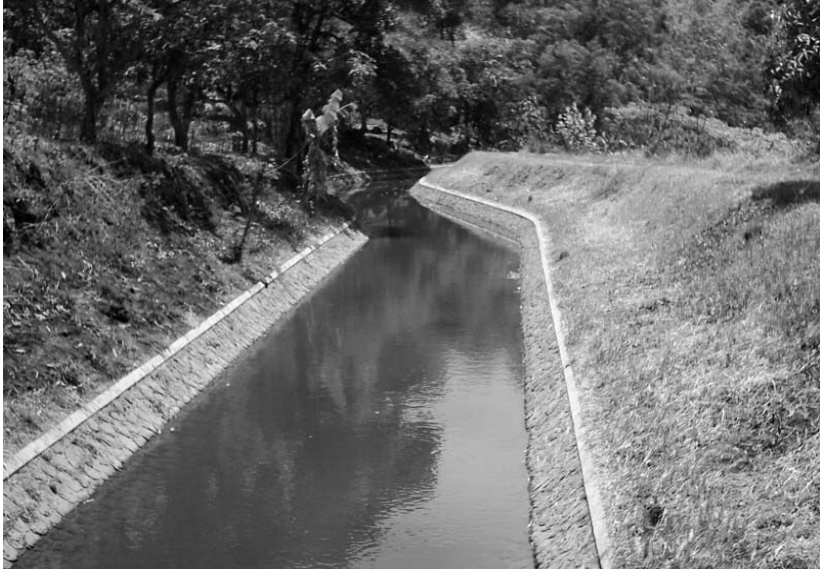
<i>Category</i> Irrigation (Main Canal)	
		<i>Structure</i> Masonry Lined Canal at Downstream of Intake	
		<i>Condition</i> <input type="checkbox"/> A <input type="checkbox"/> B <input checked="" type="checkbox"/> C <input type="checkbox"/> D

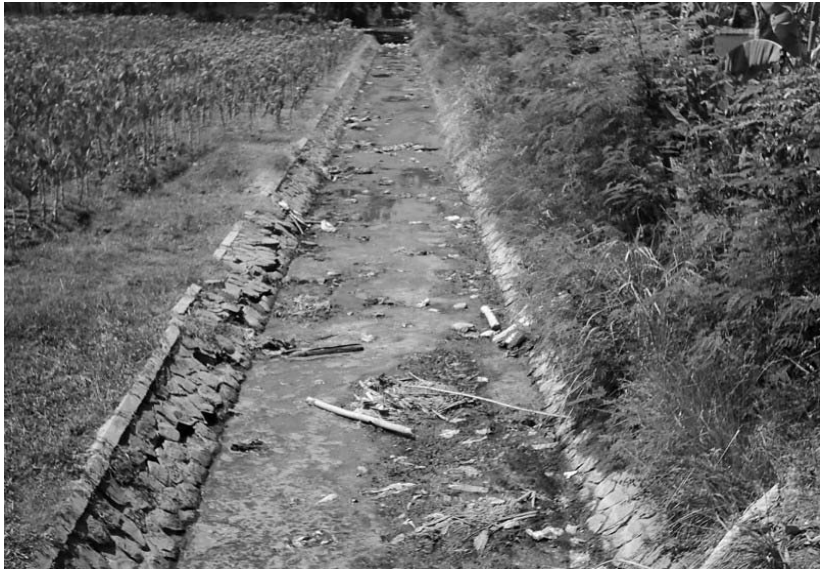
<i>Category</i> Irrigation (Secondary Canal)		
		<i>Structure</i> Masonry Lined Canal		
		<i>Condition</i> <input type="checkbox"/> A <input type="checkbox"/> B <input checked="" type="checkbox"/> C <input type="checkbox"/> D		
		<i>Problems</i> Require major repair of canal and removal of sediments

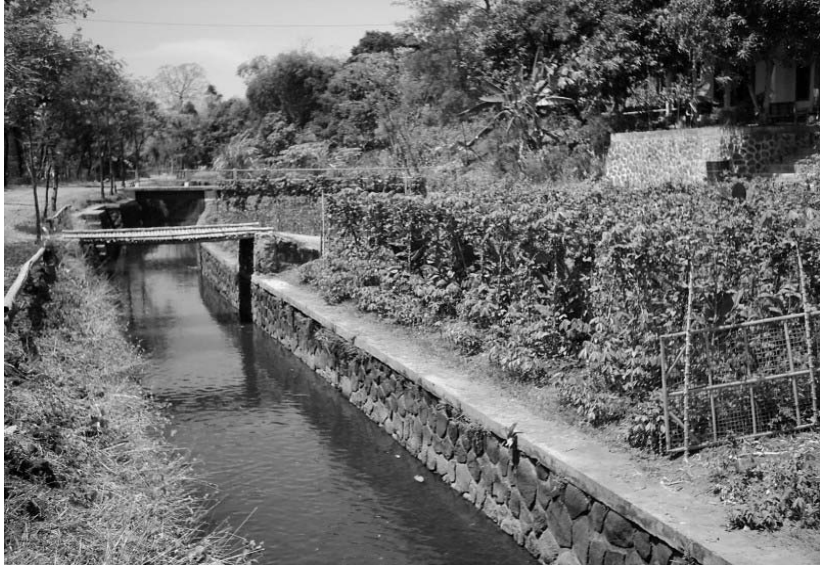
<i>Category</i> Irrigation (Secondary Canal)		
		<i>Structure</i> Masonry Lined Canal		
		<i>Condition</i> <input type="checkbox"/> A <input type="checkbox"/> B <input checked="" type="checkbox"/> C <input type="checkbox"/> D		
		<i>Problems</i> Require major repair of canal and removal of sediments

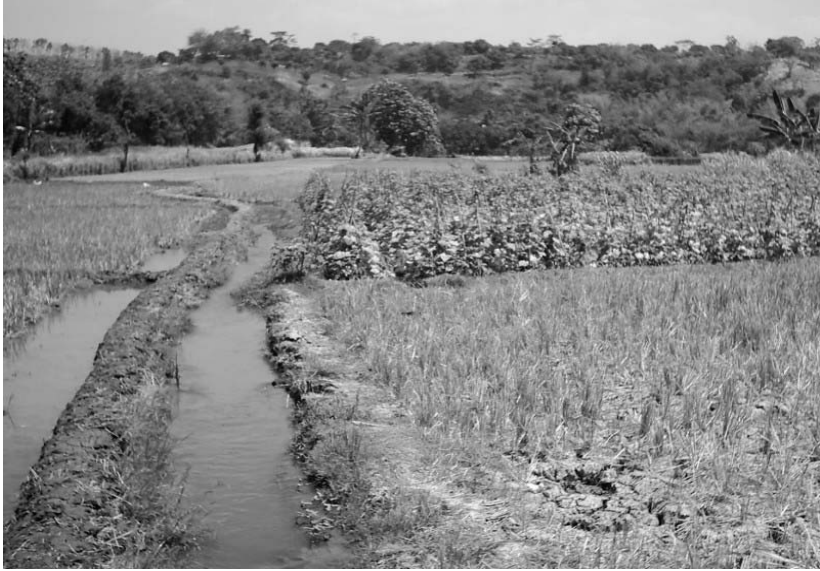
<i>Category</i> Irrigation (Tertiary Canal)		
		<i>Structure</i> Tertiary Canal		
		<i>Condition</i> <input type="checkbox"/> A <input type="checkbox"/> B <input checked="" type="checkbox"/> C <input checked="" type="checkbox"/> D

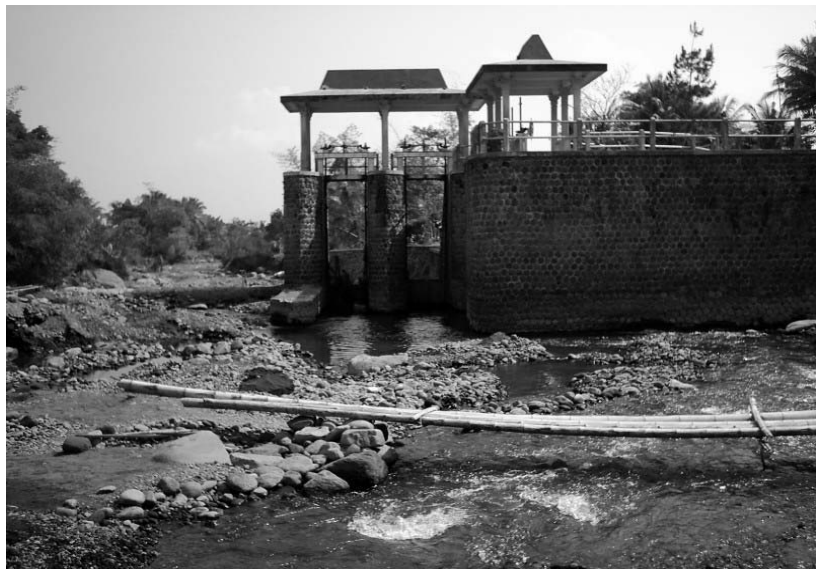
<i>Category</i> Irrigation (Headworks)			
		<i>Structure</i> Intake and Scouring Sluice			
		<i>Condition</i> <input type="checkbox"/> A <input type="checkbox"/> B <input checked="" type="checkbox"/> C <input type="checkbox"/> D			
		<i>Problems</i> Require major repair for civil and gate works

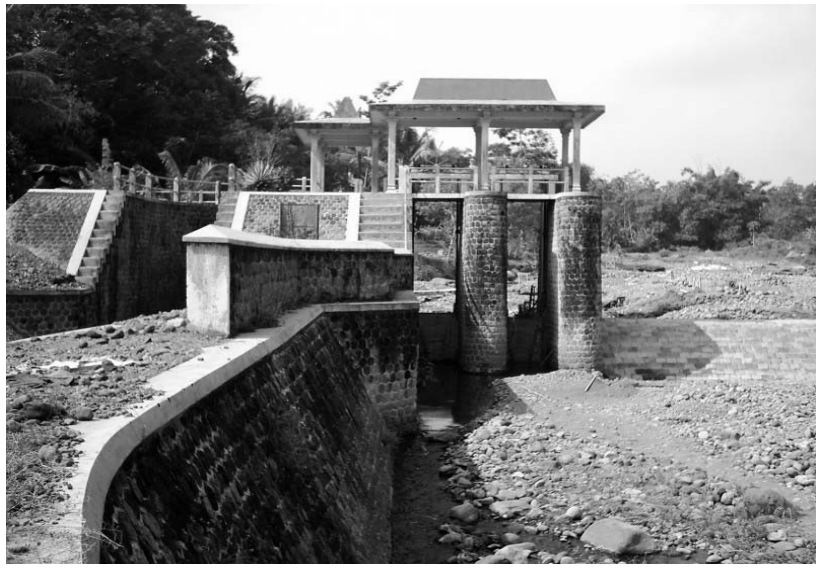
<i>Category</i> Irrigation (Headworks)			
		<i>Structure</i> Fixed Weir, Rear View			
		<i>Condition</i> <input type="checkbox"/> A <input type="checkbox"/> B <input checked="" type="checkbox"/> C <input type="checkbox"/> D			
		<i>Problems</i> Require major repair for civil and gate works

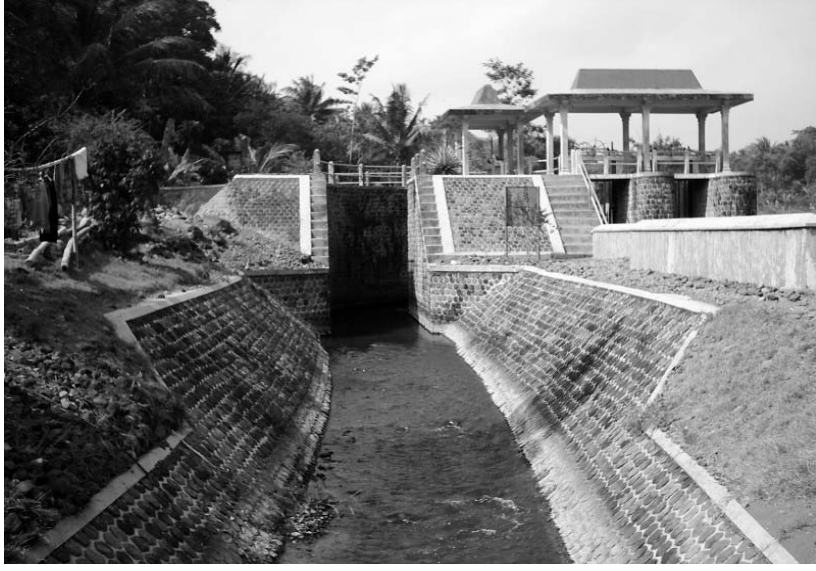
<i>Category</i> Irrigation (Headworks)			
		<i>Structure</i> Intake, Rear View			
		<i>Condition</i> <input type="checkbox"/> A <input type="checkbox"/> B <input checked="" type="checkbox"/> C <input type="checkbox"/> D

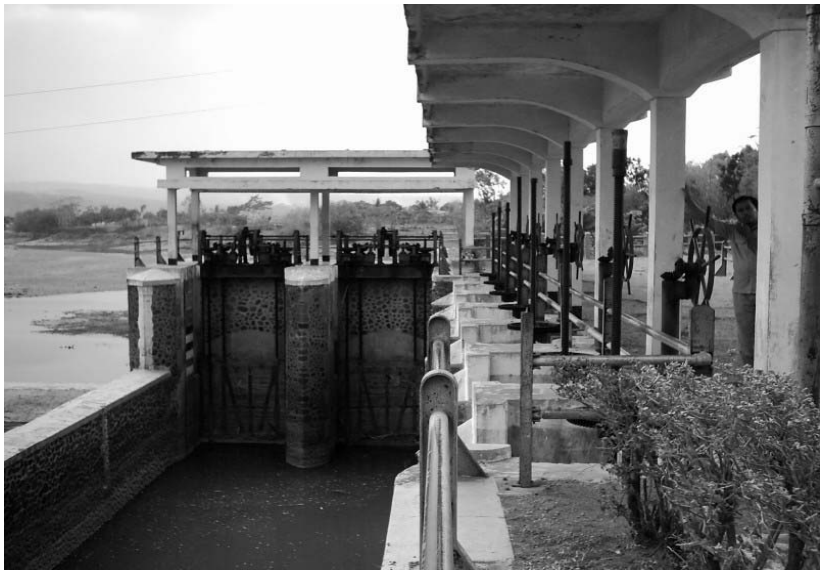
<i>Category</i> Irrigation (Headworks)		
		<i>Structure</i> Fixed Weir, Intake and Scouring Sluice		
		<i>Condition</i> <input type="checkbox"/> A <input type="checkbox"/> B <input checked="" type="checkbox"/> C <input type="checkbox"/> D		
		<i>Problems</i> Require major repair of civil works and to replace gate leaf by steel construction

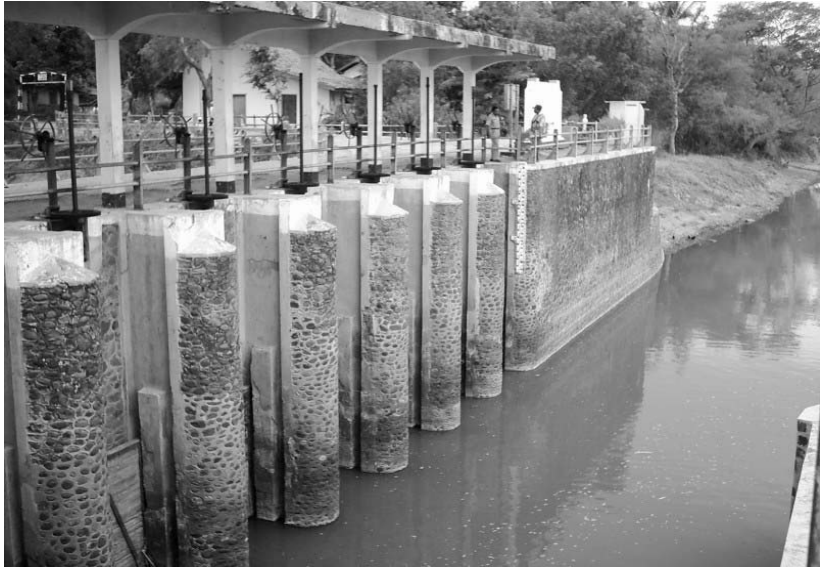
<i>Category</i> Irrigation (Headworks)		
		<i>Structure</i> Intake		
		<i>Condition</i> <input type="checkbox"/> A <input type="checkbox"/> B <input checked="" type="checkbox"/> C <input type="checkbox"/> D		
		<i>Problems</i> Require major repair of civil works and to replace gate leaf by steel construction

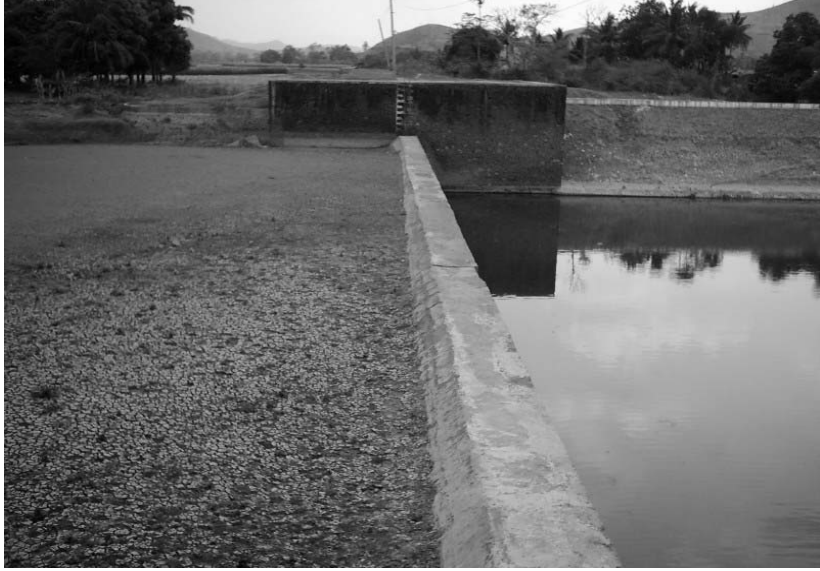
<i>Category</i> Irrigation (Headworks)		
		<i>Structure</i> Overflow Weir		
		<i>Condition</i> <input type="checkbox"/> A <input type="checkbox"/> B <input checked="" type="checkbox"/> C <input type="checkbox"/> D

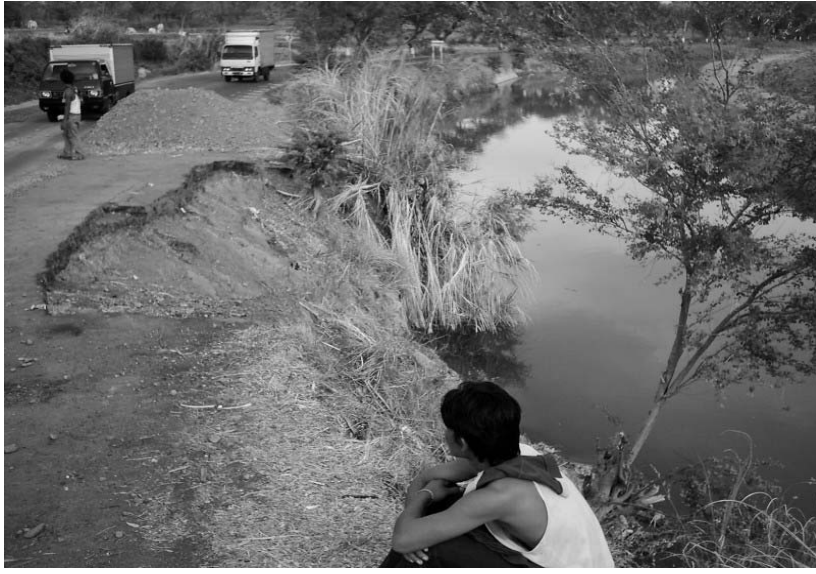
<i>Category</i> Irrigation (Secondary Canal)		
		<i>Structure</i> Canal		
		<i>Condition</i> <input type="checkbox"/> A <input type="checkbox"/> B <input checked="" type="checkbox"/> C <input type="checkbox"/> D		
		<i>Problems</i> Require removal of sediments and repair / replacement of lining		
 		<i>Category</i> Irrigation (Paddy Field)		
		<i>Structure</i> Field Canal and Paddy Field		
		<i>Condition</i> <input type="checkbox"/> A <input type="checkbox"/> B <input checked="" type="checkbox"/> C <input type="checkbox"/> D

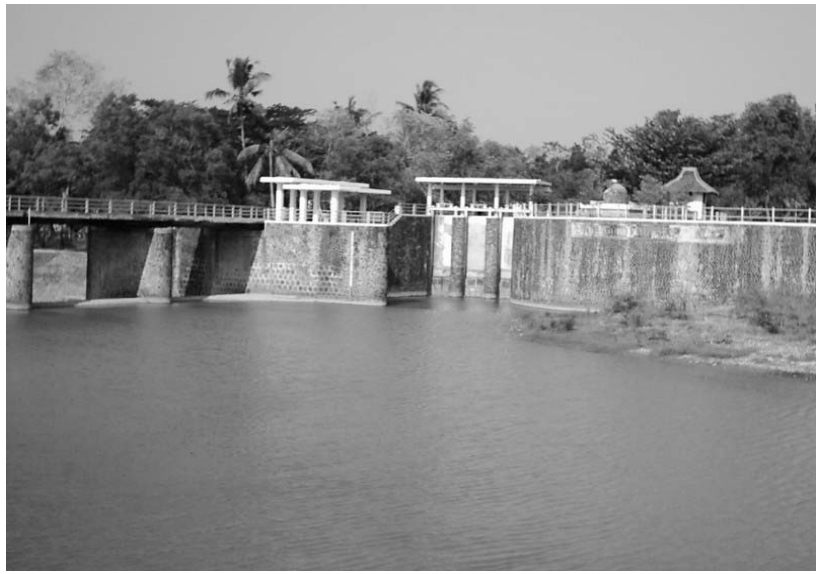
<i>Category</i> Irrigation (Headworks)		
		<i>Structure</i> Fixed Weir, Intake and Scouring Sluice		
		<i>Condition</i> <input type="checkbox"/> A <input type="checkbox"/> B <input checked="" type="checkbox"/> C <input type="checkbox"/> D		
		<i>Problems</i> Require repair for civil and gate works

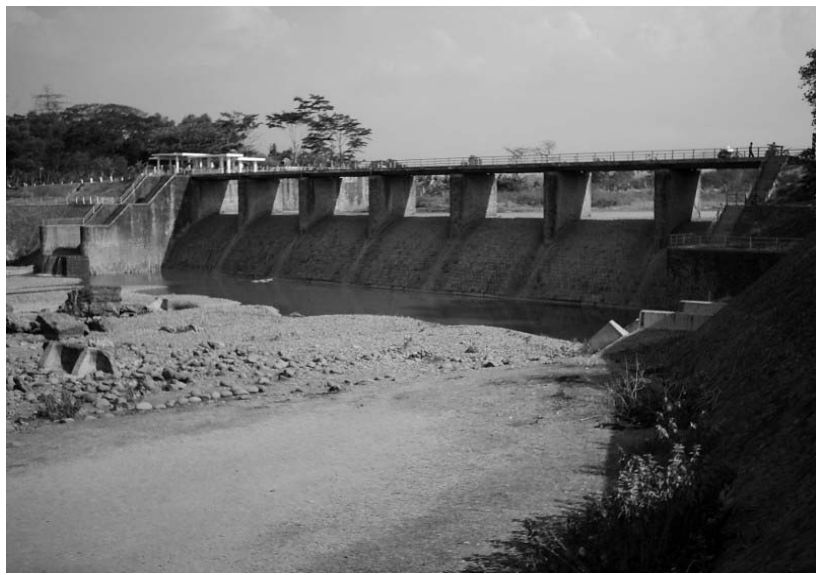
<i>Category</i> Irrigation (Headworks)		
		<i>Structure</i> Fixed Weir, Downstream View		
		<i>Condition</i> <input type="checkbox"/> A <input type="checkbox"/> B <input checked="" type="checkbox"/> C <input type="checkbox"/> D		
		<i>Problems</i> Require repairing of stilling basin and protection work

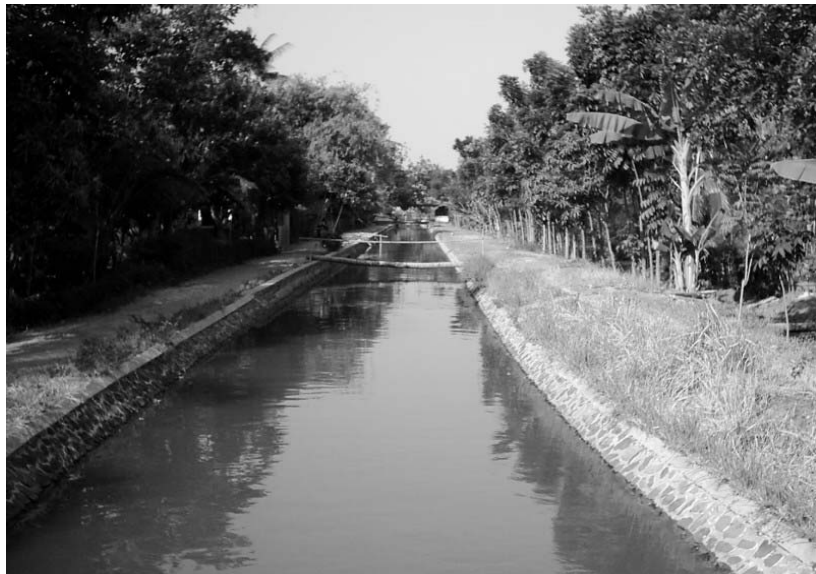
<i>Category</i> Irrigation (Main Canal)		
		<i>Structure</i> Masonry Lined Canal		
		<i>Condition</i> <input type="checkbox"/> A <input checked="" type="checkbox"/> B <input type="checkbox"/> C <input type="checkbox"/> D

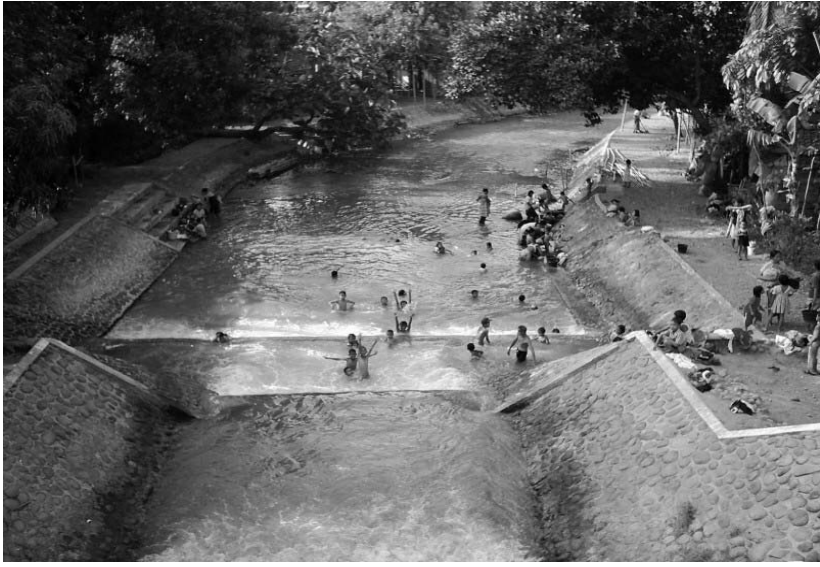
<p><u>Category</u> Irrigation (Main Canal)</p>		
		<p><u>Structure</u> Masonry Lined Canal</p>		
		<p><u>Condition</u> <input type="checkbox"/> A <input checked="" type="checkbox"/> B <input type="checkbox"/> C <input type="checkbox"/> D</p>		
		<p><u>Problems</u> Require minor repairs of canal and widening of inspection road</p>
