The Study on Comprehensive Recovery Program of Irrigation Agriculture
Japan International Cooperation Agency

Location Map of Irrigation Schemes in Pekalongan District

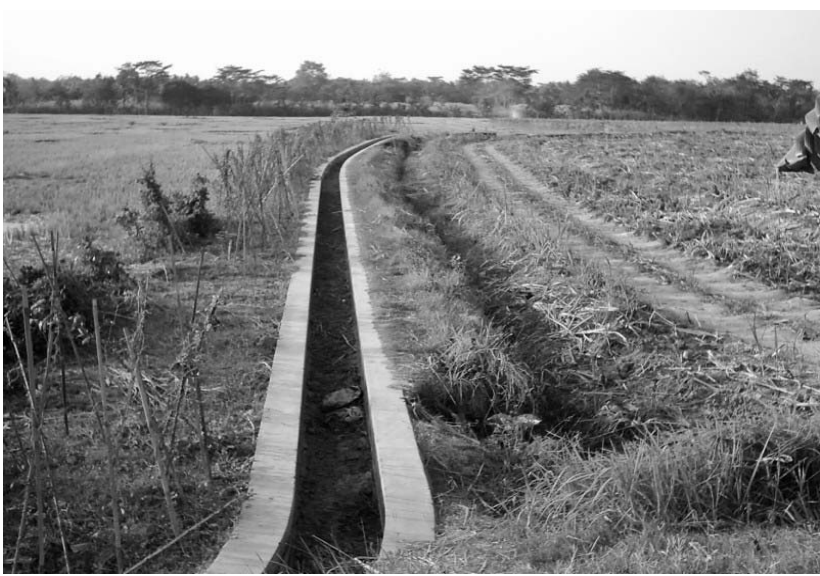
<p><u>Category</u> Irrigation (Tertiary Canal)</p>		
		<p><u>Structure</u> Masonry Lined Canal</p>		
		<p><u>Condition</u> <input type="checkbox"/> A <input type="checkbox"/> B <input checked="" type="checkbox"/> C <input type="checkbox"/> D</p>		
		<p><u>Problems</u> Require division box, farm road, etc.</p>
