# ***PART-III***

***Present Condition and  
Pre-F/S level Development Plan  
for Each Irrigation Scheme***

The Study on Comprehensive Recovery Program  
of Irrigation Agriculture

**Location Map of Irrigation Schemes  
in Bulukumba District**

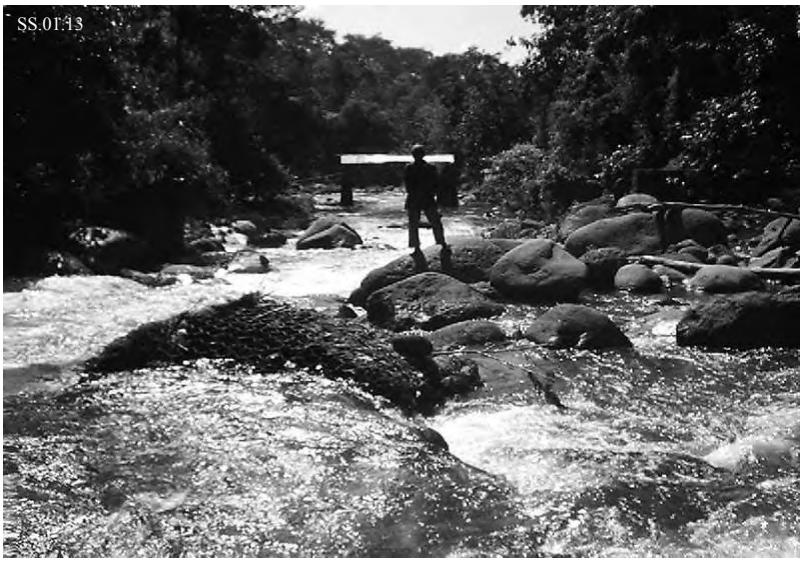
<p><u>Category</u> Irrigation (Headworks)</p> <hr/> <p><u>Structure</u> Fixed Weir</p> <hr/> <p><u>Condition</u>  <input type="checkbox"/> A    <input type="checkbox"/> B    <input checked="" type="checkbox"/> C    <input type="checkbox"/> D</p> <hr/> <p><u>Problems</u> Crack or damage on wier crest; settlement of weir body; deflection of pier of weir.</p>

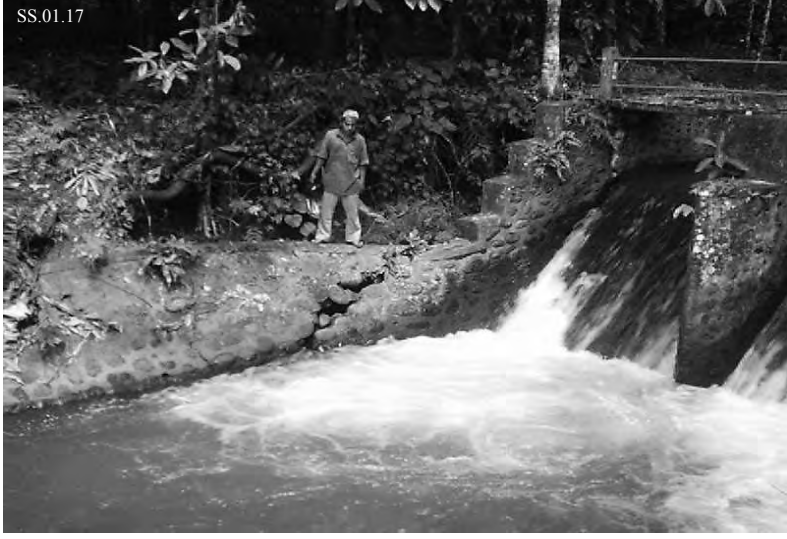
<p><u>Category</u> Irrigation (Headworks)</p> <hr/> <p><u>Structure</u> Fixed Weir</p> <hr/> <p><u>Condition</u>  <input type="checkbox"/> A    <input type="checkbox"/> B    <input checked="" type="checkbox"/> C    <input type="checkbox"/> D</p> <hr/> <p><u>Problems</u> Crack or damage on weir crest; settlement of weir body; deflection of pier of weir; crack on retaining wall of weir.</p>

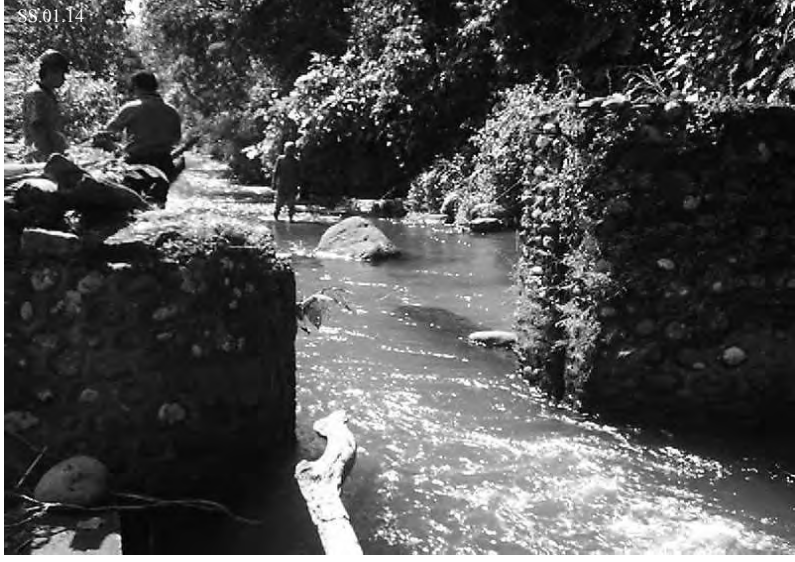
<p><u>Category</u> Irrigation (Headworks)</p> <hr/> <p><u>Structure</u> Intake</p> <hr/> <p><u>Condition</u>  <input type="checkbox"/> A    <input type="checkbox"/> B    <input checked="" type="checkbox"/> C    <input type="checkbox"/> D</p> <hr/> <p><u>Problems</u> No intake gate was provided</p>

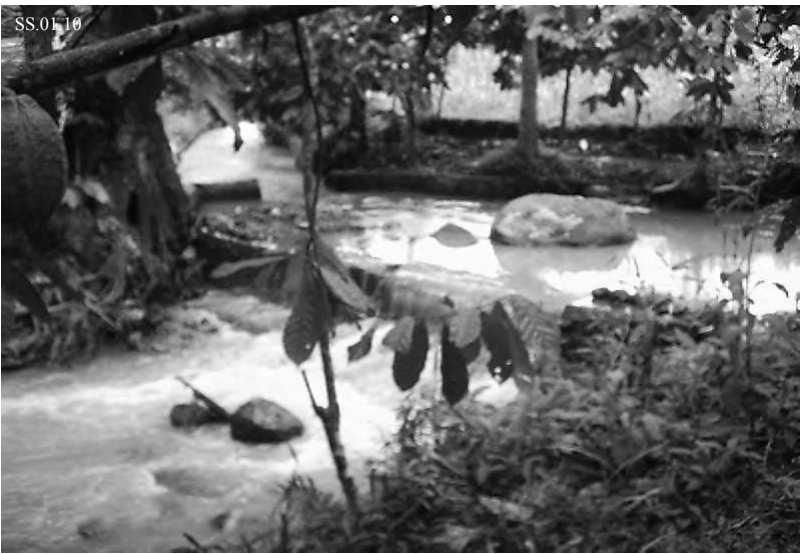
<p><u>Category</u> Irrigation (Main Canal)</p>			
		<p><u>Structure</u> Main Canal</p>			
		<p><u>Condition</u>  <input type="checkbox"/> A    <input type="checkbox"/> B    <input type="checkbox"/> C    <input checked="" type="checkbox"/> D</p>			
		<p><u>Problems</u> Sedimentation; leakage from canal; collapse of canal; difficulty on maintenance of earth canal; no inspection road.</p>			
 		<p><u>Category</u> Agriculture, On-Farm</p>			
		<p><u>Activity</u> Land Preparation</p>			
		<p><u>Condition</u>  <input type="checkbox"/> A    <input type="checkbox"/> B    <input type="checkbox"/> C    <input checked="" type="checkbox"/> D</p>			
		<p><u>Problems</u> Low density of on-farm canals and farm roads.</p>			
 		<p><u>Category</u> Agriculture, On-Farm</p>			
		<p><u>Activity</u> Paddy Field</p>

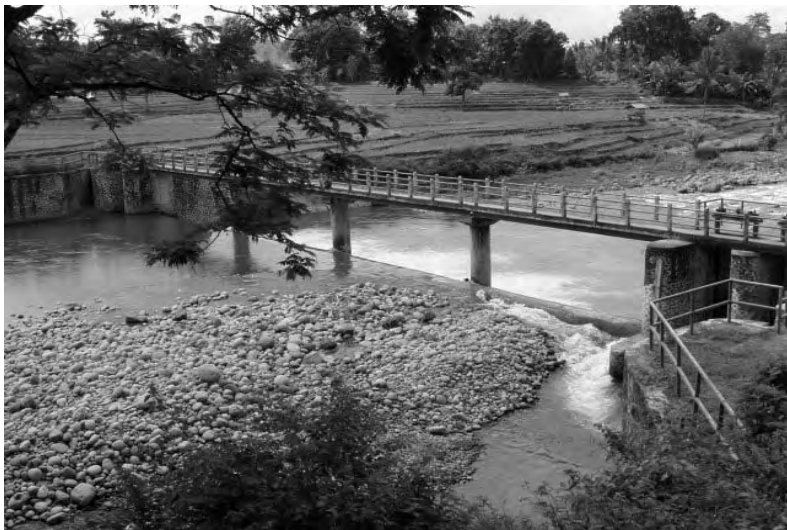
<p><u>Category</u> Irrigation (Headworks)</p>			
		<p><u>Structure</u> Fixed Weir</p>			
		<p><u>Condition</u>  <input type="checkbox"/> A    <input type="checkbox"/> B    <input checked="" type="checkbox"/> C    <input type="checkbox"/> D</p>

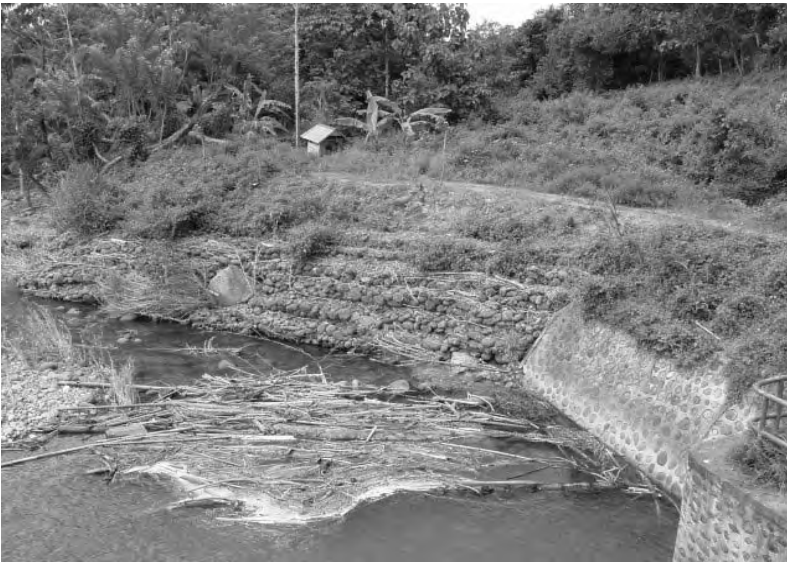
<p><u>Category</u> Irrigation (Headworks)</p>			
		<p><u>Structure</u> Gabion on Right of Weir</p>			
		<p><u>Condition</u>  <input type="checkbox"/> A    <input type="checkbox"/> B    <input checked="" type="checkbox"/> C    <input type="checkbox"/> D</p>

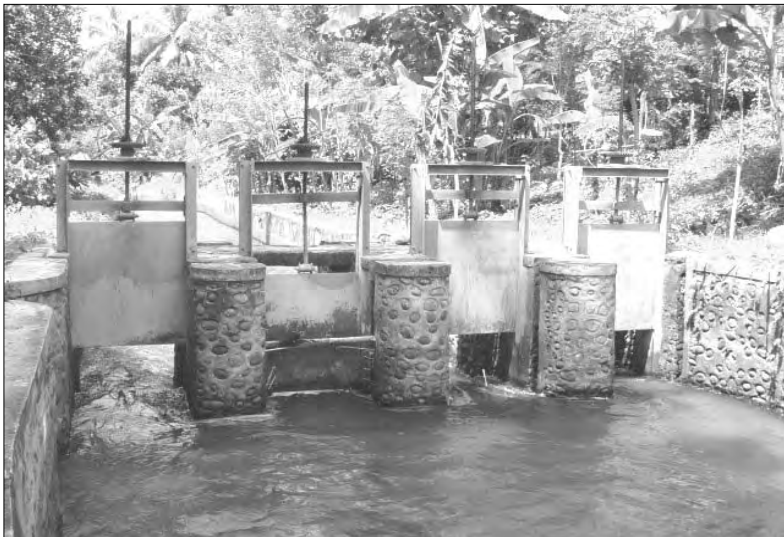
<p><u>Category</u> Irrigation (Main Canal)</p>			
		<p><u>Structure</u> Division Structure</p>			
		<p><u>Condition</u>  <input type="checkbox"/> A    <input type="checkbox"/> B    <input type="checkbox"/> C    <input checked="" type="checkbox"/> D</p>			
		<p><u>Problems</u> Crack or damage on weir crest; settlement of weir body; deflection of pier of weir</p>

<p><u>Problems</u> Washed away of riprap or blocks at downstream of stilling basin; sedimentation.</p>			
		<p><u>Problems</u> Lower function of division structure due to sedimentation in front of structure.</p>
