The Study on Comprehensive Recovery Program
of Irrigation Agriculture

Japan International Cooperation Agency

I. PROJECT FUNDAMENTALS										
I.1 General										
(1) Code Number	: 73050051	(7) Number of Farmers	: 782							
(2) Name of Irrigation Scheme	: Jenemarrung	(8) Water Resource River	: Jenemarrung

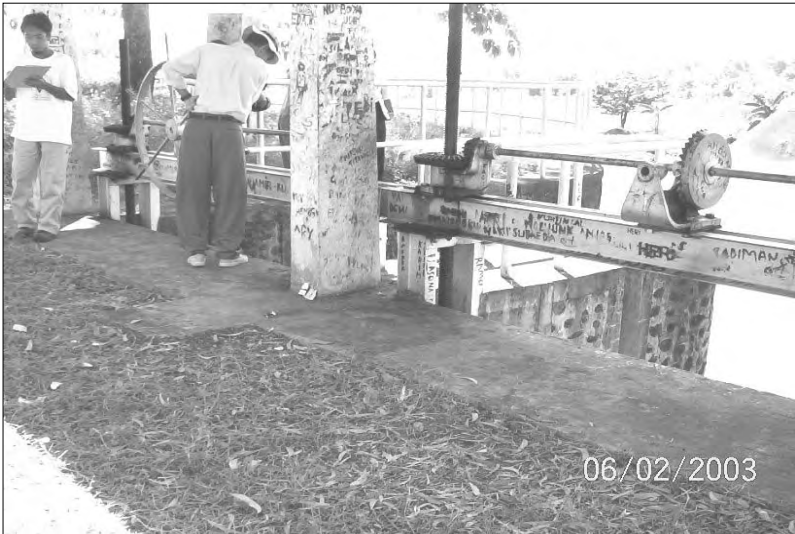
<i>Category</i> Irrigation (Headworks)		
		<i>Structure</i> Intake		
		<i>Condition</i> <input type="checkbox"/> A <input type="checkbox"/> B <input checked="" type="checkbox"/> C <input type="checkbox"/> D

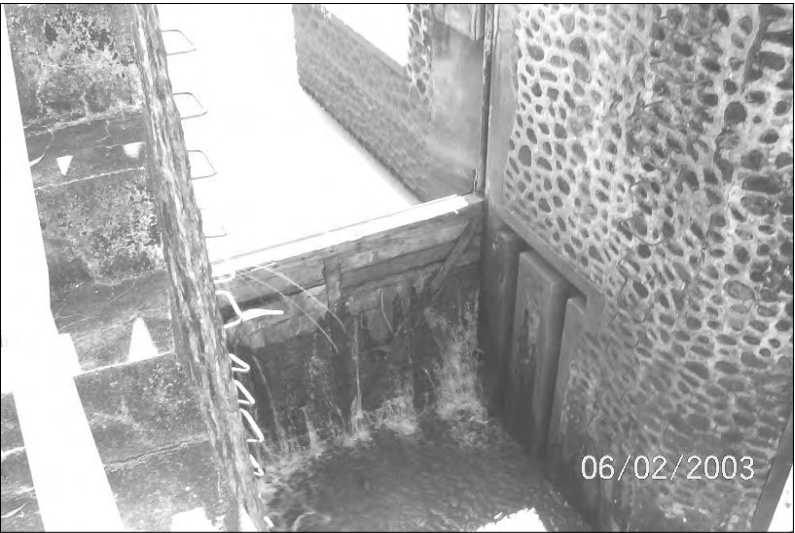
<i>Category</i> Irrigation (Headworks)		
		<i>Structure</i> Intake Gate		
		<i>Condition</i> <input type="checkbox"/> A <input type="checkbox"/> B <input checked="" type="checkbox"/> C <input type="checkbox"/> D

<i>Problems</i> Leakage from gate leaf; insufficient strength against design load due to rust, decay of steel material; problem on management due to lack of periodically maintenance

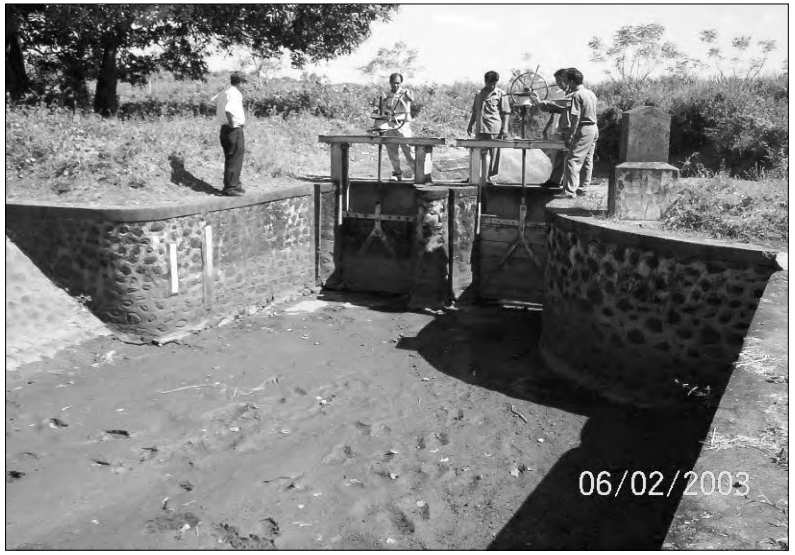
<i>Category</i> Irrigation (Main Canal)		
		<i>Structure</i> Division Structure		
		<i>Condition</i> <input type="checkbox"/> A <input type="checkbox"/> B <input type="checkbox"/> C <input checked="" type="checkbox"/> D

<i>Problems</i> Leakage from gate leaf; insufficient strength against design load due to rust, decay of steel material; problem on management due to lack of periodically maintenance		
		<i>Problems</i> Lower function of division structure due to sedimentation in front of structure; physical operation problem on structure; deterioration of gate.

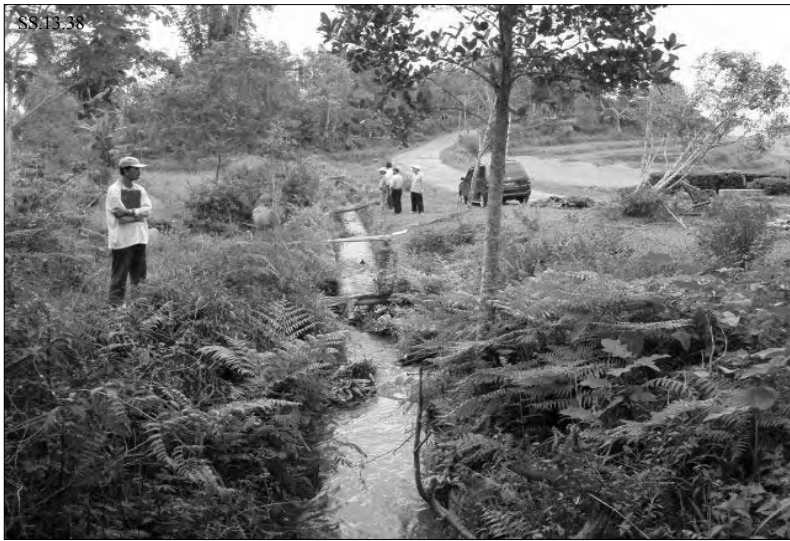
<p><u>Category</u> Irrigation (Secondary Canal)</p>			
		<p><u>Structure</u> Secondary Canal</p>			
		<p><u>Condition</u> <input type="checkbox"/> A <input type="checkbox"/> B <input type="checkbox"/> C <input checked="" type="checkbox"/> D</p>			
		<p><u>Problems</u> Sedimentation, collapse of canal; leakage from canal; difficulty on maintenance of earth canal.</p>

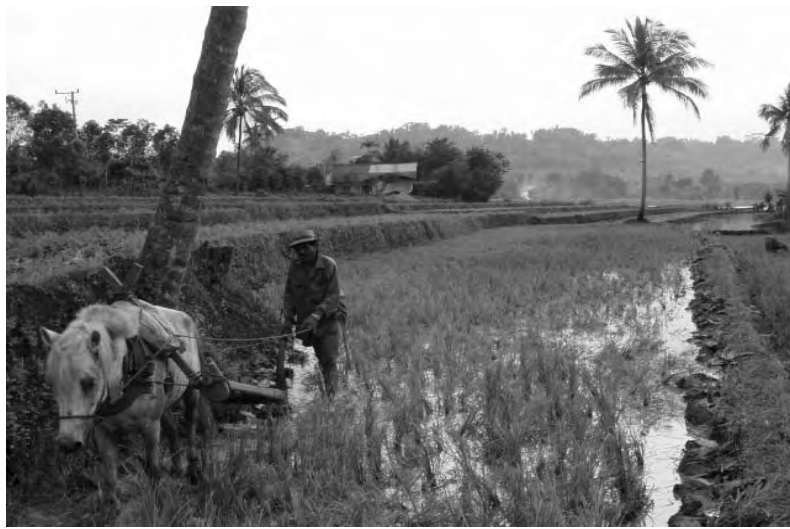
<p><u>Category</u> Agriculture, On-Farm</p>			
		<p><u>Activity</u> Land Preparation by Horse Power</p>			
		<p><u>Condition</u> <input type="checkbox"/> A <input type="checkbox"/> B <input type="checkbox"/> C <input checked="" type="checkbox"/> D</p>			
		<p><u>Problems</u> Low density of on-farm canals and farm roads.</p>

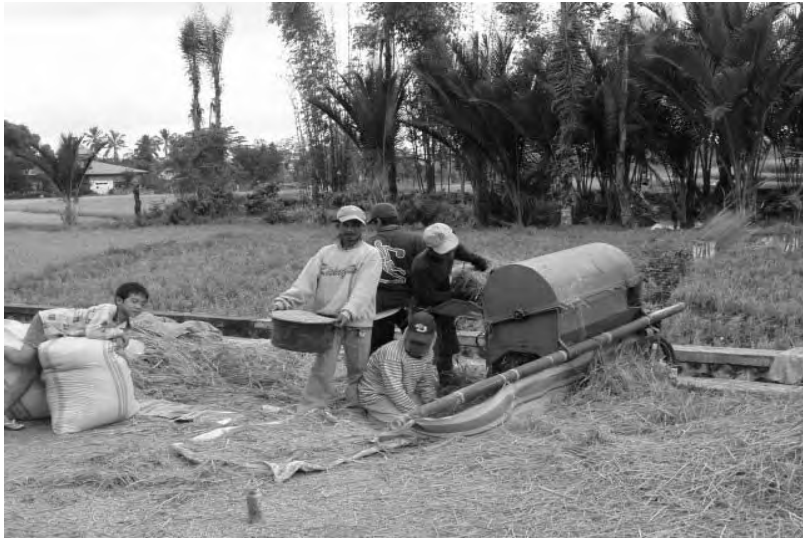
<p><u>Category</u> Agriculture, On-Farm</p>			
		<p><u>Activity</u> Threshing by Power</p>

<p><u>Condition</u> <input type="checkbox"/> A <input type="checkbox"/> B <input type="checkbox"/> C <input checked="" type="checkbox"/> D</p>			
		<p><u>Problems</u></p>
