The Study on Comprehensive Recovery Program
of Irrigation Agriculture

Japan International Cooperation Agency

I. PROJECT FUNDAMENTALS										
I.1 General										
(1) Code Number	: 73080053	(7) Number of Farmers	: 10,514							
(2) Name of Irrigation Scheme	: Bantimurung	(8) Water Resource River	: Bantimurung

Scheme	Bantimurung	District	Maros		
Technical Level	Technical	Registered Area	6,513 ha	Year of Construction	1930/86

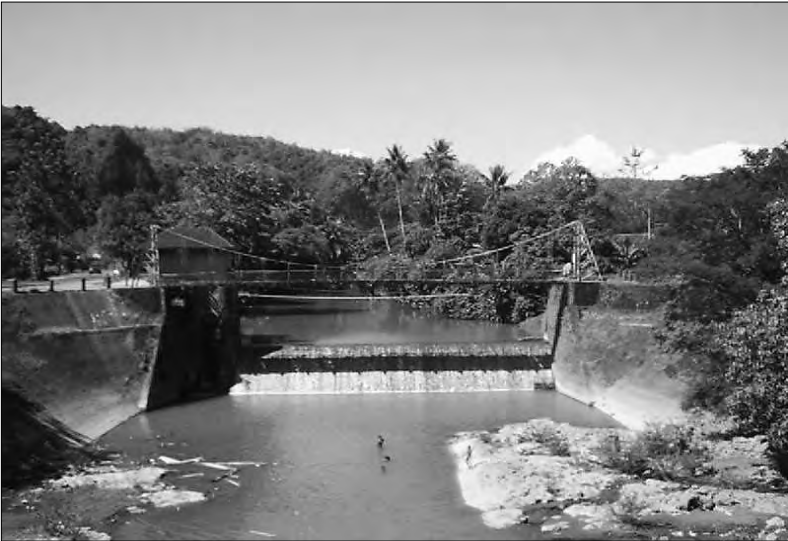
<p><u>Category</u> Irrigation (Headworks)</p>			
		<p><u>Structure</u> Fixed Weir</p>			
		<p><u>Condition</u> <input type="checkbox"/> A <input type="checkbox"/> B <input checked="" type="checkbox"/> C <input type="checkbox"/> D</p>

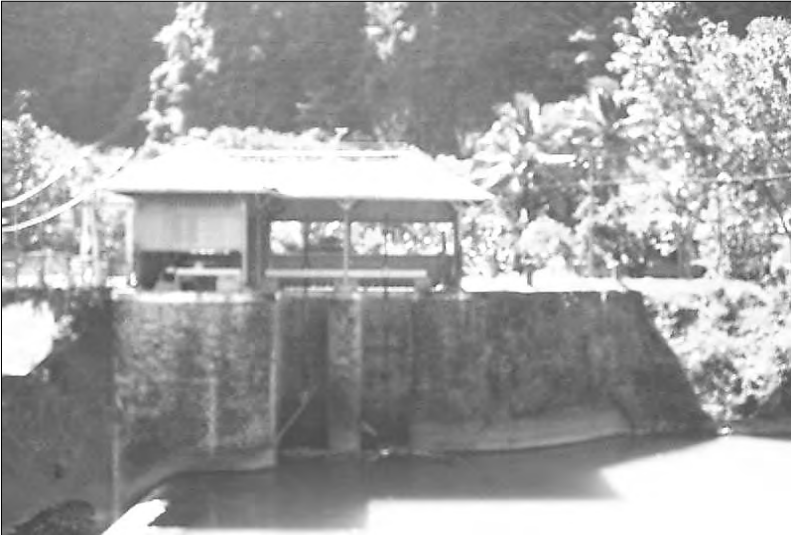
<p><u>Category</u> Irrigation (Headworks)</p>			
		<p><u>Structure</u> Intake</p>			
		<p><u>Condition</u> <input type="checkbox"/> A <input type="checkbox"/> B <input type="checkbox"/> C <input checked="" type="checkbox"/> D</p>

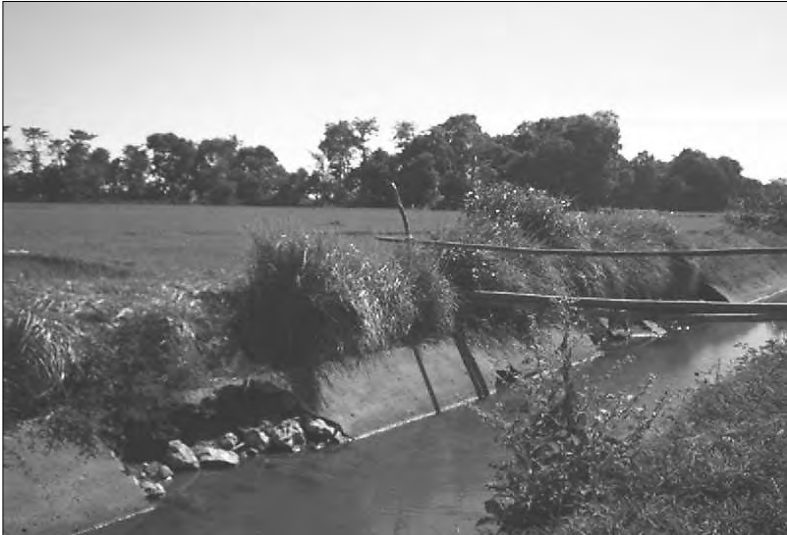
<p><u>Category</u> Irrigation (Main Canal)</p>			
		<p><u>Structure</u> Concrete Lined Canal</p>			
		<p><u>Condition</u> <input type="checkbox"/> A <input type="checkbox"/> B <input type="checkbox"/> C <input checked="" type="checkbox"/> D</p>			
		<p><u>Problems</u> Crack or damage on weir crest; settlement of weir body; deflection of pier of weir</p>

<p><u>Problems</u> Leakage from gate leaf; insufficient strength against design load due to rust, decay of steel material; problem on management due to lack of periodically maintenance</p>			
		<p><u>Problems</u> Sedimentation; crack or damage on lined canal; leakage from lined canal; deflection of lining toward inside of canal.</p>

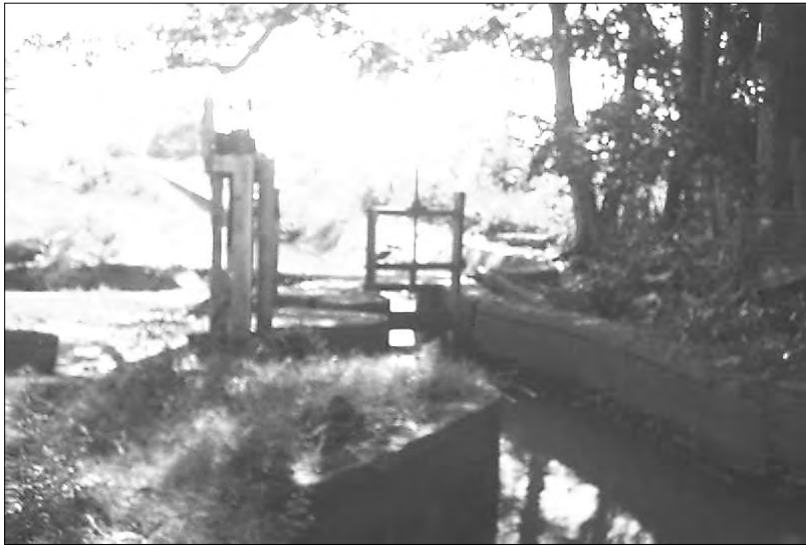
<p><u>Category</u> Irrigation (Secondary Canal)</p>			
		<p><u>Structure</u> Division Structure</p>			
		<p><u>Condition</u> <input type="checkbox"/> A <input type="checkbox"/> B <input checked="" type="checkbox"/> C <input type="checkbox"/> D</p>

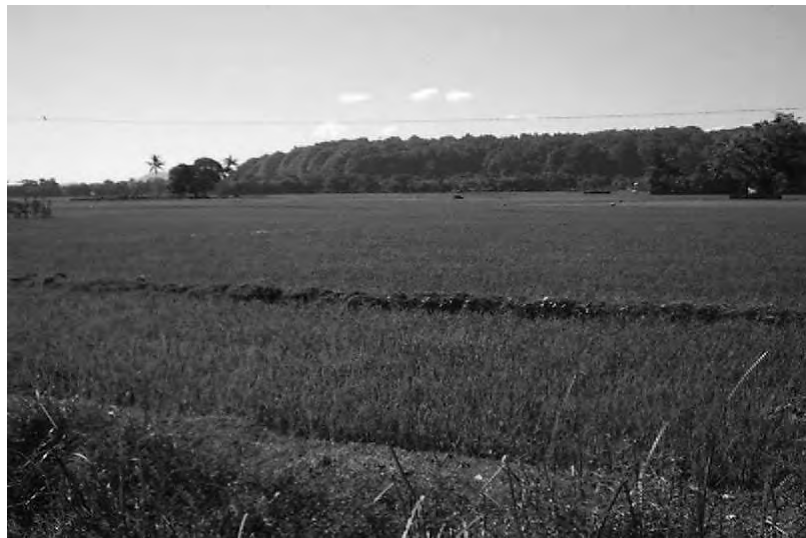
<p><u>Category</u> Agriculture, On-Farm</p>			
		<p><u>Activity</u> Paddy Field</p>			
		<p><u>Condition</u> <input type="checkbox"/> A <input type="checkbox"/> B <input type="checkbox"/> C <input checked="" type="checkbox"/> D</p>

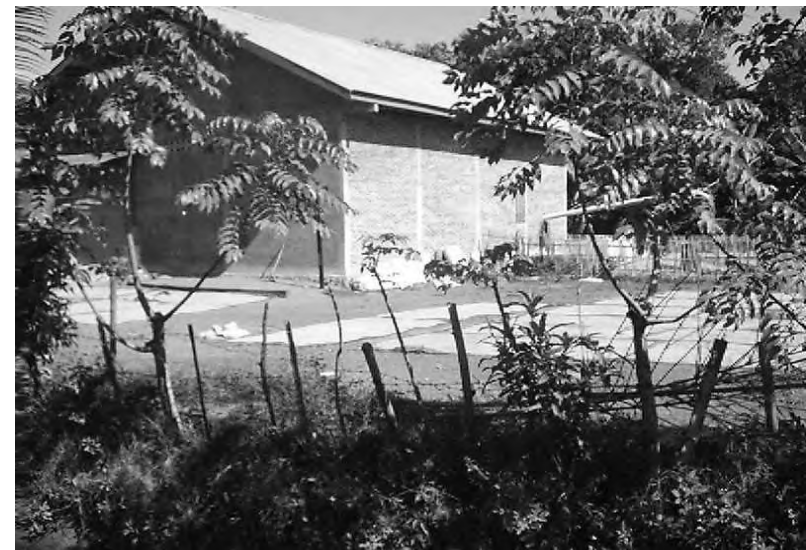
<p><u>Category</u> Post-harvest Facility</p>			
		<p><u>Activity</u> Drying Yard</p>			
		<p><u>Condition</u> <input type="checkbox"/> A <input type="checkbox"/> B <input type="checkbox"/> C <input checked="" type="checkbox"/> D</p>			
		<p><u>Problems</u> Lower function of division structure; sedimentation at inside of canal; physical operation problem on structure.</p>

<p><u>Problems</u> Low density of on-farm canals and farm roads.</p>			
		<p><u>Problems</u></p>

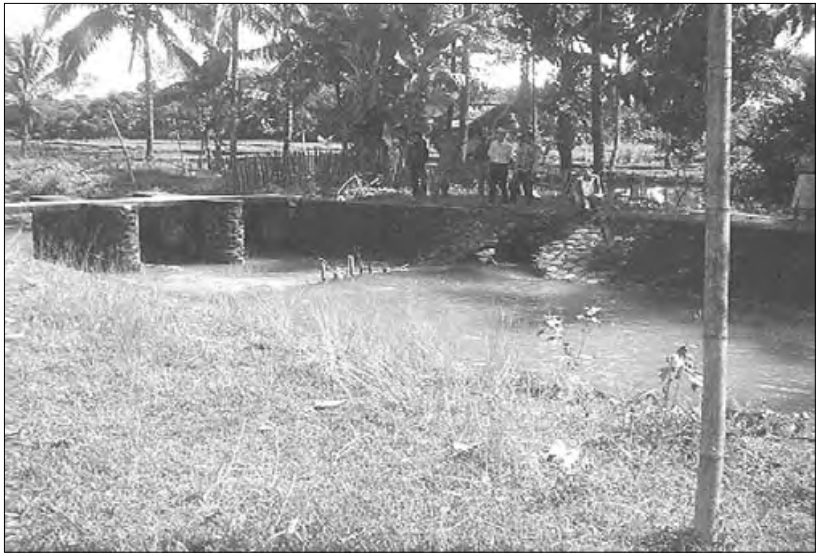
<p><u>Category</u> Irrigation (Main Canal)</p>			
				<p><u>Structure</u> Division Structure</p>			
				<p><u>Condition</u> <input type="checkbox"/> A <input type="checkbox"/> B <input type="checkbox"/> C <input checked="" type="checkbox"/> D</p>			
				<p><u>Problems</u> Lower function of division structure; sedimentation at inside of canal; physical operation problem on structure.</p>

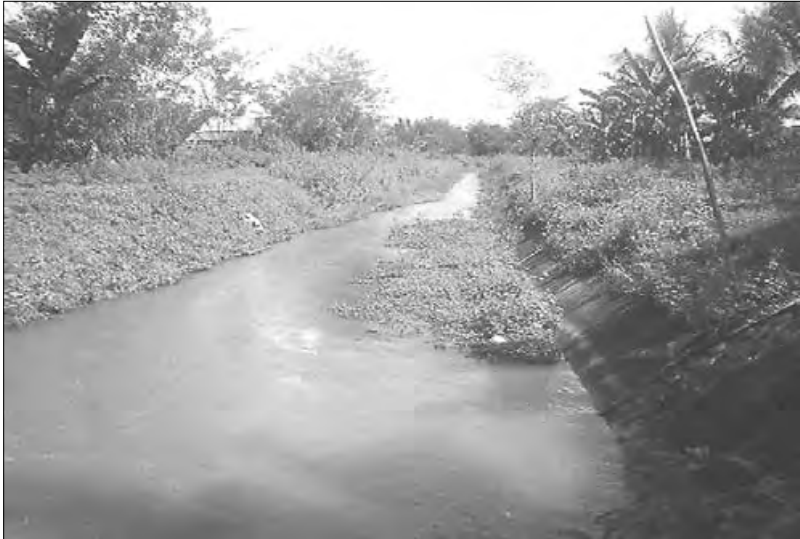
<p><u>Category</u> Irrigation (Main Canal)</p>			
				<p><u>Structure</u> Lined Canal</p>			
				<p><u>Condition</u> <input type="checkbox"/> A <input type="checkbox"/> B <input type="checkbox"/> C <input checked="" type="checkbox"/> D</p>			
				<p><u>Problems</u> Sedimentation; crack or damage on lined canal; leakage from lined canal; deflection of lining toward inside of canal.</p>

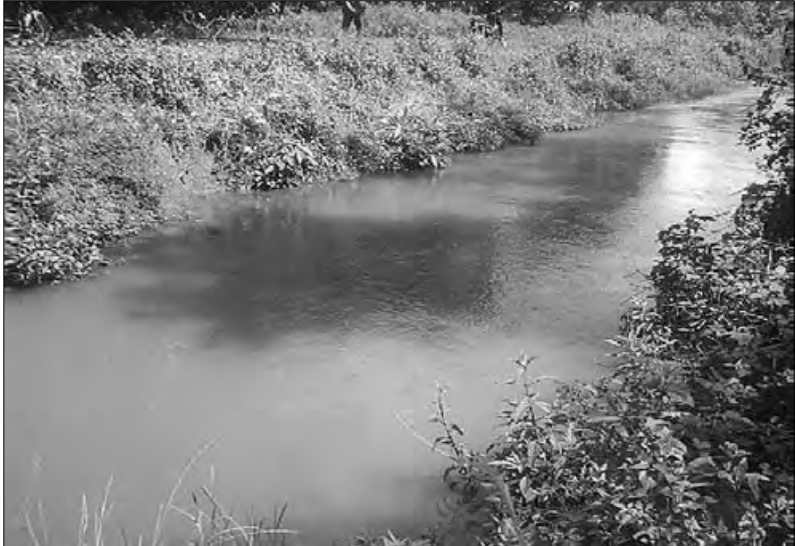
<p><u>Category</u> Irrigation (Main Canal)</p>			
				<p><u>Structure</u> Earth Canal</p>			
				<p><u>Condition</u> <input type="checkbox"/> A <input type="checkbox"/> B <input type="checkbox"/> C <input checked="" type="checkbox"/> D</p>			
				<p><u>Problems</u> Sedimentation; collapse of canal; leakage from canal; difficulty on maintenance of earth canal.</p>

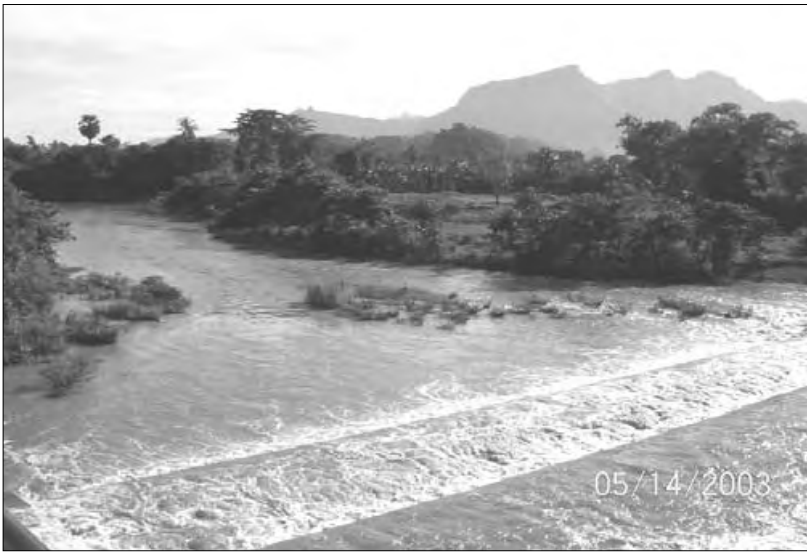
<i>Category</i> Irrigation (Headworks)		
		<i>Structure</i> Fixed Weir		
		<i>Condition</i> <input type="checkbox"/> A <input checked="" type="checkbox"/> B <input type="checkbox"/> C <input type="checkbox"/> D

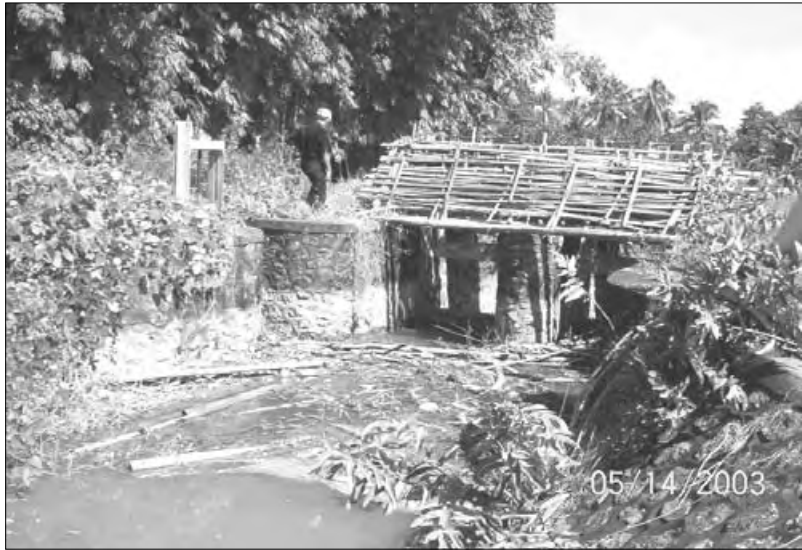
<i>Category</i> Irrigation (Main Canal)		
		<i>Structure</i> Division Structure		
		<i>Condition</i> <input type="checkbox"/> A <input type="checkbox"/> B <input type="checkbox"/> C <input checked="" type="checkbox"/> D

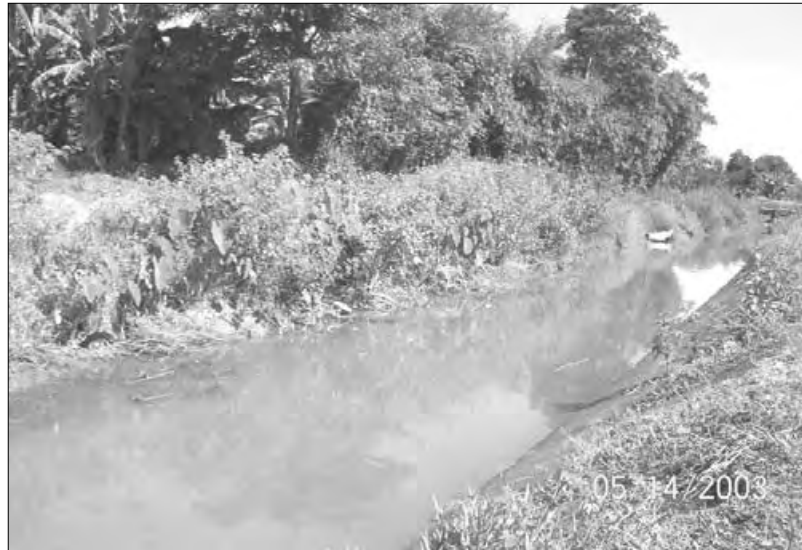
<i>Category</i> Irrigation (Main Canal)		
		<i>Structure</i> Earth Canal		
		<i>Condition</i> <input type="checkbox"/> A <input type="checkbox"/> B <input checked="" type="checkbox"/> C <input type="checkbox"/> D		
		<i>Problems</i> Crack or damage on weir crest; settlement of weir body.		
		<i>Problems</i> Totally damaged		
		<i>Problems</i> Sedimentation; collapse of canal; leakage from canal; difficulty on maintenance of earth canal.

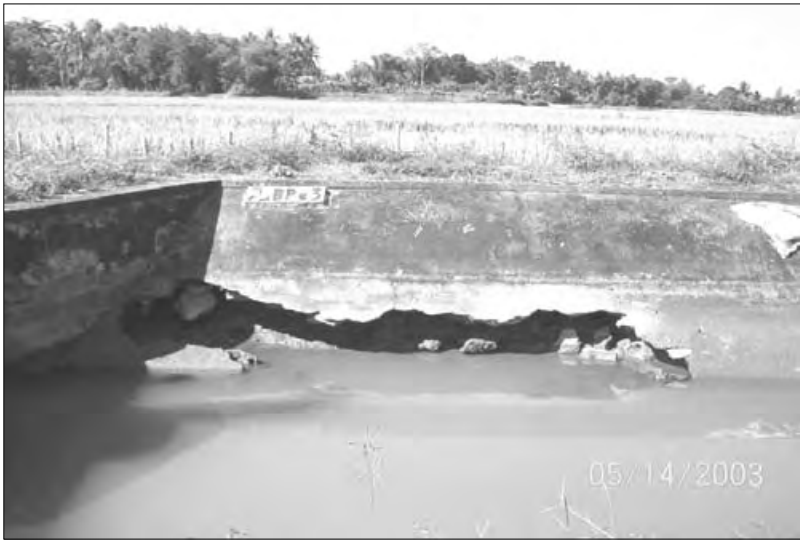
<p><u>Category</u> Irrigation (Main Canal)</p>		
		<p><u>Structure</u> Concrete Lined Canal</p>		
		<p><u>Condition</u> <input type="checkbox"/> A <input type="checkbox"/> B <input checked="" type="checkbox"/> C <input type="checkbox"/> D</p>		
		<p><u>Problems</u> Crack or damage on lined canal; deflection of lining toward inside of canal.</p>

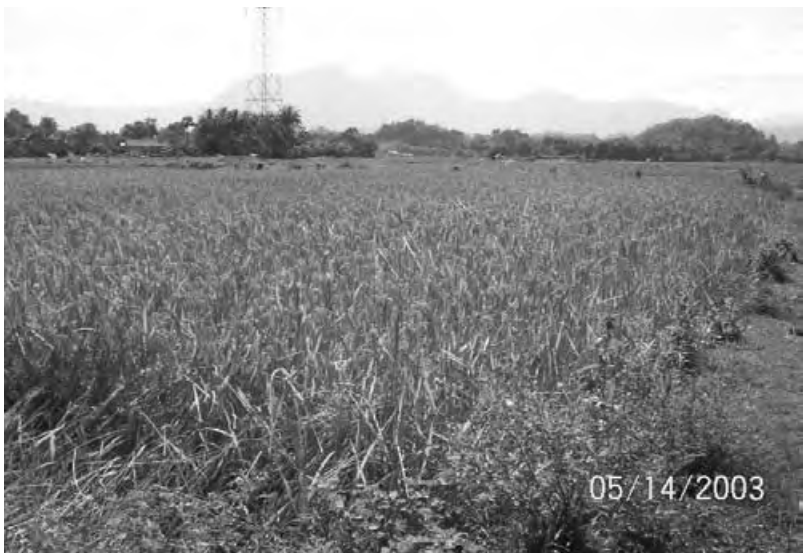
<p><u>Category</u> Agriculture, On-Farm</p>		
		<p><u>Activity</u> Paddy Cultivation (just before harvesting)</p>		
		<p><u>Condition</u> <input type="checkbox"/> A <input type="checkbox"/> B <input checked="" type="checkbox"/> C <input type="checkbox"/> D</p>		
		<p><u>Problems</u> Low density of on-farm canals and farm roads.</p>

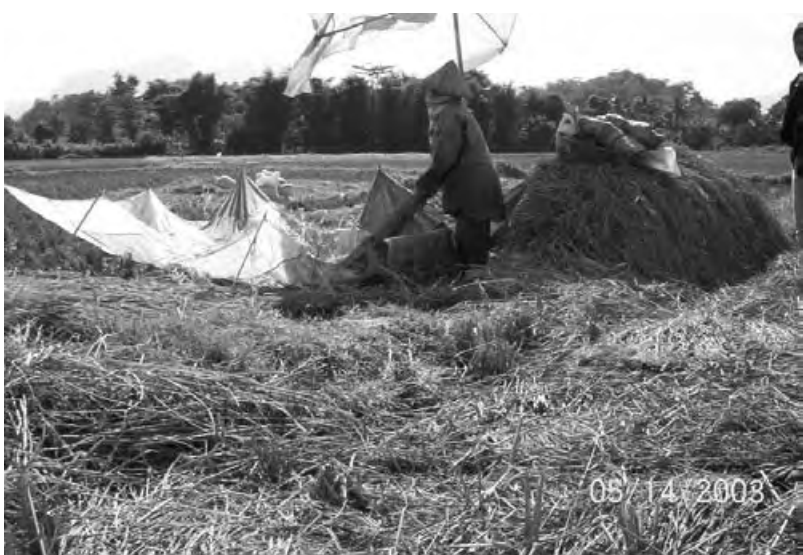
<p><u>Category</u> Agriculture, On-Farm</p>		
		<p><u>Activity</u> Treasher by Man Power</p>		
		<p><u>Condition</u> <input type="checkbox"/> A <input type="checkbox"/> B <input checked="" type="checkbox"/> C <input type="checkbox"/> D</p>

<p><u>Problems</u> Low density of on-farm canals and farm roads.</p>

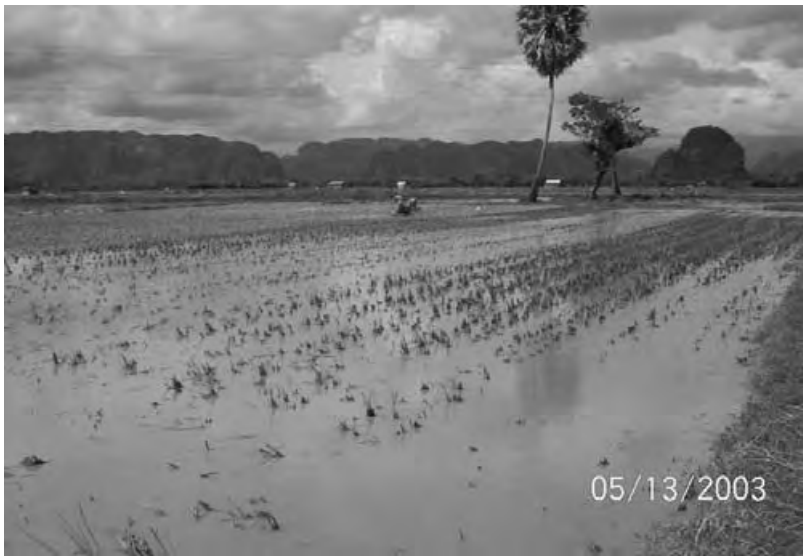
<p><u>Category</u> Agriculture, On-Farm</p>	
		<p><u>Activity</u> Land Preparation</p>	
		<p><u>Condition</u> <input type="checkbox"/> A <input type="checkbox"/> B <input checked="" type="checkbox"/> C <input type="checkbox"/> D</p>	
		<p><u>Problems</u> Low density of on-farm canals and farm roads.</p>

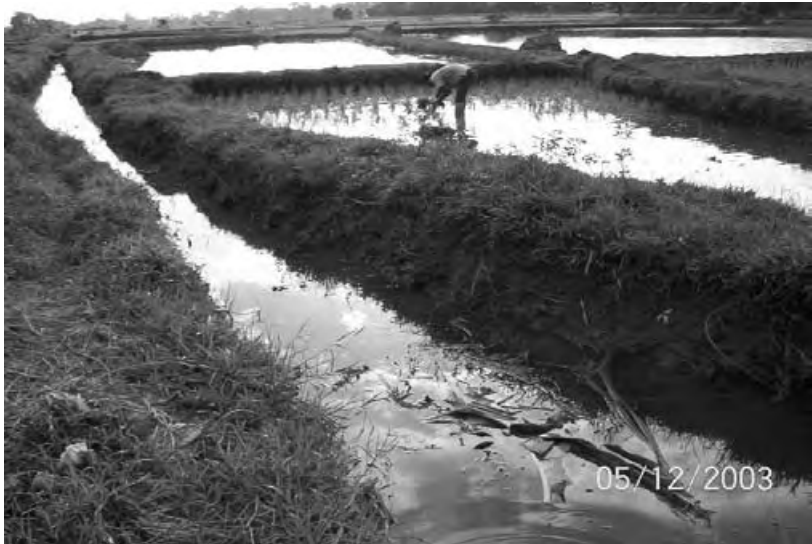
<p><u>Category</u> Agriculture, On-Farm</p>	
		<p><u>Activity</u> Transplanting</p>

<p><u>Condition</u> <input type="checkbox"/> A <input type="checkbox"/> B <input checked="" type="checkbox"/> C <input type="checkbox"/> D</p>	
		<p><u>Problems</u> Low density of on-farm canals and farm roads.</p>
