The Study on Comprehensive Recovery Program  
of Irrigation Agriculture

**Location Map of Irrigation Schemes  
in Bone District**

Scheme	Palakka	District	Bone	
Technical Level	Technical	Registered Area	4,633 ha	Year of Construction 1925/80
SS.18.35

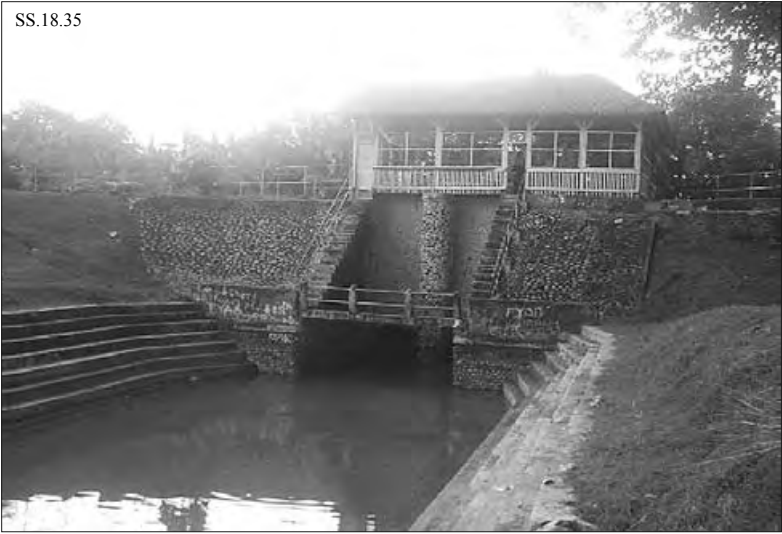
<p><u>Category</u> Irrigation (Headworks)</p> <p><u>Structure</u> Intake</p> <p><u>Condition</u>  <input type="checkbox"/> A    <input checked="" type="checkbox"/> B    <input type="checkbox"/> C    <input type="checkbox"/> D</p> <p><u>Problems</u> Insufficient diversion water due to sedimentation in front of intake.</p>	
SS.18.36

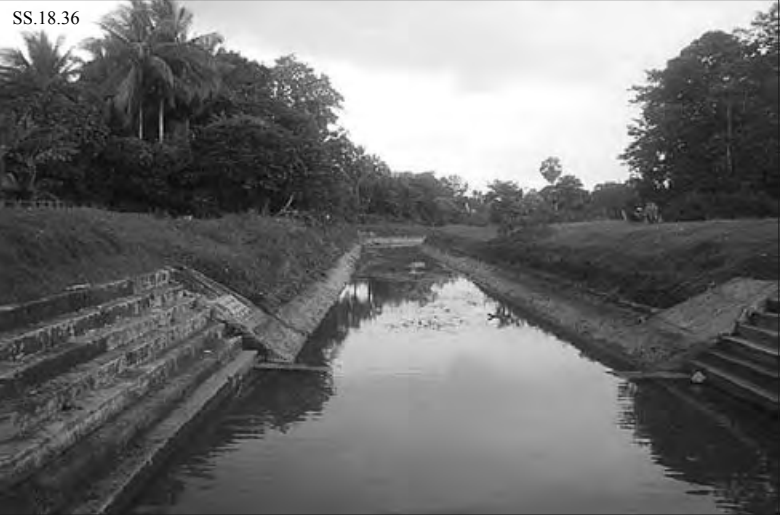
<p><u>Category</u> Irrigation (Main Canal)</p> <p><u>Structure</u> Masonry Lined Canal</p> <p><u>Condition</u>  <input type="checkbox"/> A    <input type="checkbox"/> B    <input type="checkbox"/> C    <input checked="" type="checkbox"/> D</p> <p><u>Problems</u> Sedimentation; crack or damage on lined canal; leakage from lined canal; deflection of lining toward inside of canal</p>	
SS.18.40

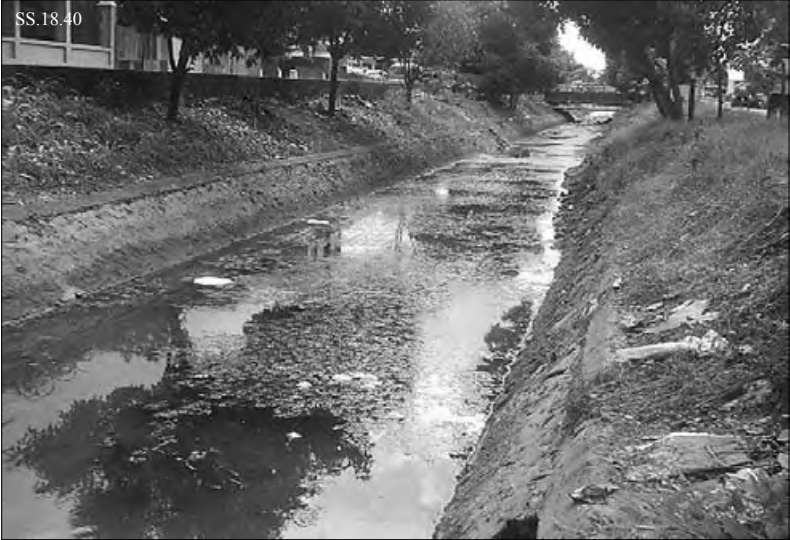
<p><u>Category</u> Irrigation (Main Canal)</p> <p><u>Structure</u> Masonry Lined Canal</p> <p><u>Condition</u>  <input type="checkbox"/> A    <input type="checkbox"/> B    <input type="checkbox"/> C    <input checked="" type="checkbox"/> D</p> <p><u>Problems</u> Sedimentation; crack or damage on lined canal; leakage from lined canal; deflection of lining toward inside of canal; no inspection road.</p>

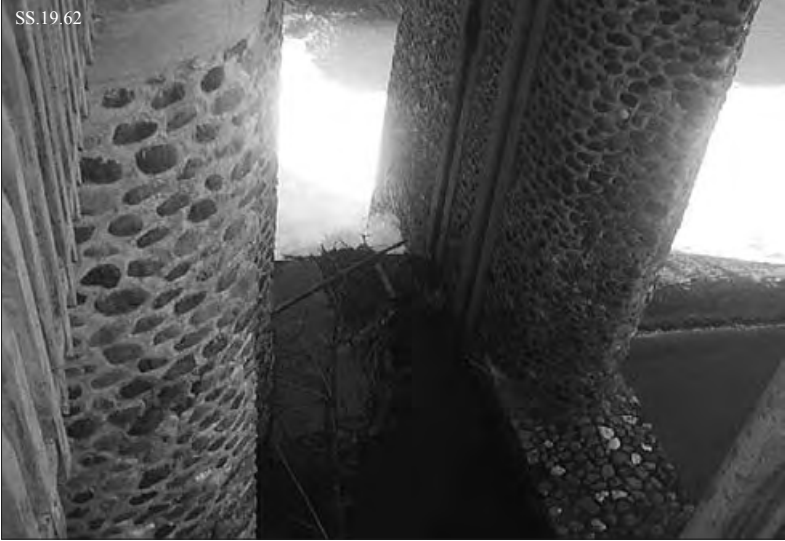
<p>SS.19.62</p>		<p><u>Category</u> Irrigation (Headworks)</p> <hr/> <p><u>Structure</u> Scouring Sluice</p> <hr/> <p><u>Condition</u>  <input type="checkbox"/> A    <input type="checkbox"/> B    <input checked="" type="checkbox"/> C    <input type="checkbox"/> D</p> <hr/> <p><u>Problems</u> Crack or damage on scouring sluice</p>

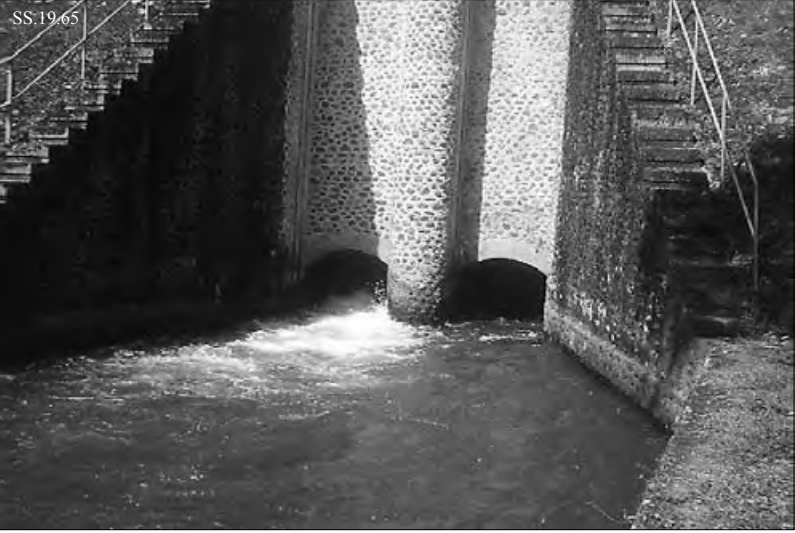
<p>SS.19.65</p>		<p><u>Category</u> Irrigation (Headworks)</p> <hr/> <p><u>Structure</u> Intake, Rear View</p> <hr/> <p><u>Condition</u>  <input type="checkbox"/> A    <input type="checkbox"/> B    <input checked="" type="checkbox"/> C    <input type="checkbox"/> D</p> <hr/> <p><u>Problems</u> Leakage from gate leaf; insufficient strength against design load due to rust, decay of steel material; problem on management due to lack of periodically maintenance</p>

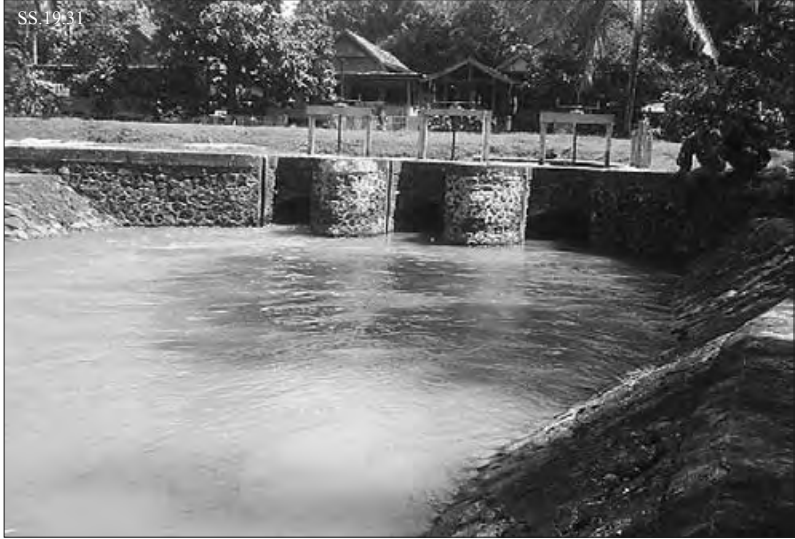
<p>SS.19.31</p>		<p><u>Category</u> Irrigation (Main Canal)</p> <hr/> <p><u>Structure</u> Check Structure</p> <hr/> <p><u>Condition</u>  <input type="checkbox"/> A    <input type="checkbox"/> B    <input type="checkbox"/> C    <input checked="" type="checkbox"/> D</p> <hr/> <p><u>Problems</u> Lower function of check structure; sedimentation at inside of canal; physical operation problem on structure.</p>

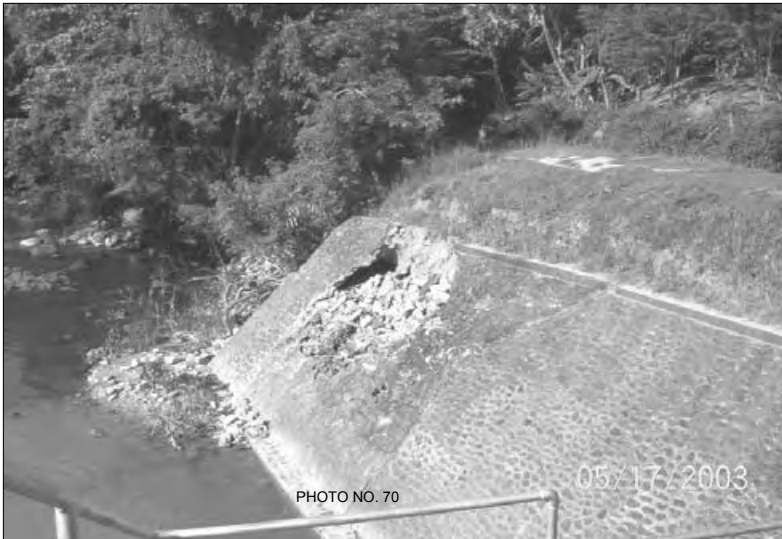
<p><u>Category</u> Irrigation (Headworks)</p>		
		<p><u>Structure</u> Retaining Wall</p>		
		<p><u>Condition</u>  <input type="checkbox"/> A    <input type="checkbox"/> B    <input type="checkbox"/> C    <input checked="" type="checkbox"/> D</p>

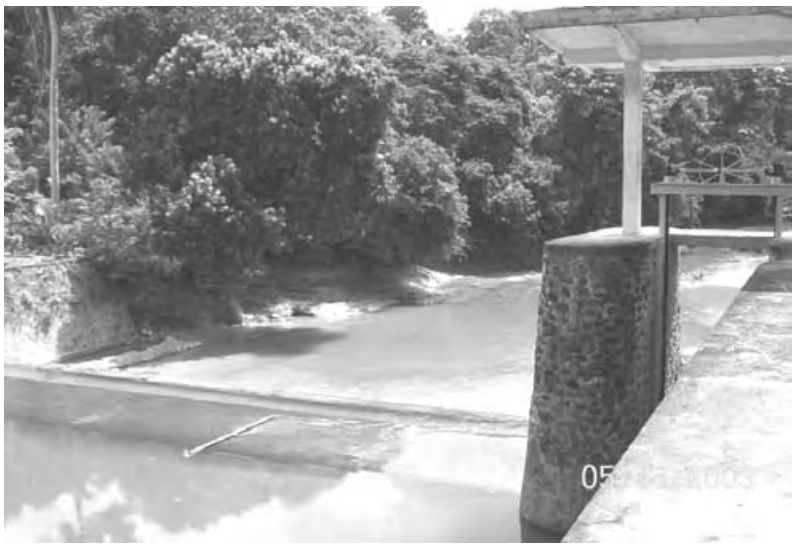
<p><u>Category</u> Irrigation (Headworks)</p>	
		<p><u>Structure</u> Fixed Weir</p>	
		<p><u>Condition</u>  <input type="checkbox"/> A    <input checked="" type="checkbox"/> B    <input type="checkbox"/> C    <input type="checkbox"/> D</p>

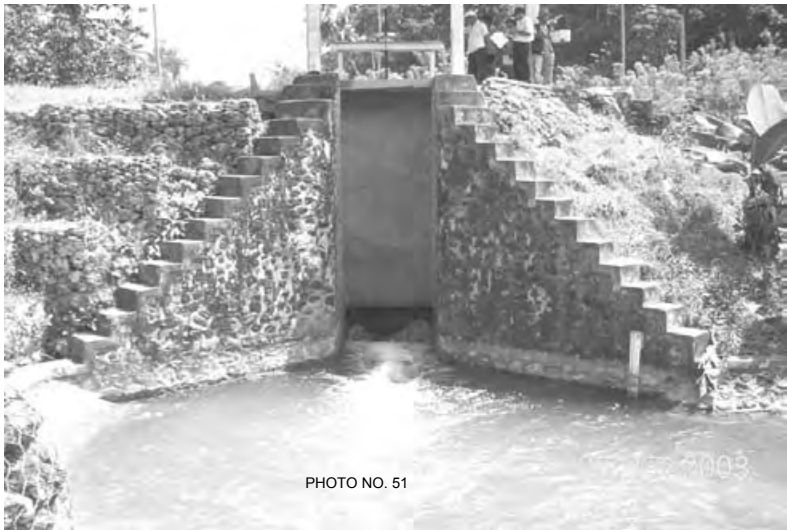
<p style="text-align: center;">PHOTO NO. 51</p>		<p><u>Category</u> Irrigation (Headworks)</p>	
		<p><u>Structure</u> Intake, Rear View</p>	
		<p><u>Condition</u>  <input type="checkbox"/> A    <input checked="" type="checkbox"/> B    <input type="checkbox"/> C    <input type="checkbox"/> D</p>

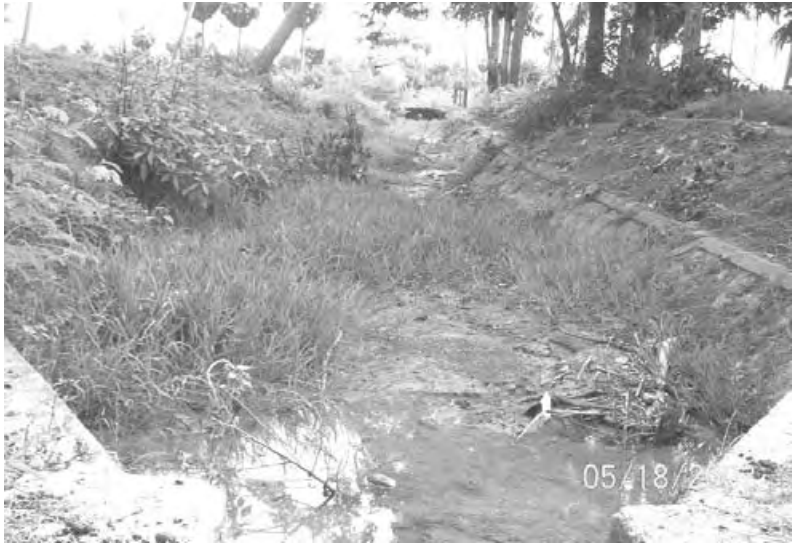
<p><u>Category</u> Irrigation (Main Canal)</p>	
		<p><u>Structure</u> Masonry Lined Canal</p>	
		<p><u>Condition</u>  <input type="checkbox"/> A    <input type="checkbox"/> B    <input type="checkbox"/> C    <input checked="" type="checkbox"/> D</p>

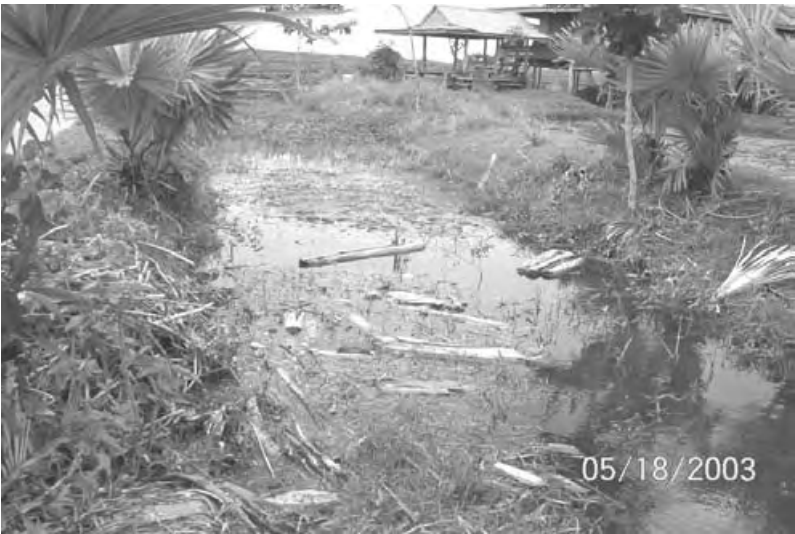
<p><u>Category</u> Irrigation (Secondary Canal)</p>	
		<p><u>Structure</u> Earth Canal</p>	
		<p><u>Condition</u> <input type="checkbox"/> A    <input type="checkbox"/> B    <input type="checkbox"/> C    <input checked="" type="checkbox"/> D</p>	
		<p><u>Problems</u> Canal is totally damaged.</p>	
 		<p><u>Category</u> Agriculture, On-Farm</p>	
		<p><u>Condition</u> Paddy for Harvest</p>	
		<p><u>Condition</u> <input type="checkbox"/> A    <input type="checkbox"/> B    <input checked="" type="checkbox"/> C    <input type="checkbox"/> D</p>	
		<p><u>Problems</u> Low density of on-farm canals and farm roads.</p>

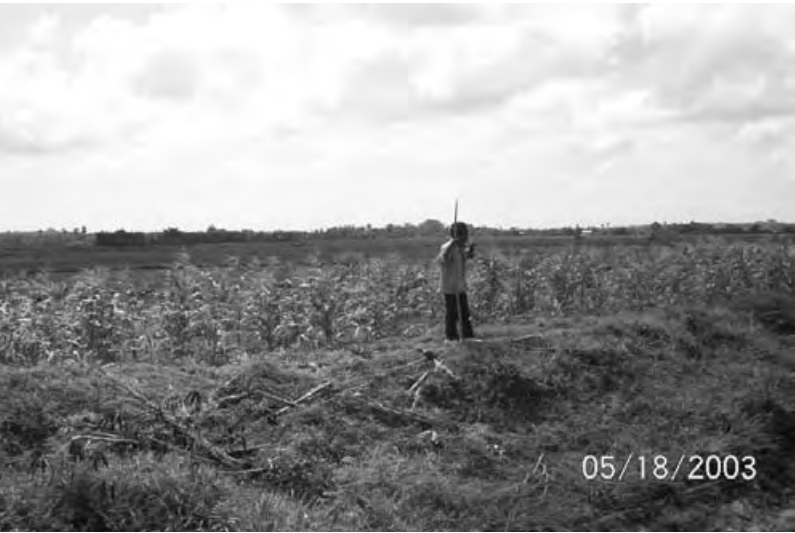
<p><u>Category</u> Agriculture, On-Farm</p>	
		<p><u>Activity</u> Secondary Crops (Maize) Cultivation</p>	
		<p><u>Condition</u> <input type="checkbox"/> A    <input type="checkbox"/> B    <input checked="" type="checkbox"/> C    <input type="checkbox"/> D</p>

<p><u>Problems</u> Low density of on-farm canals and farm roads.</p>

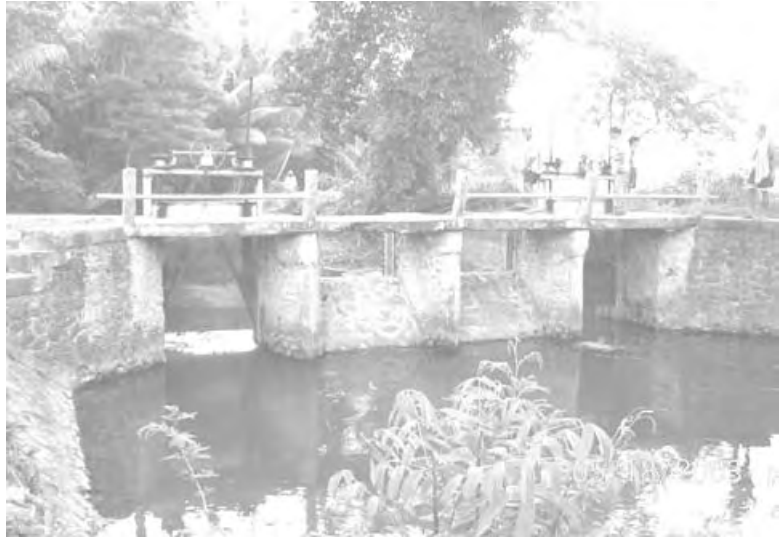
<u>Category</u> Spring Water Intake		
		<u>Structure</u> Intake		
		<u>Condition</u> <input type="checkbox"/> A <input type="checkbox"/> B <input checked="" type="checkbox"/> C <input type="checkbox"/> D		
		<u>Problems</u> Insufficient diversion water due to sedimentation in front of structure.

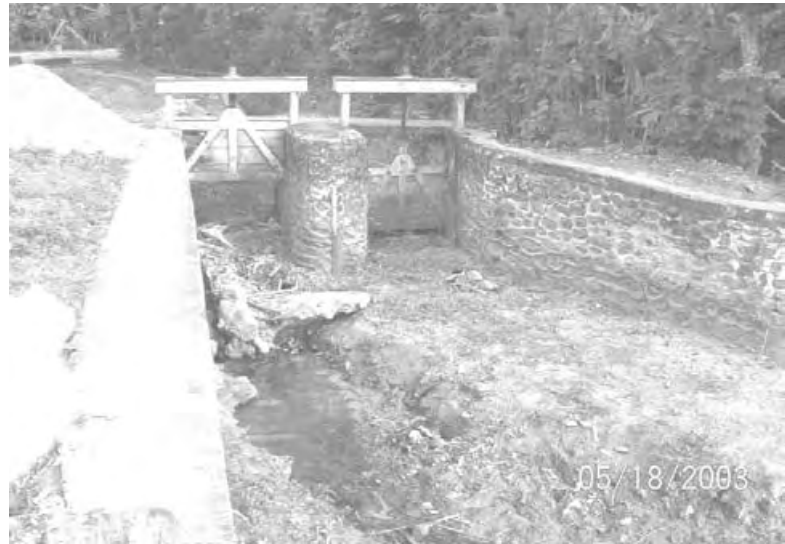
<u>Category</u> Irrigation (Secondary Canal)		
		<u>Structure</u> Check Structure		
		<u>Condition</u> <input type="checkbox"/> A <input type="checkbox"/> B <input type="checkbox"/> C <input checked="" type="checkbox"/> D		
		<u>Problems</u> Lower function of check structure due to sedimentation in front of gate; physical operation problem on structure; damage on structure; deterioration of gate.

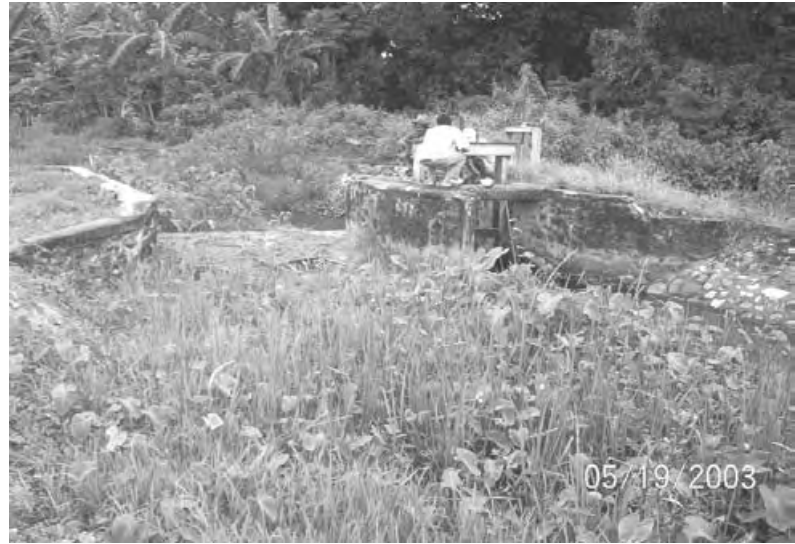
<u>Category</u> Irrigation (Secondary Canal)		
		<u>Structure</u> Masonry Lined Canal

<u>Condition</u> <input type="checkbox"/> A <input type="checkbox"/> B <input type="checkbox"/> C <input checked="" type="checkbox"/> D		
		<u>Problems</u> Not in use

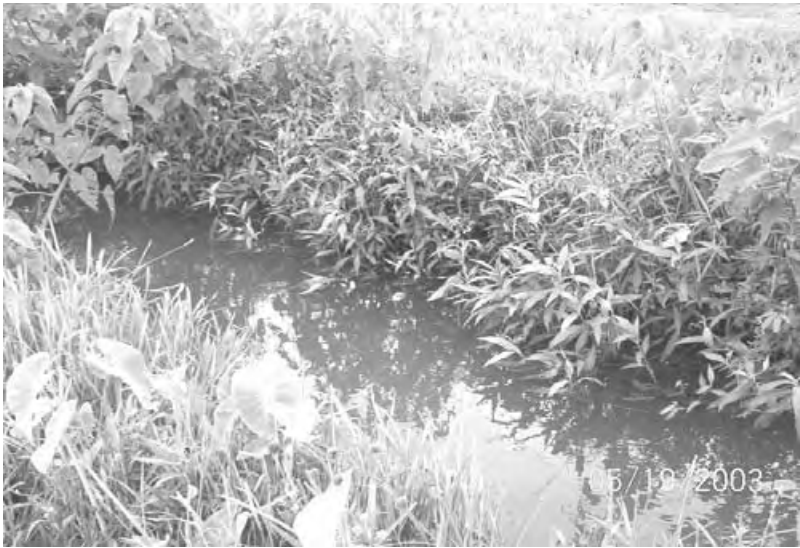
<p><u>Category</u> Irrigation (Secondary Canal)</p>			
		<p><u>Structure</u> Earth Canal</p>			
		<p><u>Condition</u>  <input type="checkbox"/> A    <input type="checkbox"/> B    <input type="checkbox"/> C    <input checked="" type="checkbox"/> D</p>			
		<p><u>Problems</u> Sedimentation; collapse of canal; leakage from canal; difficulty on maintenance of earth canal; no inspection road.</p>			
 		<p><u>Category</u> Agriculture, On-Farm</p>			
		<p><u>Activity</u> Land Preparation by Hand Tractor</p>			
		<p><u>Condition</u>  <input type="checkbox"/> A    <input type="checkbox"/> B    <input type="checkbox"/> C    <input checked="" type="checkbox"/> D</p>			
		<p><u>Problems</u> Low density of on-farm canals and farm roads.</p>			
 		<p><u>Category</u> Post-harvest Facility</p>

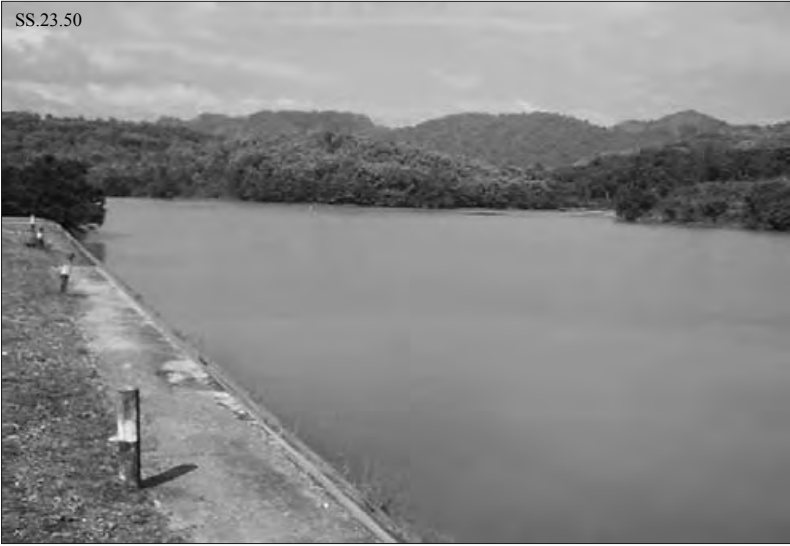
<u>Category</u>				Irrigation (Headworks)			
				<u>Structure</u>				Fixed Weir, Upstream View			
				<u>Condition</u>				<input type="checkbox"/> A <input checked="" type="checkbox"/> B <input type="checkbox"/> C <input type="checkbox"/> D			
				<u>Problems</u>				Sedimentation at weir.

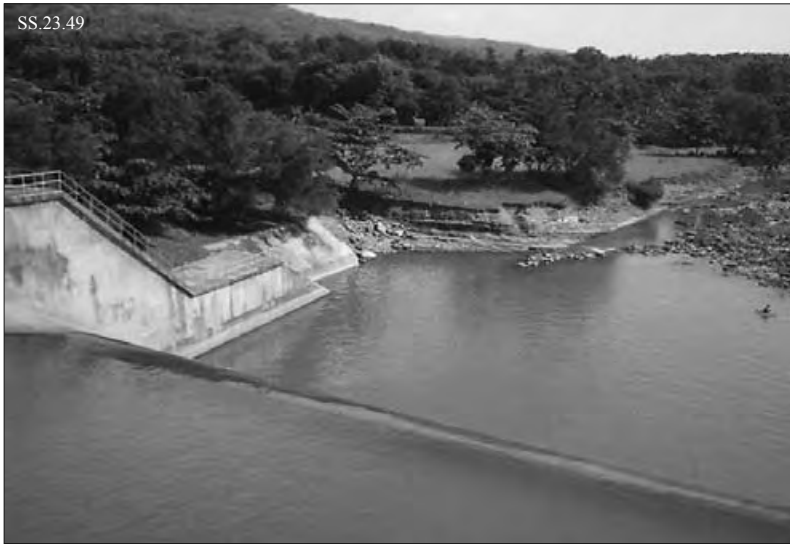
<u>Category</u>				Irrigation (Headworks)			
				<u>Structure</u>				Retaining Wall and Stilling Basin			
				<u>Condition</u>				<input type="checkbox"/> A <input checked="" type="checkbox"/> B <input type="checkbox"/> C <input type="checkbox"/> D			
				<u>Problems</u>				Fallen down, incline or washed away of retaining wall of weir; washed away of stilling basin

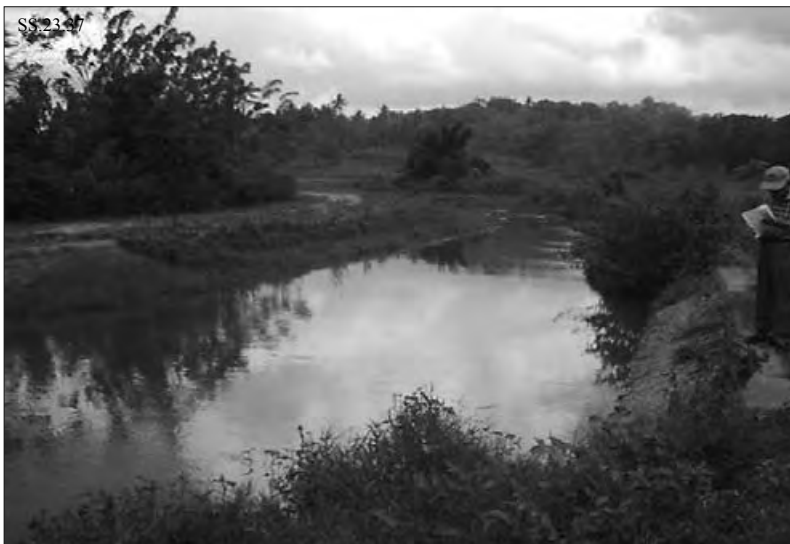
<u>Category</u>				Irrigation (Main Canal)			
				<u>Structure</u>				Masonry Lined Canal			
				<u>Condition</u>				<input type="checkbox"/> A <input type="checkbox"/> B <input type="checkbox"/> C <input checked="" type="checkbox"/> D

<u>Problems</u>				Sedimentation; crack or damage on lined canal; leakage from lined canal; deflection of lining toward inside of canal; no inspection road.
