The Study on Comprehensive Recovery Program
of Irrigation Agriculture

Japan International Cooperation Agency

**Location Map of Irrigation Schemes
in Sidrap District**

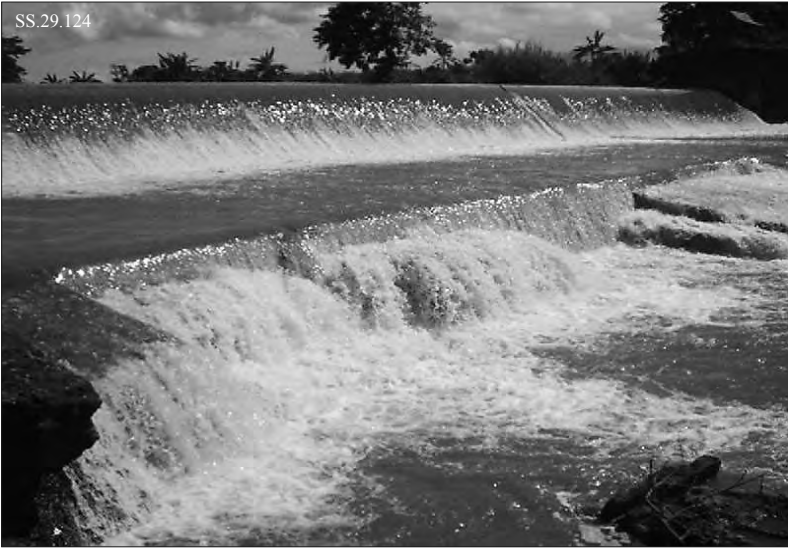
<p><u>Category</u> Irrigation (Headworks)</p> <hr/> <p><u>Structure</u> Stilling Basin, Ripraps</p> <hr/> <p><u>Condition</u> <input type="checkbox"/> A <input type="checkbox"/> B <input checked="" type="checkbox"/> C <input type="checkbox"/> D</p> <hr/> <p><u>Problems</u> Washed away of stilling basin; washed away of ripraps or gabions at downstream of stilling basin.</p>

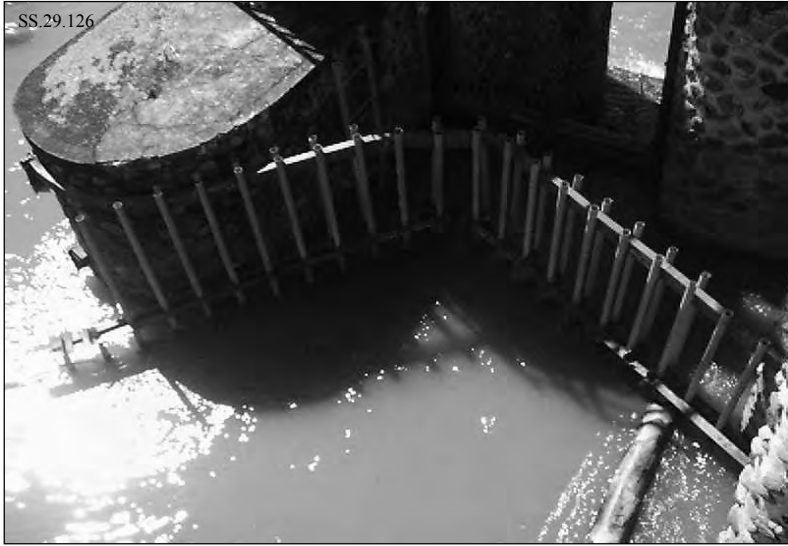
<p><u>Category</u> Irrigation (Headworks)</p> <hr/> <p><u>Structure</u> Intake and Trash Rack</p> <hr/> <p><u>Condition</u> <input type="checkbox"/> A <input type="checkbox"/> B <input type="checkbox"/> C <input checked="" type="checkbox"/> D</p> <hr/> <p><u>Problems</u> Leakage from gate leaf; insufficient strength against design load due to rust, decay of steel material; problem on management due to lack of periodically maintenance; broken of gates.</p>

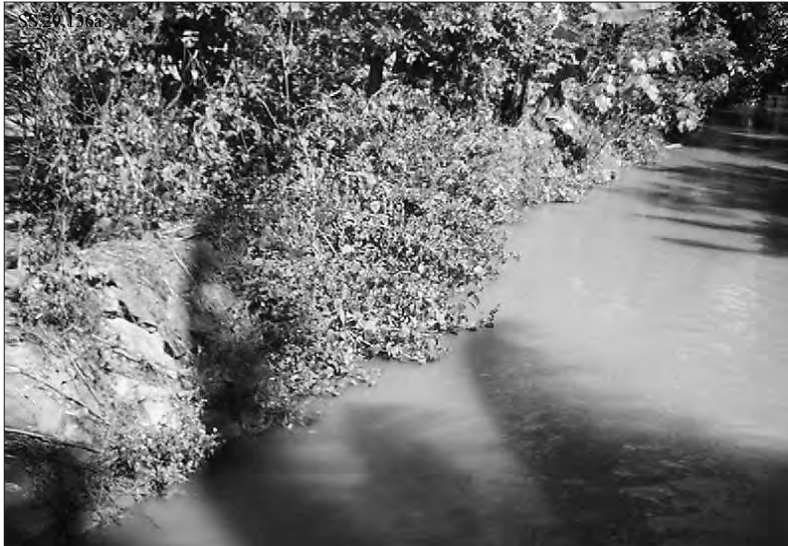
<p><u>Category</u> Irrigation (Main Canal)</p> <hr/> <p><u>Structure</u> Masonry Lined Canal</p> <hr/> <p><u>Condition</u> <input type="checkbox"/> A <input type="checkbox"/> B <input checked="" type="checkbox"/> C <input type="checkbox"/> D</p> <hr/> <p><u>Problems</u> Sedimentation; crack or damage on lined canal; leakage from lined canal; deflection of lining toward inside of canal; no inspection road.</p>

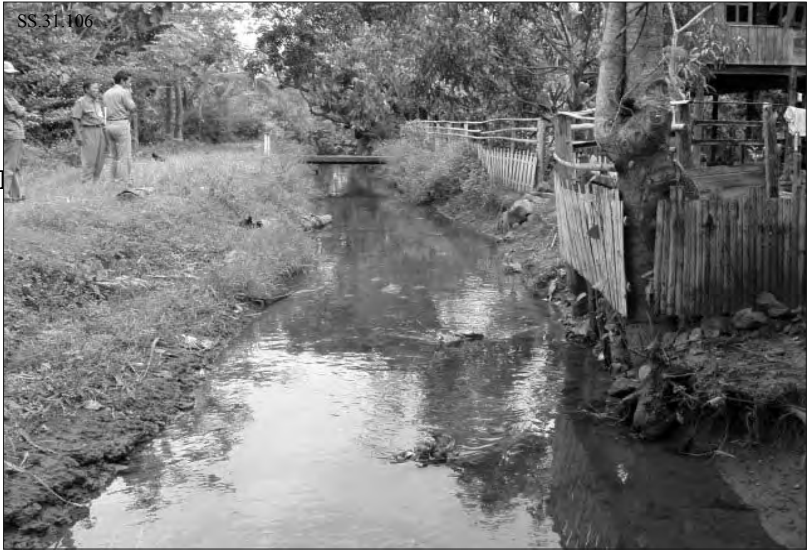
<p><u>Category</u> Irrigation (Secondary Canal)</p> <p><u>Structure</u> Earth Canal</p> <p><u>Condition</u> <input type="checkbox"/> A <input type="checkbox"/> B <input type="checkbox"/> C <input checked="" type="checkbox"/> D</p> <p><u>Problems</u> Sedimentation; collapse of canal; leakage from canal; difficulty on maintenance of earth canal; no inspection road.</p>	
<input checked="" type="checkbox"/>

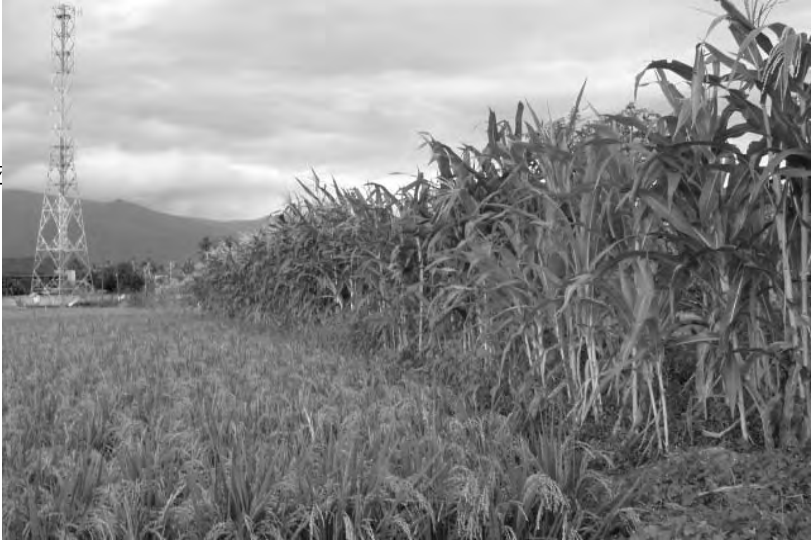
<p><u>Category</u> Agriculture, On-Farm</p> <p><u>Activity</u> Paddy and Secondary Crops Cultivation</p> <p><u>Condition</u> <input type="checkbox"/> A <input type="checkbox"/> B <input type="checkbox"/> C <input checked="" type="checkbox"/> D</p> <p><u>Problems</u></p>	
<input checked="" type="checkbox"/>

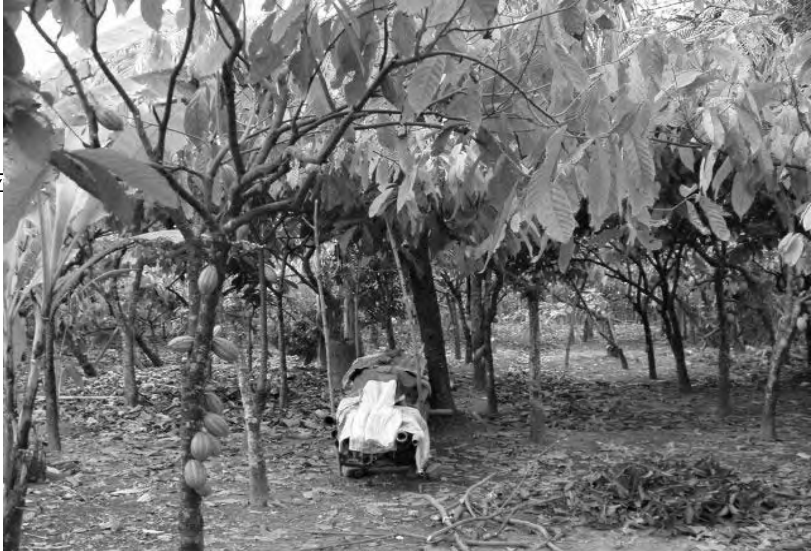
<p><u>Category</u> Agriculture, Agro-economy</p> <p><u>Activity</u> Cacao Cultivation</p> <p><u>Condition</u> <input type="checkbox"/> A <input type="checkbox"/> B <input type="checkbox"/> C <input checked="" type="checkbox"/> D</p> <p><u>Problems</u></p>
