The Study on Comprehensive Recovery Program
of Irrigation Agriculture

Japan International Cooperation Agency

**Location Map of Irrigation Schemes
in Luwu District**

I. PROJECT FUNDAMENTALS									
I.1 General									
(1) Code Number	: 73170162			(7) Number of Farmers	: 5,500				
(2) Name of Irrigation Scheme	: Padang Sappa			(8) Water Resource River	: Noling

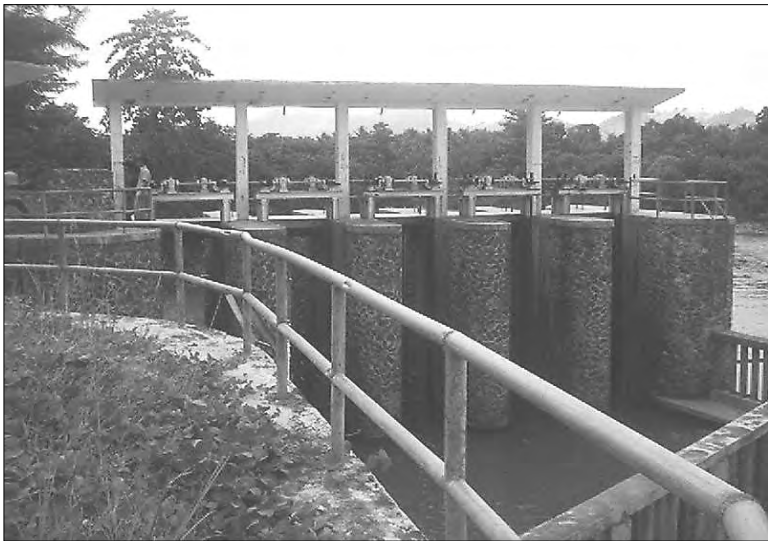
<p><u>Category</u> Irrigation (Headworks)</p>			
		<p><u>Structure</u> Fixed Weir, Intake</p>			
		<p><u>Condition</u> <input type="checkbox"/> A <input checked="" type="checkbox"/> B <input type="checkbox"/> C <input type="checkbox"/> D</p>

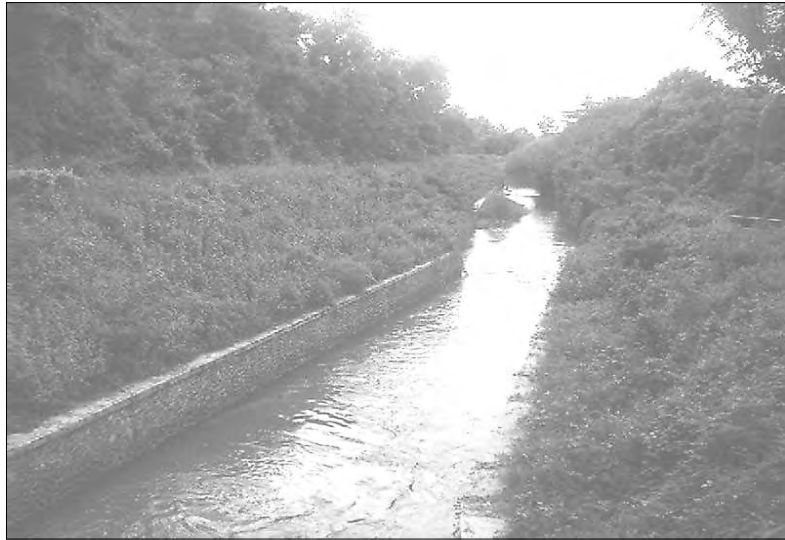
<p><u>Category</u> Irrigation Canal</p>			
		<p><u>Structure</u> Masonry Lined Canal</p>			
		<p><u>Condition</u> <input type="checkbox"/> A <input type="checkbox"/> B <input type="checkbox"/> C <input checked="" type="checkbox"/> D</p>

<p><u>Problems</u> Sedimentation; leakage from lined canal; crack on lined canal; deflection of lining toward inside of canal; less maintenance; and no inspection road.</p>			
		<p><u>Problems</u> Sedimentation; collapse of canal; leakage from canal; difficulty on maintenance of earth canal; no inspection road.</p>

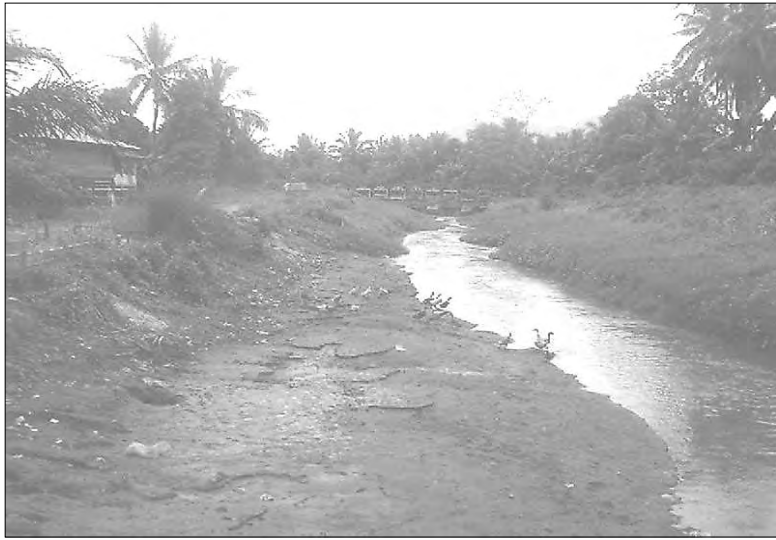
<p><u>Category</u> Irrigation (Main Canal)</p>			
		<p><u>Structure</u> Earth Canal</p>			
		<p><u>Condition</u> <input type="checkbox"/> A <input type="checkbox"/> B <input type="checkbox"/> C <input checked="" type="checkbox"/> D</p>			
		<p><u>Problems</u> Insufficient diversion water due to sedimentation in front of intake; leakage from gate leaf; insufficient strength against design load due to rust, decay of steel material; problem on management due to lack of periodically maintenance</p>

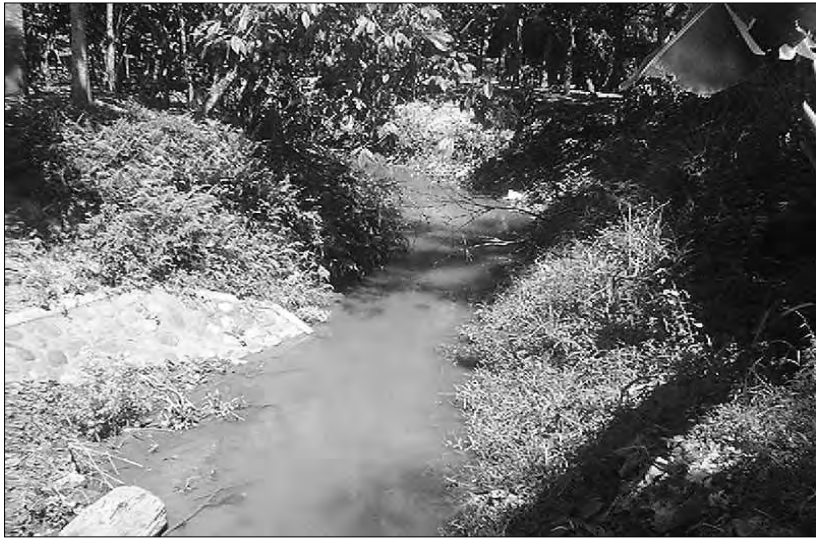
<p><u>Category</u> Irrigation (Secondary Canal)</p>			
		<p><u>Structure</u> Earth Canal</p>			
		<p><u>Condition</u> <input type="checkbox"/> A <input type="checkbox"/> B <input type="checkbox"/> C <input checked="" type="checkbox"/> D</p>			
		<p><u>Problems</u> Sedimentation; collapse of canal; leakage from canal; difficulty on maintenance of earth canal; no inspection road.</p>			
 		<p><u>Category</u> Agriculture, On-Farm</p>			
		<p><u>Activity</u> Land Preparation by Hand Tractor</p>			
		<p><u>Condition</u> <input type="checkbox"/> A <input type="checkbox"/> B <input type="checkbox"/> C <input checked="" type="checkbox"/> D</p>			
		<p><u>Problems</u> Low density of on-farm canals and farm roads.</p>

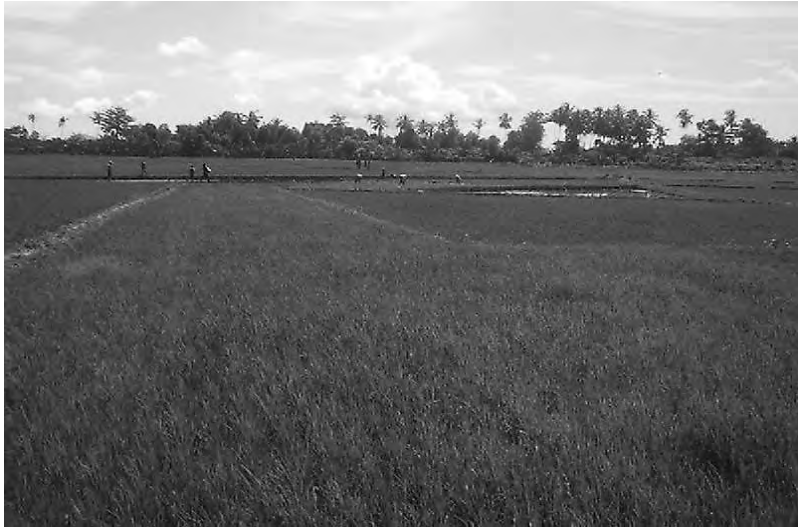
<p><u>Category</u> Agriculture, On-Farm</p>			
		<p><u>Activity</u> Paddy Cultivation</p>

<p><u>Condition</u> <input type="checkbox"/> A <input type="checkbox"/> B <input type="checkbox"/> C <input checked="" type="checkbox"/> D</p>			
		<p><u>Problems</u> Low density of on-farm canals and farm roads.</p>

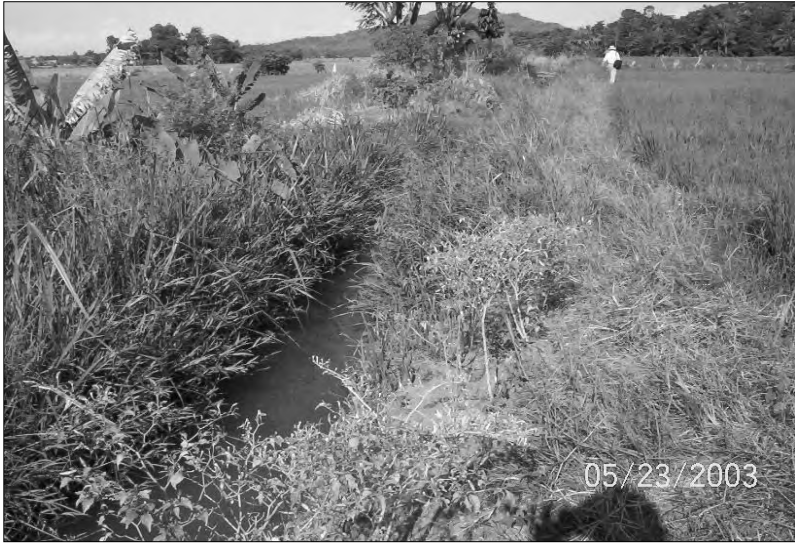
<p><u>Category</u> Irrigation (Secondary Canal)</p>			
		<p><u>Structure</u> Earth Canal</p>			
		<p><u>Condition</u> <input type="checkbox"/> A <input type="checkbox"/> B <input type="checkbox"/> C <input checked="" type="checkbox"/> D</p>			
		<p><u>Problems</u> Sedimentation; collapse of canal; leakage from canal; difficulty on maintenance of earth canal; no inspection road.</p>			
 		<p><u>Category</u> Agriculture, On-Farm</p>			
		<p><u>Activity</u> Paddy Cultivation</p>			
		<p><u>Condition</u> <input type="checkbox"/> A <input type="checkbox"/> B <input type="checkbox"/> C <input checked="" type="checkbox"/> D</p>			
		<p><u>Problems</u> Low density of on-farm canals and farm roads.</p>

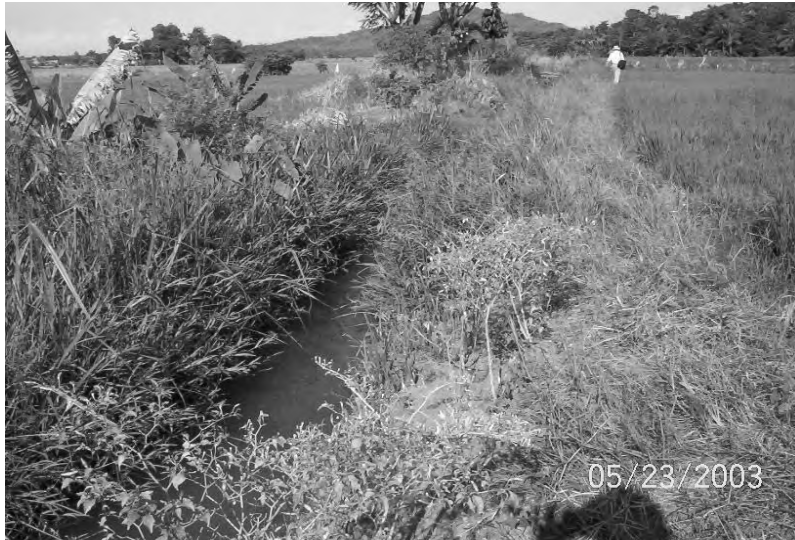
<p><u>Category</u> Agriculture, On-Farm</p>			
		<p><u>Structure</u> Farm Road and Drainage Canal</p>

<p><u>Condition</u> <input type="checkbox"/> A <input type="checkbox"/> B <input type="checkbox"/> C <input checked="" type="checkbox"/> D</p>			
		<p><u>Problems</u></p>

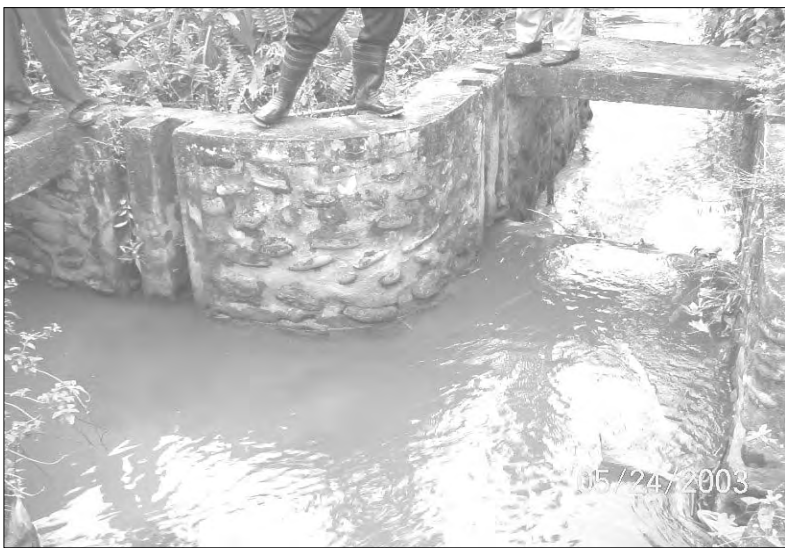
<p><u>Category</u> Irrigation (Main Canal)</p>			
		<p><u>Structure</u> Division Structure</p>			
		<p><u>Condition</u> <input type="checkbox"/> A <input type="checkbox"/> B <input type="checkbox"/> C <input checked="" type="checkbox"/> D</p>			
		<p><u>Problems</u> Lower function of division structure due to sedimentation in front gate; physical operation problem on structure.</p>

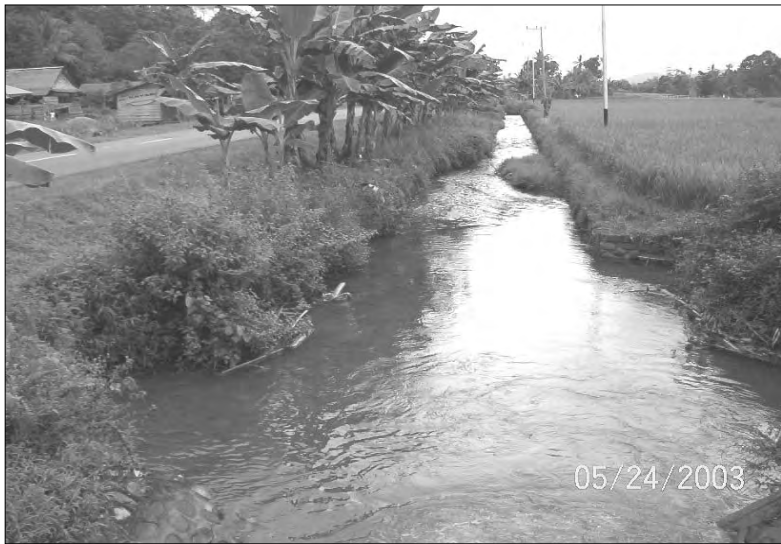
<p><u>Category</u> Irrigation (Secondary Canal)</p>			
		<p><u>Structure</u> Masonry Lined Canal</p>			
		<p><u>Condition</u> <input type="checkbox"/> A <input type="checkbox"/> B <input type="checkbox"/> C <input checked="" type="checkbox"/> D</p>			
		<p><u>Problems</u> Sedimentation; leakage from lined canal; crack on lined canal; deflection of lining toward inside of canal; less maintenance; and no inspection road.</p>

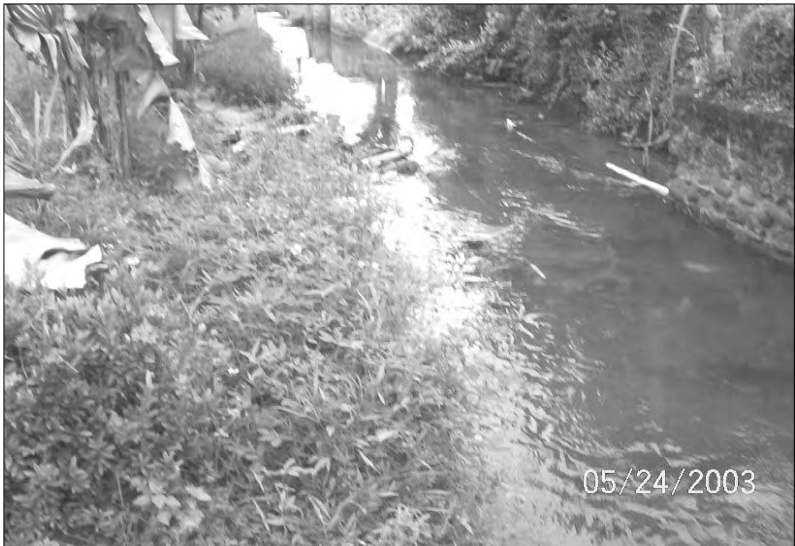
<p><u>Category</u> Irrigation (Secondary Canal)</p>			
		<p><u>Structure</u> Earth Canal</p>			
		<p><u>Condition</u> <input type="checkbox"/> A <input type="checkbox"/> B <input type="checkbox"/> C <input checked="" type="checkbox"/> D</p>			
		<p><u>Problems</u> Sedimentation; collapse of canal; leakage from canal; difficulty on maintenance of earth canal; no inspection road.</p>

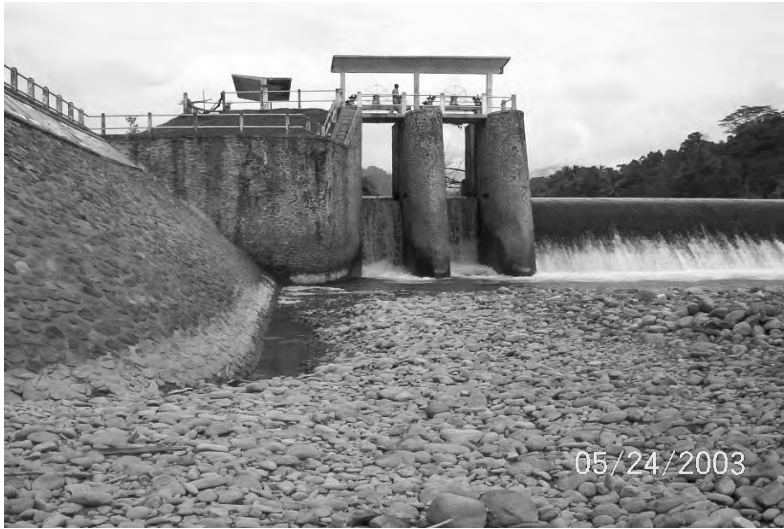
<p><u>Category</u> Irrigation (Headworks)</p>			
		<p><u>Structure</u> Fixed Weir</p>			
		<p><u>Condition</u> <input type="checkbox"/> A <input type="checkbox"/> B <input checked="" type="checkbox"/> C <input type="checkbox"/> D</p>			
		<p><u>Problems</u> Crack or damage on weir crest; settlement of weir body; deflection of pier of weir; rock sedimentation at weir.</p>

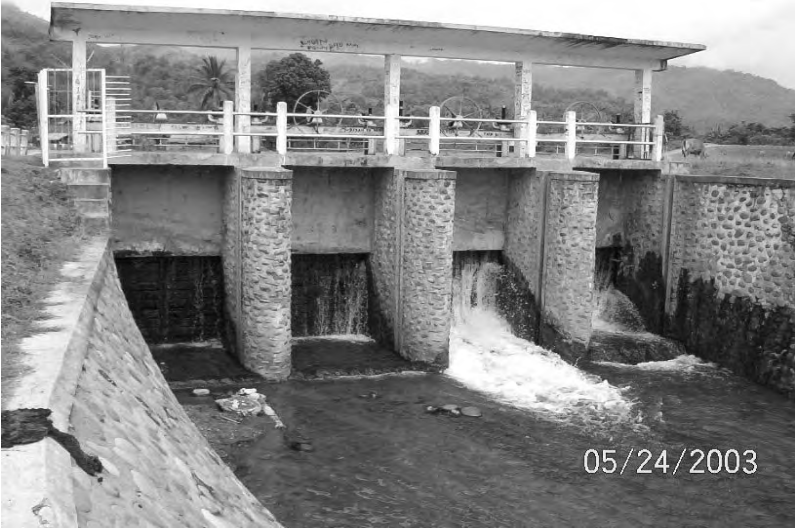
<p><u>Category</u> Irrigation (Headworks)</p>			
		<p><u>Structure</u> Intake</p>			
		<p><u>Condition</u> <input type="checkbox"/> A <input type="checkbox"/> B <input checked="" type="checkbox"/> C <input type="checkbox"/> D</p>			
		<p><u>Problems</u> Insufficient diversion water due to sedimentation in front of intake; leakage from gate leaf; insufficient strength against design load due to rust, decay of steel material; problem on management due to lack of periodically maintenance</p>

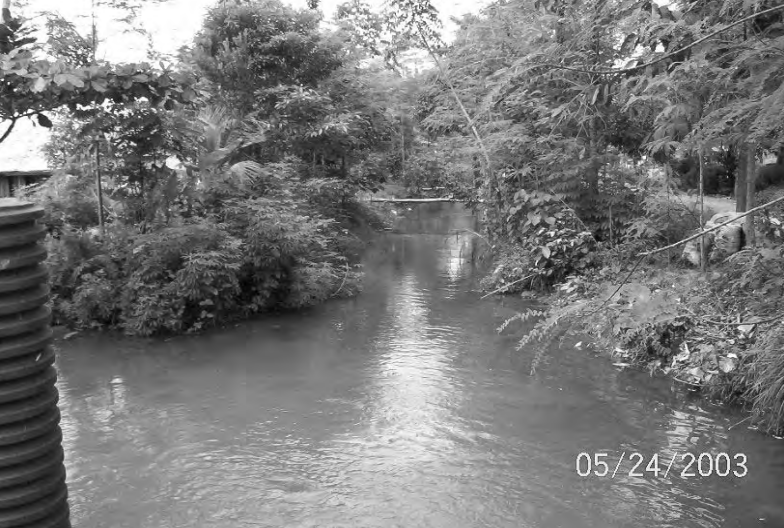
<p><u>Category</u> Irrigation (Main Canal)</p>			
		<p><u>Structure</u> Earth Canal</p>			
		<p><u>Condition</u> <input type="checkbox"/> A <input type="checkbox"/> B <input type="checkbox"/> C <input checked="" type="checkbox"/> D</p>			
		<p><u>Problems</u> Sedimentation; collapse of canal; leakage from canal; difficulty on maintenance of earth canal; no inspection road.</p>
