The Study on Comprehensive Recovery Program
of Irrigation Agriculture

Japan International Cooperation Agency

**Location Map of Irrigation Schemes
in Polmas District**

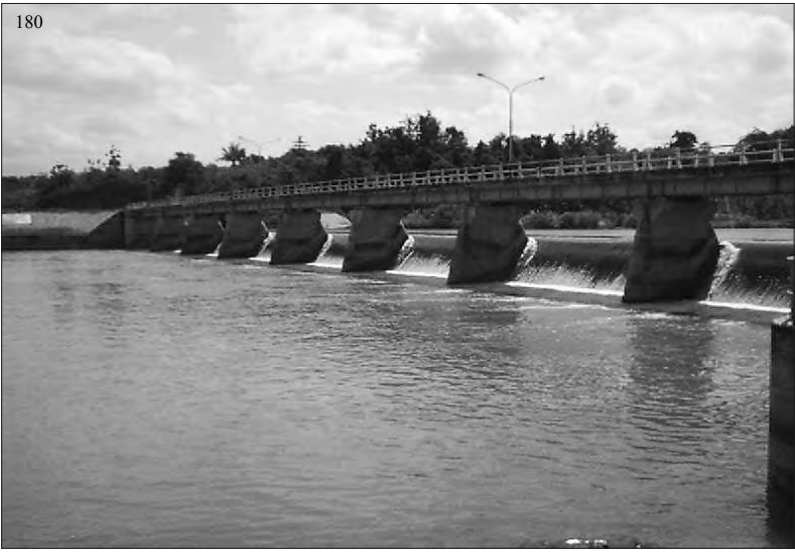
<p><u>Category</u> Irrigation (Headworks)</p> <hr/> <p><u>Structure</u> Weir Crest, Rear View</p> <hr/> <p><u>Condition</u> <input type="checkbox"/> A <input checked="" type="checkbox"/> B <input type="checkbox"/> C <input type="checkbox"/> D</p> <hr/> <p><u>Problems</u> Crack or damage on weir crest; settlement of weir body.</p>			
183

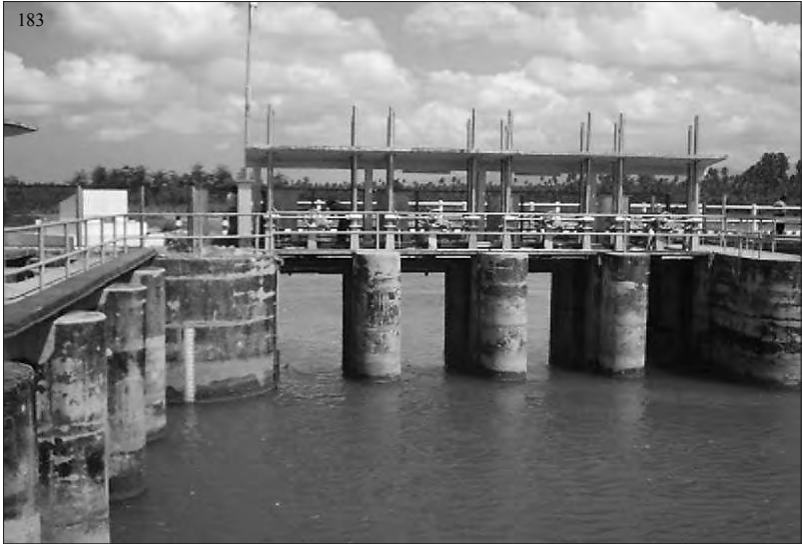
<p><u>Category</u> Irrigation (Headworks)</p> <hr/> <p><u>Structure</u> Intake, Scouring Sluice Gate</p> <hr/> <p><u>Condition</u> <input type="checkbox"/> A <input checked="" type="checkbox"/> B <input type="checkbox"/> C <input type="checkbox"/> D</p> <hr/> <p><u>Problems</u> Leakage from gate leaf; insufficient strength against design load due to rust, decay of steel material.</p>			
184

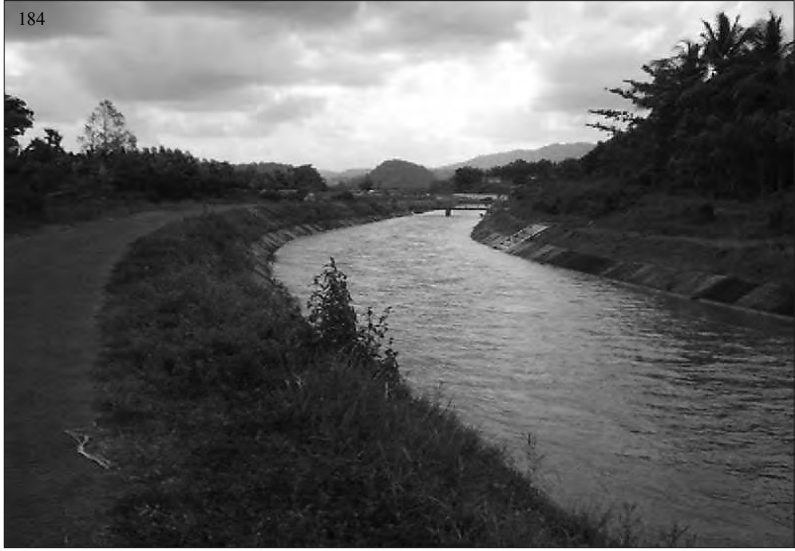
<p><u>Category</u> Irrigation (Main Canal)</p> <hr/> <p><u>Structure</u> Masonry Lined Canal</p> <hr/> <p><u>Condition</u> <input type="checkbox"/> A <input type="checkbox"/> B <input checked="" type="checkbox"/> C <input type="checkbox"/> D</p> <hr/> <p><u>Problems</u> Sedimentation; leakage from lined canal; crack on lined canal; deflection of lining toward inside of canal; less maintenance; and no inspection road.</p>

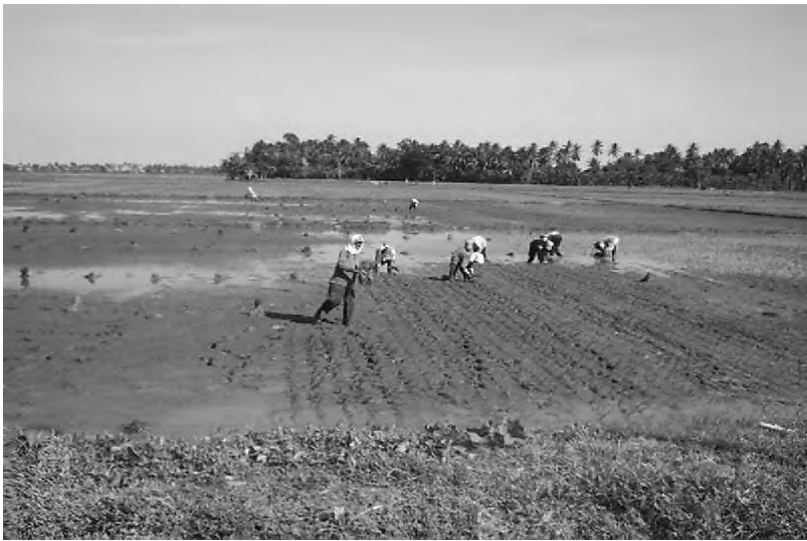
<u>Category</u> Agriculture, On-Farm	
		<u>Structure</u> Paddy Field	
		<u>Condition</u> <input type="checkbox"/> A <input type="checkbox"/> B <input type="checkbox"/> C <input checked="" type="checkbox"/> D	
		<u>Problems</u> Tranplanting

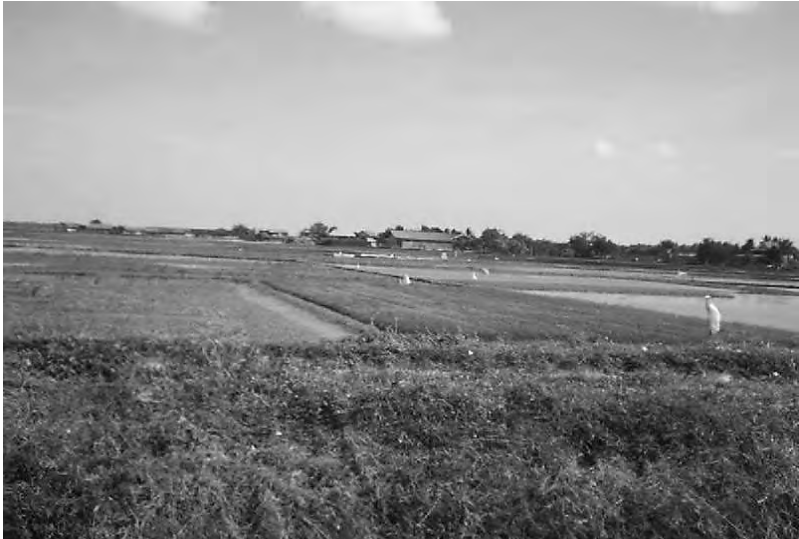
<u>Category</u> Agriculture, On-Farm	
		<u>Activity</u> Paddy Cultivation	
		<u>Condition</u> <input type="checkbox"/> A <input type="checkbox"/> B <input type="checkbox"/> C <input checked="" type="checkbox"/> D	
		<u>Problems</u> Low density of on-farm canals and farm roads.

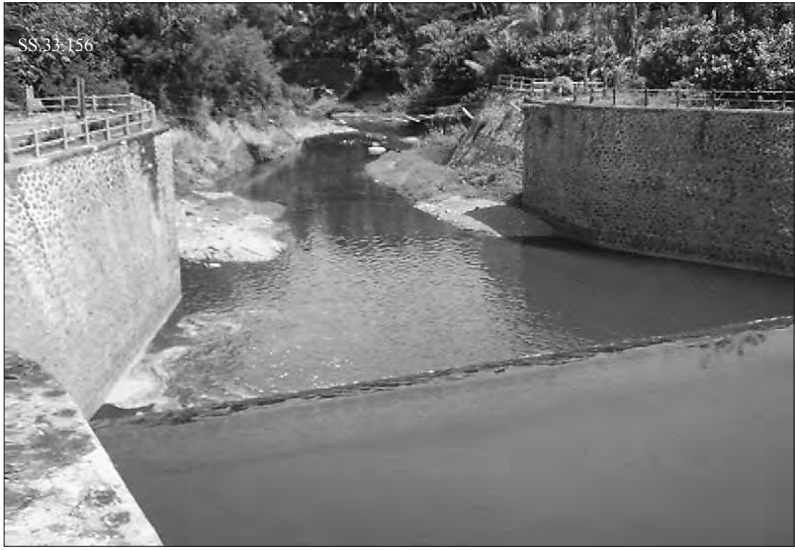
<p>SS.33.156</p>		<p><u>Category</u> Irrigation (Headworks)</p> <p><u>Structure</u> Stilling Basin, Ripraps</p> <p><u>Condition</u> <input type="checkbox"/> A <input checked="" type="checkbox"/> B <input type="checkbox"/> C <input type="checkbox"/> D</p> <p><u>Problems</u> Washed away of stilling basin; washed away of ripraps or gabions at downstream of stilling basin.</p>

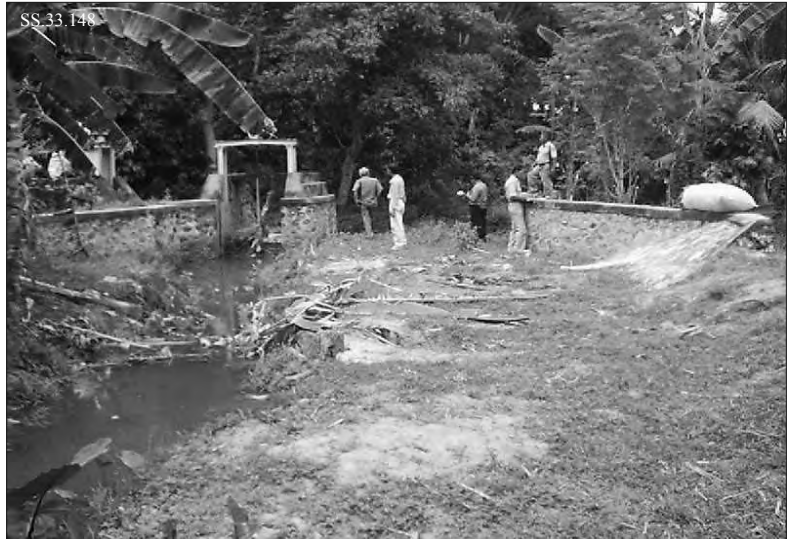
<p>SS.33.148</p>		<p><u>Category</u> Irrigation (Headworks)</p> <p><u>Structure</u> Intake</p> <p><u>Condition</u> <input type="checkbox"/> A <input type="checkbox"/> B <input type="checkbox"/> C <input checked="" type="checkbox"/> D</p> <p><u>Problems</u> Insufficient diversion water due to sedimentation in front of intake; broken of gates.</p>

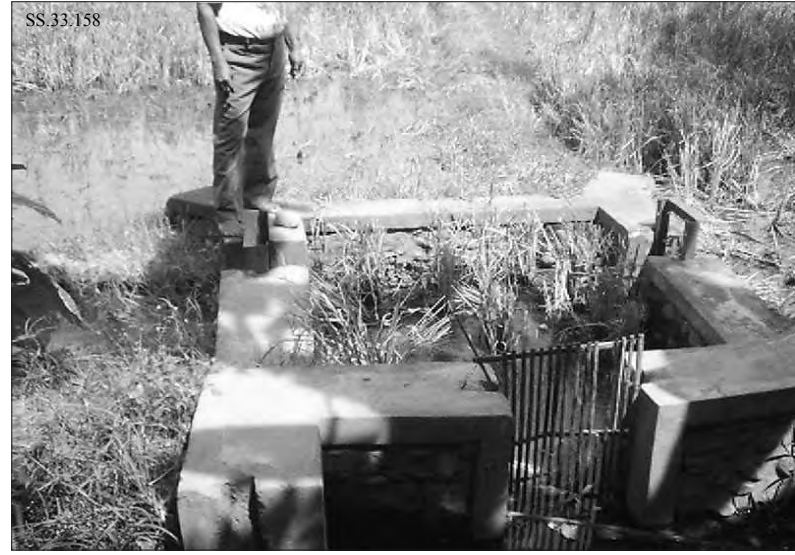
<p>SS.33.158</p>		<p><u>Category</u> Irrigation (Secondary Canal)</p> <p><u>Structure</u> Division Structure</p> <p><u>Condition</u> <input type="checkbox"/> A <input type="checkbox"/> B <input type="checkbox"/> C <input checked="" type="checkbox"/> D</p> <p><u>Problems</u> Lower function of division structure due to sedimentation in front gate; physical operation problem on structure; deterioration of steel gates..</p>

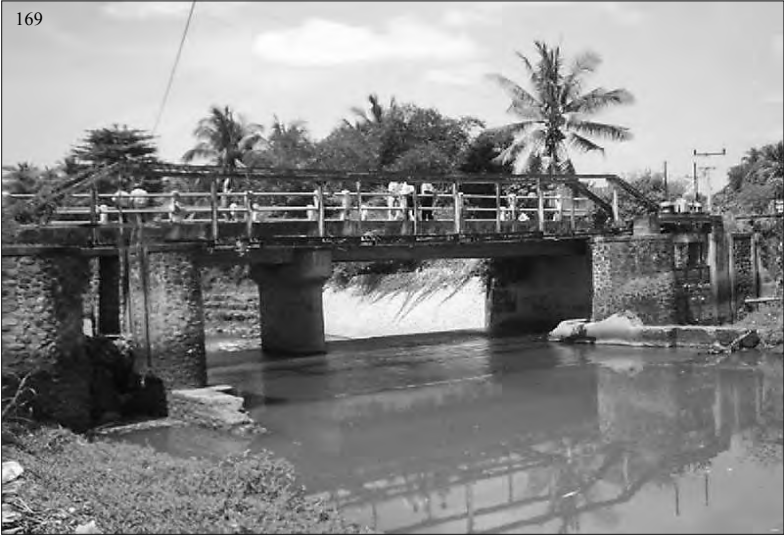
<p><u>Category</u> Irrigation (Headworks)</p> <hr/> <p><u>Structure</u> Fixed Weir</p> <hr/> <p><u>Condition</u> <input type="checkbox"/> A <input type="checkbox"/> B <input type="checkbox"/> C <input checked="" type="checkbox"/> D</p> <hr/> <p><u>Problems</u> Not in use at present</p>		
171

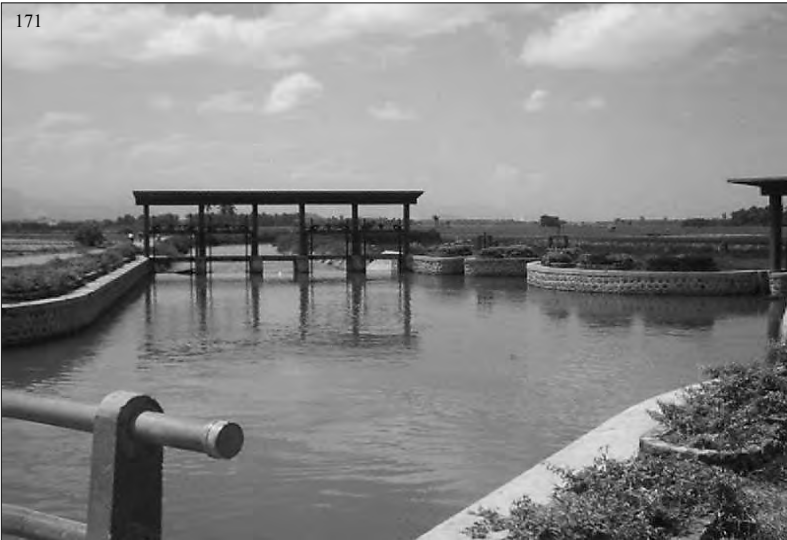
<p><u>Category</u> Irrigation (Main Canal)</p> <hr/> <p><u>Structure</u> Division Structure</p> <hr/> <p><u>Condition</u> <input type="checkbox"/> A <input type="checkbox"/> B <input checked="" type="checkbox"/> C <input type="checkbox"/> D</p> <hr/> <p><u>Problems</u> Lower function of division structure due to sedimentation in front gate; physical operation problem on structure.</p>		
170

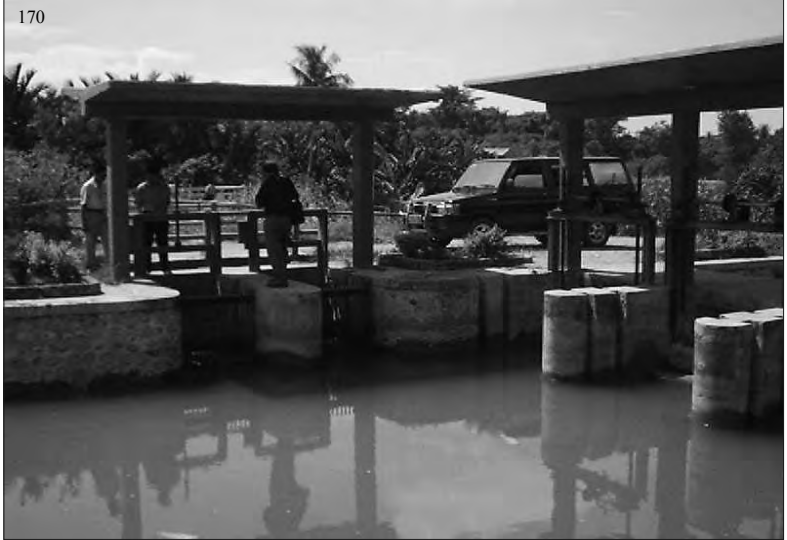
<p><u>Category</u> Irrigation (Main Canal)</p> <hr/> <p><u>Structure</u> Division Structure</p> <hr/> <p><u>Condition</u> <input type="checkbox"/> A <input type="checkbox"/> B <input checked="" type="checkbox"/> C <input type="checkbox"/> D</p> <hr/> <p><u>Problems</u> Lower function of division structure due to sedimentation in front gate; physical operation problem on structure.</p>

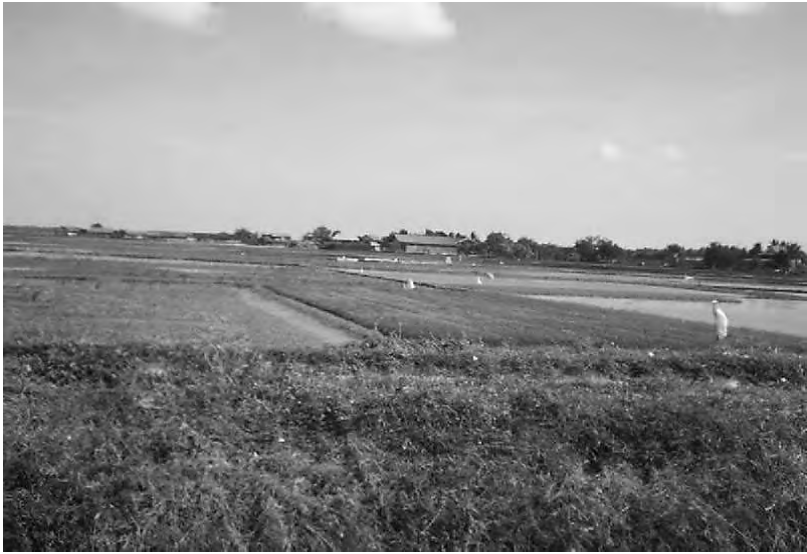
<u>Category</u> Agriculture, On-Farm	
		<u>Activity</u> Paddy Cultivation	
		<u>Condition</u> <input type="checkbox"/> A <input type="checkbox"/> B <input checked="" type="checkbox"/> C <input type="checkbox"/> D	
 		<u>Category</u> Agriculture, On-Farm	
		<u>Activity</u> Harvesting	
		<u>Condition</u> <input type="checkbox"/> A <input type="checkbox"/> B <input checked="" type="checkbox"/> C <input type="checkbox"/> D	
		<u>Problems</u> Low density of on-farm canals and farm roads.	
		<u>Category</u>	
		<u>Activity</u>	
		<u>Condition</u> <input type="checkbox"/> A <input type="checkbox"/> B <input type="checkbox"/> C <input type="checkbox"/> D	
		<u>Problems</u>
