The Study on Comprehensive Recovery Program  
of Irrigation Agriculture

Japan International Cooperation Agency

**Location Map of Irrigation Schemes  
in Luwu Utara District**

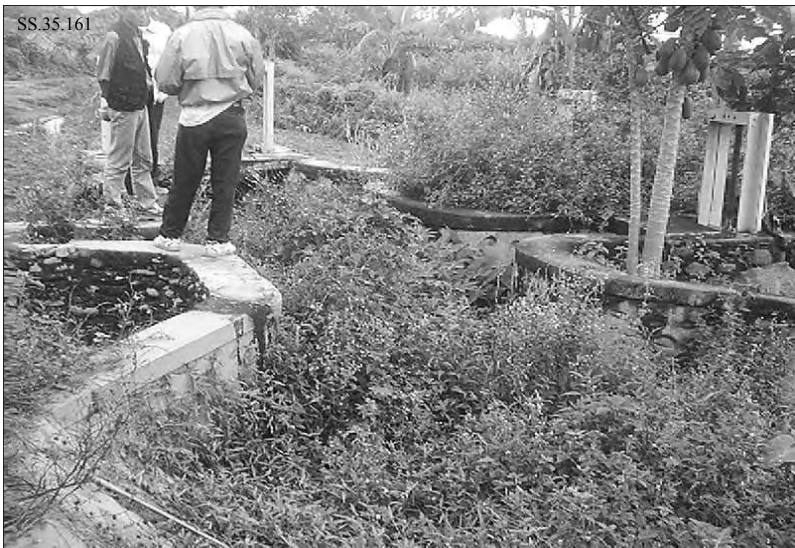
<p>SS.35.161</p>		<p><u>Category</u> Irrigation (Main Canal)</p> <p><u>Structure</u> Division Structure</p> <p><u>Condition</u>  <input type="checkbox"/> A    <input type="checkbox"/> B    <input type="checkbox"/> C    <input checked="" type="checkbox"/> D</p> <p><u>Problems</u> Steel gates are out of service; lower function due to sedimentation in front of structure.</p>

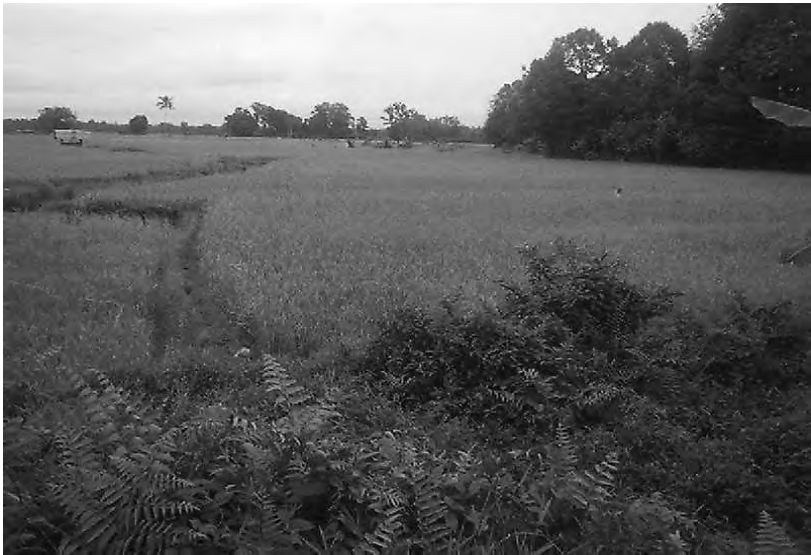
<p><u>Category</u> Ariculture, On-Farm</p> <p><u>Activity</u> Paddy Cultivation</p> <p><u>Condition</u>  <input type="checkbox"/> A    <input type="checkbox"/> B    <input checked="" type="checkbox"/> C    <input type="checkbox"/> D</p> <p><u>Problems</u> Low density of on-farm canals and farm roads.</p>

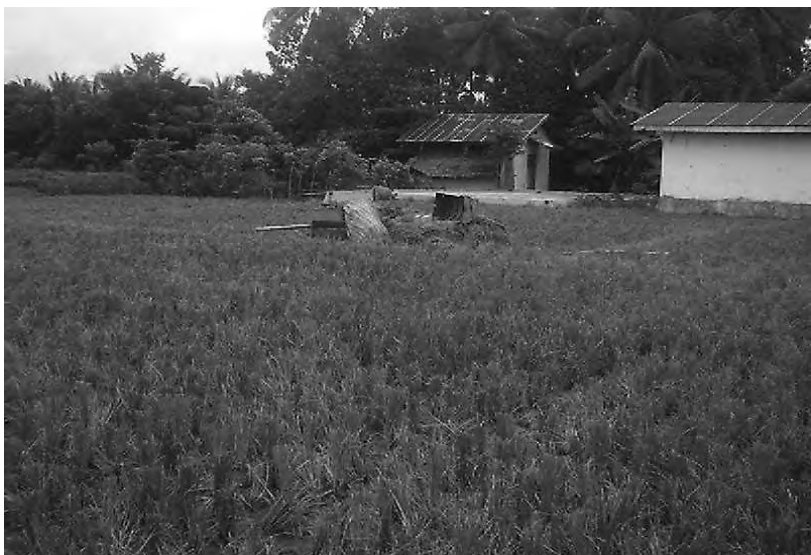
<p><u>Category</u> Ariculture, On-Farm</p> <p><u>Activity</u> Treshering</p> <p><u>Condition</u>  <input type="checkbox"/> A    <input type="checkbox"/> B    <input checked="" type="checkbox"/> C    <input type="checkbox"/> D</p> <p><u>Problems</u> Low density of on-farm canals and farm roads.</p>

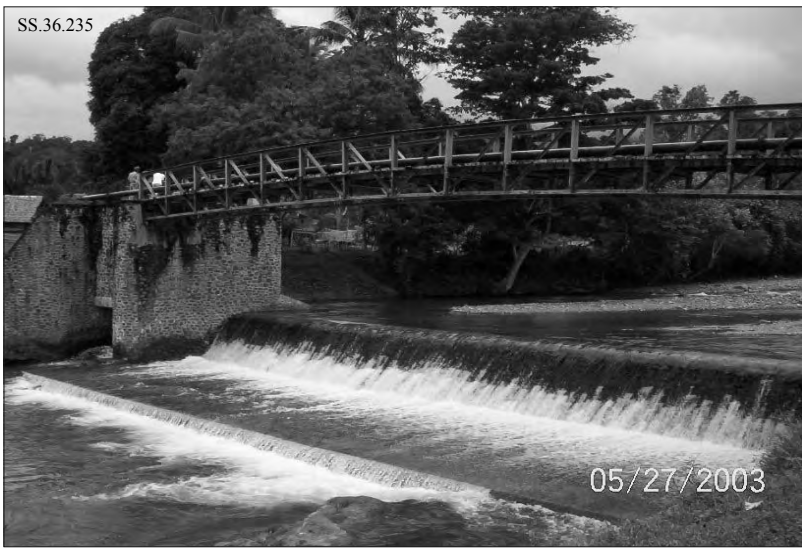
<i>Category</i> Irrigation (Headworks)			
	<i>Structure</i> Fixed Weir			
	<i>Condition</i> <input type="checkbox"/> A <input checked="" type="checkbox"/> B <input type="checkbox"/> C <input type="checkbox"/> D			
<i>Problems</i> Insufficient diversion water due to sedimentation in front of intake.				
SS.36.243

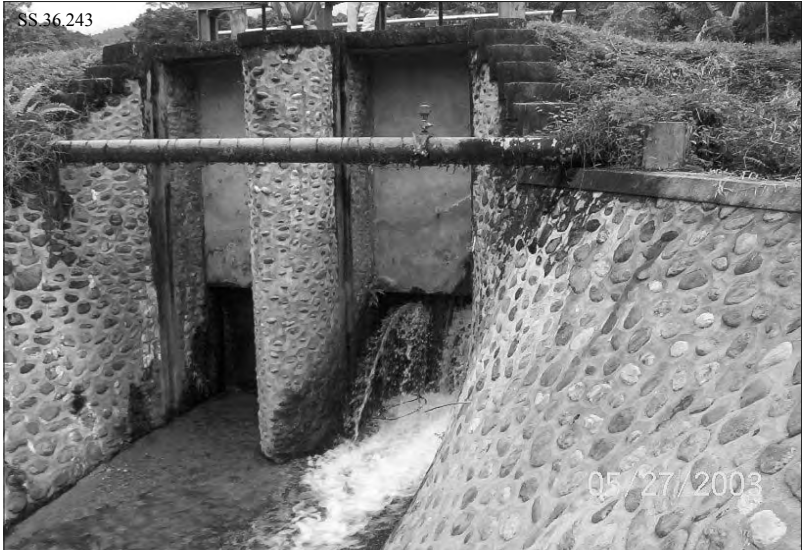
<i>Category</i> Irrigation (Headworks)			
	<i>Structure</i> Intake			
	<i>Condition</i> <input type="checkbox"/> A <input checked="" type="checkbox"/> B <input type="checkbox"/> C <input type="checkbox"/> D			
<i>Problems</i> Leakage from gate leaf; insufficient strength against design load due to rust, decay of steel material; problem on management due to lack of periodically maintenance				
SS.36.249

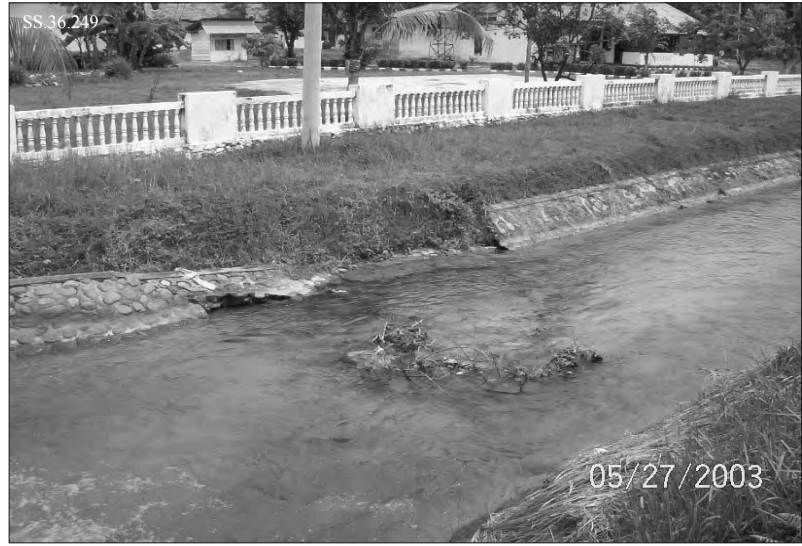
<i>Category</i> Irrigation (Main Canal)			
	<i>Structure</i> Masonry Lined Canal

<i>Condition</i> <input type="checkbox"/> A <input type="checkbox"/> B <input checked="" type="checkbox"/> C <input type="checkbox"/> D			
<i>Problems</i> Sedimentation; leakage from lined canal; crack on lined canal; deflection of lining toward inside of canal; less maintenance; and no inspection road.

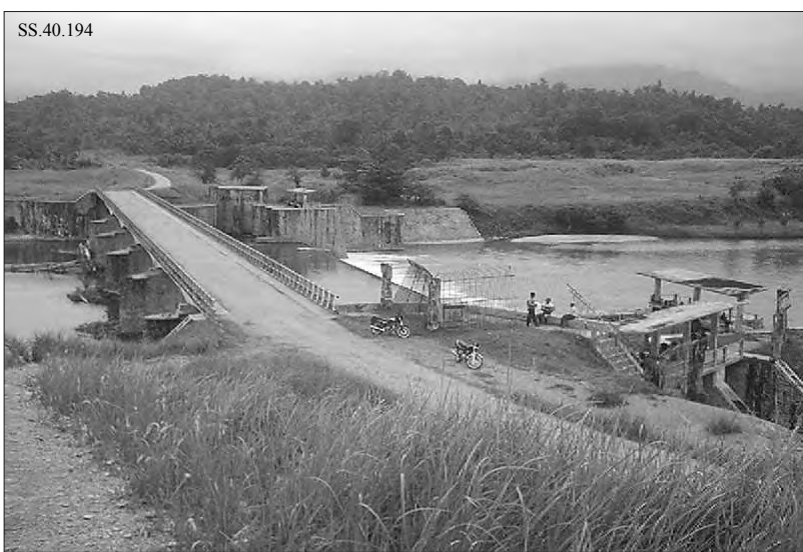
<p><u>Category</u> Irrigation (Headworks)</p> <p><u>Structure</u> Fixed Weir</p> <p><u>Condition</u>  <input type="checkbox"/> A    <input checked="" type="checkbox"/> B    <input type="checkbox"/> C    <input type="checkbox"/> D</p> <p><u>Problems</u> Crack or damage on weir crest; settlement of weir body.</p>

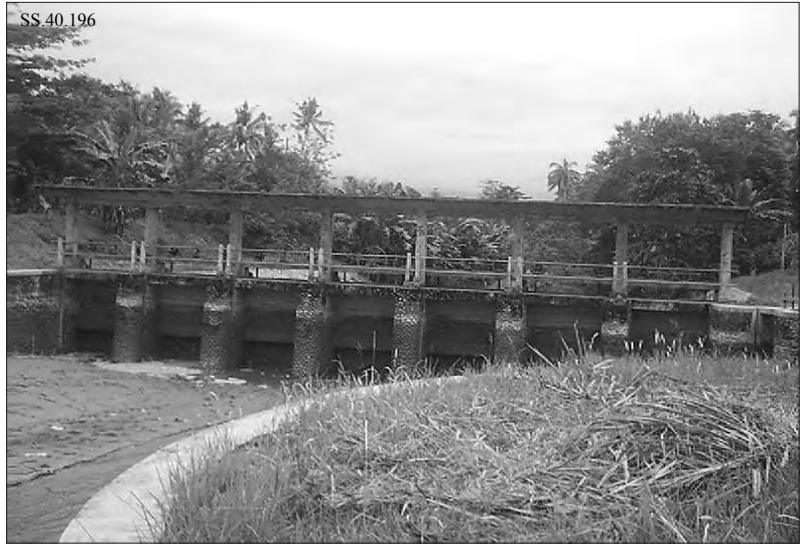
<p><u>Category</u> Main Canal</p> <p><u>Structure</u> Division Structure</p> <p><u>Condition</u>  <input type="checkbox"/> A    <input type="checkbox"/> B    <input type="checkbox"/> C    <input checked="" type="checkbox"/> D</p> <p><u>Problems</u> Lower function of division structure due to sedimentation in front of gate; physical operation problem on structure; deterioration of steel gates.</p>

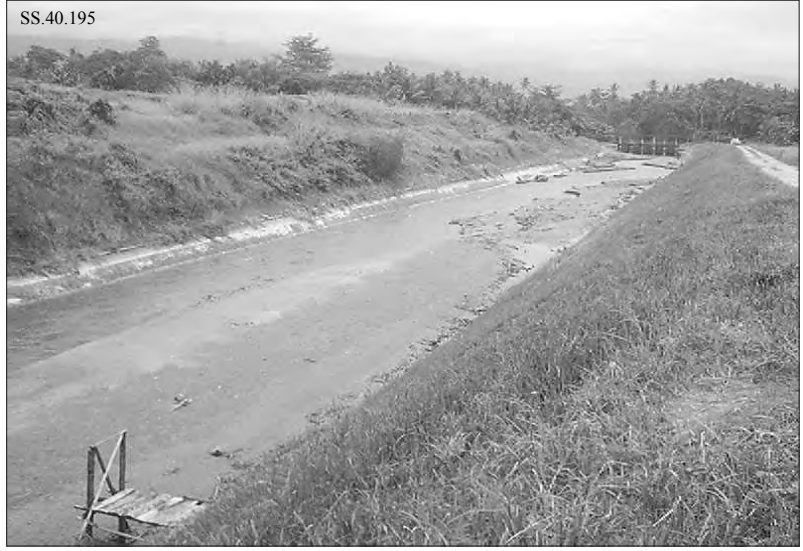
<p><u>Category</u> Irrigation (Main Canal)</p> <p><u>Structure</u> Masonry Lined Canal</p> <p><u>Condition</u>  <input type="checkbox"/> A    <input type="checkbox"/> B    <input type="checkbox"/> C    <input checked="" type="checkbox"/> D</p> <p><u>Problems</u> Sedimentation; leakage from lined canal; crack on lined canal; deflection of lining toward inside of canal; less maintenance; and no inspection road.</p>

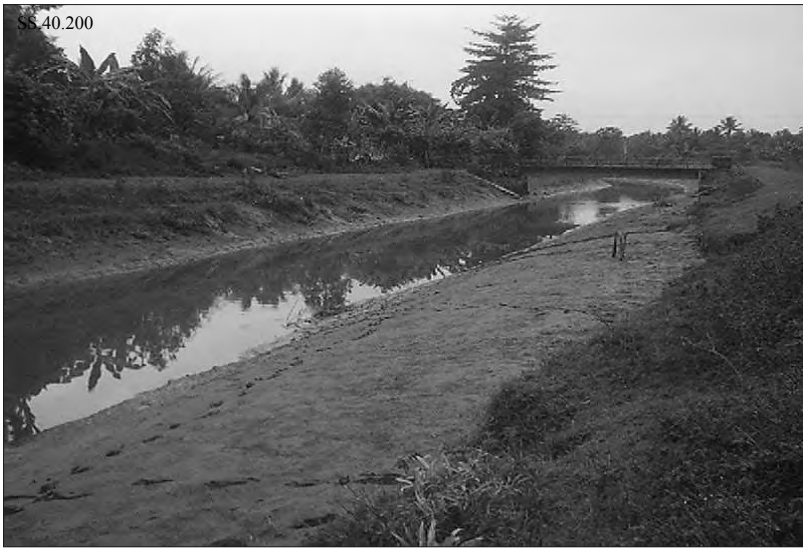
<p><u>Category</u> Irrigation (Main Canal)</p> <hr/> <p><u>Structure</u> Earth Canal</p> <hr/> <p><u>Condition</u>  <input type="checkbox"/> A    <input type="checkbox"/> B    <input type="checkbox"/> C    <input checked="" type="checkbox"/> D</p> <hr/> <p><u>Problems</u> Sedimentation; collapse of canal; leakage from canal; difficulty on maintenance of earth canal; no inspection road.</p>

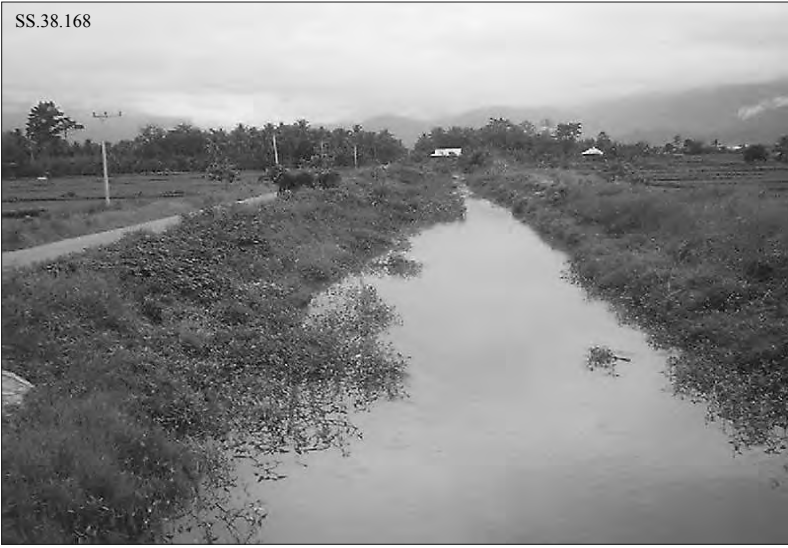
<p><u>Category</u> Irrigation (Main Canal)</p> <hr/> <p><u>Structure</u> Earth Canal</p> <hr/> <p><u>Condition</u>  <input type="checkbox"/> A    <input type="checkbox"/> B    <input type="checkbox"/> C    <input checked="" type="checkbox"/> D</p> <hr/> <p><u>Problems</u> Sedimentation; collapse of canal; leakage from canal; difficulty on maintenance of earth canal; no inspection road.</p>		
SS.38.170	 	<p><u>Category</u> Irrigation (Main Canal)</p> <hr/> <p><u>Structure</u> Masonry Lined Canal</p> <hr/> <p><u>Condition</u>  <input type="checkbox"/> A    <input type="checkbox"/> B    <input type="checkbox"/> C    <input checked="" type="checkbox"/> D</p> <hr/> <p><u>Problems</u> Sedimentation; leakage from lined canal; crack on lined canal; deflection of lining toward inside of canal; less maintenance; and no inspection road.</p>

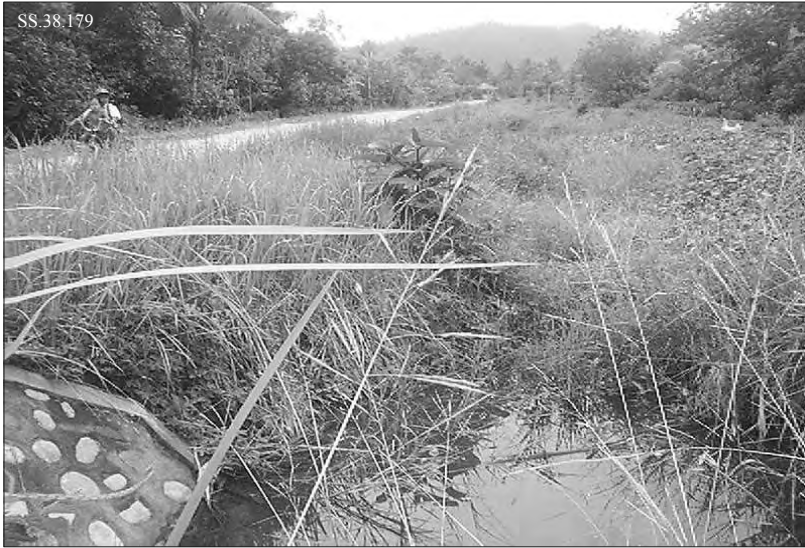
<u>Category</u> Irrigation (Secondary Canal)		
		<u>Structure</u> Earth Canal		
		<u>Condition</u> <input type="checkbox"/> A <input type="checkbox"/> B <input type="checkbox"/> C <input checked="" type="checkbox"/> D		
		<u>Problems</u> Sedimentation; leakage from lined canal; crack on lined canal; deflection of lining toward inside of canal; less maintenance; and no inspection road.

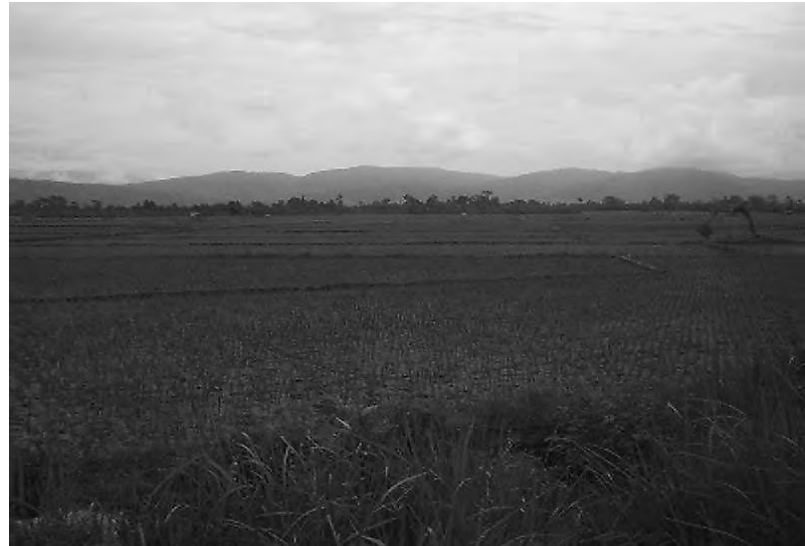
<u>Category</u> Ariculture, On-Farm		
		<u>Activity</u> Paddy Cultivation		
		<u>Condition</u> <input type="checkbox"/> A <input type="checkbox"/> B <input checked="" type="checkbox"/> C <input type="checkbox"/> D		
		<u>Problems</u> Low density of on-farm canals and farm roads.
