I. PROJECT FUNDAMENTALS									
I.1 General									
(1) Code Number	: 73220172			(7) Number of Farmers	: 1,250				
(2) Name of Irrigation Scheme	: Kalaena Kanan II			(8) Water Resource River	: Kalaena

I. PROJECT FUNDAMENTALS										
I.1 General										
(1) Code Number	: 73220173			(7) Number of Farmers	: 1,500					
(2) Name of Irrigation Scheme	: Kalaena (Rt. Bendung)			(8) Water Resource River	: Kalaena

I. PROJECT FUNDAMENTALS									
I.1 General									
(1) Code Number	: 73220226			(7) Number of Farmers	: 257				
(2) Name of Irrigation Scheme	: Kuri-Kuri, Kasambi			(8) Water Resource River	: Masamba

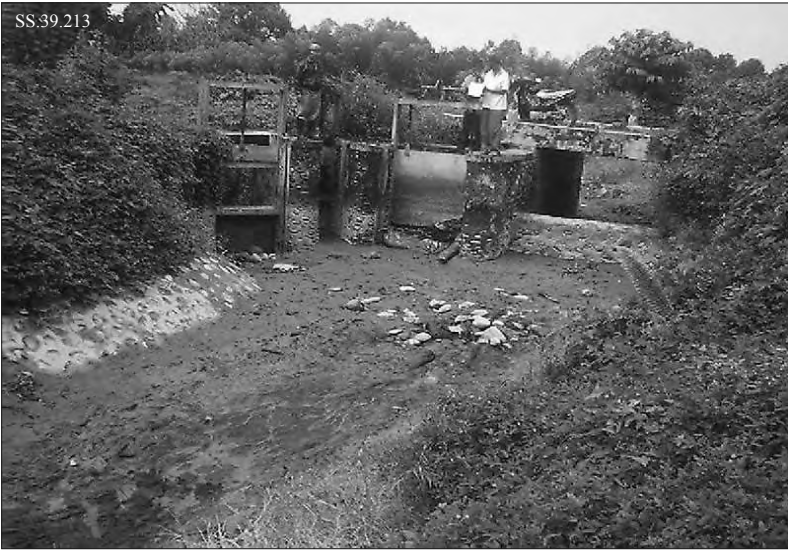
<p><u>Category</u> Irrigation (Secondary Canal)</p> <hr/> <p><u>Structure</u> Division Structure</p> <hr/> <p><u>Condition</u> <input type="checkbox"/> A <input type="checkbox"/> B <input type="checkbox"/> C <input checked="" type="checkbox"/> D</p> <hr/> <p><u>Problems</u> Lower function of division structure due to sedimentation in front of gate; physical operation problem on structure; deterioration of steel gates; damage on structure.</p>

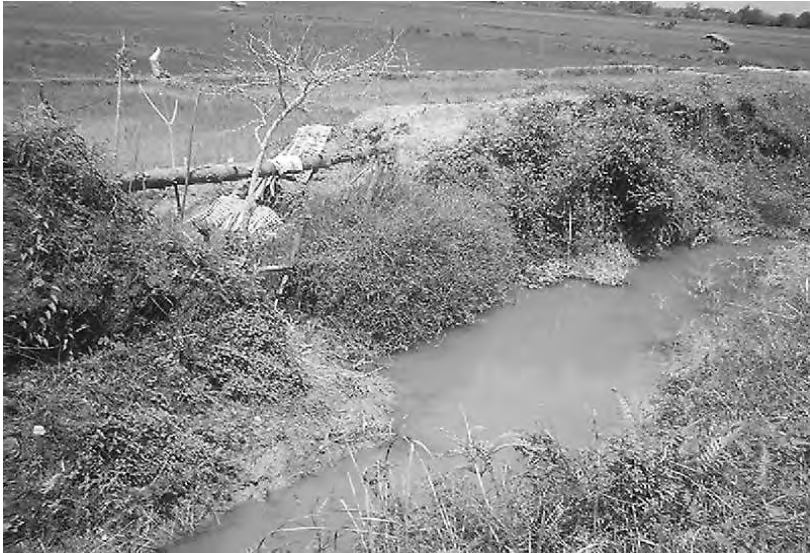
<p><u>Category</u> Irrigation (Secondary Canal)</p> <hr/> <p><u>Activity</u> Earth Canal</p> <hr/> <p><u>Condition</u> <input type="checkbox"/> A <input type="checkbox"/> B <input checked="" type="checkbox"/> C <input type="checkbox"/> D</p> <hr/> <p><u>Problems</u> Sedimentation; collapse of canal; leakage from canal; difficulty on maintenance of earth canal; no inspection road.</p>

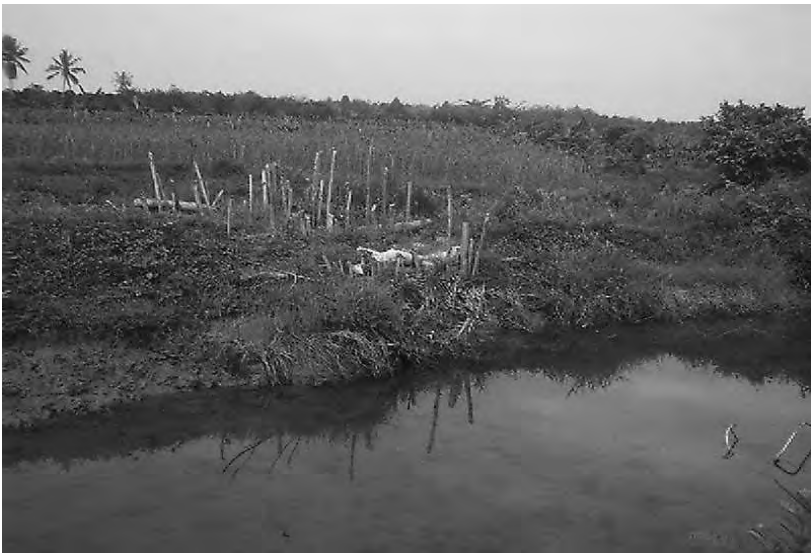
<p><u>Category</u> Ariculture, On-Farm</p> <hr/> <p><u>Activity</u> Secondary Crop Cultivation</p> <hr/> <p><u>Condition</u> <input type="checkbox"/> A <input type="checkbox"/> B <input checked="" type="checkbox"/> C <input type="checkbox"/> D</p> <hr/> <p><u>Problems</u></p>

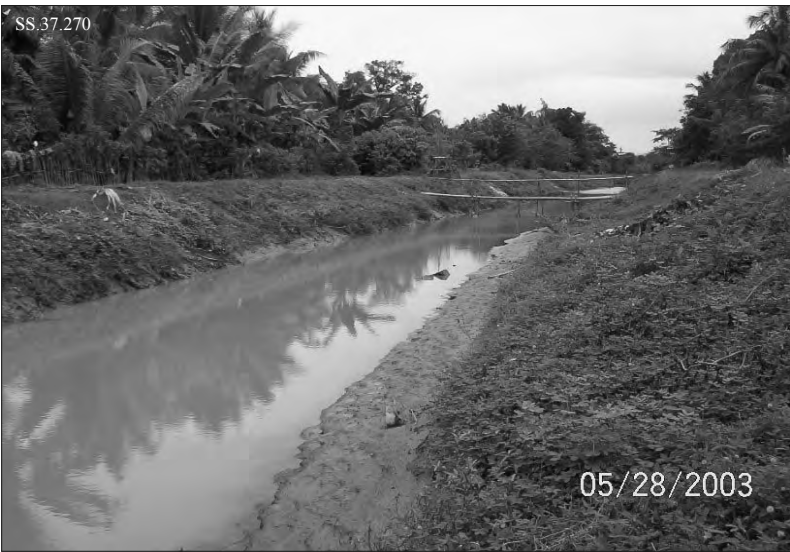
<p><u>Category</u> Irrigation (Main Canal)</p> <hr/> <p><u>Structure</u> Earth Canal</p> <hr/> <p><u>Condition</u> <input type="checkbox"/> A <input type="checkbox"/> B <input checked="" type="checkbox"/> C <input type="checkbox"/> D</p> <hr/> <p><u>Problems</u> Sedimentation; collapse of canal; leakage from canal; difficulty on maintenance of earth canal; no inspection road.</p>

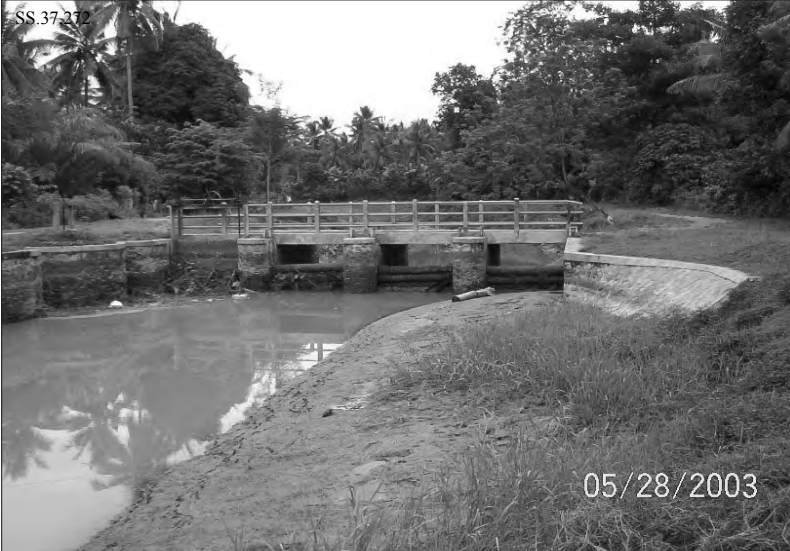
<p><u>Category</u> Irrigation (Main Canal)</p> <hr/> <p><u>Structure</u> Division Structure</p> <hr/> <p><u>Condition</u> <input type="checkbox"/> A <input type="checkbox"/> B <input checked="" type="checkbox"/> C <input type="checkbox"/> D</p> <hr/> <p><u>Problems</u> Lower function of division structure due to sedimentation in front of gate; physical operation problem on structure; deterioration of steel gates.</p>

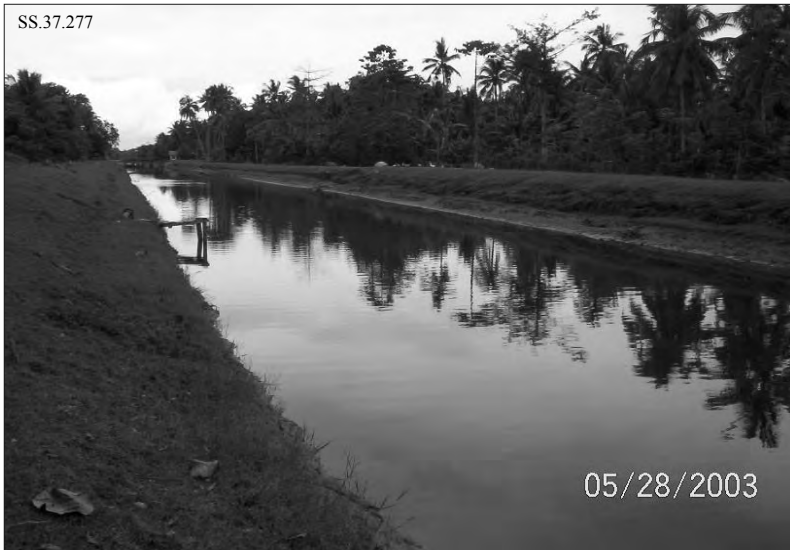
<p><u>Category</u> Irrigation (Main Canal)</p> <hr/> <p><u>Structure</u> Masonry Lined Canal</p> <hr/> <p><u>Condition</u> <input type="checkbox"/> A <input type="checkbox"/> B <input checked="" type="checkbox"/> C <input type="checkbox"/> D</p> <hr/> <p><u>Problems</u> Sedimentation; leakage from lined canal; crack on lined canal; deflection of lining toward inside of canal; less maintenance; and no inspection road.</p>

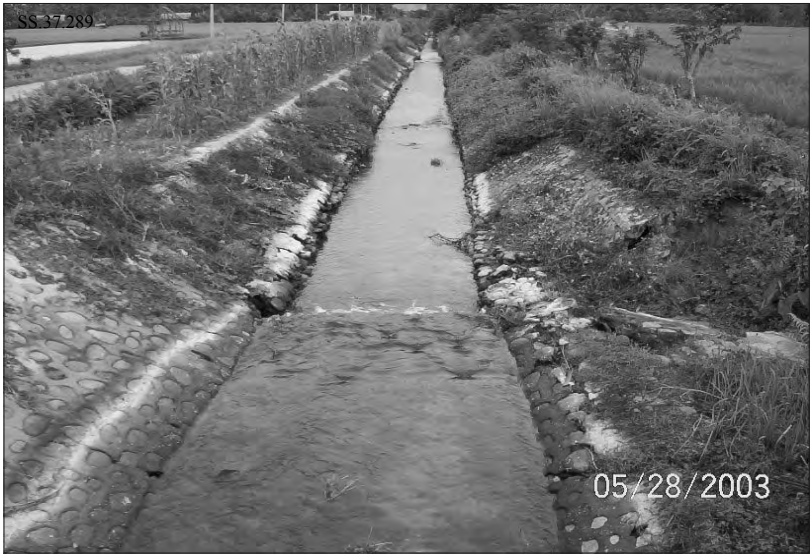
<i>Category</i> Irrigation (Secondary Canal)	
		<i>Structure</i> Masonry Lined Canal	
		<i>Condition</i> <input type="checkbox"/> A <input type="checkbox"/> B <input checked="" type="checkbox"/> C <input type="checkbox"/> D

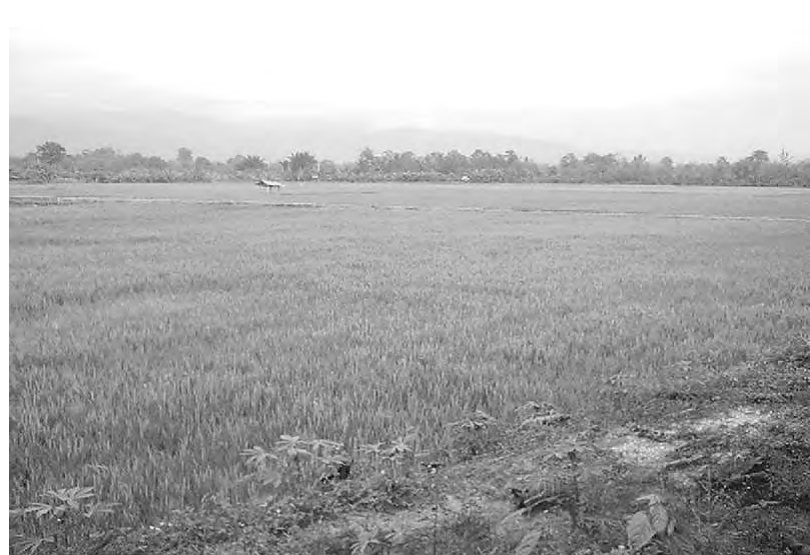
<i>Category</i> Ariculture, On-Farm	
		<i>Activity</i> Paddy Cultivation	
		<i>Condition</i> <input type="checkbox"/> A <input type="checkbox"/> B <input checked="" type="checkbox"/> C <input type="checkbox"/> D

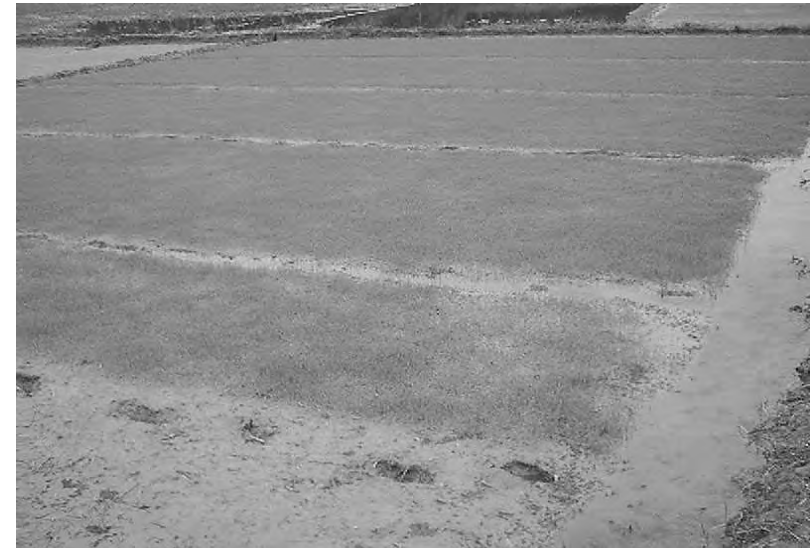
<i>Category</i> Ariculture, On-Farm	
		<i>Activity</i> Nursery Preparation	
		<i>Condition</i> <input type="checkbox"/> A <input type="checkbox"/> B <input checked="" type="checkbox"/> C <input type="checkbox"/> D	
		<i>Problems</i> Sedimentation; leakage from lined canal; crack on lined canal; deflection of lining toward inside of canal; less maintenance; and no inspection road.
