DOCUMENTATION OF RIVER SURVEY 2003

Name of River / Canal	: Kali Sunter	Date of Survey	: 24-02-2003
Location	: Kel. Sunter Jaya	Filled by	: PT. MITRAPACIFIC CONSULINDO INTERNATIONAL
No. of Picture	:		
Title	:

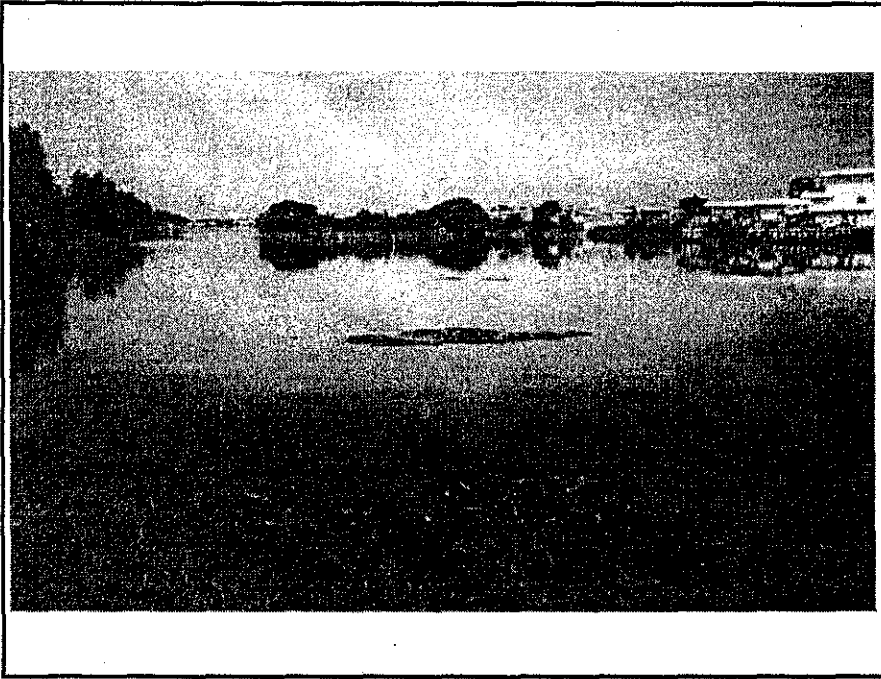
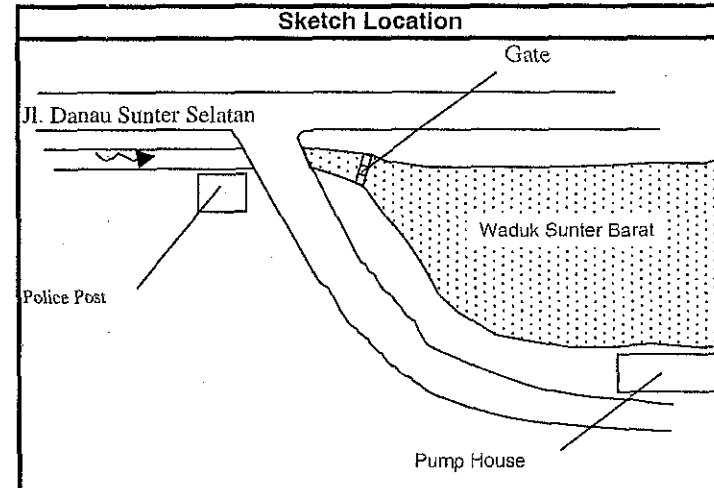
- Sedimentation in reservoir to increase reservoir capacity.

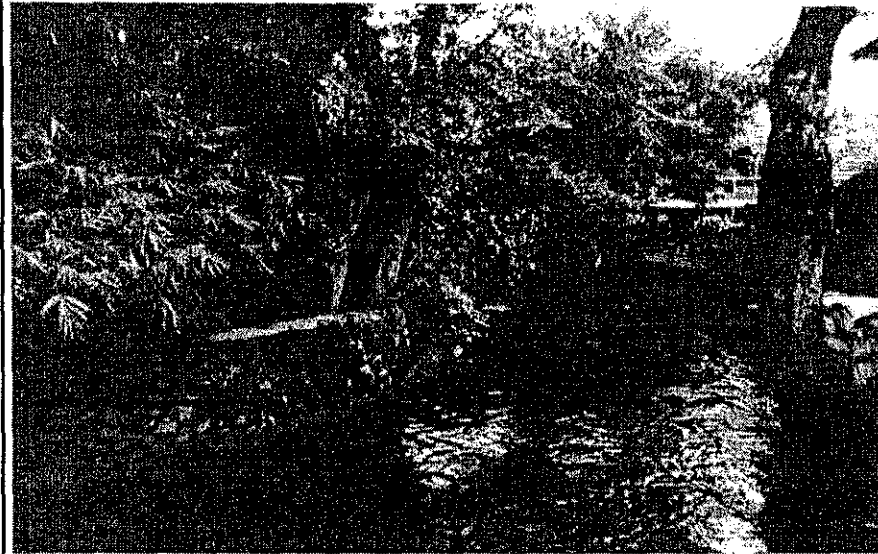
- Meandered alignment of river, with community participation for clean environment of the river

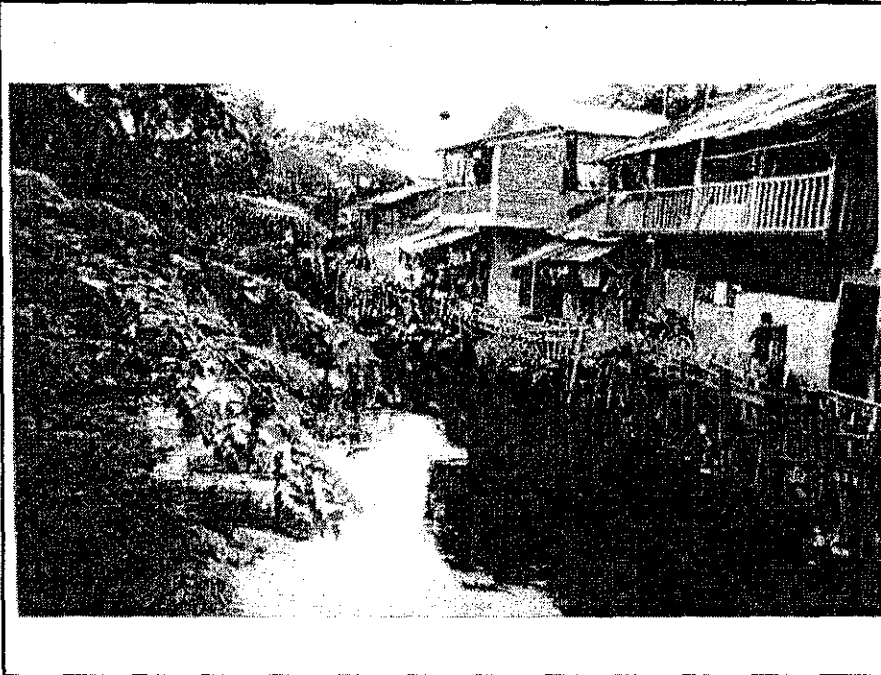
- Community commitment and contribution for maintenance of the river, building the dikes and keep river clean.

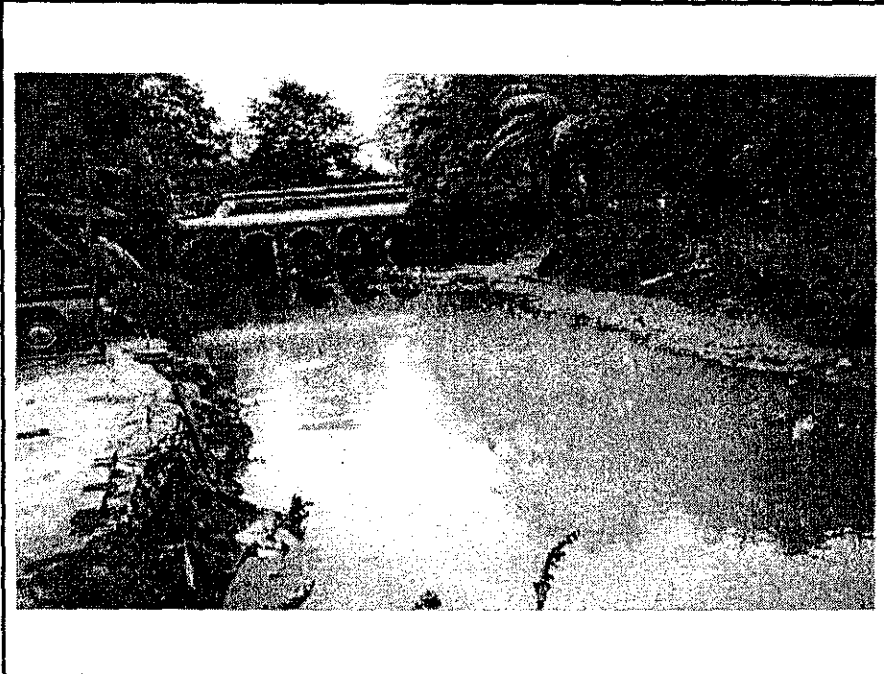
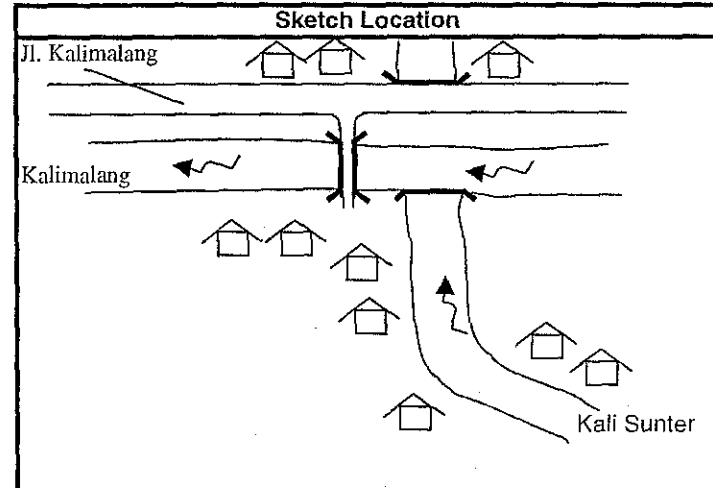
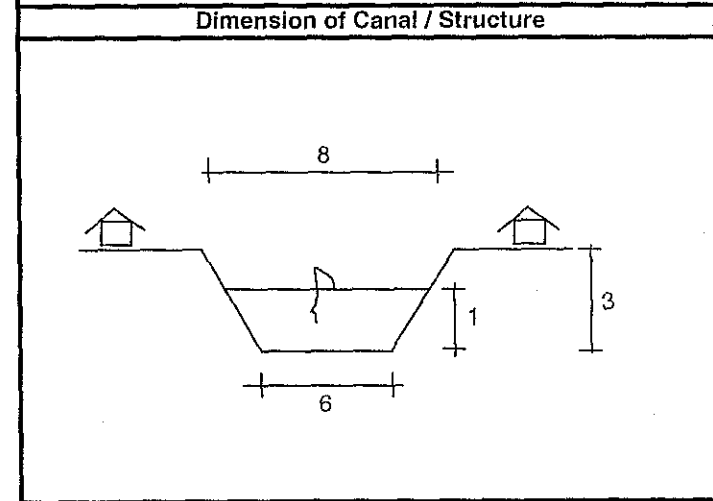
- No dike provided and housing in the river bank, can increase the flood area.

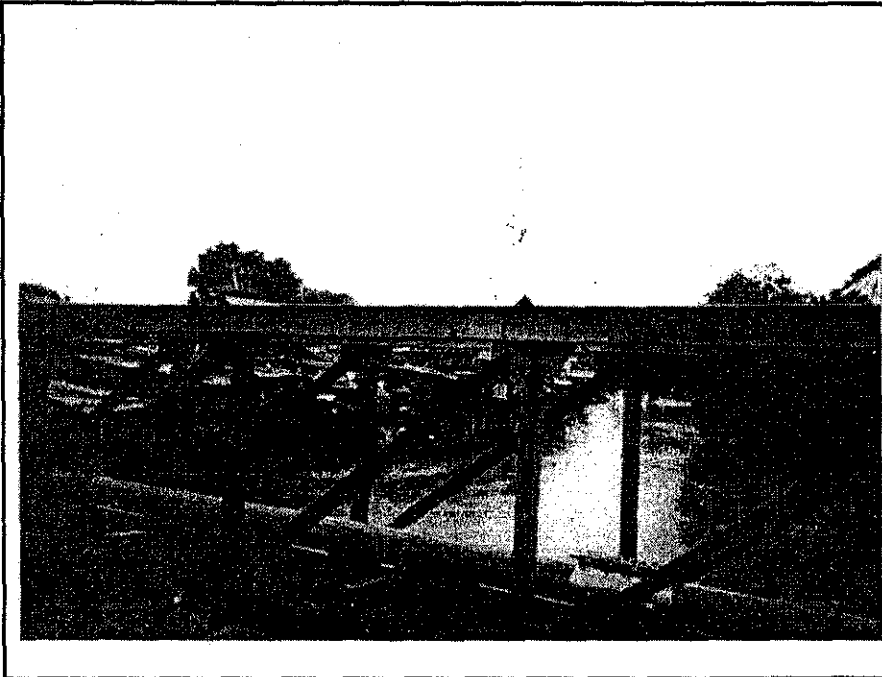
- houses built along the riverbank, against regulation and use river as disposal area.

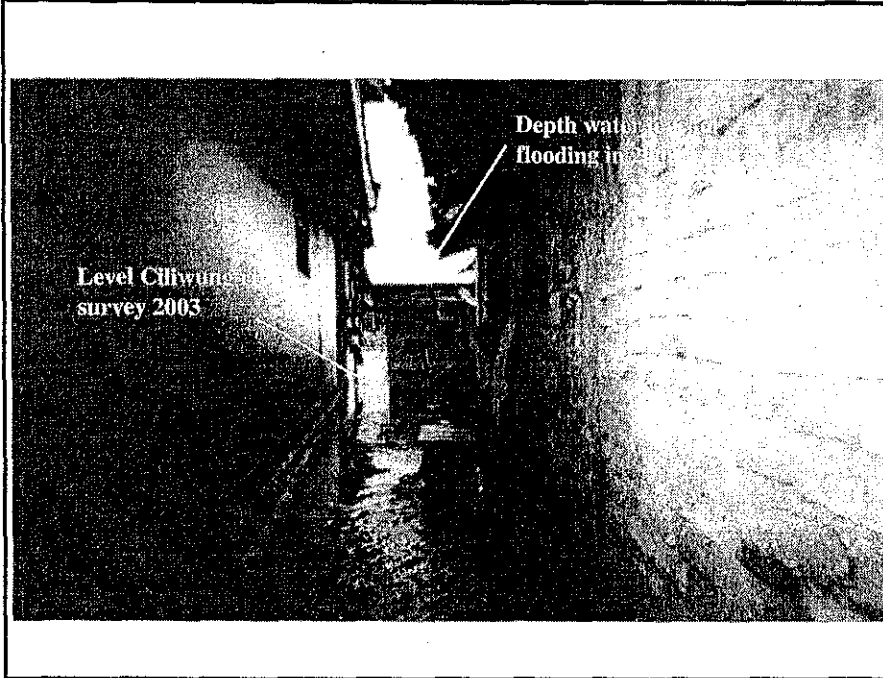
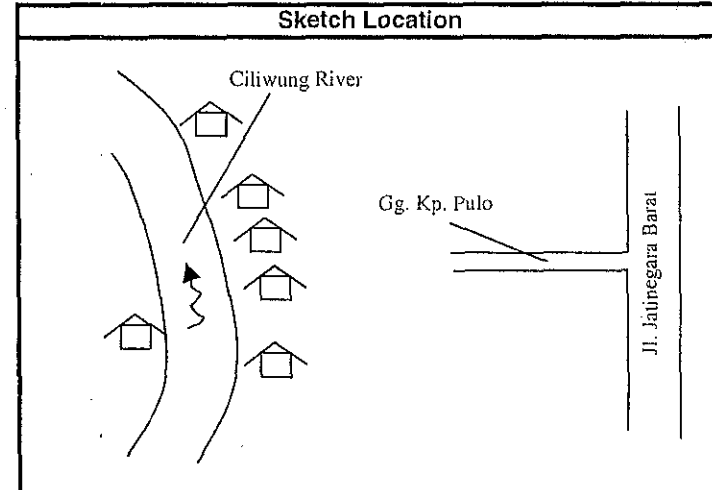
- Flood level during 2002 inundation and during survey 2003, indicated in the picture as influence from Ciliwung river.

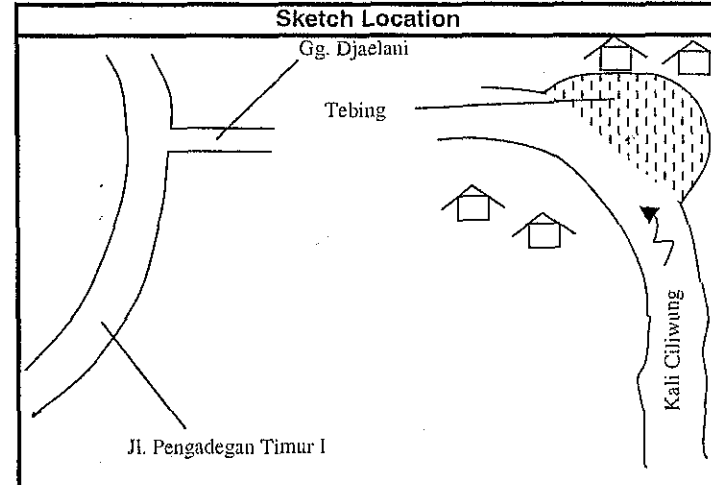
- Slope of riverbank, (high slope without slope protection) sensitive for sliding
- River not completed with dyke in the left bank, risk of overflow.

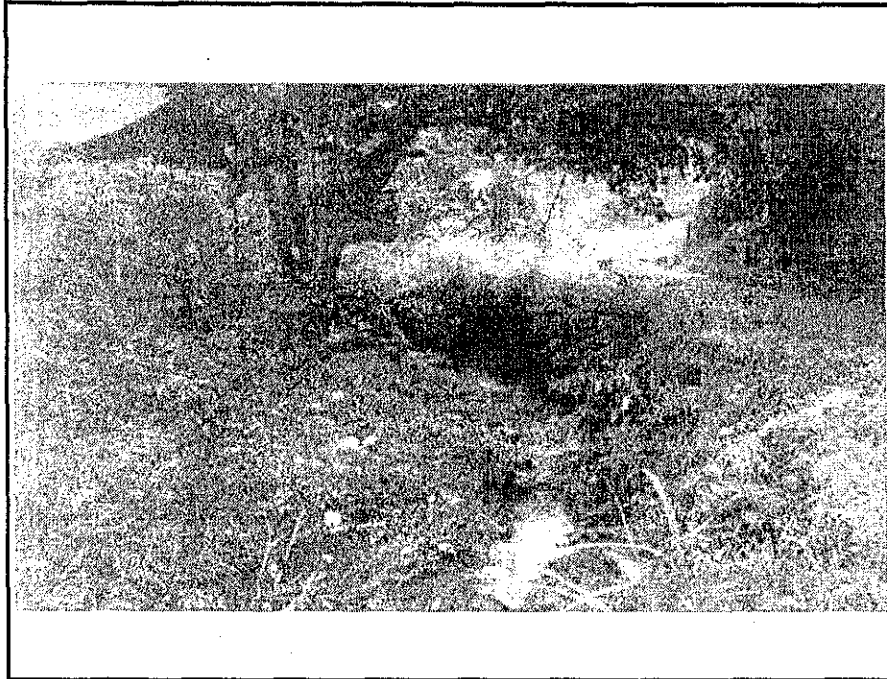
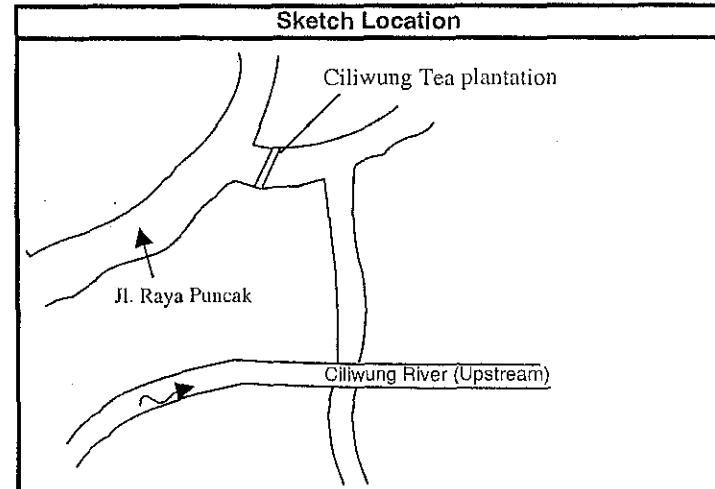
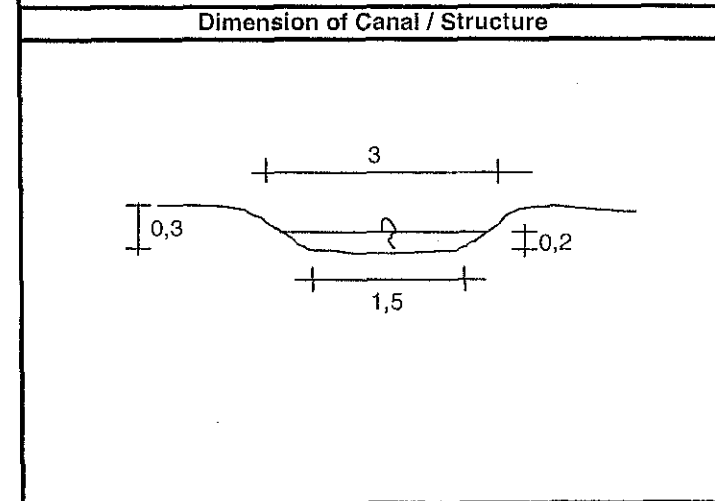
-Upstream of Ciliwung river, annual crops (avocado) conservation by local farmer in river area.

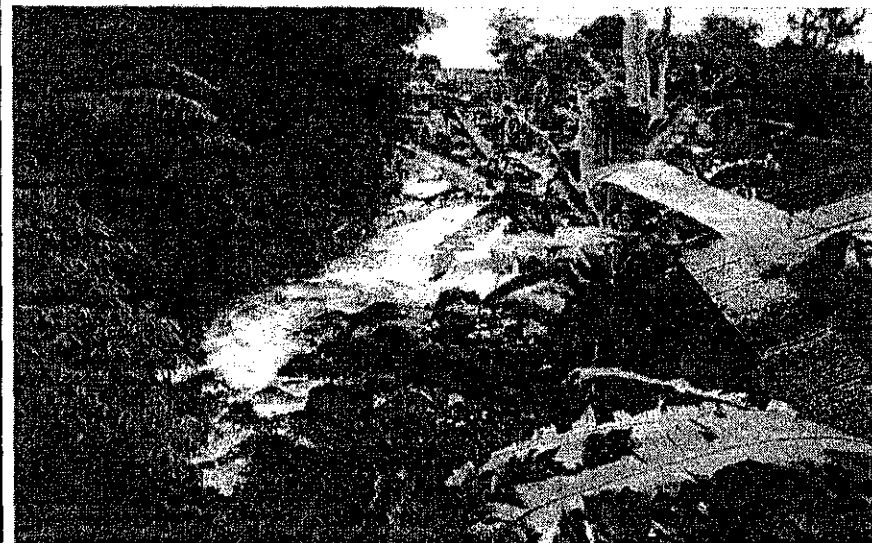
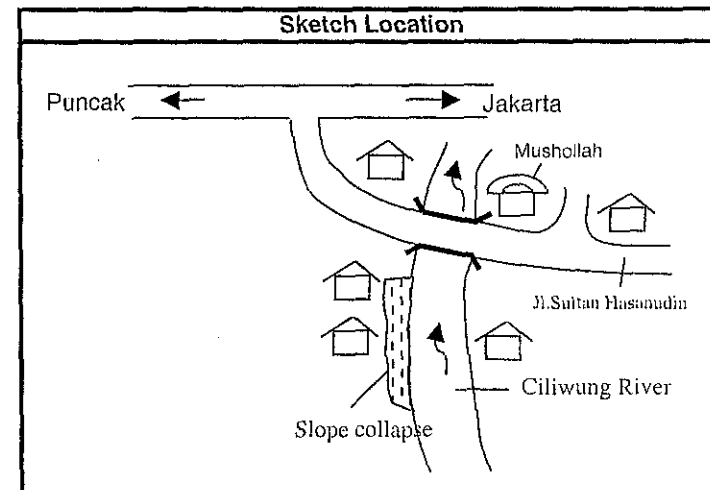
- Steep slope and house development in the river bank, has risk of land slide.

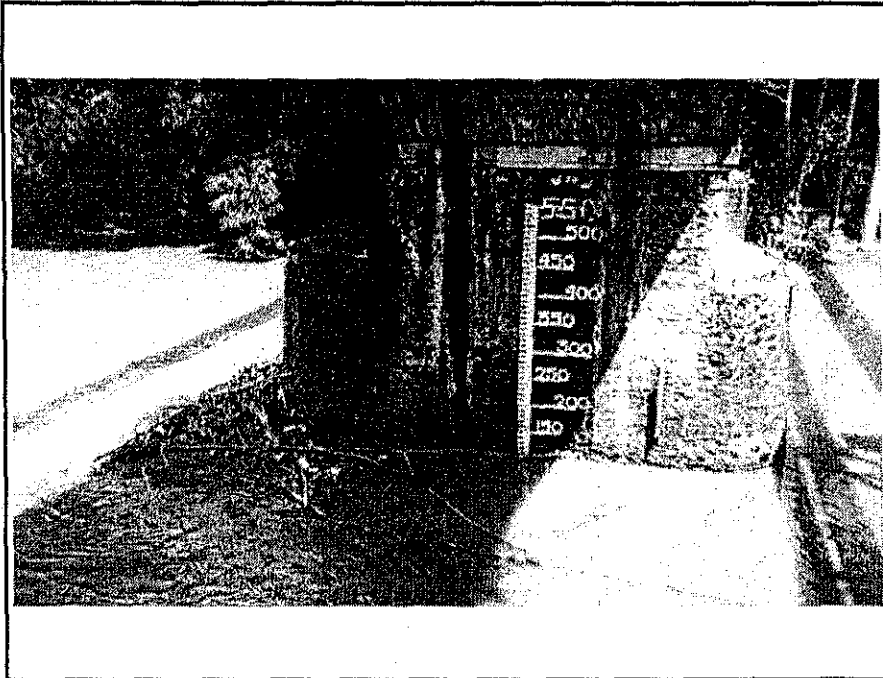
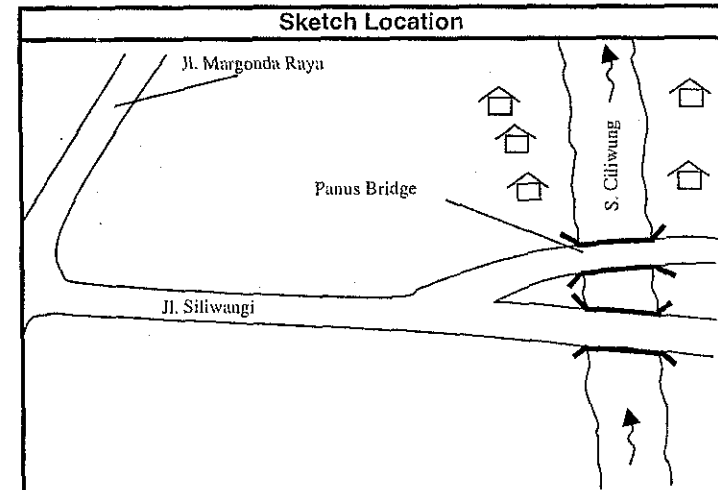
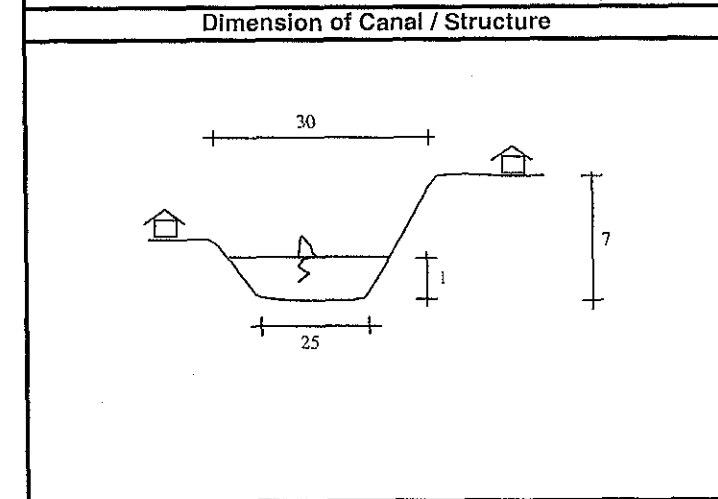
- Land slope sensitive to slide down in one side of the bank with water level measurement as reference.
- Information by telepon to Manggarai :
 - Warning I 250 cm
 - Warning II 220 cm

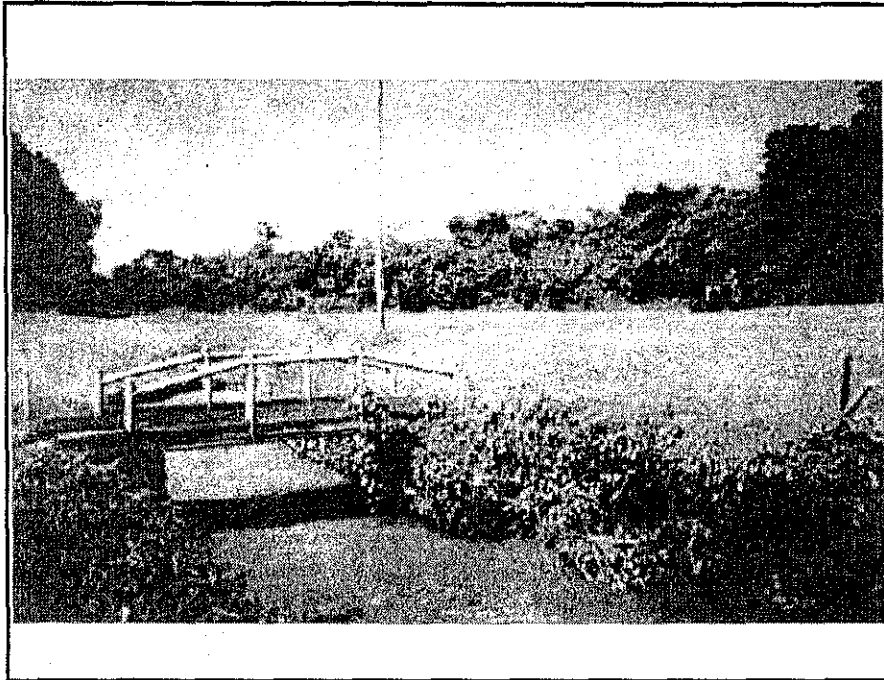
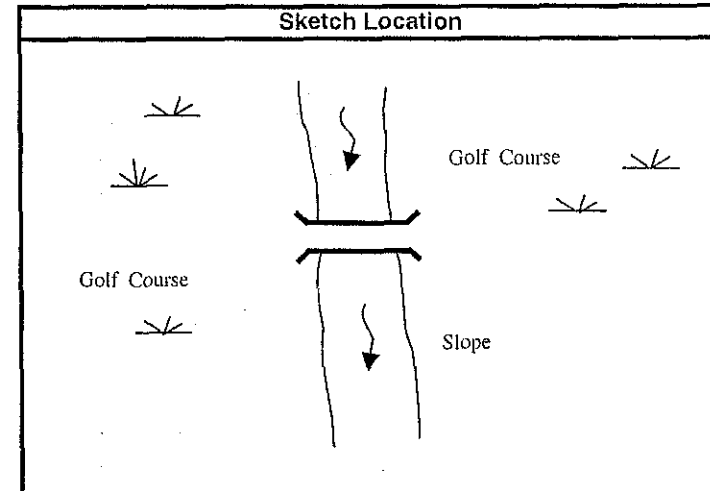
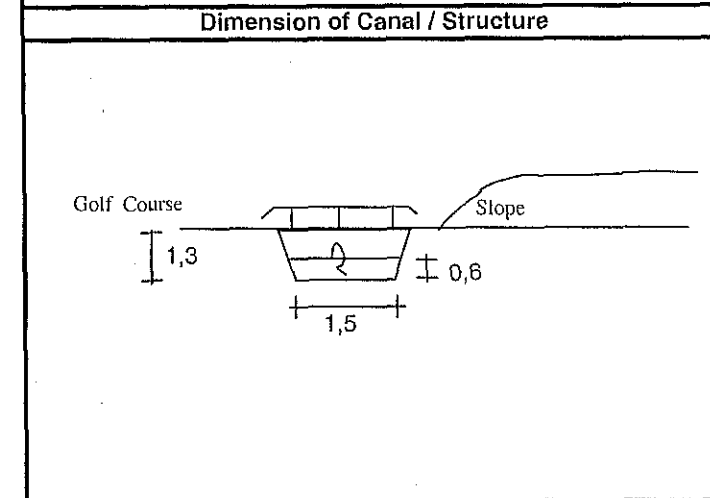
- Highes Velocity of river tributary straight to Cikeas river.
 No retention facility to reduce flow.

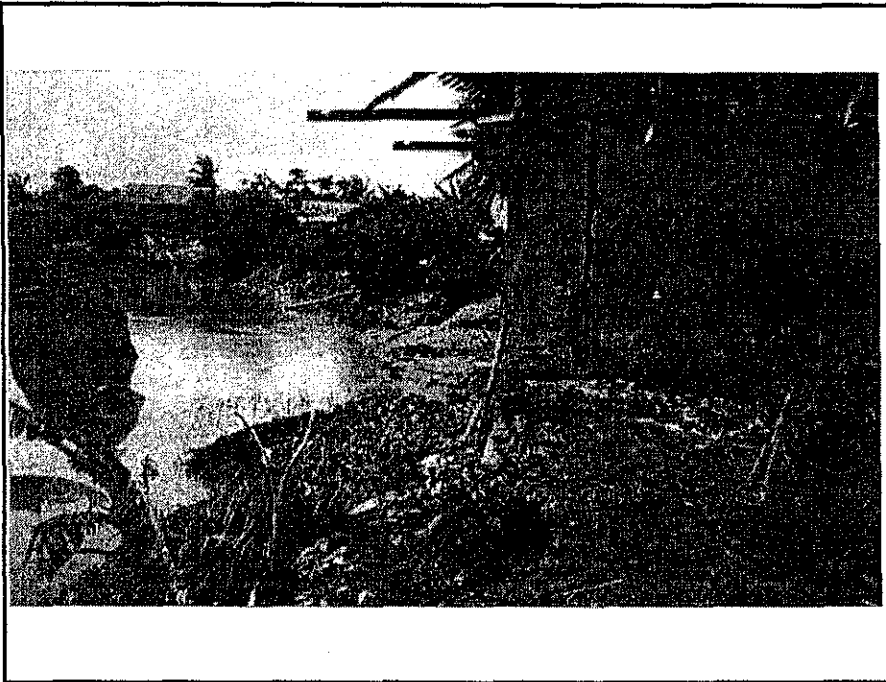
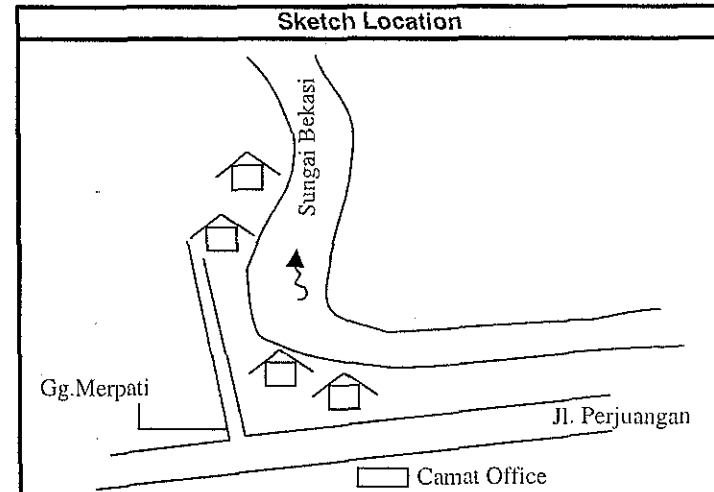
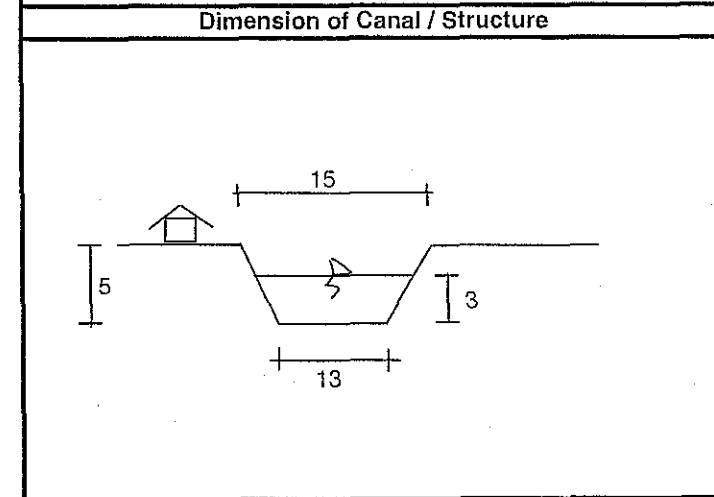
Erosion in riverbank and existing dike was broken by contractor to use the soil embankment in other area (Perum. Asri, Bekasi), when flooded the inundation to other area.

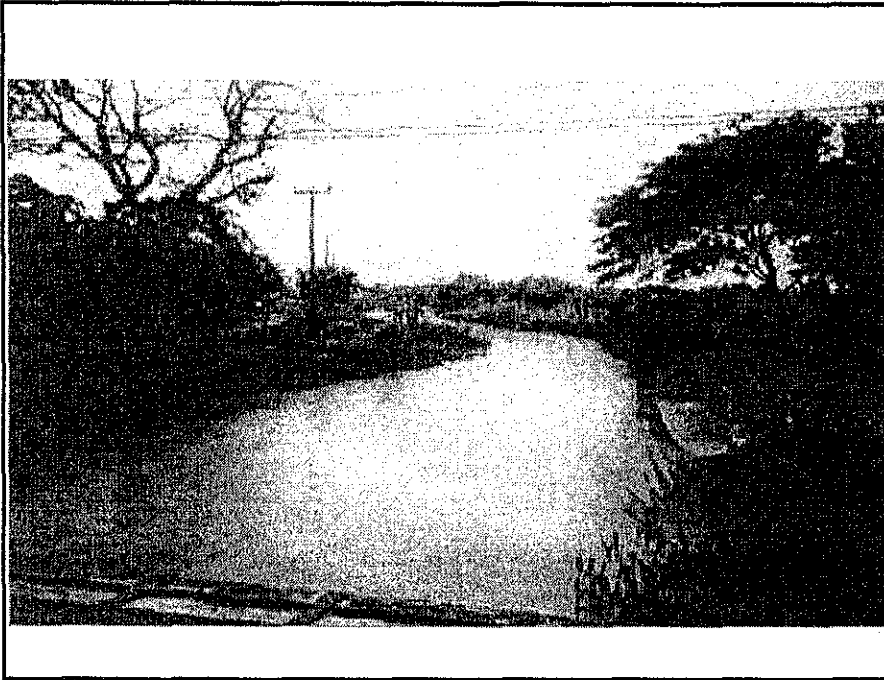
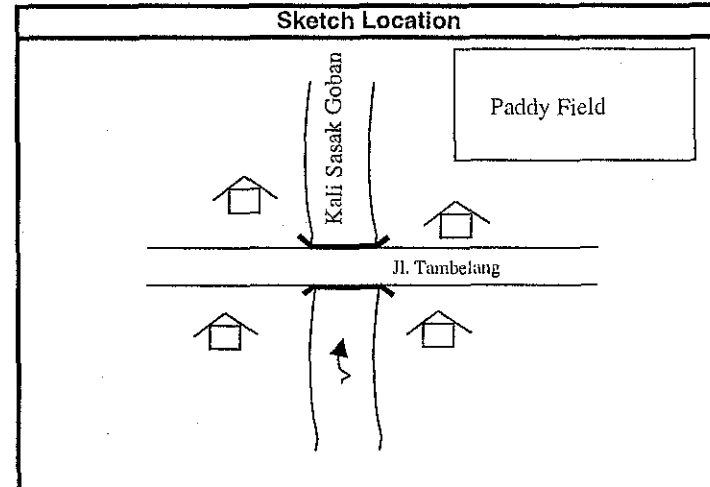
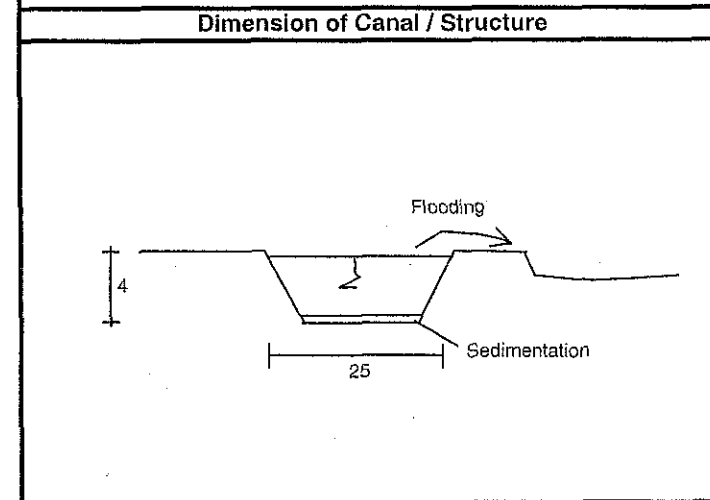
- Flooding when survey, inundation occurred to paddy field
- Mud sedimentation occurred along the sasak river.

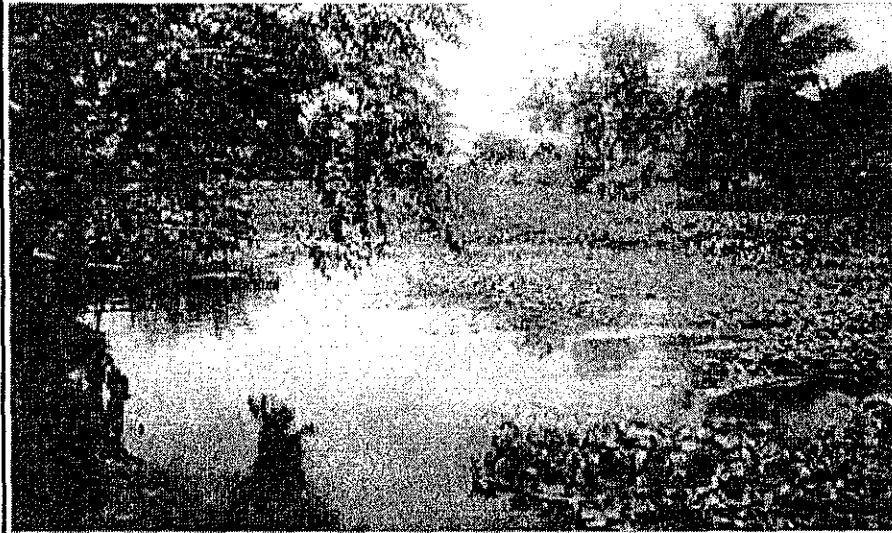
- Kali Bekasi has different depth from 3 ~ 5 m cause by sedimentation, part the area covered with water weeds planted by local people

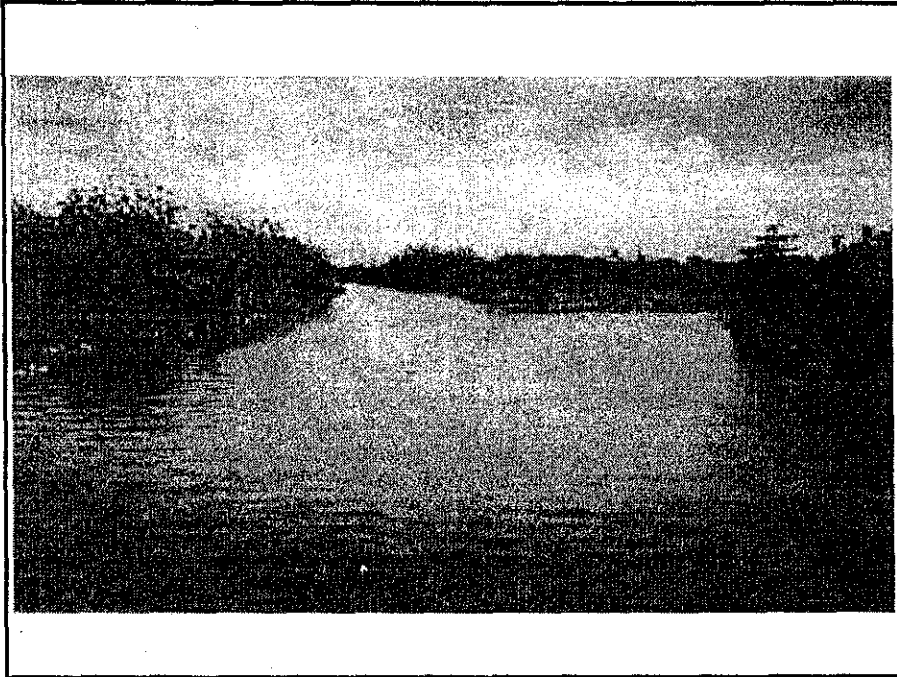
- Sedimentation in part of river.
- Erosion occurred the river.

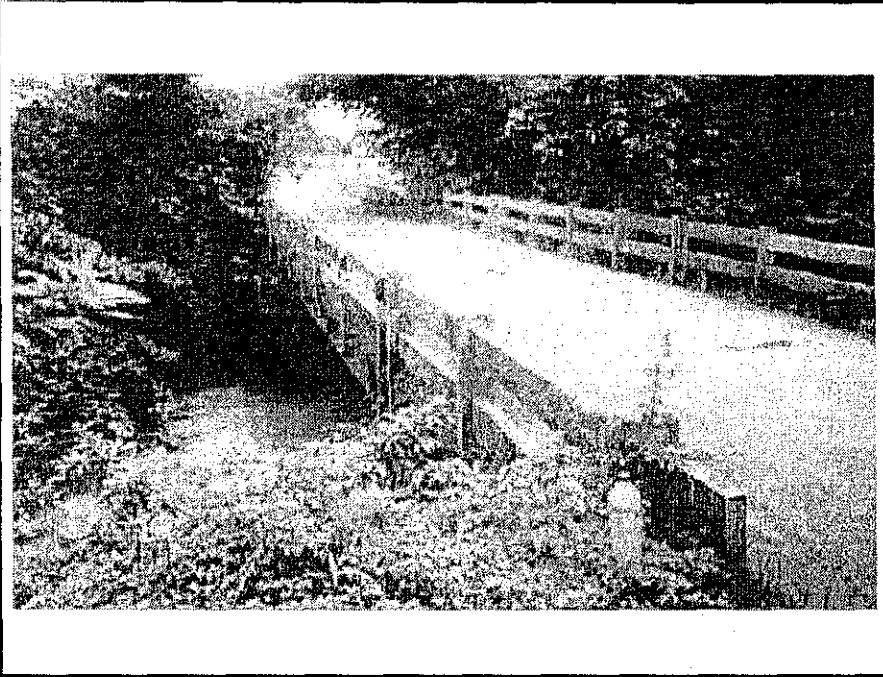
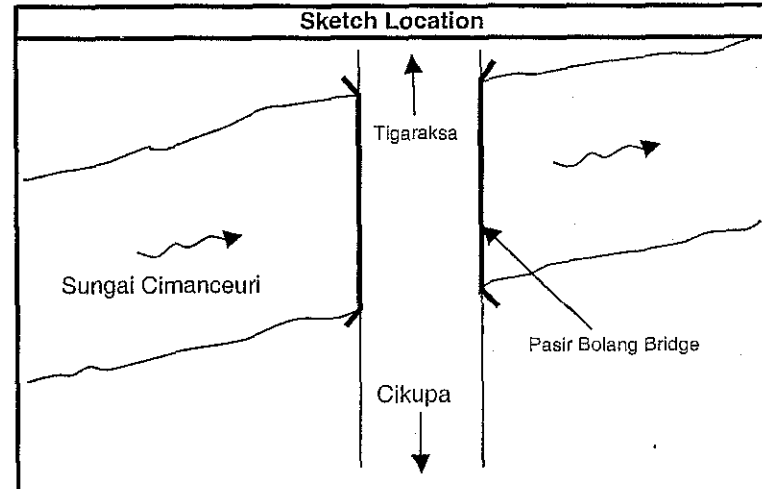
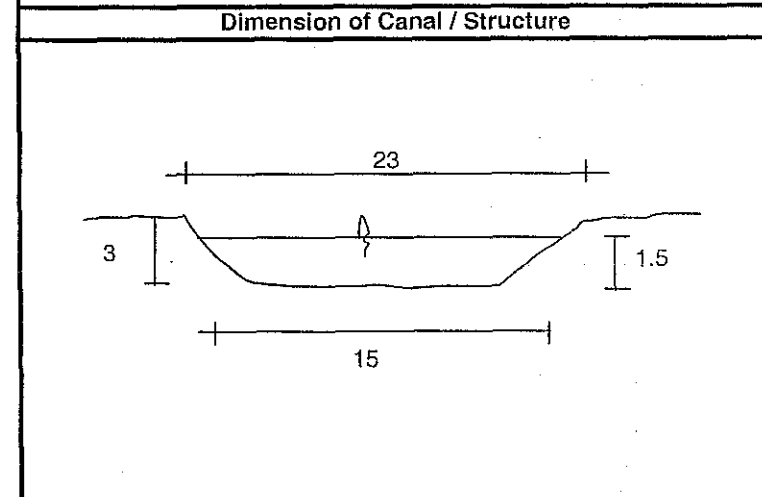
- River condition during flood, water level increase 1,5 m from the normal condition

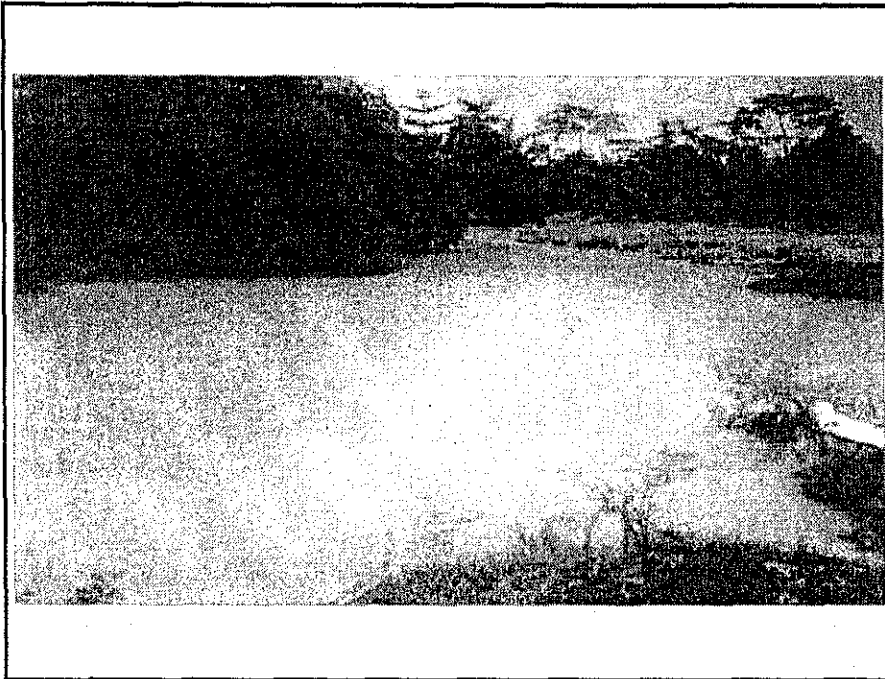
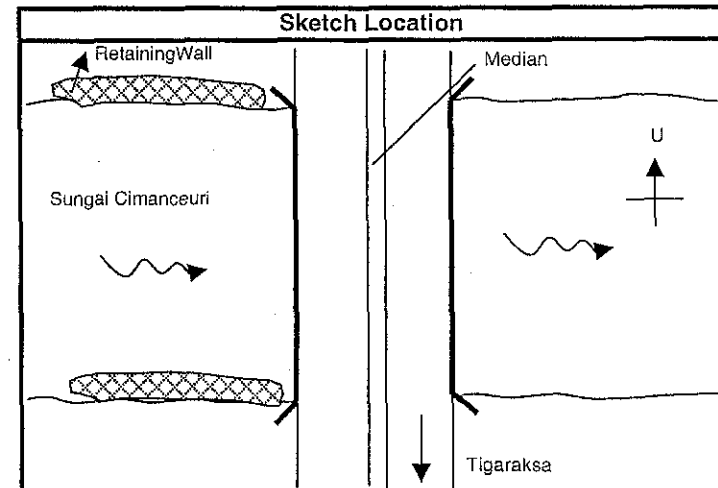
- Flooding condition during 2003 survey, 2.5 m increase of water level compare to normal condition.

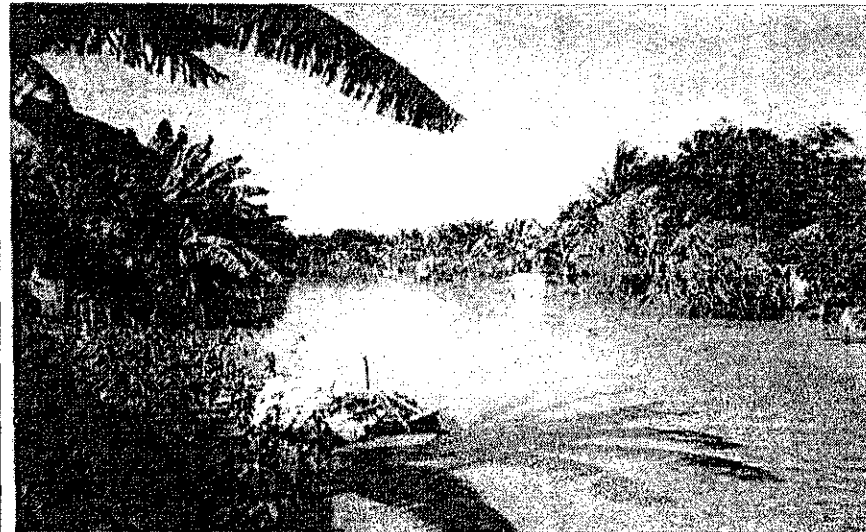
- Drainase is not infuction. Backwater flooding may happen from tidal influence.

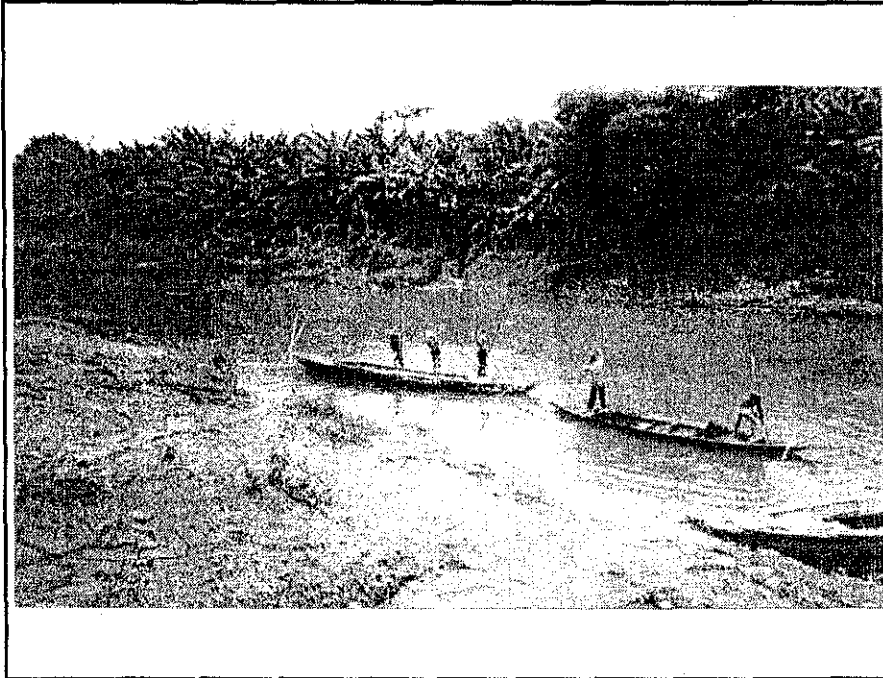
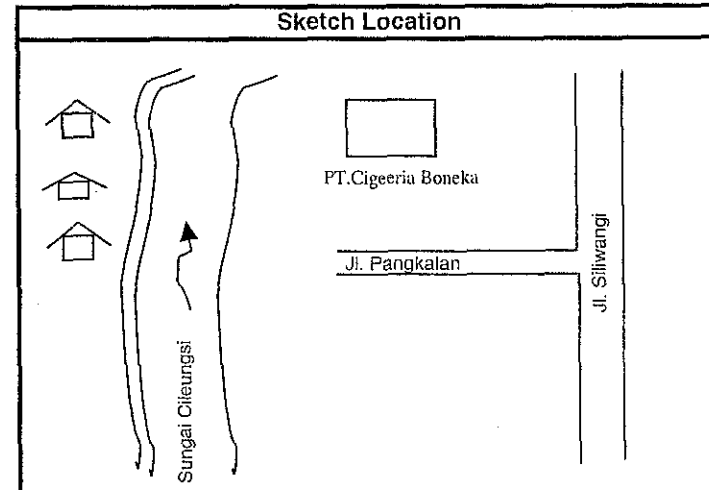
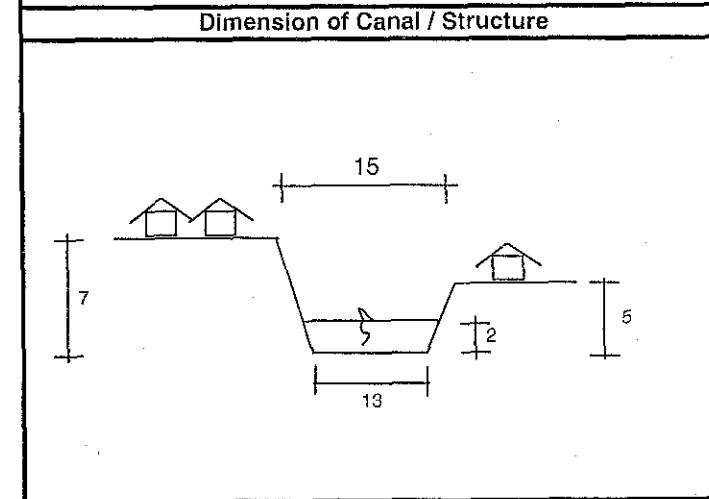
- Sand quarry collecting, from the river as small scale business, change the flowcapacity of the river course.

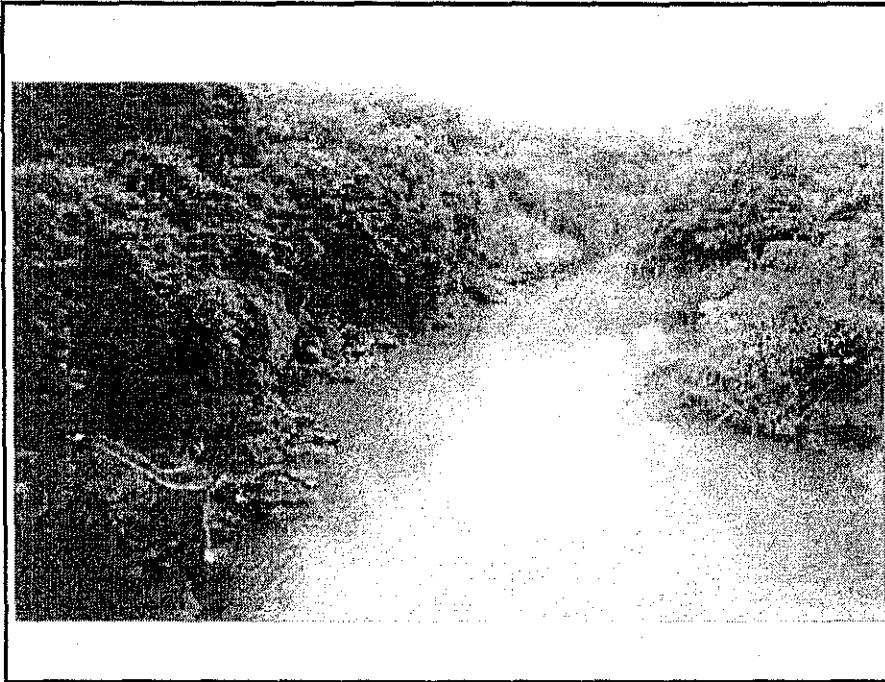
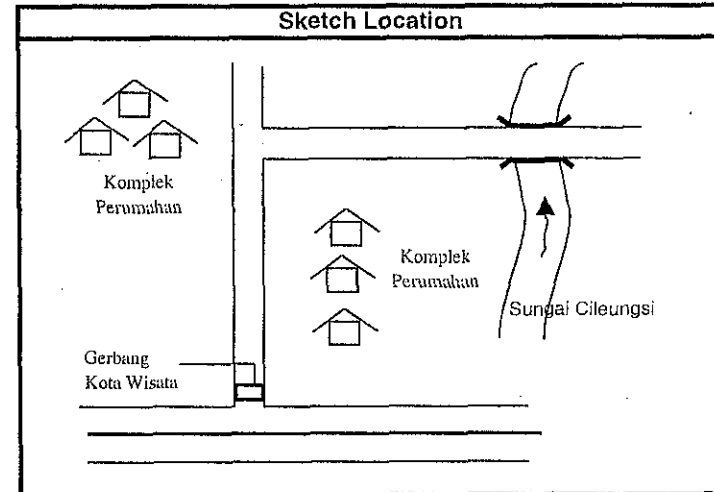
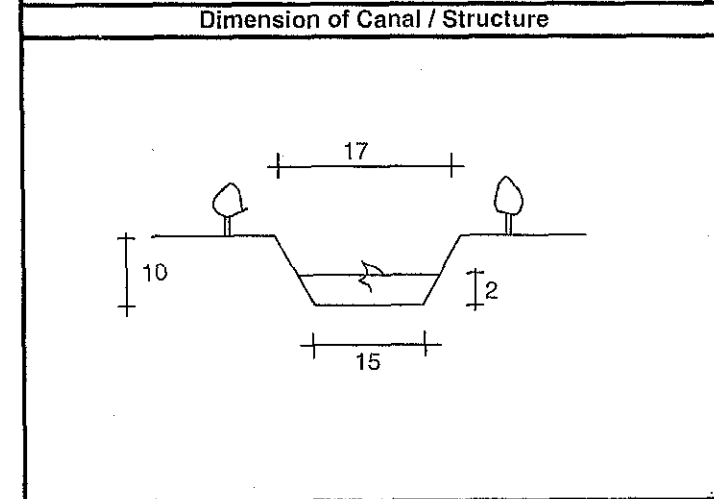
- There are sand quarry by people along the river

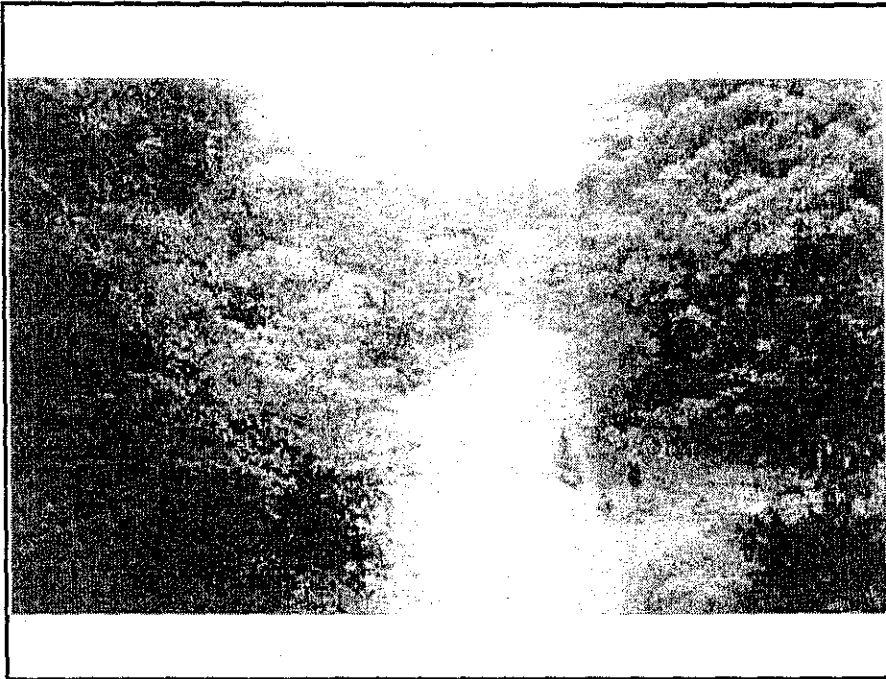
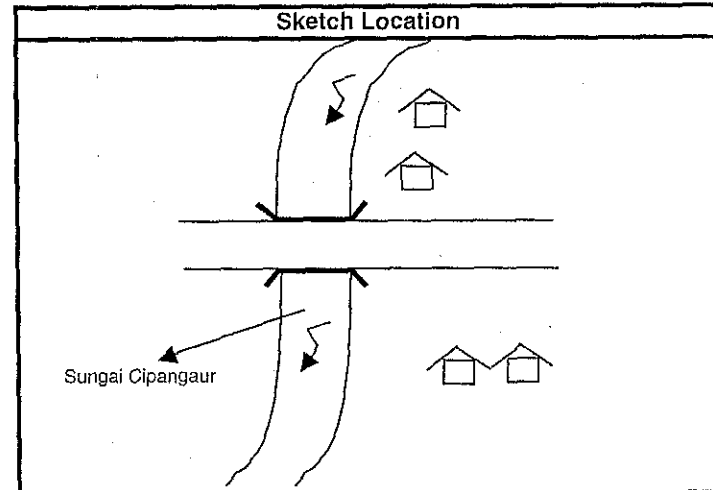
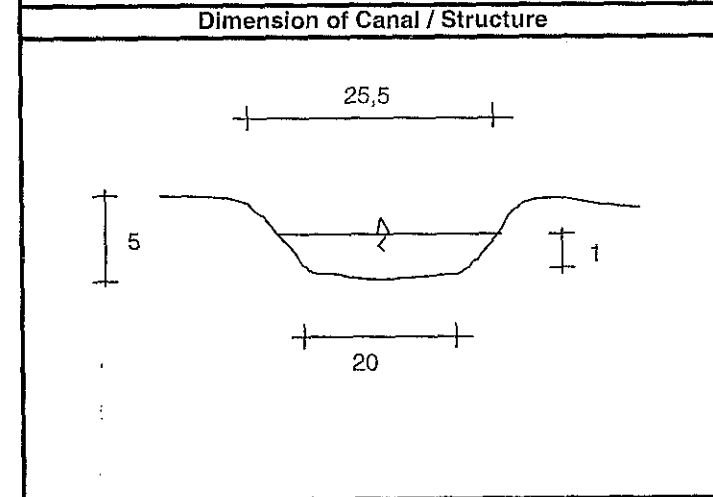
- There are sand quarry by people along the river

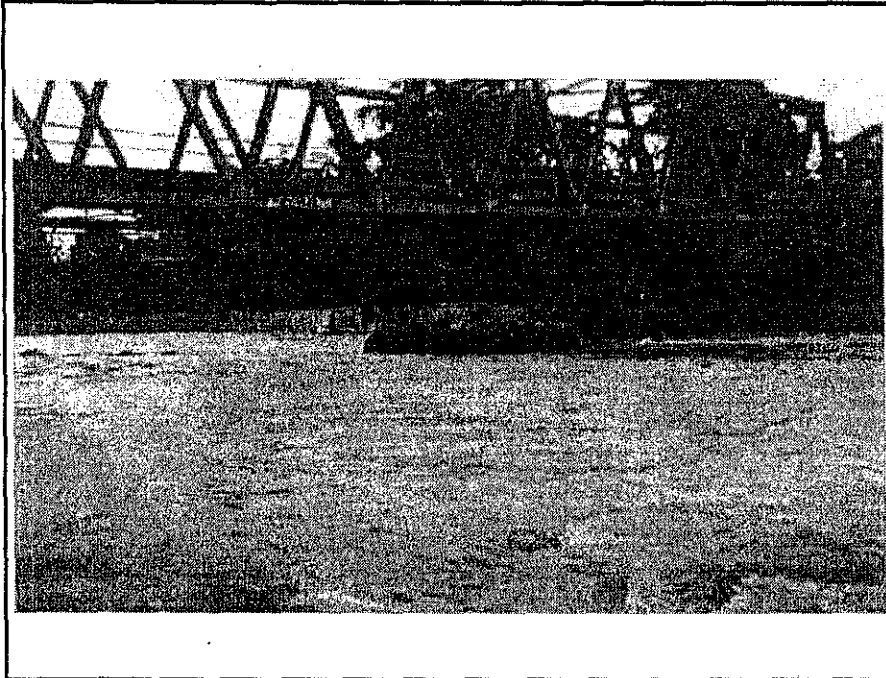
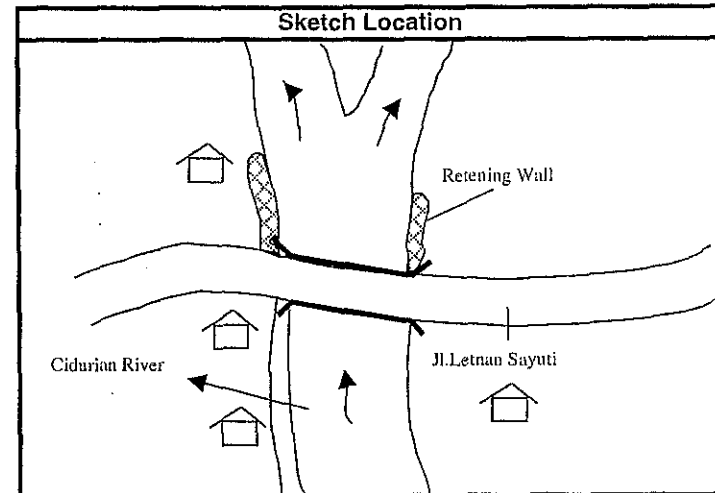
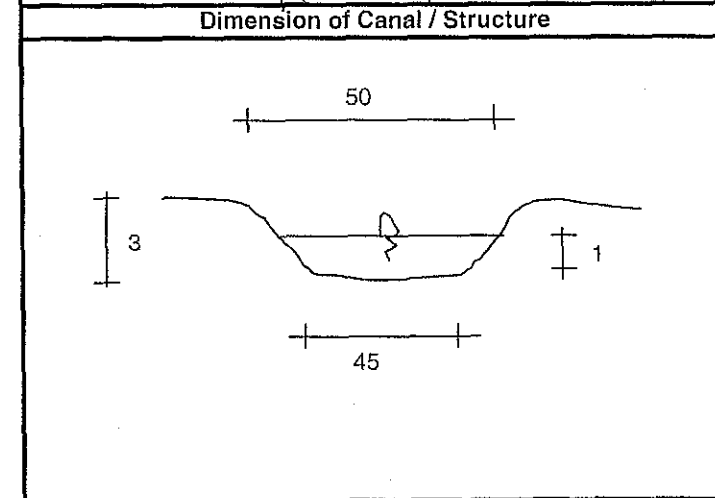
- Sand collector or quarrying from riverbed cause flow change of the water course.
