DOCUMENTATION OF RIVER SURVEY 2003

Name of River / Canal	: Kali Sunter	Date of Survey	: 24-02-2003
Location	: Kel. Sunter Jaya	Filled by	: PT. MITRAPACIFIC CONSULINDO INTERNATIONAL
No. of Picture	:		
Title	:

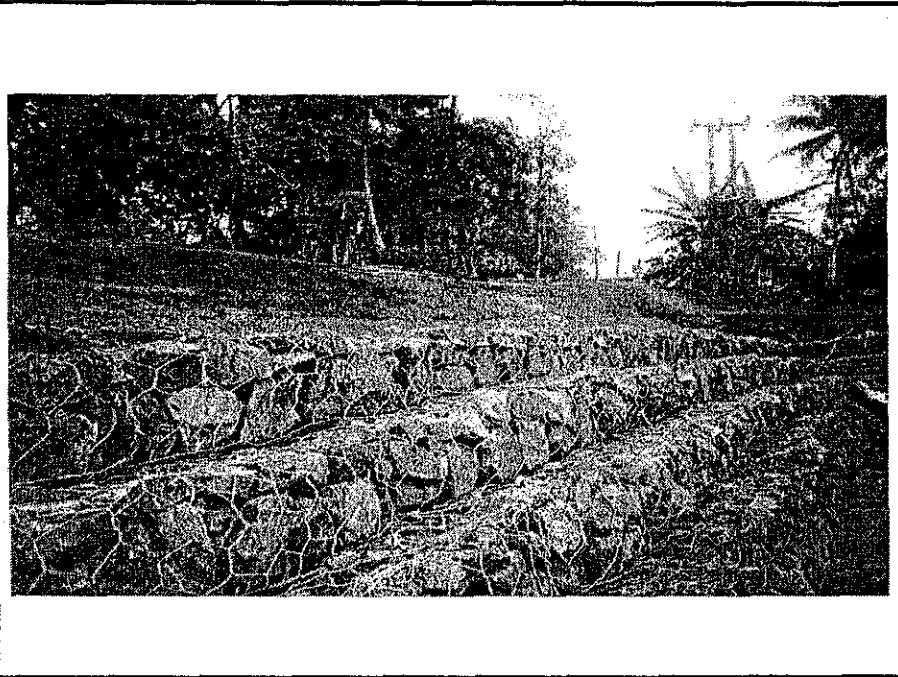
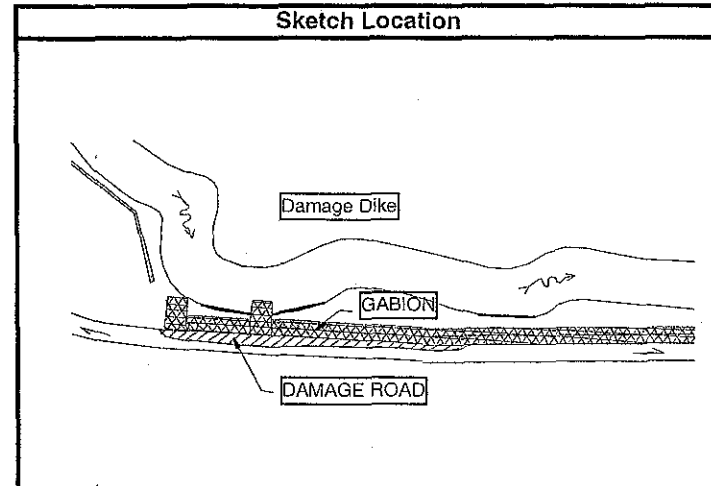
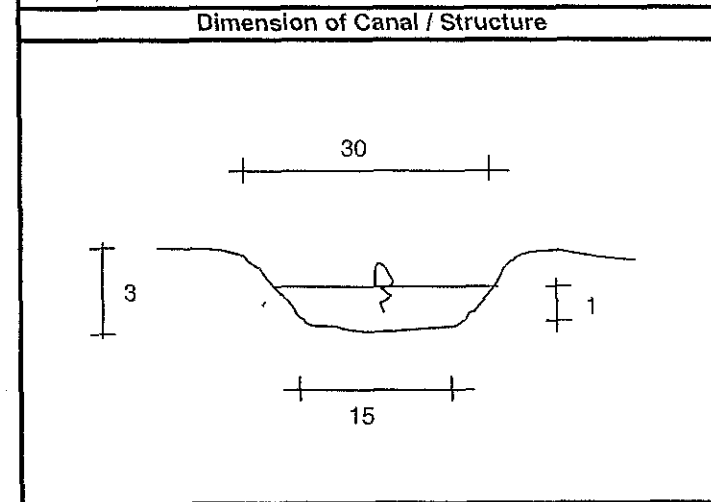
- Road alignment is too close to the river.
- Gabion in Pasir Ampo was not working during flood 2002, land slide happened to the road above the gabion.
