APPENDIX C

DOCUMENTATION
OF
PUMP & GATE SURVEY

List of Pump and Gate Survey Location 2003

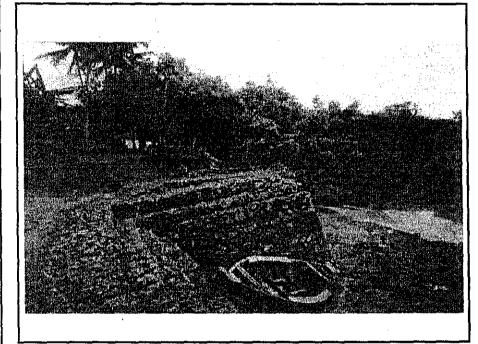
-Land slide occurred in river bend area, but some area was protected by gabion.

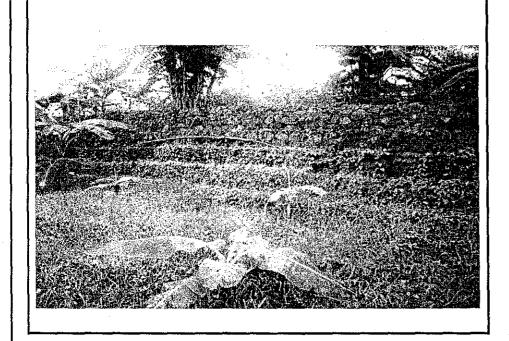
Gabion as slope protection of Cidurian riverbank which is vulnerable for land slide and erosion.

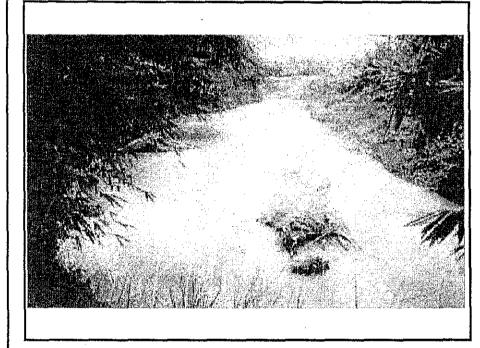
- Sand extraction and collection from the river sediment.

The water level and flow are change from sand extraction.

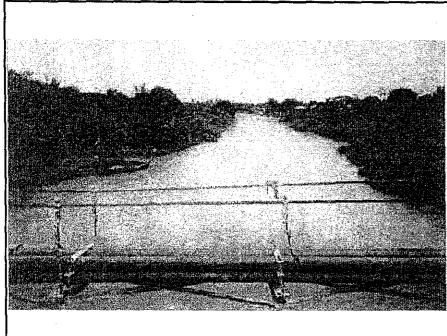
-Water level increase and inundated the settlement area during flood 2003 to a depth of 50 - 100 cm for 5-15 days.

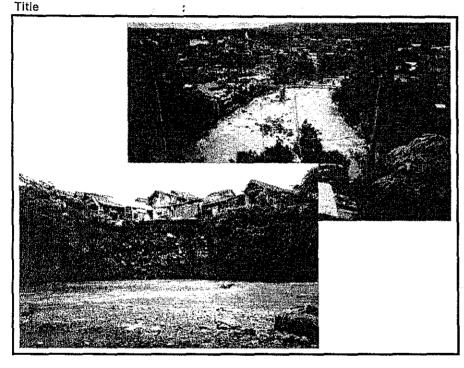
- Housing is restricted zone of river, cause erosion and sedimentation.

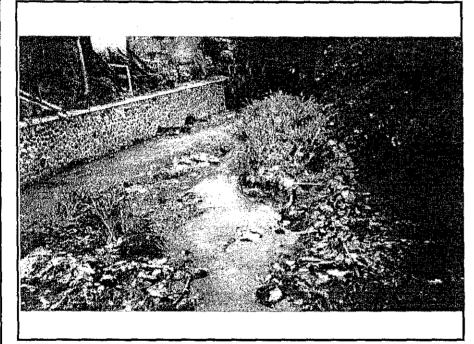
- Housing along river, and use the river as disposal area, no solid waste facilities in the housing area.
- Sediments and garbages appear in the river, decrease flow capacity of the river to increase flood area.

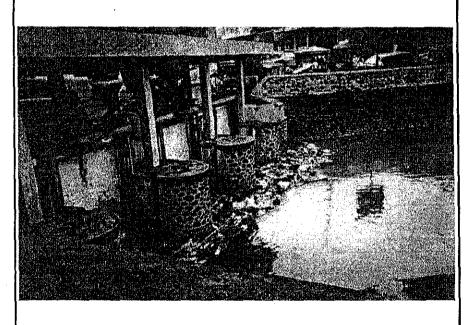
- Gate already rehabilitation, improve the pump height and dikes.
- Garbage accumulated at upstream gate.
- Large reduction of irrigation area, become 1250 ha from 4500 ha.

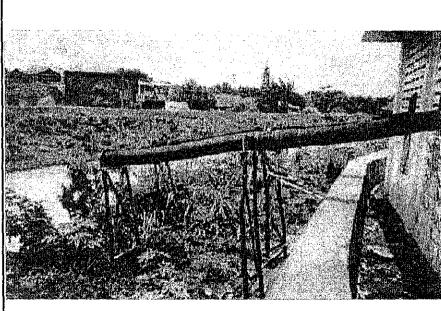
Density housing around the situ (lake). Pump operates to control flood in the reservoir to Kali Sabi. The housing suffers of annual flooding as it low lying area

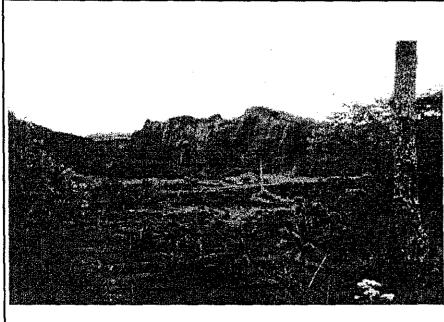
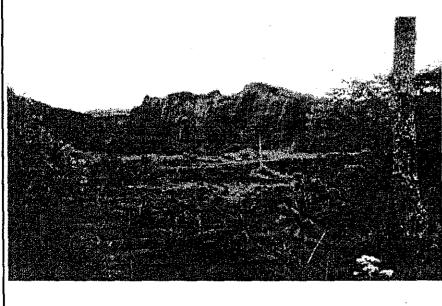
- Small scale quarrying without protection for keeping erosion away from river. Risk erosion and sedimentation to Cisadane river.

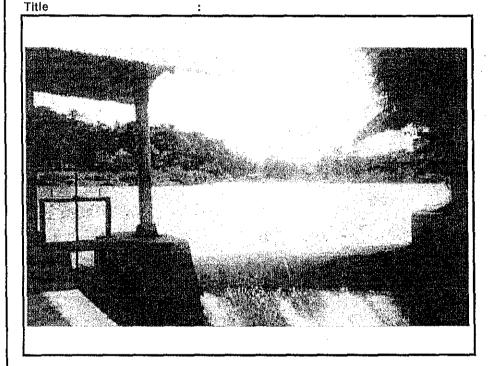
Flooding condition in 2002 gate facilities not function

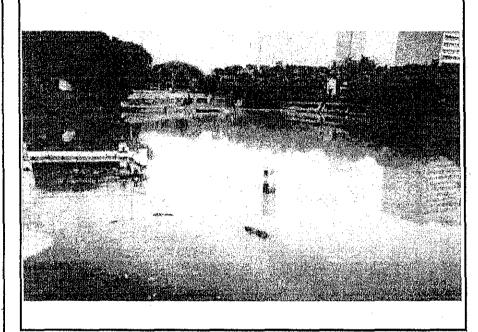
- There is five old pumps and add two news pump

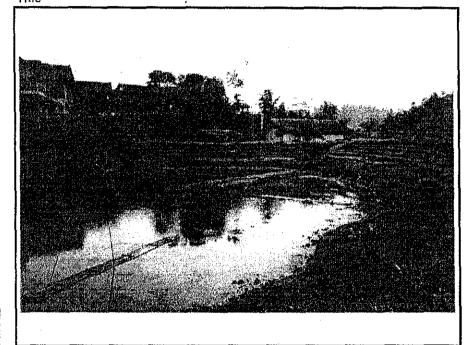
- Lake is used by local people to change into rice field; will reduce also retension capacity of the lake

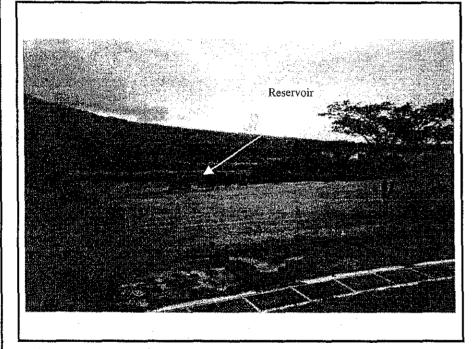
Rancamaya golf property, lakes are provided as retension basin to keep runoff before flows to Cisadane

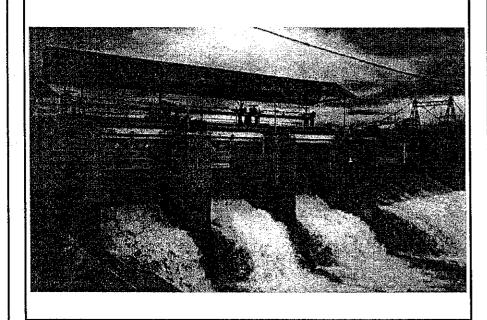
- Height water level during survey 0.30 m

- Katulampa aquipped with AWLR and communication facilities, as it use for important reference control of flooding to the downstream.

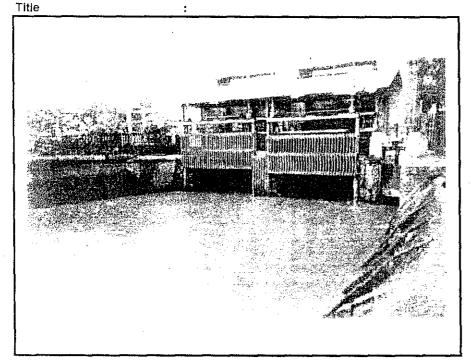
Gate works property width 5.20 m (2 Unit) attached with trash rack, electrically operated equipped with radio communication and warning system operated by PIPWSCC.

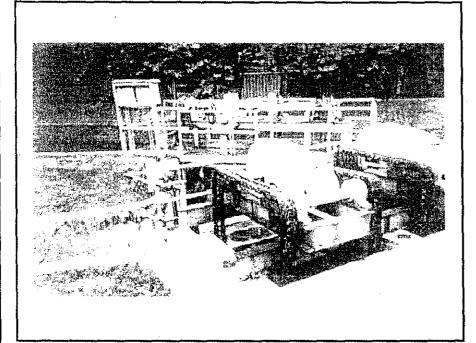
- Condition of pump is good with capacity 1.1 m3/sec (5 Series) in West Setiabudi and 3 series pump (1.1 m3/sec) in East Setiabudi.
- Gate operated manually to control Setiabudi reservoir and flow to Cideng river.

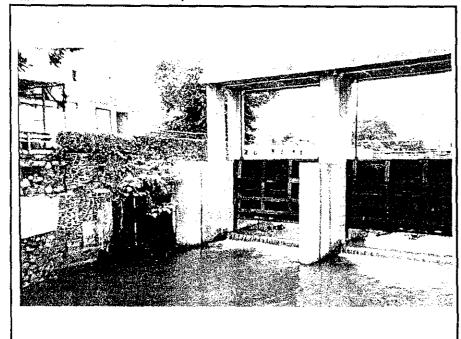
Sluice gate in function (2 gate at width of 2 m) ,electrical operated, AWLR and warning system through radio telecomunitation are provided, under PU-DKI JKT.

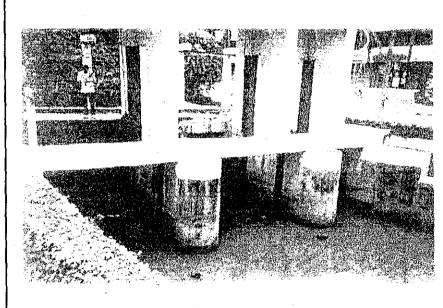
- Gate operates electrically in good function with width 3 m each (3 Unit), operated by PU - DKI JAKARTA

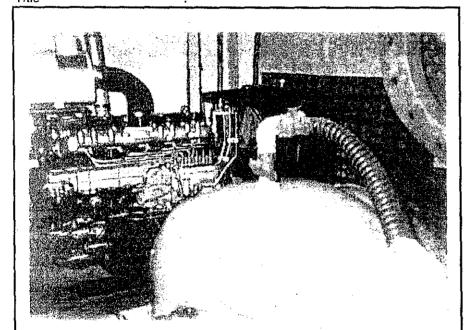
- Sluice gate 1 m width (2 unit) and pump are in working condition capacity of the pump is not identified, the pump is operated to control inundation in Jl. Kartini area

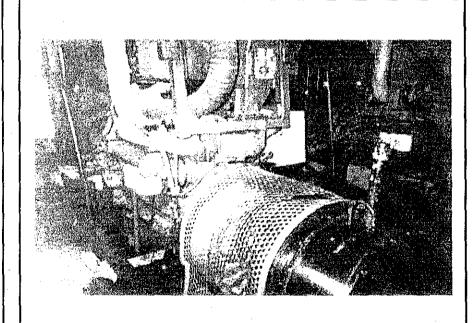
Sluice gate (2 gate in 2m width) not stright but in function.

Pump capacity 1.8 m 3/sec x 2, good condition operated when area around pump location flooded, under PU - DKI JAKARTA.

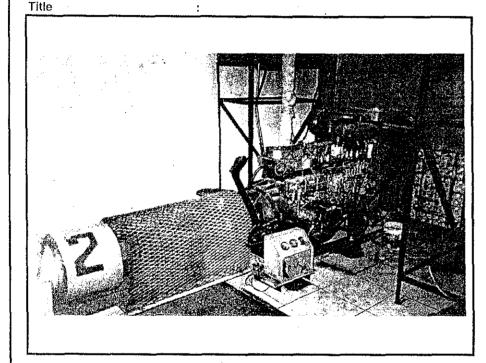
Pump capacity is 159m3/sec each, from total 2 unit at working condition in the south, operate by Mangga Dua Square in the north, operate by WTC Mangga Dua

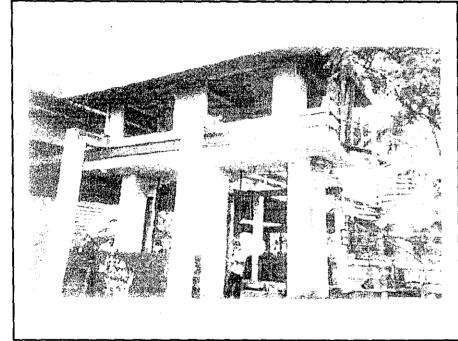
- Shice gate (2 gate of 2.5 m width) and scholl balk are in good operation, in flushing Ancol river from Ciliwung operated by PU - DKI JAKARTA.

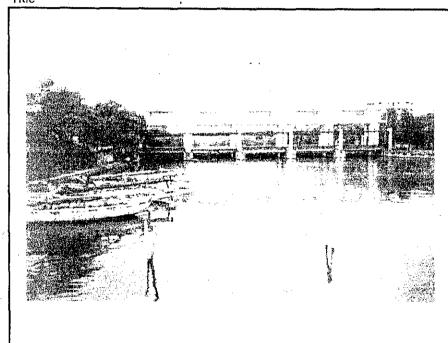
- Gate in good operation but measuring level scale was damaged. The function is to regulate the tidal influence to Ciliwung river. Operated by PU- DKI JAKARTA.

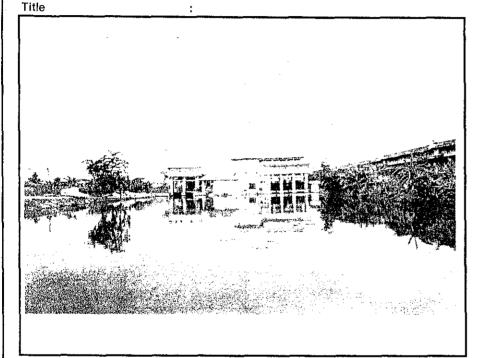
The gate working well. (2 gate each 3 m width). 3 Unit pumps are provided with each capacity 5 m3/sec. Equipped with radio communication operate under PU - DKI JAKARTA.

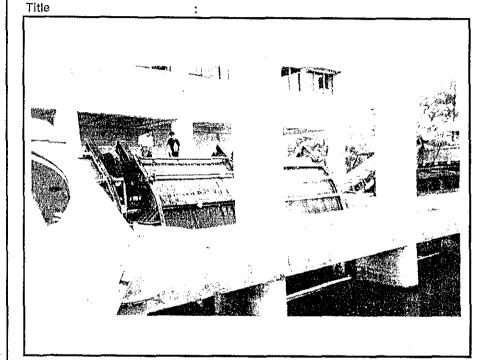
- 3 unit station pump with capacity 3,3 m3/sec. New pump with 4 m3/sec will add in year 2004.
- 2 unit moveable pump, with capacity each 250 l/sec. Propided for emergency
- The pump conserve for 2000 Ha catchment of North Jakarta and will be in operation when water level above + 70 cm.
- -Pump cannot control waterlevel for longperiod of rain (more than 4 hours).
- Operated under PU DKI JAKARTA.

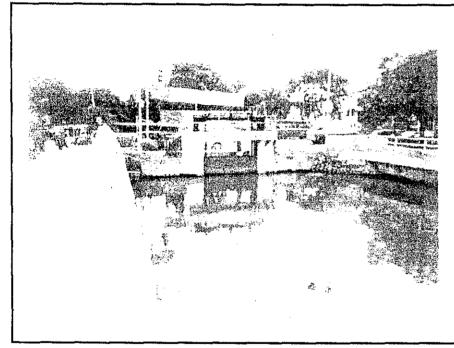
- Sluice gate good condition
- The width of gate is 2 x 3 m
- Gate not completed with house gate

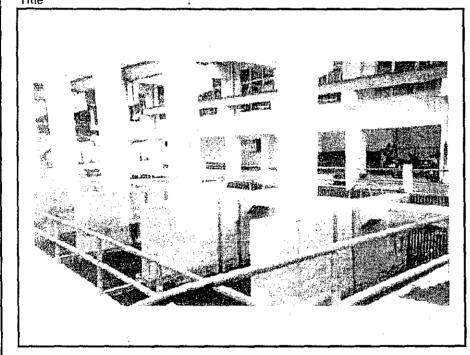
- Pump capacityu is 6 x 2.5 m3/sec (6 series) in good operation, use to control water level on the south Sunter reservior, cleaning gambage with manual. Equipped with radio communication and operated by PU - DKI JAKARTA.
