パキスタン・イスラム共和国

タウンサ堰部分改修計画

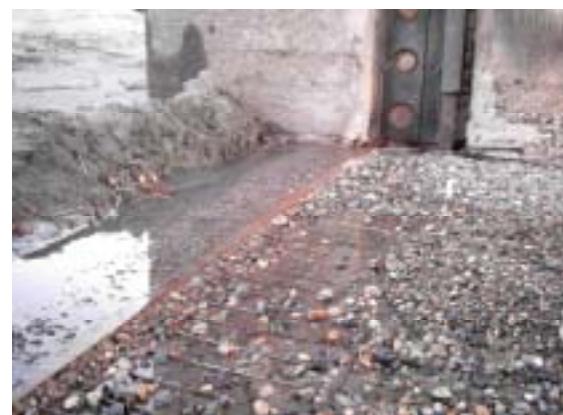
- (2) 損傷の著しいクレストでは、スキンコンクリートの表面が摩耗によって擦り減り、アンカーと鉄筋が露出しており、骨材も剥離している。
- (3) 減勢工におけるフリクションブロックとコンクリートブロックは、著しい摩耗によって原形をとどめておらず形状が変形して丸みを帯びている。また、フリクションブロック周辺の橋脚側面の壁体部は、流下する高速流によって侵食されており、モルタル成分が流出して骨材が露出している。

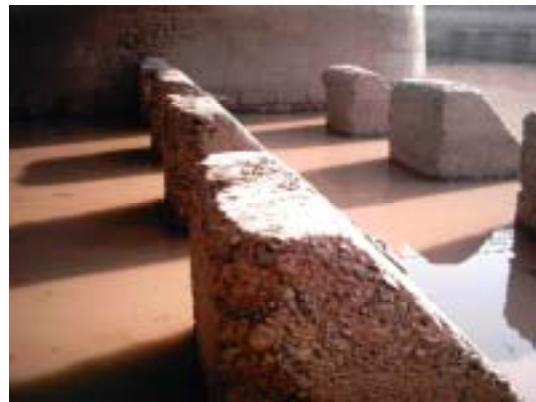
このようなコンクリートの劣化は、特にGATE No. 16-20, 24-28, 44-46, 50-51及び62-65に見られる。

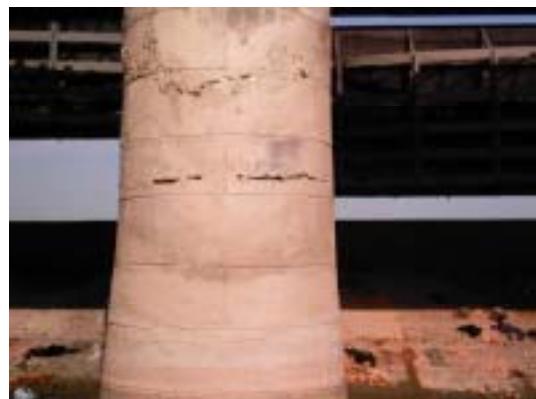
以上、橋脚に水平に亀裂が入っているところは、GATE No. 33-34で、下流側に剥離があるのは、GATE No. 11と24である。

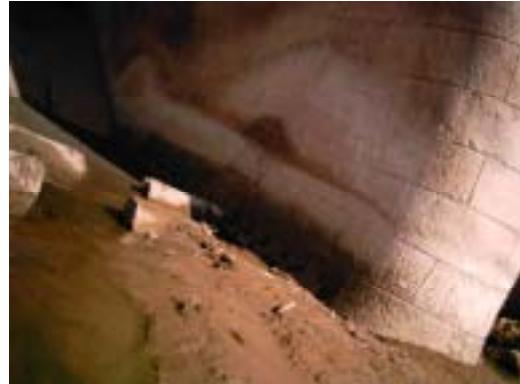
2.3.5 水理構造物のコンクリート強度

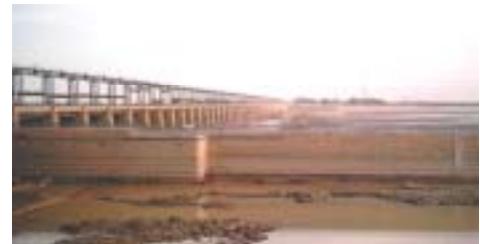
Considering this situation, JICA conducted “Feasibility Study on Taunsa Barrage Irrigation System Rehabilitation in Islamic Republic of Pakistan” from August 1997 to August 1998, based on the request of Government of Pakistan, and proposed rehabilitation programs of Taunsa Barrage. Based on the F/S, Government of Punjab Province with Government of Pakistan once requested 6 sets of bulkhead gates for Japan’s Grant Aid Scheme in September 2001 in order to rehabilitate the most deteriorated parts of Taunsa Barrage and to improve the operation and maintenance conditions of the barrage.

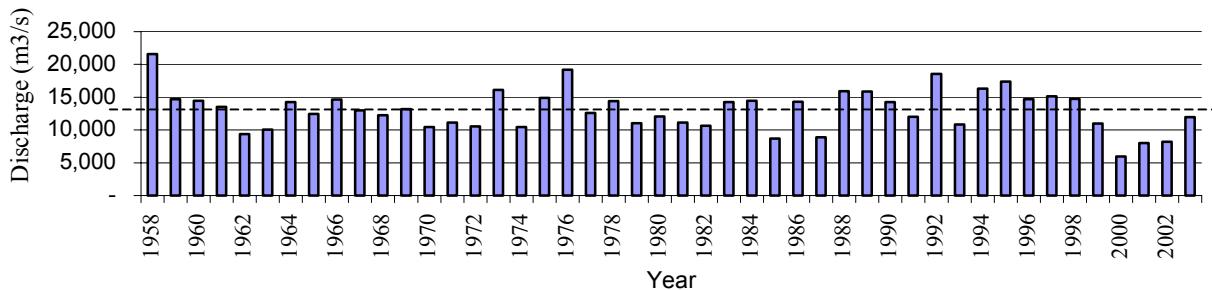
The maximum discharge upto 2003 is 21,585 m³/s in 1958, and the minimum discharge is 5,941 m³/s in 2000. The average discharge is estimated around 13,000 m³/s.

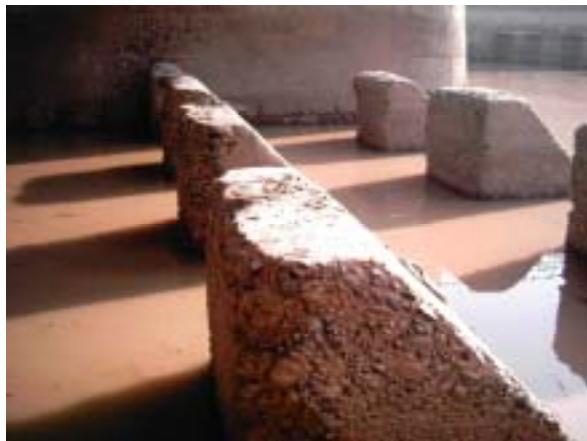
7 Friction block wear condition

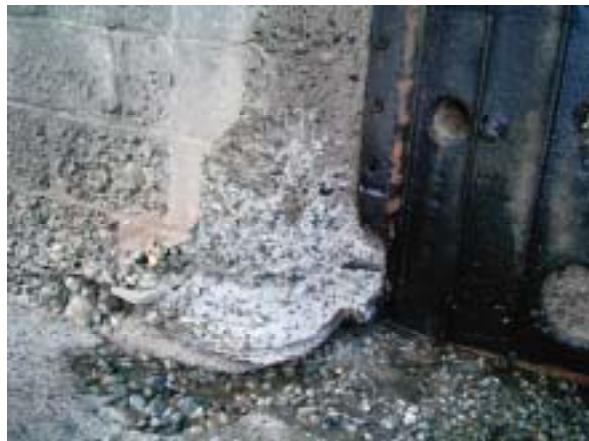
8 Gate bottom wear condition

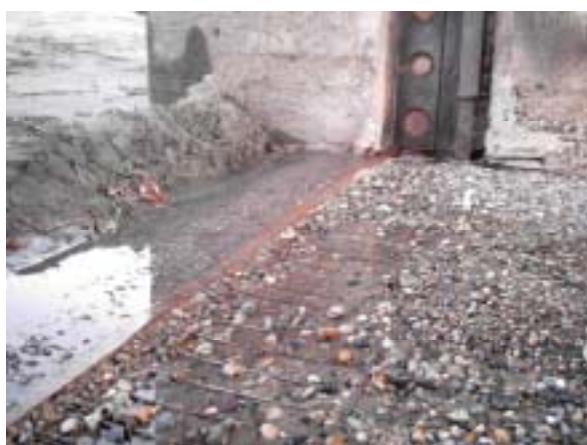
9 Gate crest wear condition

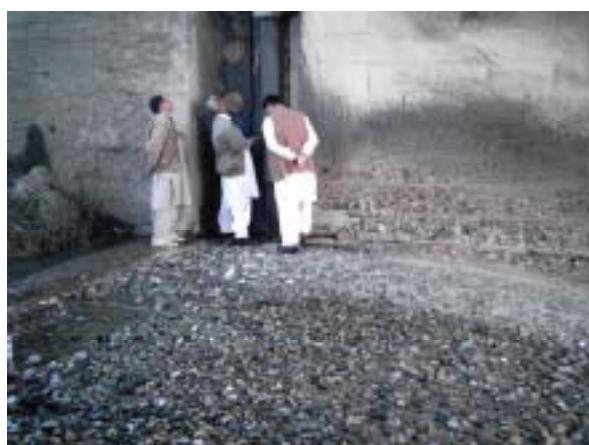
10 Gate crest wear condition

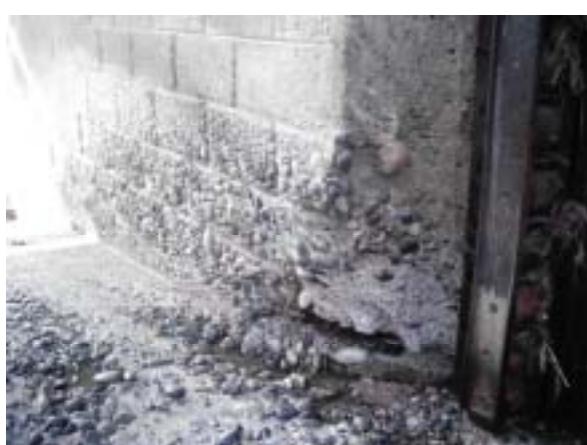
11 Gate foot wear condition

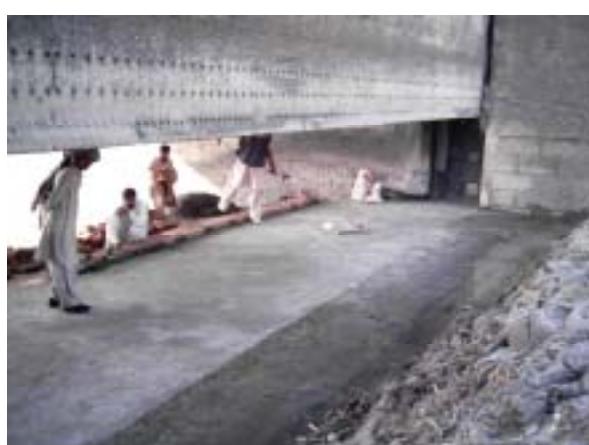
12 Gate crest repair condition

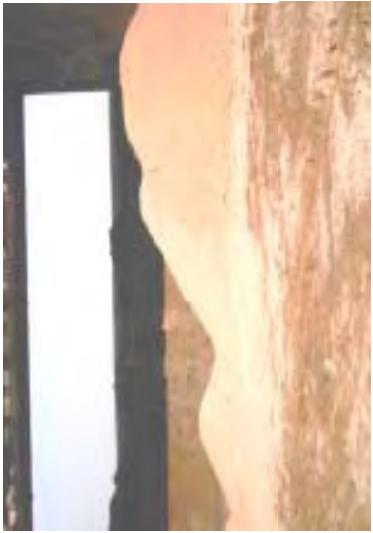
BARRAGE LEDGER NOTE			
DESIGN CONDITION		Gate No. 28	
Barrage Width	4,343 ft (1,324.66 m)		
Gate Number	Nos. 65		
Design Discharge	28,300 m ³ /s (Max 21,530 m ³ /s)		
3 years Return period	13,000 m ³ /s		
Longitudinal Profile	1/5,000		
Crest Elevation (top)	RL 428 ft		
Apron Elevation (down stream)	RL 416 ft (h=12 ft / h=3.66 m)		
Crest Width	60 ft (18.29 m)		
Crest Length	Upstream 28.0 m Down stream 40.0 m		
Apron Length	Upstream 80.0 m Down stream 79.0 m		
Cobble stone length	Down stream 80.6 m		
Flood water level	Upstream RL 447 ft (421 ft) h=7.63 m		
Flood water level	Down stream RL 440 ft (416 ft) h=7.32 m		
CONCRETE DIAGNOSIS			
Check Item	Right Pier	Centre Crest	Left Pier
