**BARRAGE LEDGER NOTE**

**CONCRETE DIAGNOSIS**

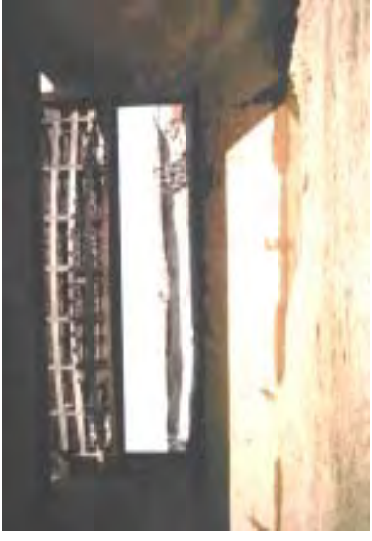
DESIGN CONDITION		Gate No. 35
Barrage Width	4,343 ft (1,324.66 m)

Check Item	Right Pier	Centre Creast	Left Pier	Location
(A) Deterioration				
Abrasion	B	A	B	
Exfoliation	C	C	C	
Corrosion	C	B	C	
Cracking	B	C	C	
(B) Displacement				
Cracking	C	C	C	
Exfoliation	C	C	C	
(C) Sedimentation	A	A	A	
(D) Neutralization		8 mm		
(E) Concrete Strength (N/mm <sup>2</sup> )	31.5	27.7	29.6	
Schmidt hammer	Ave. 29.63 N/mm <sup>2</sup>			
<u>Diagnosis</u>	Edge Corrosion	Crest Abrasion	Edge Corrosion	Sedimentation before Gate is more than 2 m and Friction Block is silted. Exfoliation is the gate edge on the both pier.
<u>Evaluation</u>	Partially Repair

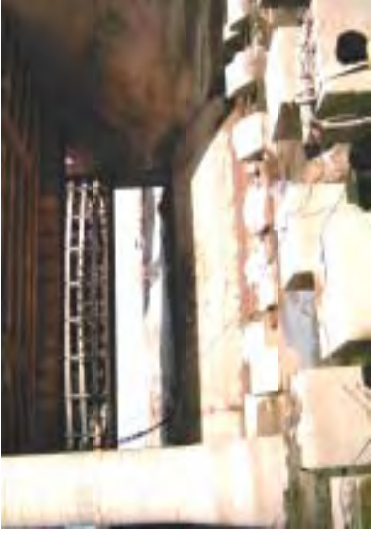
DESIGN CONDITION		Gate No. 36
Barrage Width	4,343 ft (1,324.66 m)

Abrasion	B	Flooring	B	
Exfoliation	C	C	C	
Corrosion	C	Flooring	C	
Cracking	C	C	C	
(B) Displacement				
Cracking	C	C	C	
Exfoliation	C	C	C	
(C) Sedimentation	A	A	A	
(D) Neutralization		5 mm		
(E) Concrete Strength (N/mm <sup>2</sup> )	30.9	29.0	27.1	
Schmidt hammer	Ave. 28.99 N/mm <sup>2</sup>			
<u>Diagnosis</u>	Edge Corrosion	Crest Abrasion	Edge Corrosion	Sedimentation before Gate is more than 2 m and Friction Block is silted. Exfoliation is the gate edge on the both pier.
<u>Evaluation</u>	Partially Repair

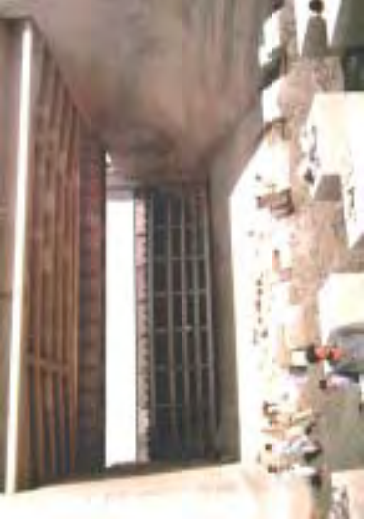
DESIGN CONDITION		Gate No. 37
Barrage Width	4,343 ft (1,324.66 m)

Exfoliation	C	C	C	
Corrosion	C	Flooring	C	
Cracking	C	C	C	
(B) Displacement				
Cracking	C	C	C	
Exfoliation	C	C	C	
(C) Sedimentation	A	A	A	
(D) Neutralization		10 mm		
(E) Concrete Strength (N/mm <sup>2</sup> )	27.1	30.3	27.7	
Schmidt hammer	Ave. 28.36 N/mm <sup>2</sup>			
<u>Diagnosis</u>	Edge Corrosion	Crest Abrasion	Edge Corrosion	Sedimentation before Gate is more than 2 m and Friction Block is silted. Exfoliation is the gate edge on the both pier.
<u>Evaluation</u>	Partially Repair

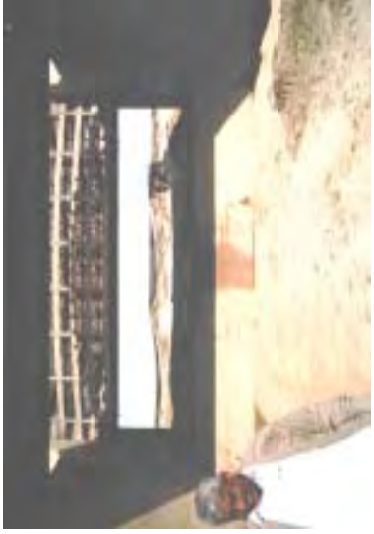
DESIGN CONDITION		Gate No. 38
Barrage Width	4,343 ft (1,324.66 m)

Abrasion	B	A	B	
Exfoliation	C	C	C	
Corrosion	C	B	C	
Cracking	C	C	C	
(B) Displacement				
Cracking	C	C	C	
Exfoliation	C	C	C	
(C) Sedimentation	A	A	A	
(D) Neutralization		8 mm		
(E) Concrete Strength (N/mm <sup>2</sup> )	28.4	33.4	32.8	
Schmidt hammer	Ave. 29.41 N/mm <sup>2</sup>			
<u>Diagnosis</u>	Edge Corrosion	Crest Abrasion	Edge Corrosion	Sedimentation before Gate is more than 2 m and Friction Block is silted. Exfoliation is the gate edge on the both pier.
<u>Evaluation</u>	Partially Repair

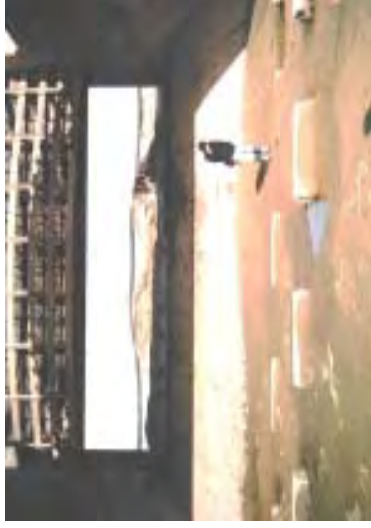
Gate No. 39

Check Item	Concrete Diagnosis		Location
	Right Pier	Centre Crest	
(A) Deterioration			
Abrasion	B	A	B
Exfoliation	C	C	C
Corrosion	C	B	C
Cracking	C	C	C
(B) Displacement			
Cracking	C	C	C
Exfoliation	C	C	C
(C) Sedimentation	A	A	A
(D) Neutralization	7 mm		
(E) Concrete Strength (N/mm <sup>2</sup> )	27.7	29.6	30.9
Schmidt hammer	Ave. 29.41 N/mm <sup>2</sup>		
<u>Diagnosis</u>	Edge Corrosion	Crest Abrasion	Edge Corrosion
<u>Evaluation</u>	Partially Repair		
Sedimentation before Gate is more than 2 m and Friction Block is silted. Exfoliation is the gate edge on the both pier.

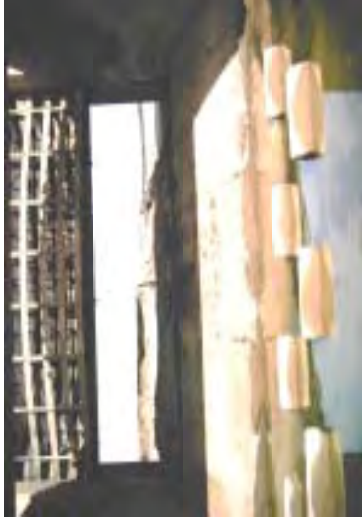
Gate No. 40

Check Item	CONCRETE DIAGNOSIS	
	Right Pier	Left Pier
(A) Deterioration		
Abrasion	B	B
Exfoliation	C	C
Corrosion	B	B
Cracking	C	C
(B) Displacement		
Cracking	C	C
Exfoliation	C	C
(C) Sedimentation	A	A
(D) Neutralization	7 mm	
(E) Concrete Strength (N/mm <sup>2</sup> )	32.2	33.4
Schmidt hammer	Ave. 31.95 N/mm <sup>2</sup>	
<u>Diagnosis</u>	Edge Corrosion	Edge Corrosion
<u>Evaluation</u>	Crest Abrasion	Partially Repair

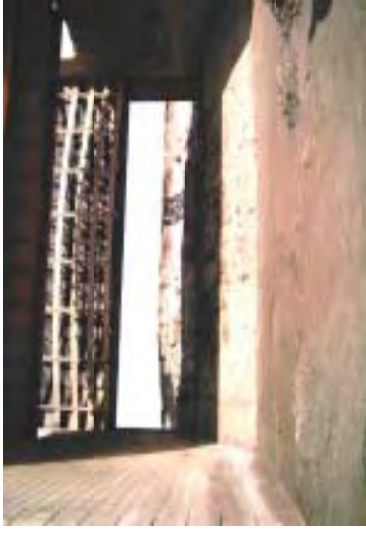
DESIGN CONDITION		Gate No. 41
Barrage Width	4,343 ft (1,324.66 m)

Abrasion	B	A	B	
Exfoliation	C	B	C	
Corrosion	C	B	C	
Cracking	C	C	C	
(B) Displacement				
Cracking	C	C	C	
Exfoliation	C	C	C	
(C) Sedimentation	A	A	A	
(D) Neutralization		5 mm		
(E) Concrete Strength (N/mm2)	32.8	32.2	32.2	
Schmidt hammer	Ave. 32.38 N/mm2			
<u>Diagnosis</u>	Edge Corrosion	Crest Abrasion	Edge Corrosion	Sedimentation before Gate is more than 2 m and Friction Block is silted. Exfoliation is the gate edge on the both pier.
<u>Evaluation</u>	Partially Repair

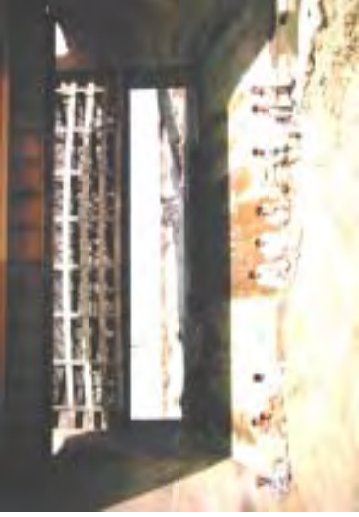
DESIGN CONDITION		Gate No.42
Barrage Width	4,343 ft (1,324.66 m)

Abrasion	B	A	B	
Exfoliation	C	B	C	
Corrosion	C	B	C	
Cracking	C	C	C	
(B) Displacement				
Cracking	C	C	C	
Exfoliation	C	C	C	
(C) Sedimentation	A	A	A	
(D) Neutralization		6 mm		
(E) Concrete Strength (N/mm2)	27.1	29.0	29.0	
Schmidt hammer	Ave. 28.36 N/mm2			
<u>Diagnosis</u>	Edge Corrosion	Crest Abrasion	Edge Corrosion	Sedimentation before Gate is more than 2 m and Friction Block is silted. Exfoliation is the gate edge on the both pier.
<u>Evaluation</u>	Partially Repair

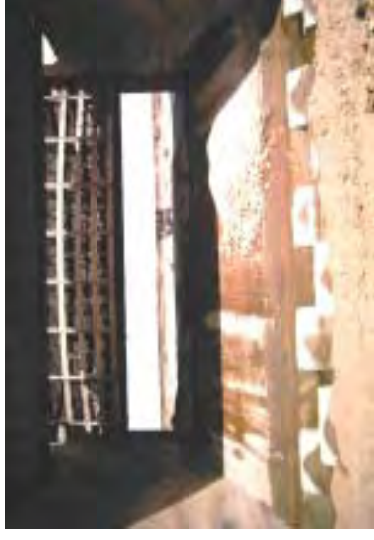
Check Item	Right Pier	Centre Creast	Left Pier	Location
(A) Deterioration				
Abrasion	B	A	B	
Exfoliation	C	B	C	
Corrosion	C	B	C	
Cracking	C	C	C	
(B) Displacement				
Cracking	C	C	C	
Exfoliation	C	C	C	
(C) Sedimentation				
(D) Neutralization				
(E) Concrete Strength (N/mm <sup>2</sup> )	28.4	32.8	30.3	
Schmidt hammer	Ave. 30.47 N/mm <sup>2</sup>			
<u>Diagnosis</u>	Edge Corrosion	Crest Abrasion	Edge Corrosion	Sedimentation before Gate is more than 2 m and Friction Block is silted. Exfoliation is the gate edge on the both pier.
<u>Evaluation</u>	Partially Repair

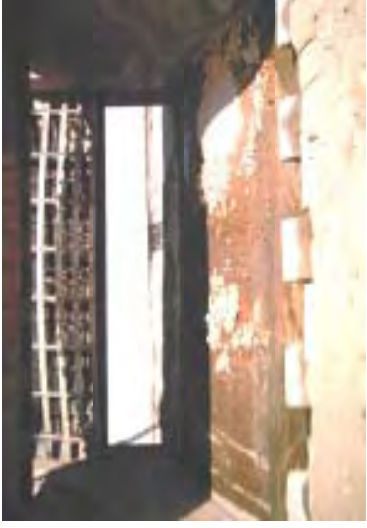
DESIGN CONDITION		Gate No. 44
Barrage Width	4,343 ft (1,324.66 m)

Check Item	Right Pier	Centre Crest	Left Pier	Location
(A) Deterioration				
Abrasion	B	A	B	
Exfoliation	C	A	C	
Corrosion	C	A	C	
Cracking	C	C	C	
(B) Displacement				
Cracking	C	C	C	
Exfoliation	C	C	C	
(C) Sedimentation	A	A	A	
(D) Neutralization		5 mm		
(E) Concrete Strength (N/mm2)	30.3	27.7	30.9	
Schmidt hammer	Ave. 29.63 N/mm2			Partially exfoliation on the Crest
<u>Diagnosis</u>	Edge Corrosion	Crest Abrasion	Edge Corrosion	Comments
<u>Evaluation</u>	Crest Repair			Sedimentation before Gate is more than 2 m and Friction Block is silted. Exfoliation is the gate edge on the both pier.

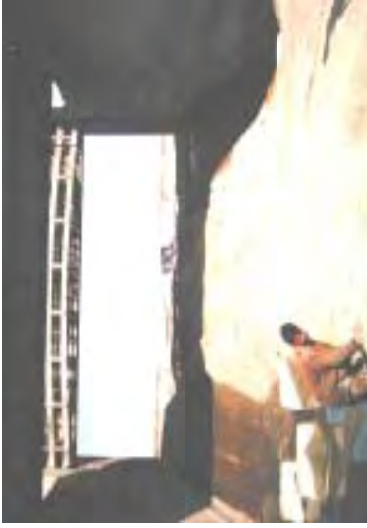
DESIGN CONDITION		Gate No. 45
Barrage Width	4,343 ft (1,324.66 m)

Check Item	Right Pier	Centre Crest	Left Pier	Location
(A) Deterioration				
Abrasion	B	A	B	
Exfoliation	C	B	C	
Corrosion	C	A	C	
Cracking	C	C	C	
(B) Displacement				
Cracking	C	C	C	
Exfoliation	C	C	C	
(C) Sedimentation	A	A	A	
(D) Neutralization		8 mm		
(E) Concrete Strength (N/mm2)	29.6	32.8	33.4	
Schmidt hammer	Ave. 31.95 N/mm2			
<u>Diagnosis</u>	Edge Corrosion	Crest Abrasion	Edge Corrosion	Sedimentation before Gate is more than 2 m and Friction Block is silted. Exfoliation is the gate edge on the both pier.
<u>Evaluation</u>	Partially Repair

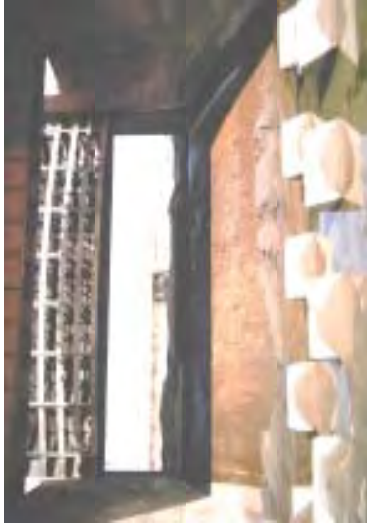
DESIGN CONDITION		Gate No. 46
Barrage Width	4,343 ft (1,324.66 m)

Check Item	Right Pier	Centre Crest	Left Pier	Location
(A) Deterioration				
Abrasion	B	A	B	
Exfoliation	C	A	C	
Corrosion	C	A	C	
Cracking	C	C	C	
(B) Displacement				
Cracking	C	C	C	
Exfoliation	C	C	C	
(C) Sedimentation	A	A	A	
(D) Neutralization		8 mm		
(E) Concrete Strength (N/mm2)	27.7	30.9	30.3	
Schmidt hammer	Ave. 29.63 N/mm2			Partially exfoliation on the Crest
<u>Diagnosis</u>	Edge Corrosion	Crest Abrasion	Edge Corrosion	Comments
<u>Evaluation</u>	Crest Repair			Sedimentation before Gate is more than 2 m and Friction Block is silted. Exfoliation is the gate edge on the both pier.

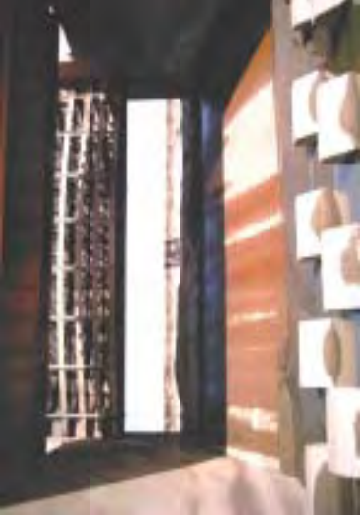
DESIGN CONDITION		Gate No. 47
Barrage Width	4,343 ft (1,324.66 m)

Abrasion	B	A	B	
Exfoliation	C	B	A	
Corrosion	C	A	C	
Cracking	C	C	C	
(B) Displacement				
Cracking	C	C	C	
Exfoliation	C	C	C	
(C) Sedimentation	A	A	A	
(D) Neutralization		8 mm		
(E) Concrete Strength (N/mm2)	33.4	31.5	32.2	
Schmidt hammer	Ave. 32.38 N/mm2			
<u>Diagnosis</u>	Edge Corrosion	Crest Abrasion	Edge Corrosion	Sedimentation before Gate is more than 2 m and Friction Block is silted. Exfoliation is the gate edge on the both pier.
<u>Evaluation</u>	Partially Repair

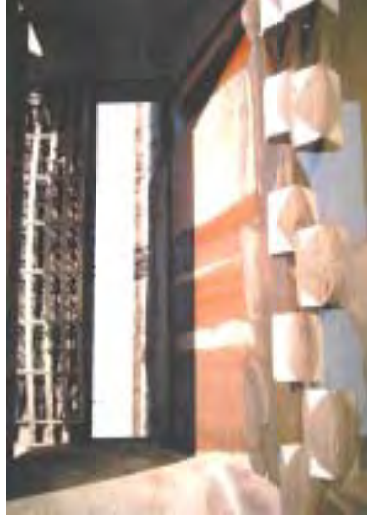
Gate No. 48

Check Item	Right Pier	Centre Creast	Left Pier
(A) Deterioration			
Abrasion	B	A	B
Exfoliation	C	B	C
Corrosion	C	A	C
Cracking	C	C	C
(B) Displacement			
Cracking	C	C	C
Exfoliation	C	C	C
(C) Sedimentation	A	A	A
(D) Neutralization		12 mm	
(E) Concrete Strength (N/mm <sup>2</sup> )	31.5	32.2	30.3
Schmidt hammer	Ave. 31.32 N/mm <sup>2</sup>		
<u>Diagnosis</u>	Edge Corrosion	Crest Abrasion	Edge Corrosion
<u>Evaluation</u>	Partially Repair

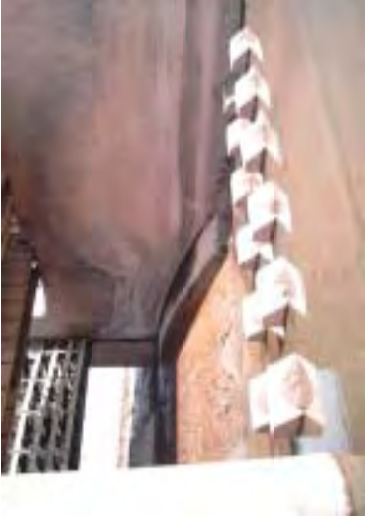
DESIGN CONDITION		Gate No. 49
Barrage Width	4,343 ft (1,324.66 m)

Check Item	CONCRETE DIAGNOSIS		Location
	Right Pier	Centre Creast	
(A) Deterioration			
Abrasion	B	A	B
Exfoliation	C	B	C
Corrosion	C	A	C
Cracking	C	C	C
(B) Displacement			
Cracking	C	C	C
Exfoliation	C	C	C
(C) Sedimentation	A	A	A
(D) Neutralization		8 mm	
(E) Concrete Strength (N/mm2)	26.5	29.6	27.1
Schmidt hammer	Ave 27.47 N/mm2		
<u>Diagnosis</u>	Edge Corrosion	Crest Abrasion	Edge Corrosion
<u>Evaluation</u>	Partially Repair		
Comments Sedimentation before Gate is more than 2 m and Friction Block is silted. Exfoliation is the gate edge on the both pier.

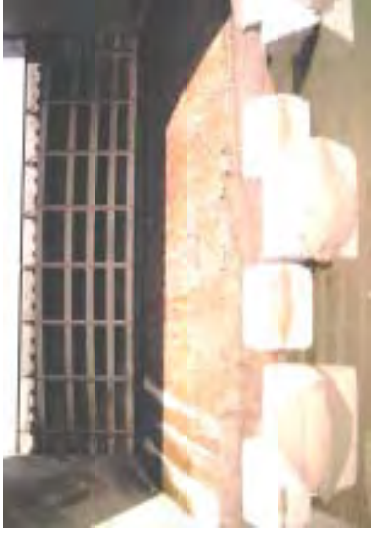
DESIGN CONDITION		Gate No. 50
Barrage Width	4,343 ft (1,324.66 m)

Abrasion	B	A	A	B		
Exfoliation	C	A	A	C		
Corrosion	C	A	A	C		
Cracking	C	C	C	C		
(B) Displacement						
Cracking	C	C	C	C		
Exfoliation	C	C	C	C		
(C) Sedimentation	A	A	A	A		
(D) Neutralization		13 mm				
(E) Concrete Strength (N/mm2)	31.5	33.4	32.8			
Schmidt hammer	Ave. 35.59 N/mm2					Partially exfoliation on the Crest
Diagnosis	Edge Corrosion	Crest Abrasion	Edge Corrosion	Edge Corrosion		Comments
Evaluation	Crest Repair					Sedimentation before Gate is more than 2 m and Friction Block is silted. Exfoliation is the gate edge on the both pier.

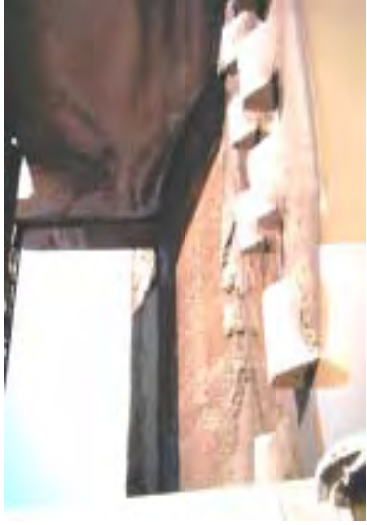
DESIGN CONDITION		Gate No. 51
Barrage Width	4,343 ft (1,324.66 m)

Exfoliation	C	A	C	
Corrosion	C	A	C	
Cracking	C	C	C	
(B) Displacement				
Cracking	C	C	C	
Exfoliation	C	C	C	
(C) Sedimentation	A	A	A	
(D) Neutralization		5 mm		
(E) Concrete Strength (N/mm <sup>2</sup> )	29.0	29.6	31.5	
Schmidt hammer		Ave. 30.05 N/mm <sup>2</sup>		
<u>Diagnosis</u>	Edge Corrosion	Crest Abrasion	Edge Corrosion	Partially exfoliation on the Crest Sedimentation before Gate is more than 2 m and Friction Block is silted. Exfoliation is the gate edge on the both pier.
<u>Evaluation</u>	Crest Repair

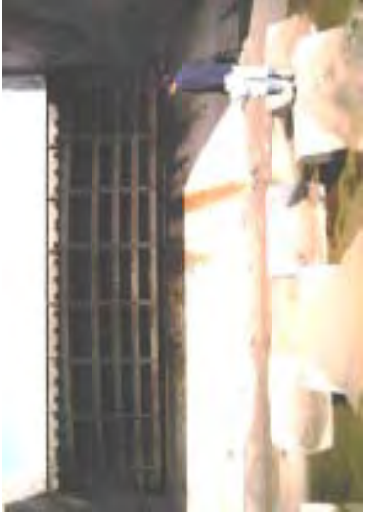
DESIGN CONDITION		Gate No. 52
Barrage Width	4,343 ft (1,324.66 m)

Abrasion	B	A	B	
Exfoliation	C	B	C	
Corrosion	C	B	C	
Cracking	C	C	C	
(B) Displacement				
Cracking	C	C	C	
Exfoliation	C	C	C	
(C) Sedimentation	A	A	A	
(D) Neutralization		11 mm		
(E) Concrete Strength (N/mm <sup>2</sup> )	30.9	30.3	27.7	
Schmidt hammer	Ave. 29.63 N/mm <sup>2</sup>			
<u>Diagnosis</u>	Edge Corrosion	Crest Abrasion	Edge Corrosion	Sedimentation before Gate is more than 2 m and Friction Block is silted. Exfoliation is the gate edge on the both pier.
<u>Evaluation</u>	Partially Repair

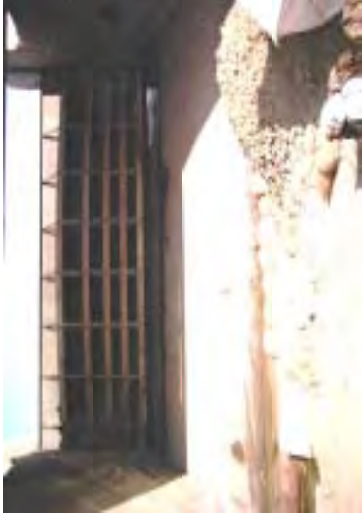
DESIGN CONDITION		Gate No. 53
Barrage Width	4,343 ft (1,324.66 m)

Abrasion	B	A	B	
Exfoliation	C	C	C	
Corrosion	C	A	C	
Cracking	C	C	C	
(B) Displacement				
Cracking	C	C	C	
Exfoliation	C	C	C	
(C) Sedimentation	A	A	A	
(D) Neutralization		8 mm		
(E) Concrete Strength (N/mm2)	32.2	27.7	29.6	
Schmidt hammer	Ave. 30.47 N/mm2			
<u>Diagnosis</u>	Edge Corrosion	Crest Abrasion	Edge Corrosion	Sedimentation before Gate is more than 2 m and Friction Block is silted. Exfoliation is the gate edge on the both pier.
<u>Evaluation</u>	Partially Repair

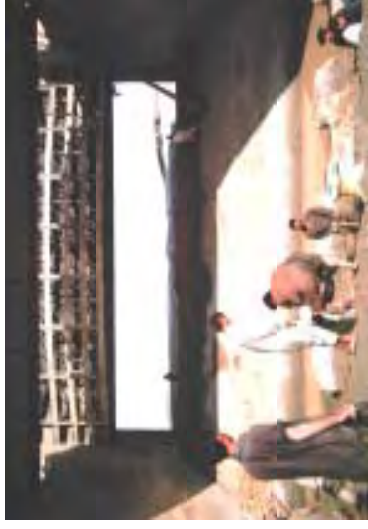
Check Item	Right Pier	Centre Creast	Left Pier	Location
(A) Deterioration				
Abrasion	B	Flooring	B	
Exfoliation	C	B	C	
Corrosion	C	A	C	
Cracking	C	C	C	
(B) Displacement				
Cracking	C	C	C	
Exfoliation	C	C	C	
(C) Sedimentation	A	A	A	
(D) Neutralization		7 mm		
(E) Concrete Strength (N/mm <sup>2</sup> )	30.9	30.9	29.6	
Schmidt hammer	Ave. 30.47 N/mm <sup>2</sup>			
<u>Diagnosis</u>	Edge Corrosion	Crest Abrasion	Edge Corrosion	Sedimentation before Gate is more than 2 m and Friction Block is silted. Exfoliation is the gate edge on the both pier.
<u>Evaluation</u>	Partially Repair

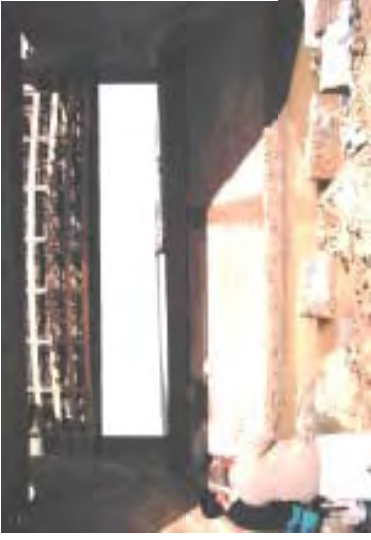
DESIGN CONDITION		Gate No. 55
Barrage Width	4,343 ft (1,324.66 m)

Abrasion	B	Flooring	B	
Exfoliation	C	B	C	
Corrosion	C	Flooring	C	
Cracking	C	C	C	
(B) Displacement				
Cracking	C	C	C	
Exfoliation	C	C	C	
(C) Sedimentation	A	A	A	
(D) Neutralization		8 mm		
(E) Concrete Strength (N/mm <sup>2</sup> )	29.6	29.0	30.3	
Schmidt hammer	Ave. 29.63 N/mm <sup>2</sup>			
<u>Diagnosis</u>	Edge Corrosion	Crest Abrasion	Edge Corrosion	Sedimentation before Gate is more than 2 m and Friction Block is silted. Exfoliation is the gate edge on the both pier.
<u>Evaluation</u>	Partially Repair

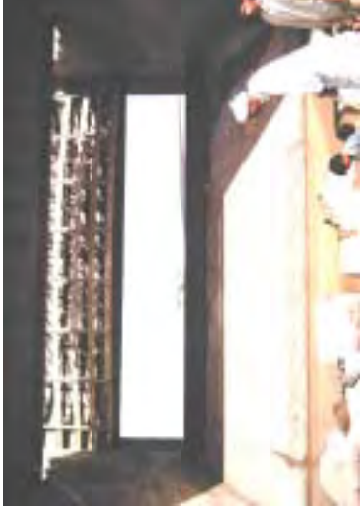
DESIGN CONDITION		Gate No. 56
Barrage Width	4,343 ft (1,324.66 m)

Check Item	Right Pier	Centre Creast	Left Pier	Location
(A) Deterioration				
Abrasion	B	Flooring	B	
Exfoliation	C	B	C	
Corrosion	A	A	A	
Cracking	C	C	C	
(B) Displacement				
Cracking	C	C	C	
Exfoliation	C	C	C	
(C) Sedimentation				
(D) Neutralization				
(E) Concrete Strength (N/mm <sup>2</sup> )	33.4	8 mm	30.3	
Schmidt hammer	Ave. 32.17 N/mm <sup>2</sup>			
<u>Diagnosis</u>	Edge Corrosion	Crest Abrasion	Edge Corrosion	Sedimentation before Gate is more than 2 m and Friction Block is silted. Exfoliation is the gate edge on the both pier.
<u>Evaluation</u>	Partially Repair

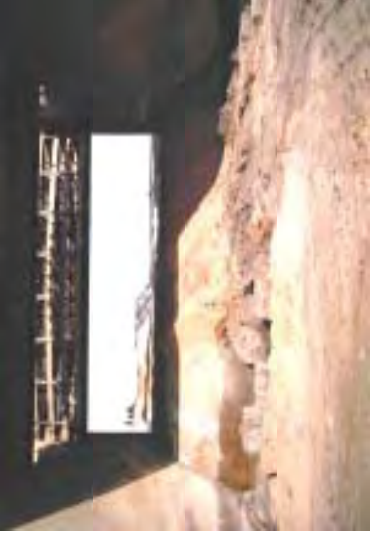
DESIGN CONDITION		Gate No. 57
Barrage Width	4,343 ft (1,324.66 m)

Check Item	Right Pier	Centre Creast	Left Pier	Location
(A) Deterioration				
Abrasion	B	A	B	
Exfoliation	C	B	C	
Corrosion	C	A	C	
Cracking	C	B	C	
(B) Displacement				
Cracking	C	C	C	
Exfoliation	C	C	C	
(C) Sedimentation				
(D) Neutralization				
(E) Concrete Strength (N/mm <sup>2</sup> )	29.0	8 mm	29.6	
Schmidt hammer		Ave. 29.84 N/mm <sup>2</sup>		
<u>Diagnosis</u>	Edge Corrosion	Crest Abrasion	Edge Corrosion	Comments
<u>Evaluation</u>	Partially Repair			Sedimentation before Gate is more than 2 m and Friction Block is silted. Exfoliation is the gate edge on the both pier.

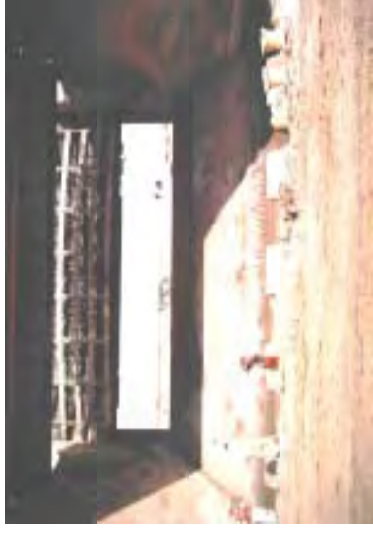
Check Item	Right Pier	Centre Creast	Left Pier	Location
(A) Deterioration				
Abrasion	B	A	B	
Exfoliation	C	B	C	
Corrosion	B	Flooring	B	
Cracking	C	C	C	
(B) Displacement				
Cracking	C	C	C	
Exfoliation	C	C	C	
(C) Sedimentation				
(D) Neutralization				
(E) Concrete Strength (N/mm <sup>2</sup> )	27.1	29.6	26.5	
Schmidt hammer	Ave. 27.72 N/mm <sup>2</sup>			
<u>Diagnosis</u>	Edge Corrosion	Crest Abrasion	Edge Corrosion	Sedimentation before Gate is more than 2 m and Friction Block is silted. Exfoliation at the gate edge on the both pier was repaired by concrete.
<u>Evaluation</u>	Partially Repair

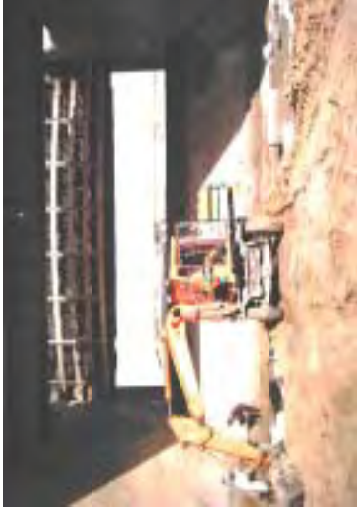
DESIGN CONDITION		Gate No. 59
Barrage Width	4,343 ft (1,324.66 m)

Exfoliation	A	B	A	
Corrosion	B	Flooring	B	
Cracking	B	C	C	
(B) Displacement				
Cracking	C	C	C	
Exfoliation	C	C	C	
(C) Sedimentation	A	A	A	
(D) Neutralization		8 mm		
(E) Concrete Strength (N/mm2)	29.0	27.7	30.3	
Schmidt hammer	Ave. 28.99 N/mm2			
<u>Diagnosis</u>	Edge Corrosion	Crest Abrasion	Edge Corrosion	Sedimentation before Gate is more than 2 m and Friction Block is silted. Exfoliation at the gate edge on the both pier was repaired by concrete.
<u>Evaluation</u>	Partially Repair

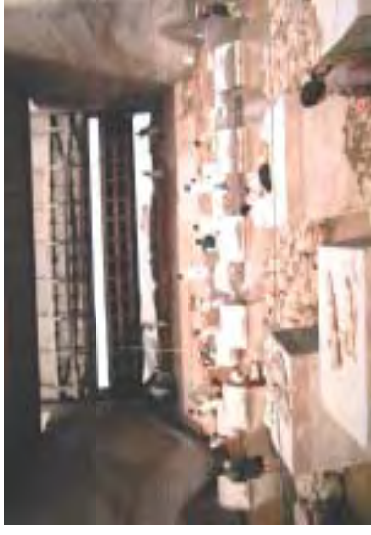
Check Item	Right Pier	Centre Crest	Left Pier	Location
(A) Deterioration				
Abrasion	B	Flooring	B	
Exfoliation	C	A	C	
Corrosion	C	Flooring	C	
Cracking	C	C	C	
(B) Displacement				
Cracking	C	C	C	
Exfoliation	C	C	C	
(C) Sedimentation	A	A	A	
(D) Neutralization		8 mm		
(E) Concrete Strength (N/mm <sup>2</sup> )	26.5	30.3	30.9	
Schmidt hammer	Ave. 29.20 N/mm <sup>2</sup>			
<u>Diagnosis</u>	Edge Corrosion	Crest Abrasion	Edge Corrosion	Partially exfoliation on the Crest
<u>Evaluation</u>	Crest Repair			Comments
				Sedimentation before Gate is more than 2 m and Friction Block is silted. Exfoliation is at the gate edge on the both pier.
