ANNEX. II

FORMATS OF DAMAGE CONDITIONS

BAY NO. 65

FORMATS OF DAMAGE CONDITIONS-BAY NO. - 65

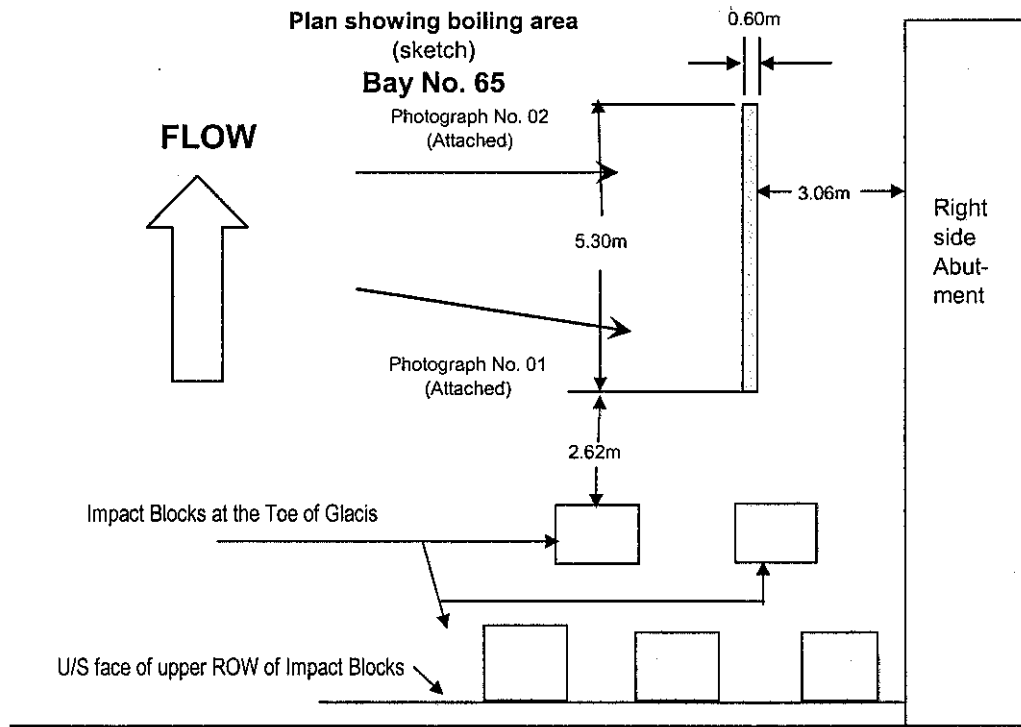
Ref No: Point No. 01	Survey date: 14-01-2004
<p>Location.</p> <p>D/S of 65th Gate/Bay from left side. (Position diagram).</p> <p>Given below.</p>	<p>Outline of damage.</p> <p>Boiling of water taking place from underneath the floor at the location shown below.</p>

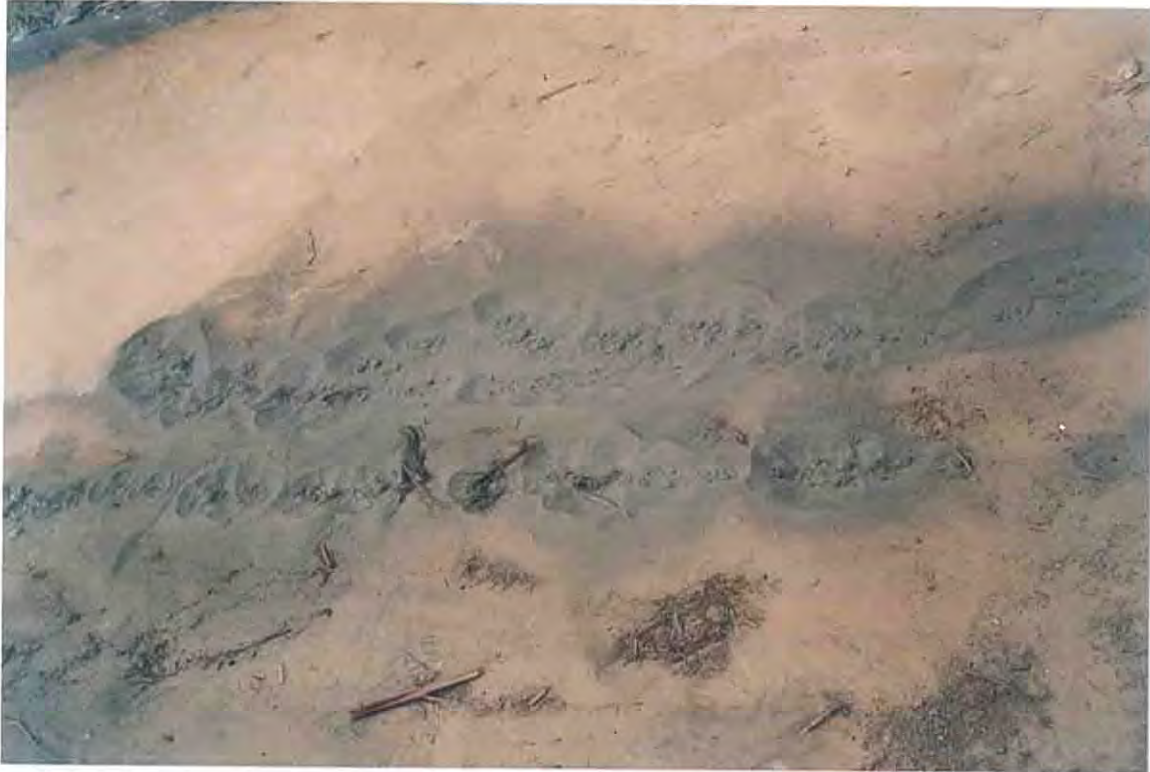
Photograph No. 01

Boiling of water taking place from underneath the floor.

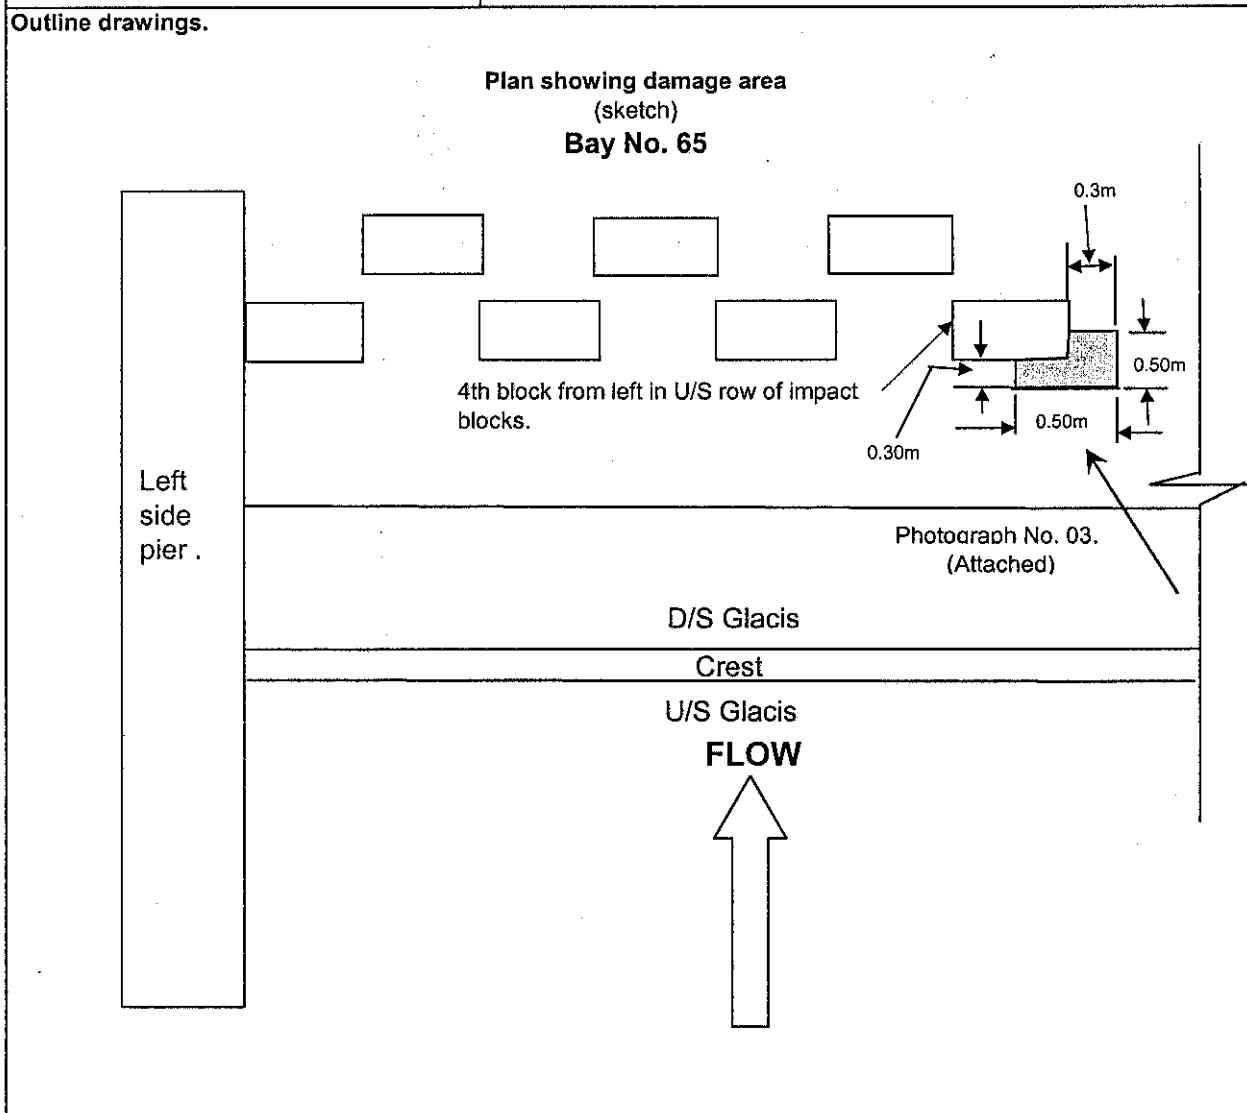
Ref No: Point No.02	Survey date: 14-01-2004
Location. D/S of 65th Gate/Bay from left side. (Position diagram). Given below.	Outline of damage. Ripping up/erosion of skin concrete (which is not monolithic with the underlying mass concrete) adjacent to the impact block- at the location shown below.

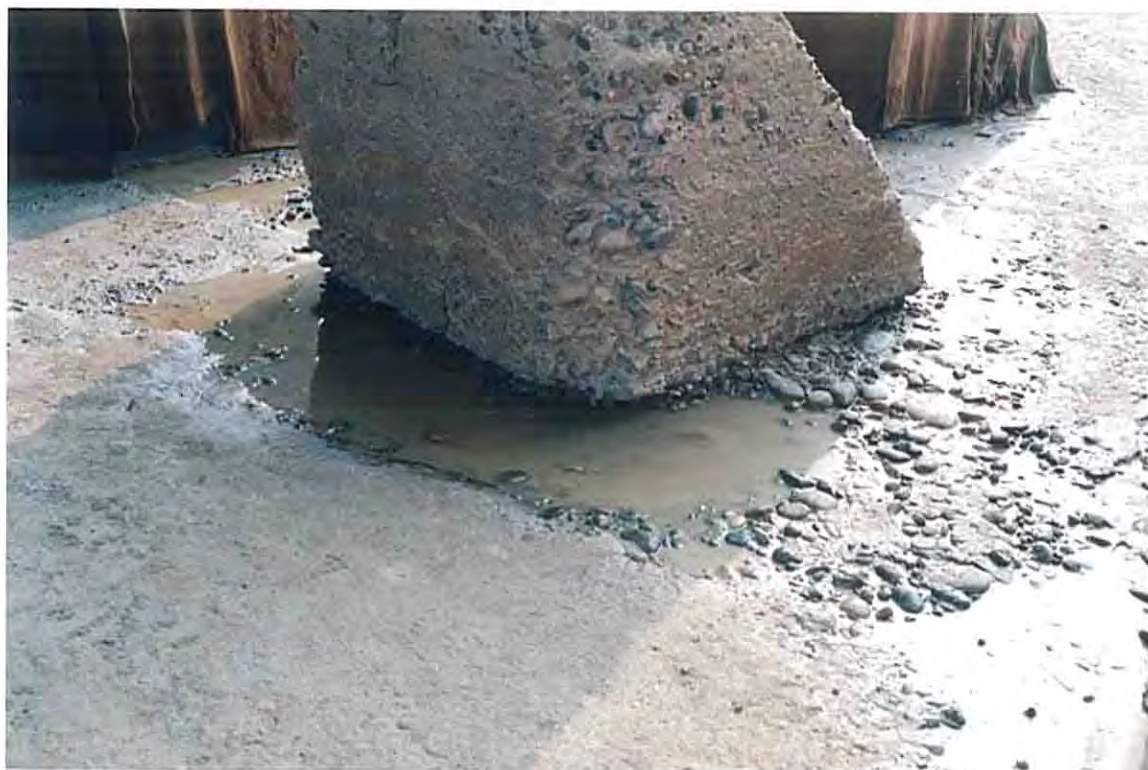
Photograph No. 03

Rippingup/erosion of skin concrete adjacent to the impact block.

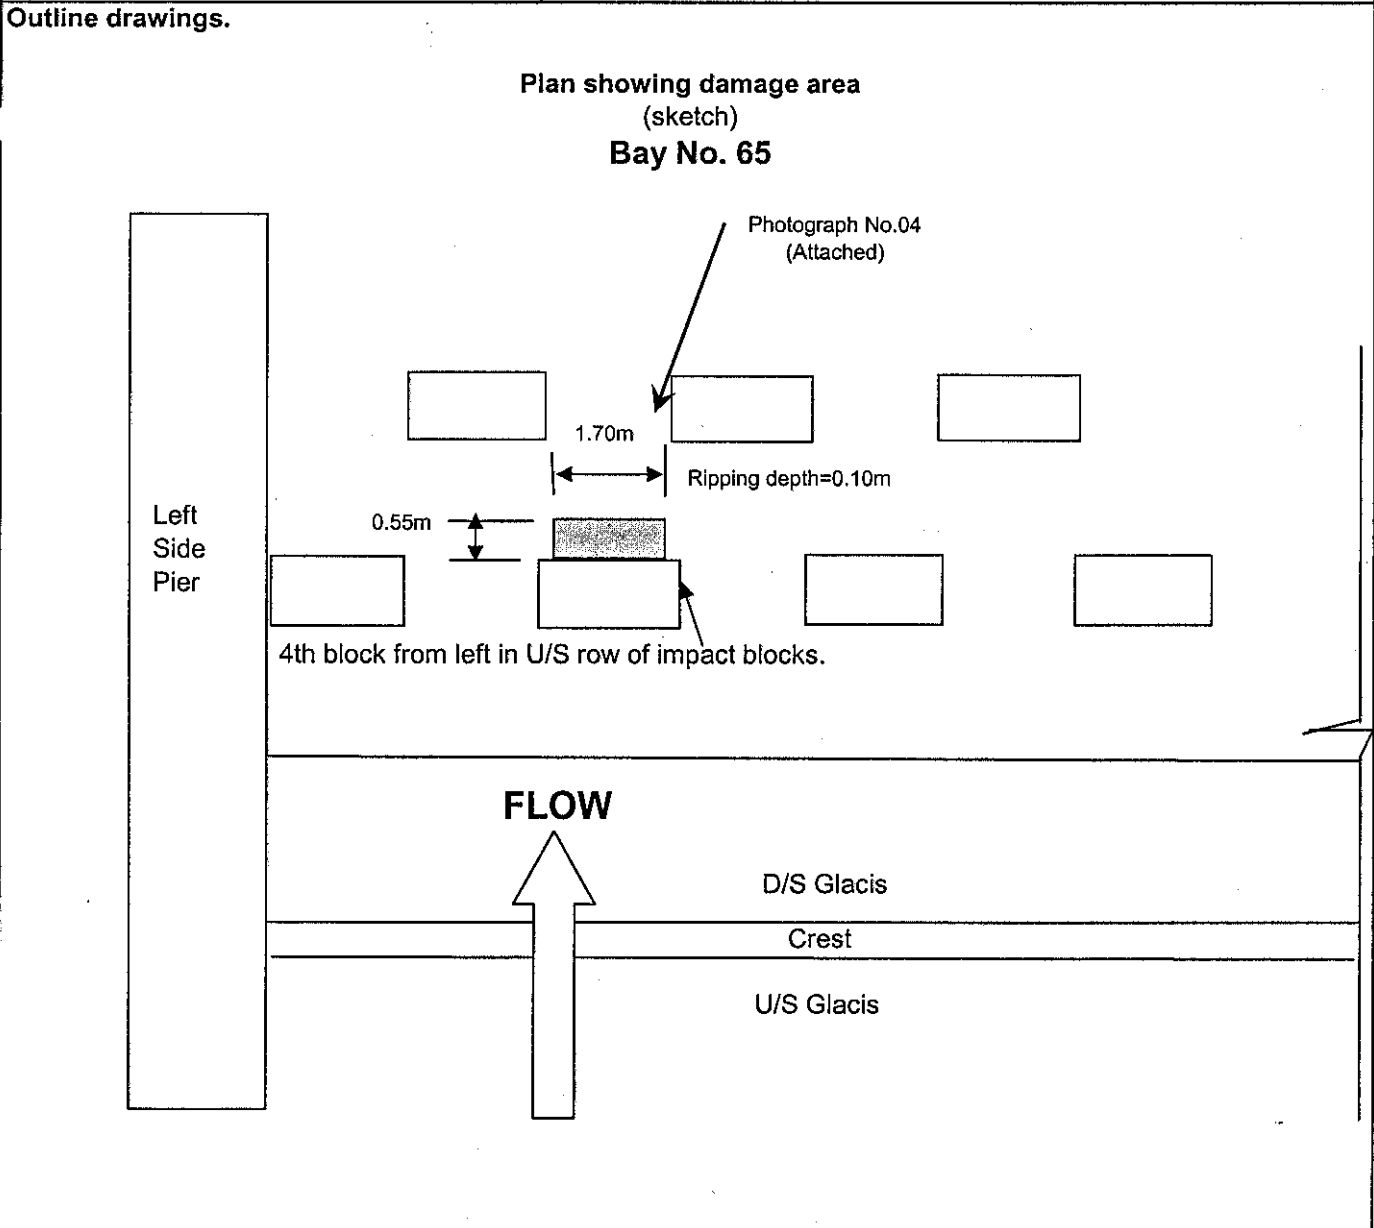
Ref No; Point No.03	Survey date: 14-01-2004
Location. D/S of 65th Gate/Bay from left side. (Position diagram). Given below.	Outline of damage. Ripping up/erosion of skin concrete (which is not monolithic with the underlying mass concrete) adjacent to the impact block- at the location shown below.

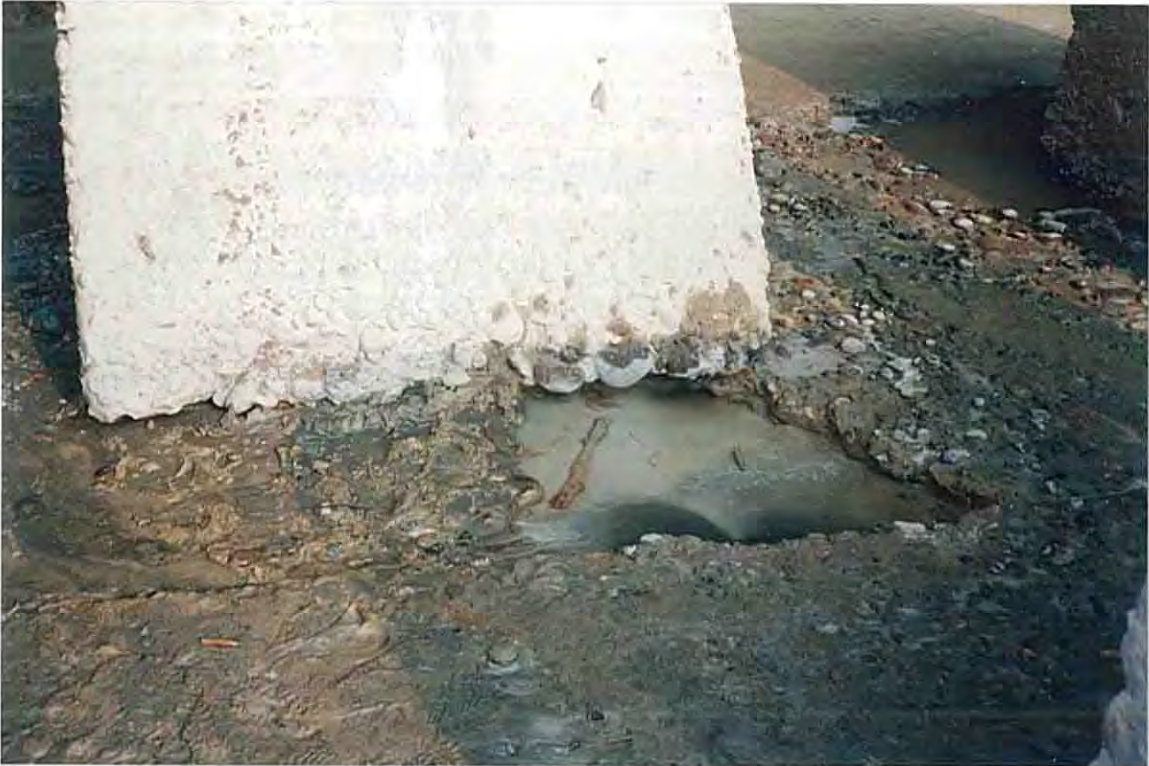
Photograph No. 04

Rippingup/erosion of skin concrete adjacent to the impact block.

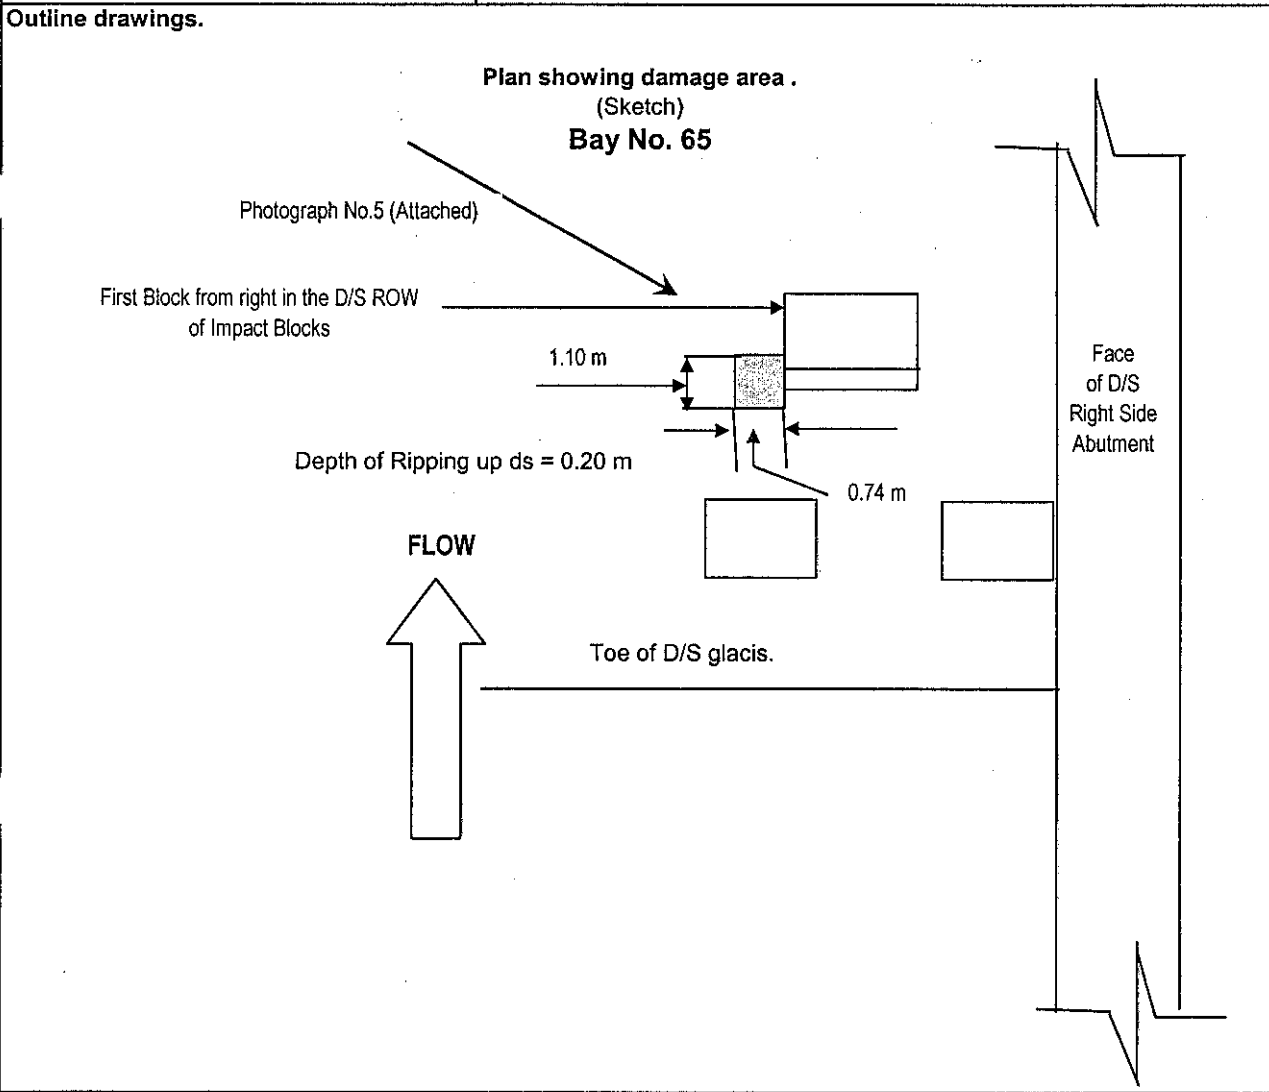
Ref No; Point No.04	Survey date: 14-01-2004
<p>Location.</p> <p>D/S of 65th Gate/Bay from left side. (Position diagram).</p> <p>Given below.</p>	<p>Outline of damage.</p> <p>Ripping up/erosion of skin concrete (which is not monolithic with the underlying mass concrete) adjacent to the impact block- at the location shown below.</p>

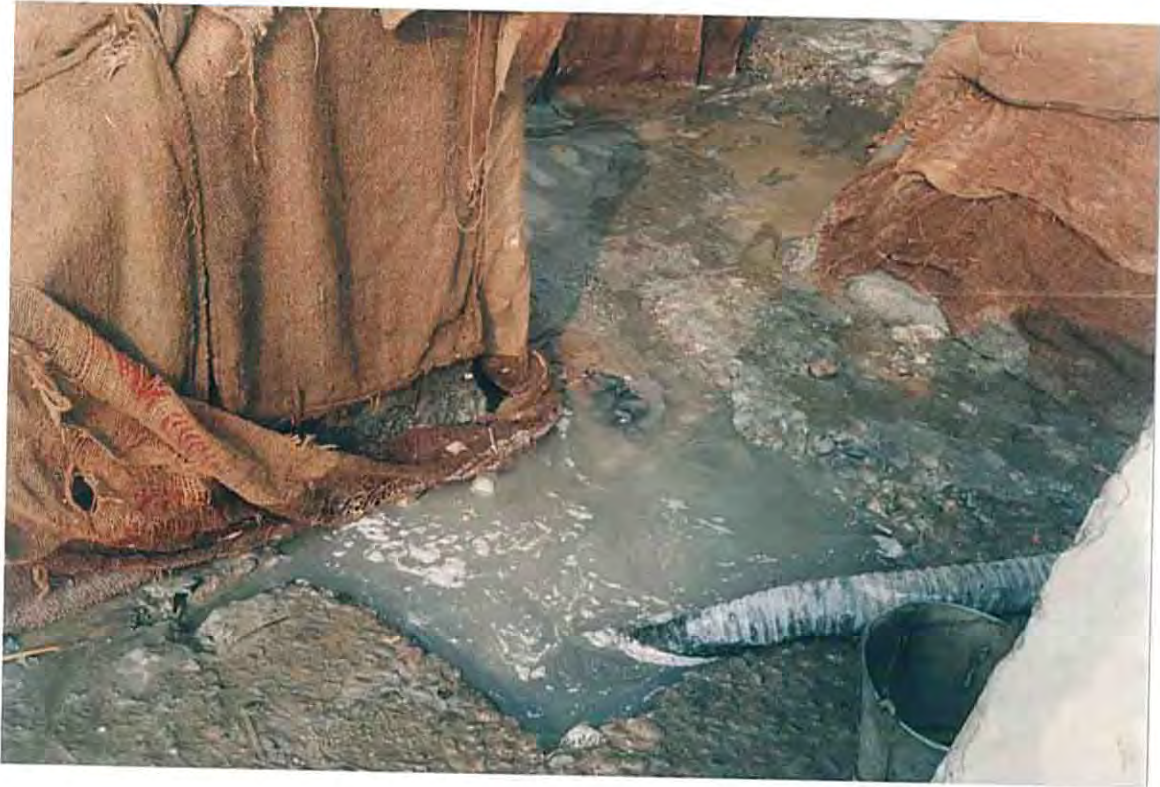
Photograph No. 05

Rippingup/erosion of skin concrete adjacent to the impact block.

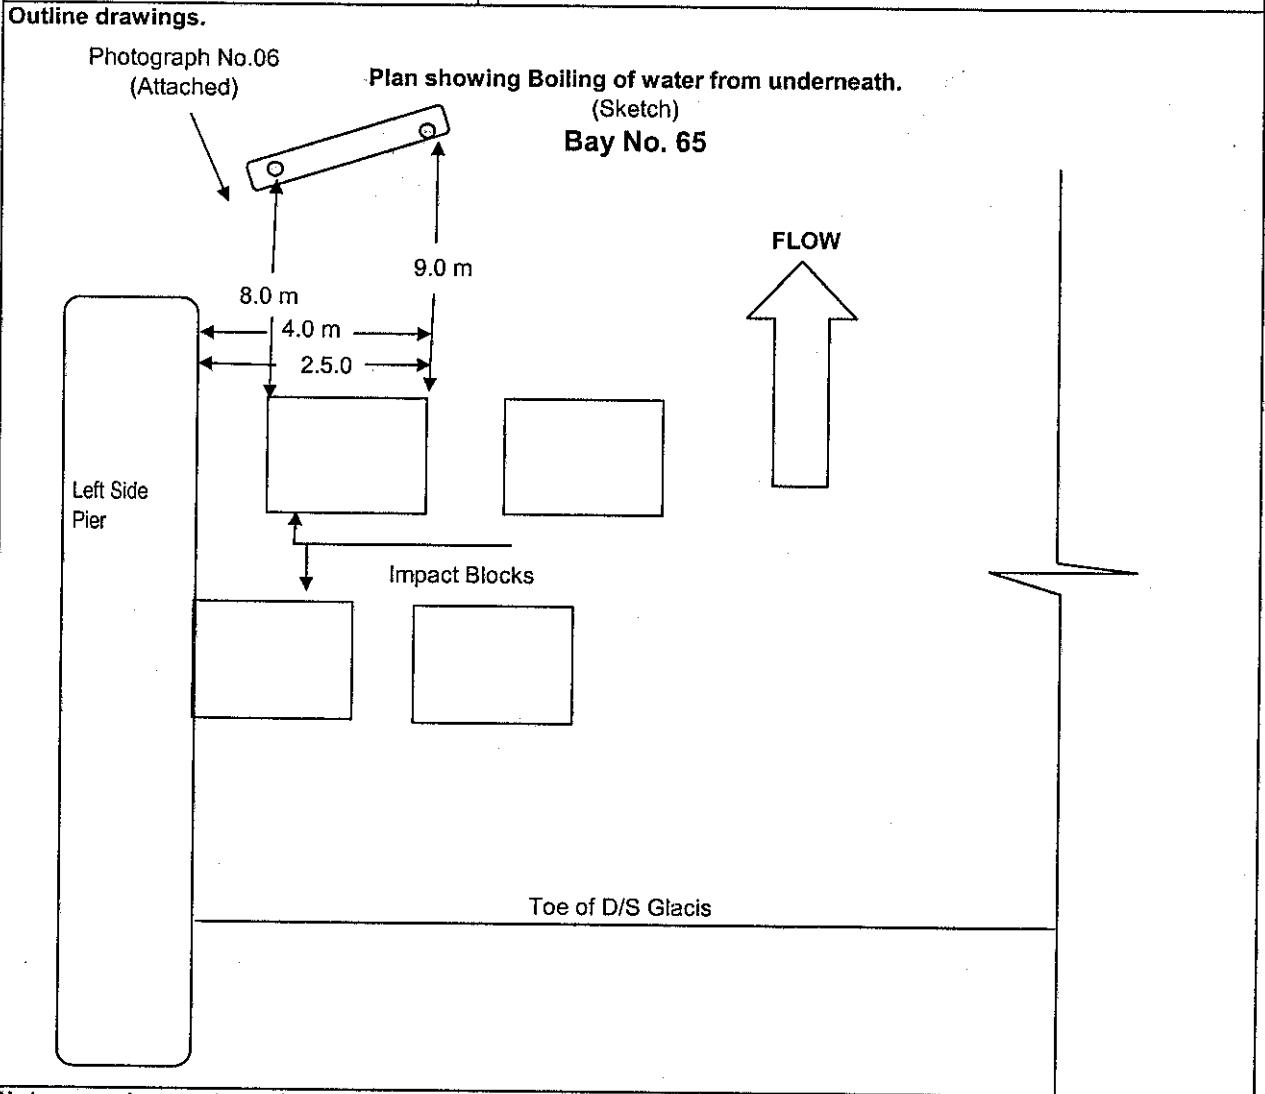
Ref No; Point No.05	Survey date: 14-01-2004
Location. D/S of 65th Gate/Bay from left side. (Position diagram). Given below.	Outline of damage. Boiling points at D/S of Bay No.65 from Left Side.

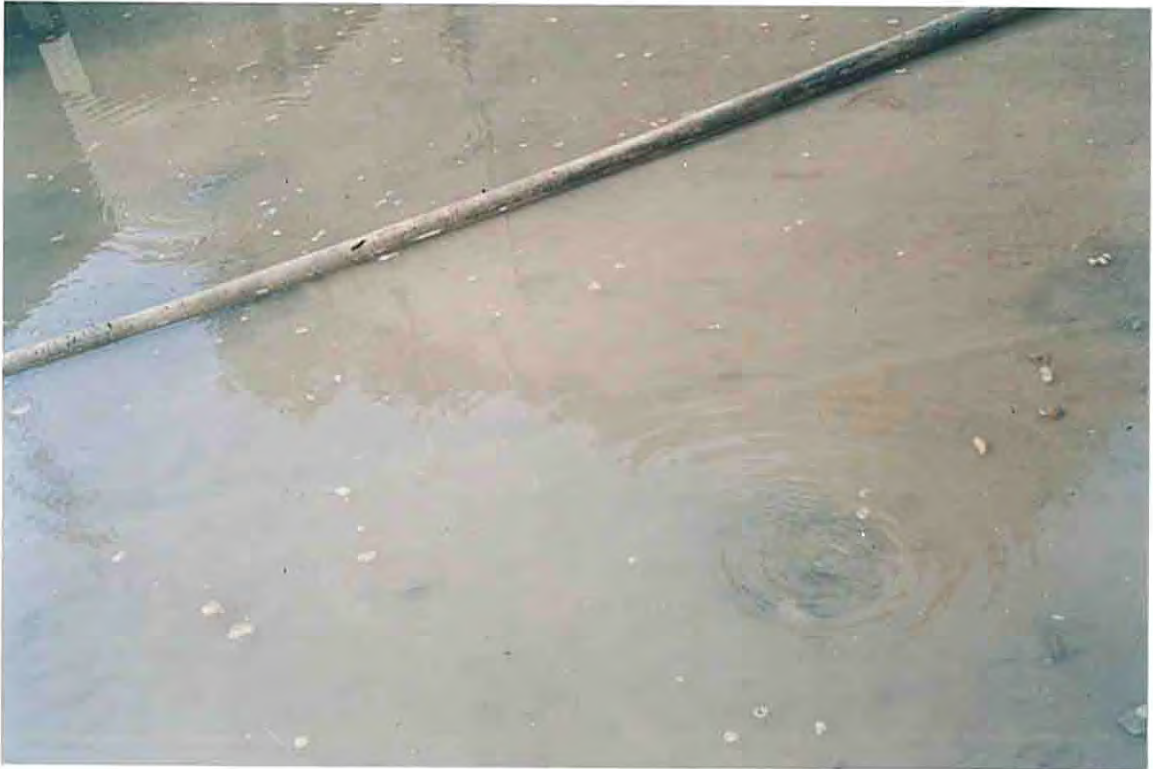
Photograph No. 06

Spring/boiling points at D/S floor of the bay

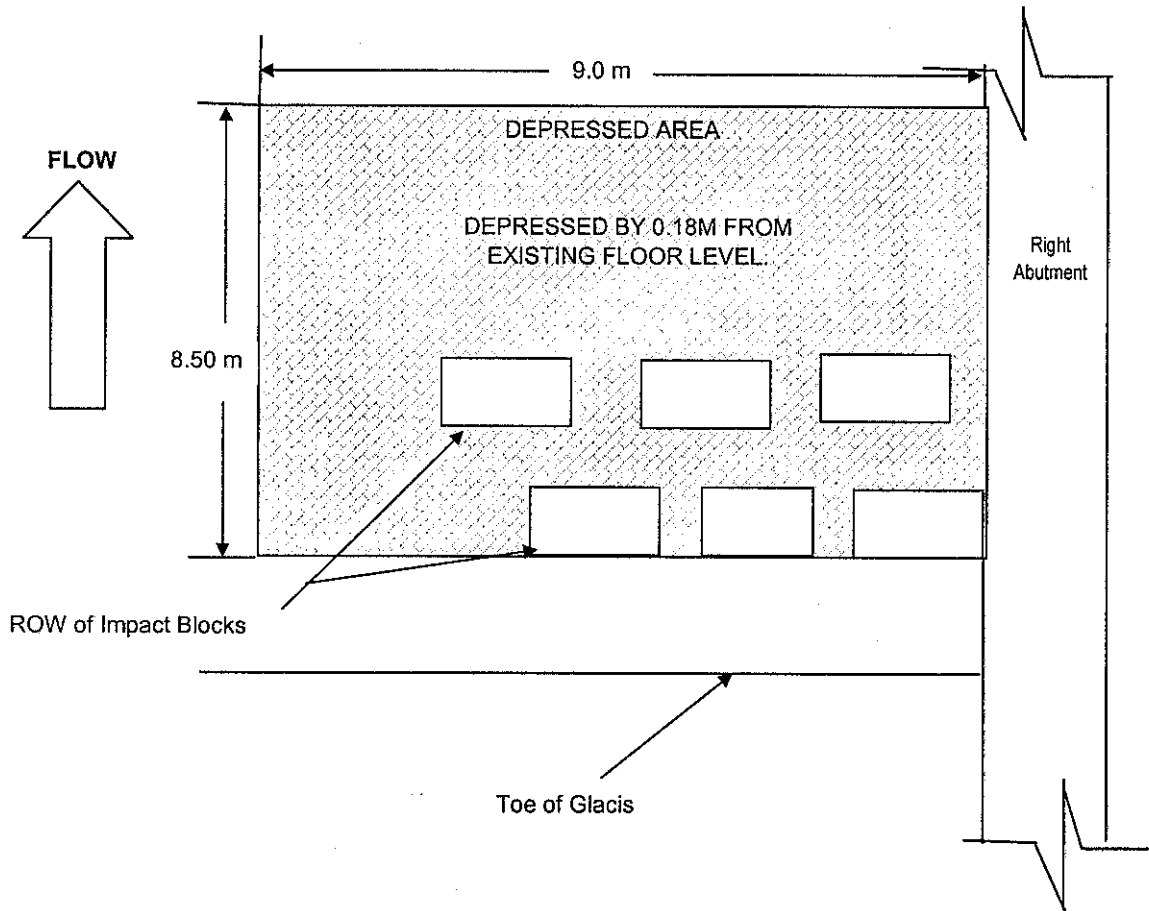
Plan showing depressed area below the floor level.
(Sketch)
Bay No. 65

Ref No; Point No. 06	Survey date: 14-01-2004
Location. D/S of 65th Gate/Bay from left side. (Position diagram). Given below.	Outline of damage. Depressed Area below the existing D/S Floor Level.

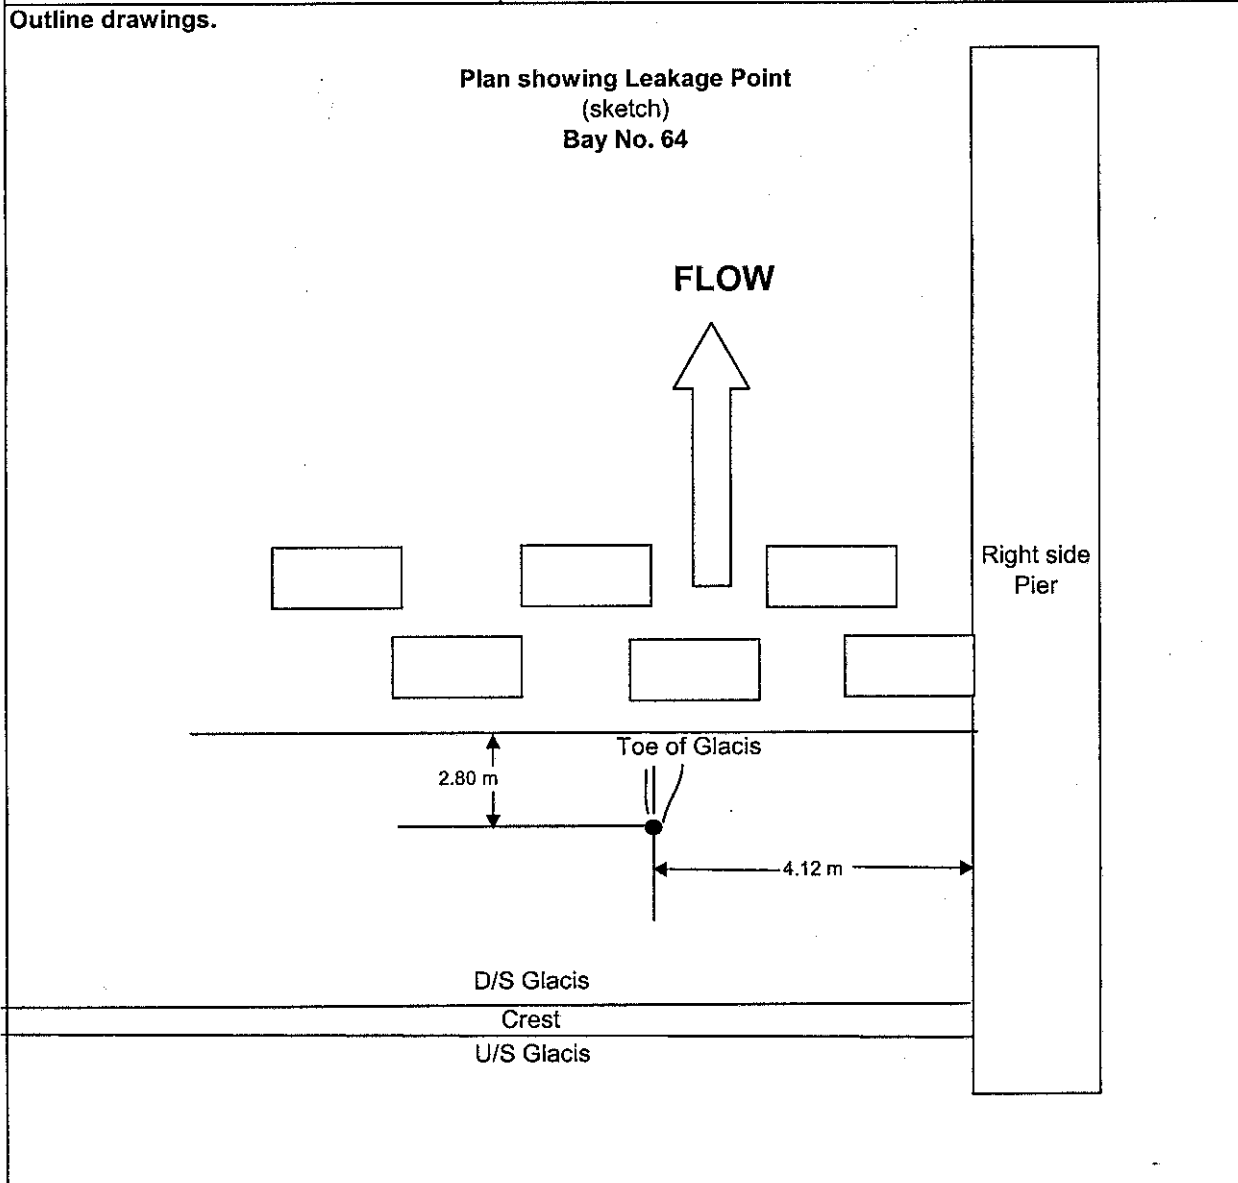
Ref No; Point No.01	Survey date: 14-01-2004
Location. D/S of 64th Gate/Bay from left side. (Position diagram). Given below.	Outline of damage. Water leakage from repaired glacis

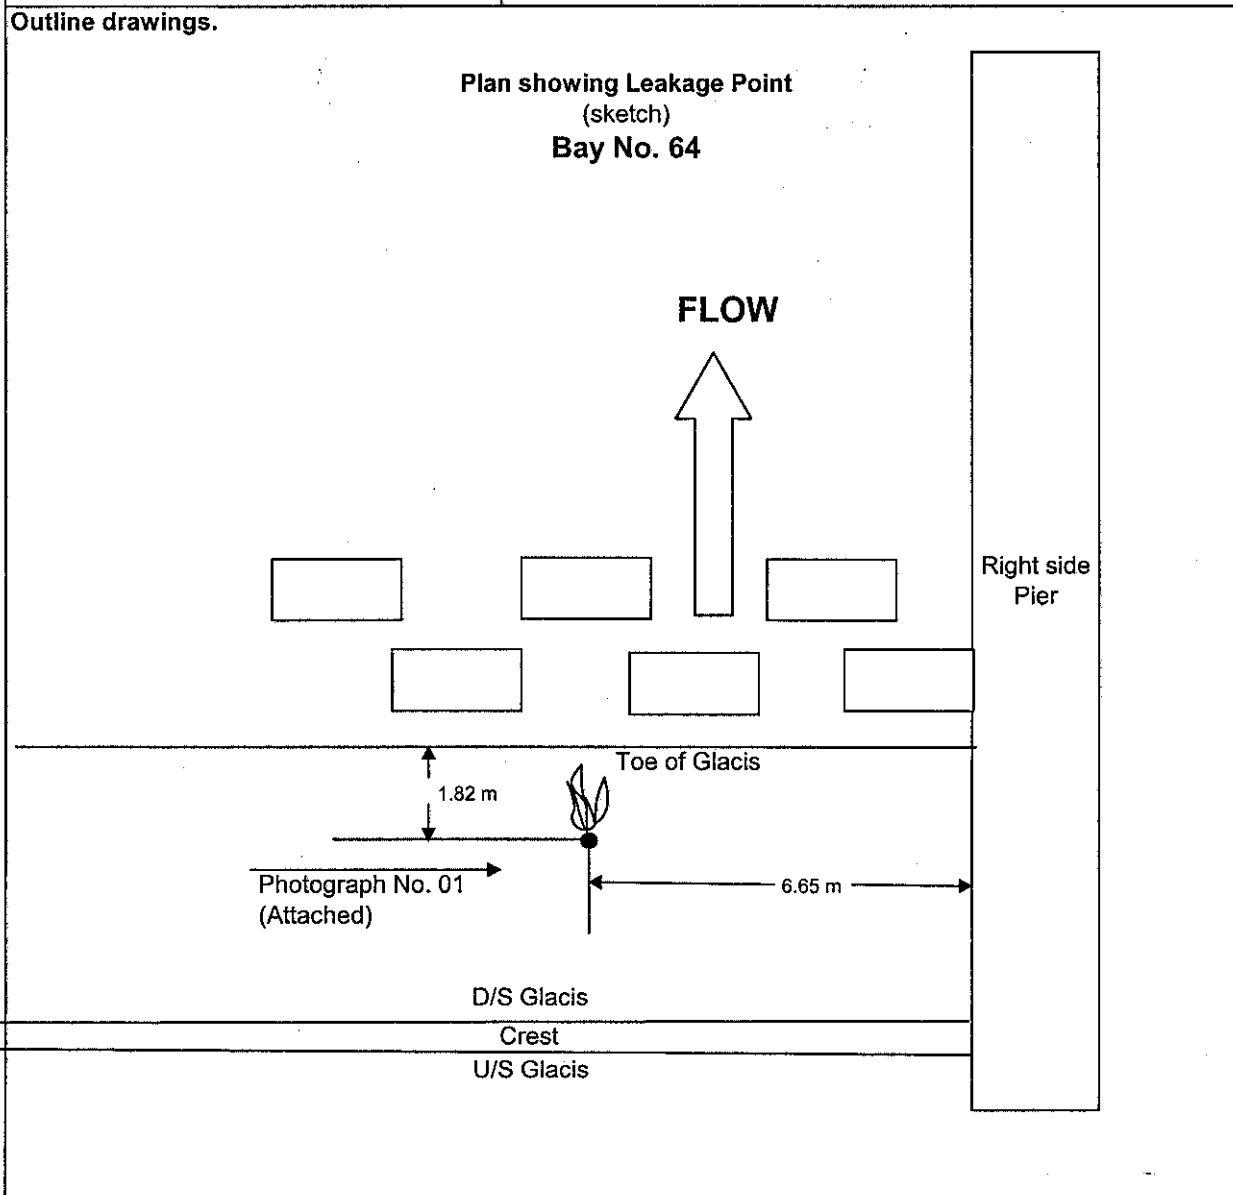
Ref No; Point No.02	Survey date: 14-01-2004
Location. D/S of 64th Gate/Bay from left side. (Position diagram). Given below.	Outline of damage. Water Leakage from the surface of repaired downstream glacis

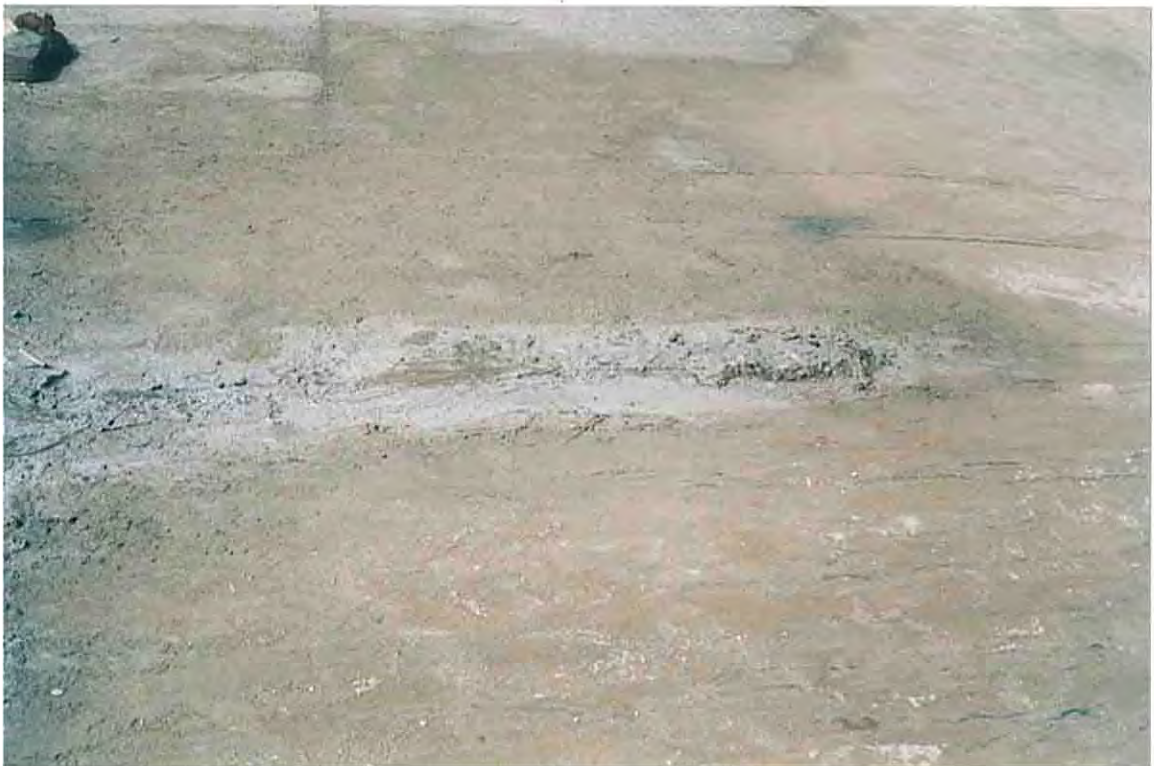
Photograph No. 01

Water leakage from the surface of repaired D/S glacis

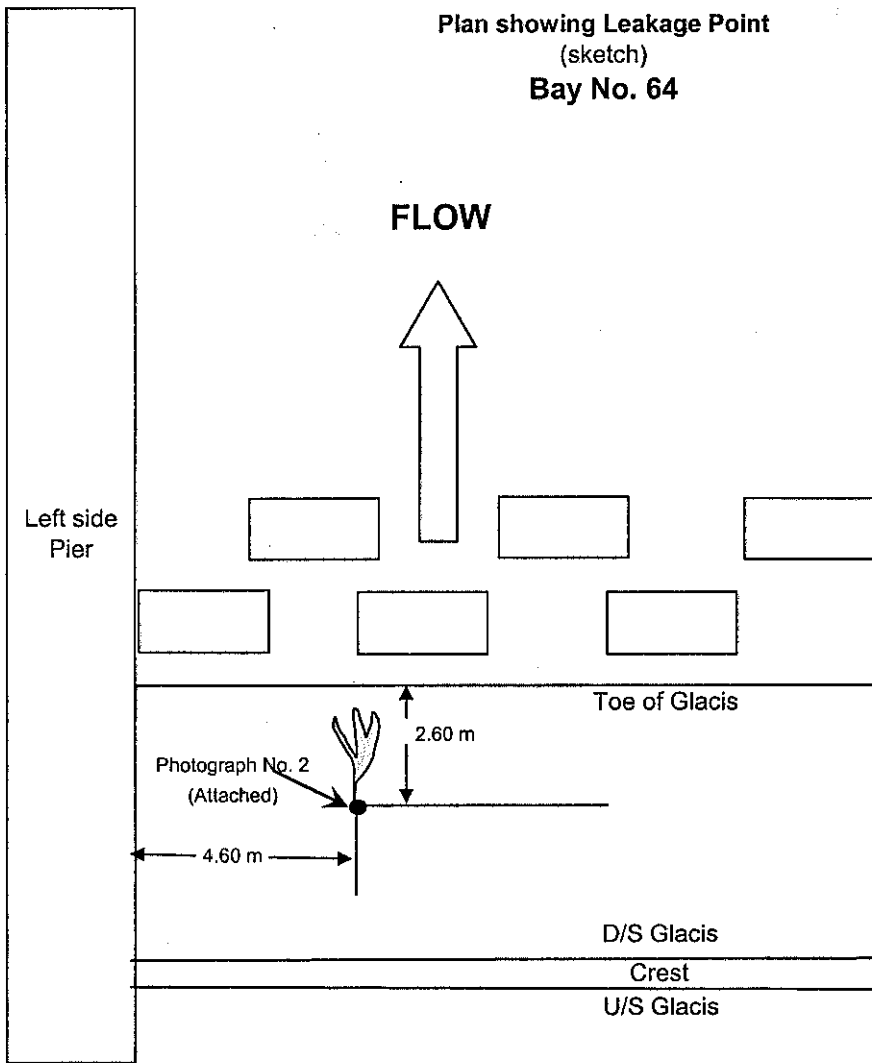
Ref No; Point No.03	Survey date: 14-01-2004
<p>Location.</p> <p>D/S of 64th Gate/Bay from left side. (Position diagram).</p> <p>Given below.</p>	<p>Outline of damage.</p> <p>Water Leakage from the surface of D/S repaired glacis.</p>

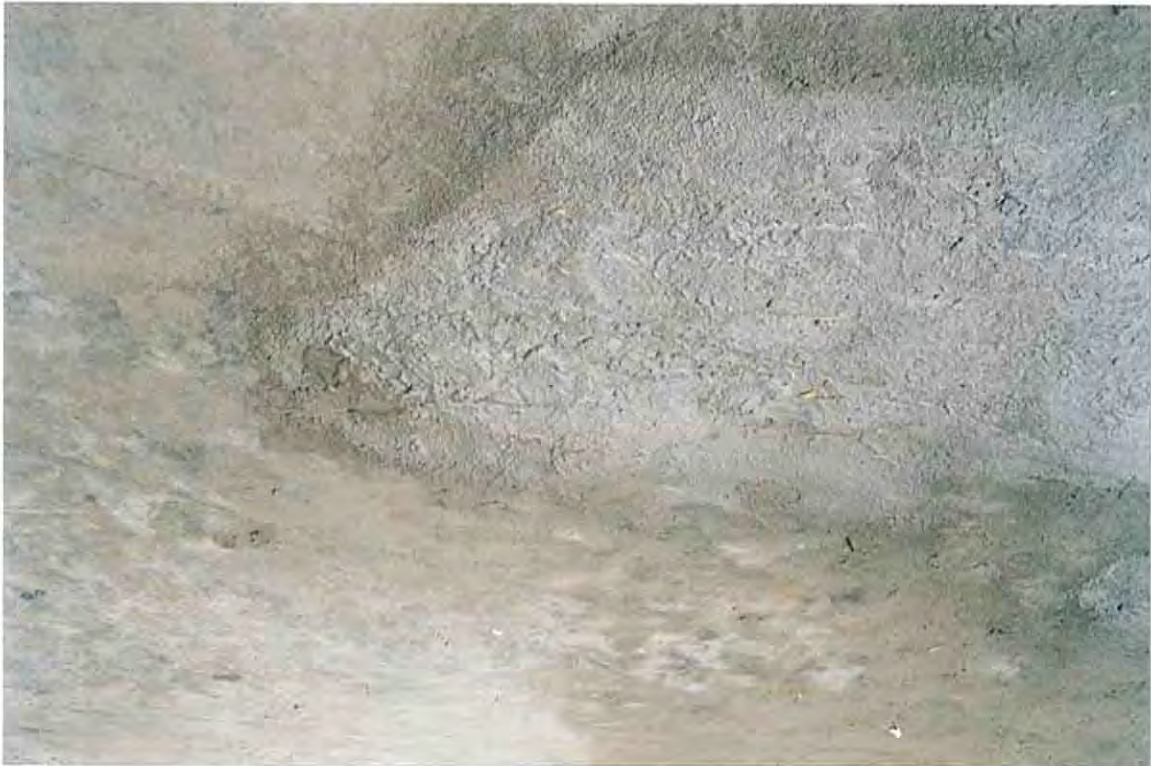
Photograph No. 02

Water leakage from the surface of repaired D/S glacis

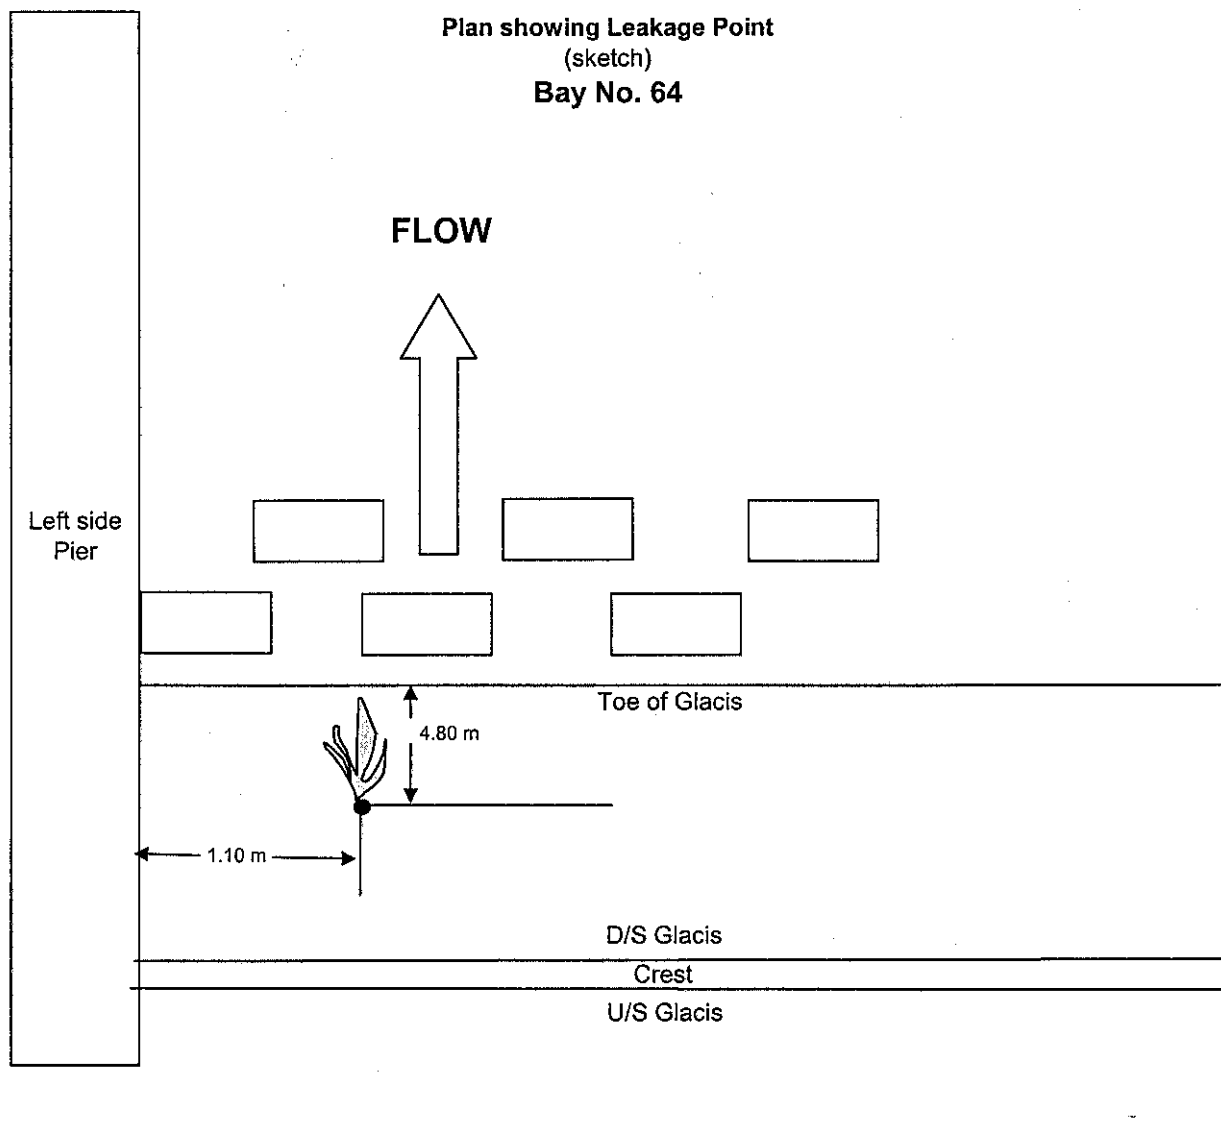
Ref No; Point No.04	Survey date: 14-01-2004
Location. D/S of 64th Gate/Bay from left side. (Position diagram). Given below.	Outline of damage. Water Leakage from the surface of repaired downstream glacis

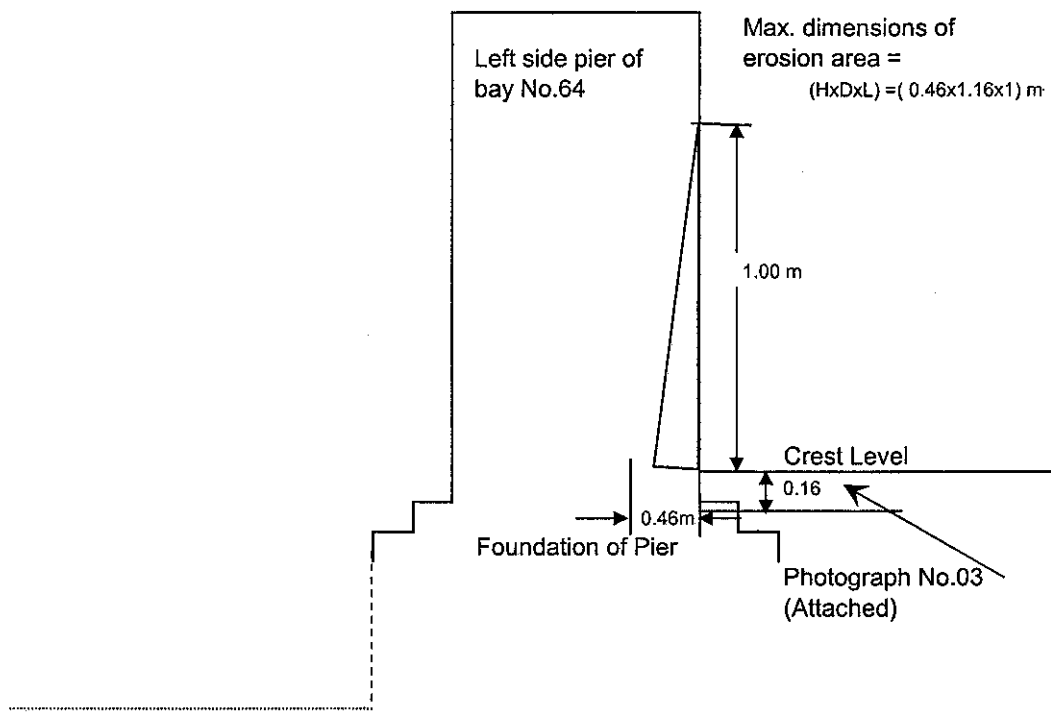
**Section showing erosion of Pier near its bottom.
(Sketch)
Bay No. 64**

Ref No; Point No.05	Survey date: 14-01-2004
<p>Location.</p> <p>D/S of 64th Gate/Bay from left side. (Position diagram).</p> <p>Given below.</p>	<p>Outline of damage.</p> <p>Erosion of Pier due to high velocity flow passing down below the gates.</p>

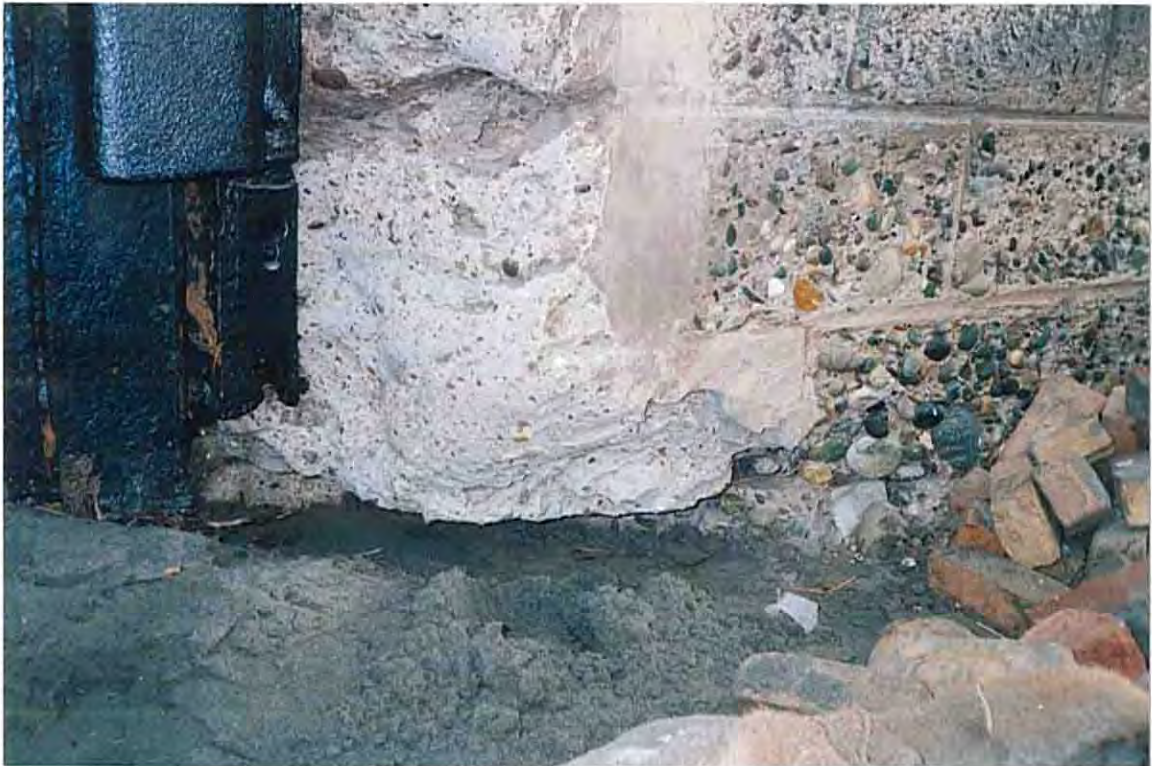
Photograph No. 03

Erosion of due to high velocity flow passing down below the gate.

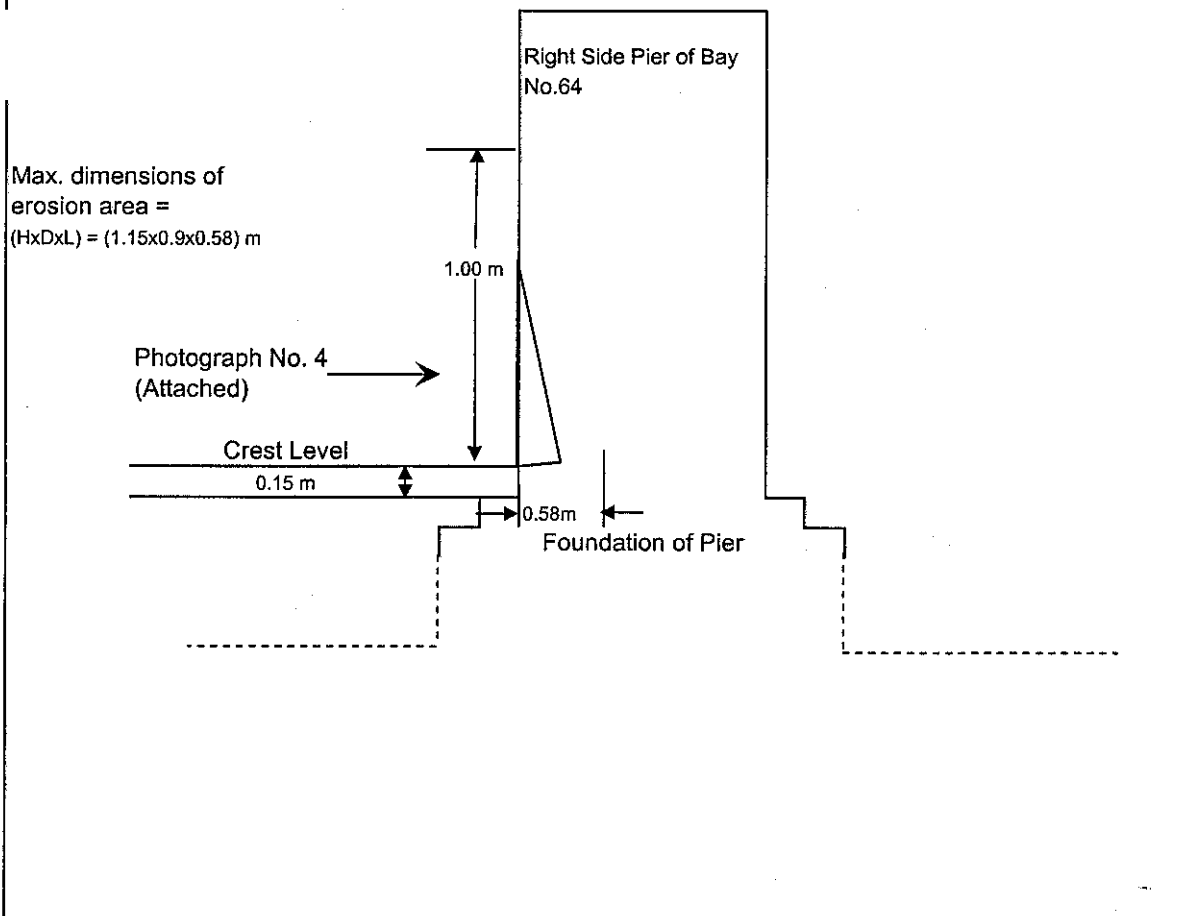
**Section showing Erosion of Pier near its Bottom
(Sketch)
Bay No. 64**

Ref No; Point No.06	Survey date: 14-01-2004
<p>Location.</p> <p>D/S of 64th Gate/Bay from left side. (Position diagram).</p> <p>Given below.</p>	<p>Outline of damage.</p> <p>Erosion of Pier due to high velocity flow passing down below the gates.</p>
