ANNEX. II

FORMATS OF DAMAGE CONDITIONS

BAY NO. 65

FORMATS OF DAMAGE CONDITIONS-BAY NO. - 65

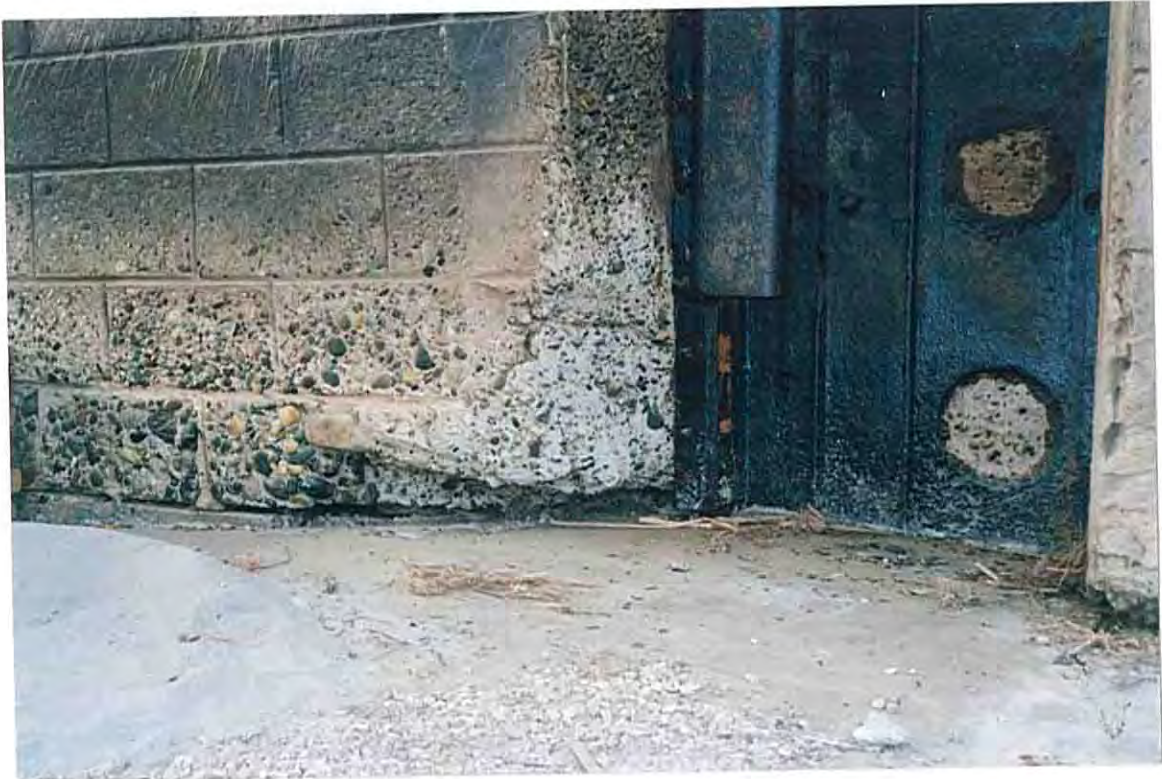
Photograph No. 04

Erosion of due to high velocity flow passing down below the gate.

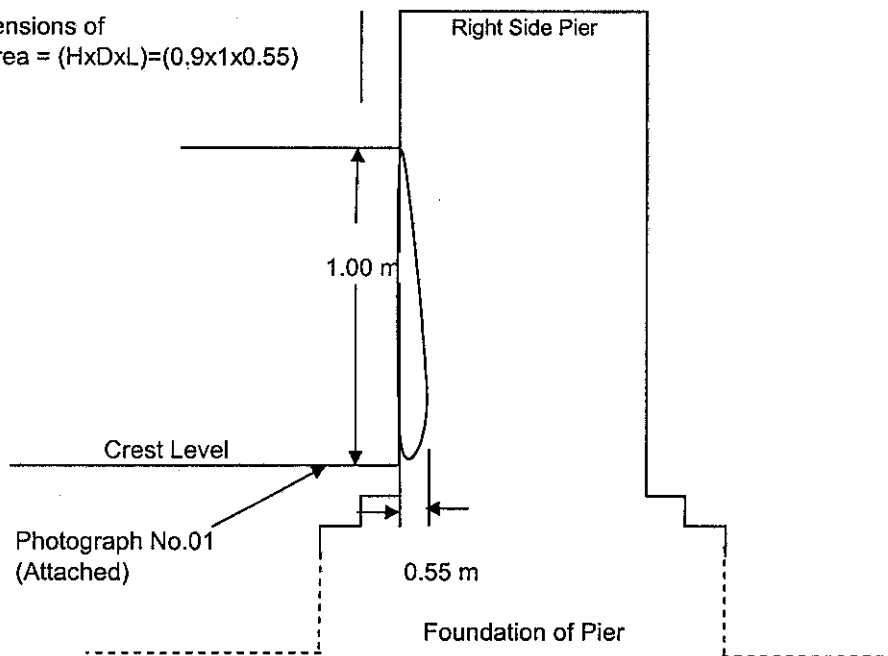
**Section showing Erosion of Pier near its Bottom
(Sketch)
Bay No; 63**

Ref No; Point No;01	Survey date: 14-01-2004
Location. D/S of 63rd Gate/Bay from left side. (Position diagram). Given below.	Outline of damage. Erosion of Pier due to high velocity flow passing down below the gates.

Max. dimensions of erosion area = (HxDxL)=(0.9x1x0.55)

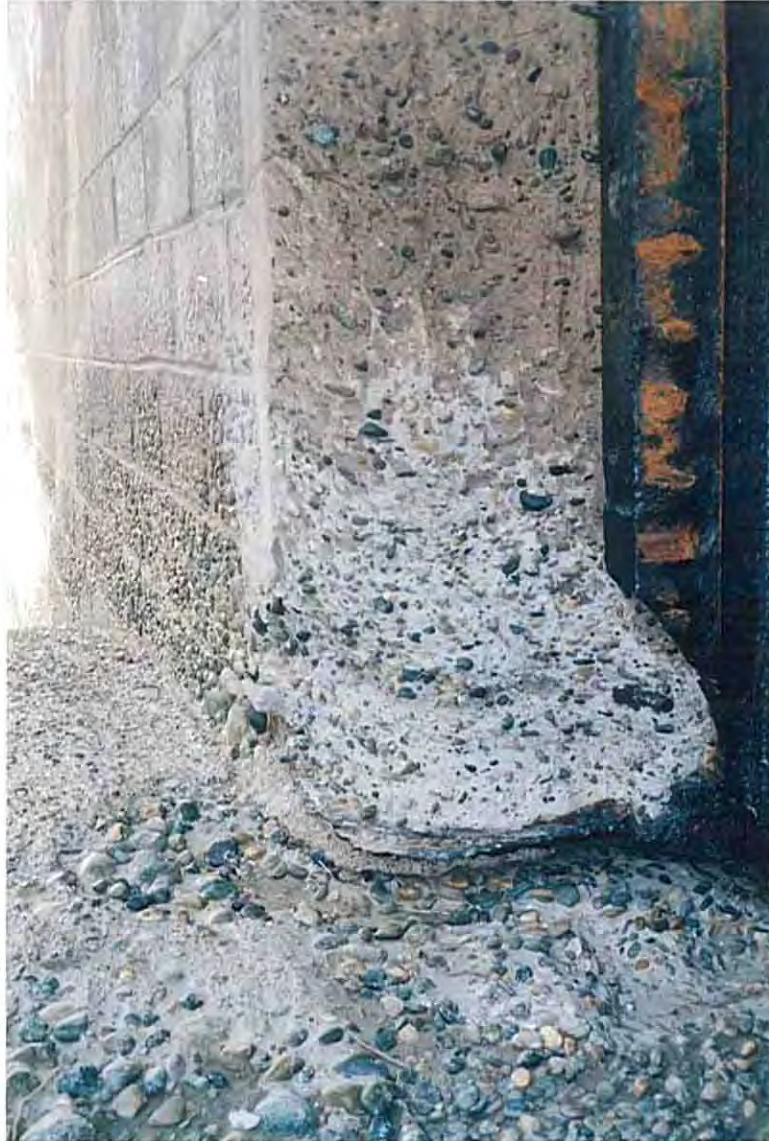
Photograph No. 01

Erosion of piers due to high velocity flow passing down below the gates

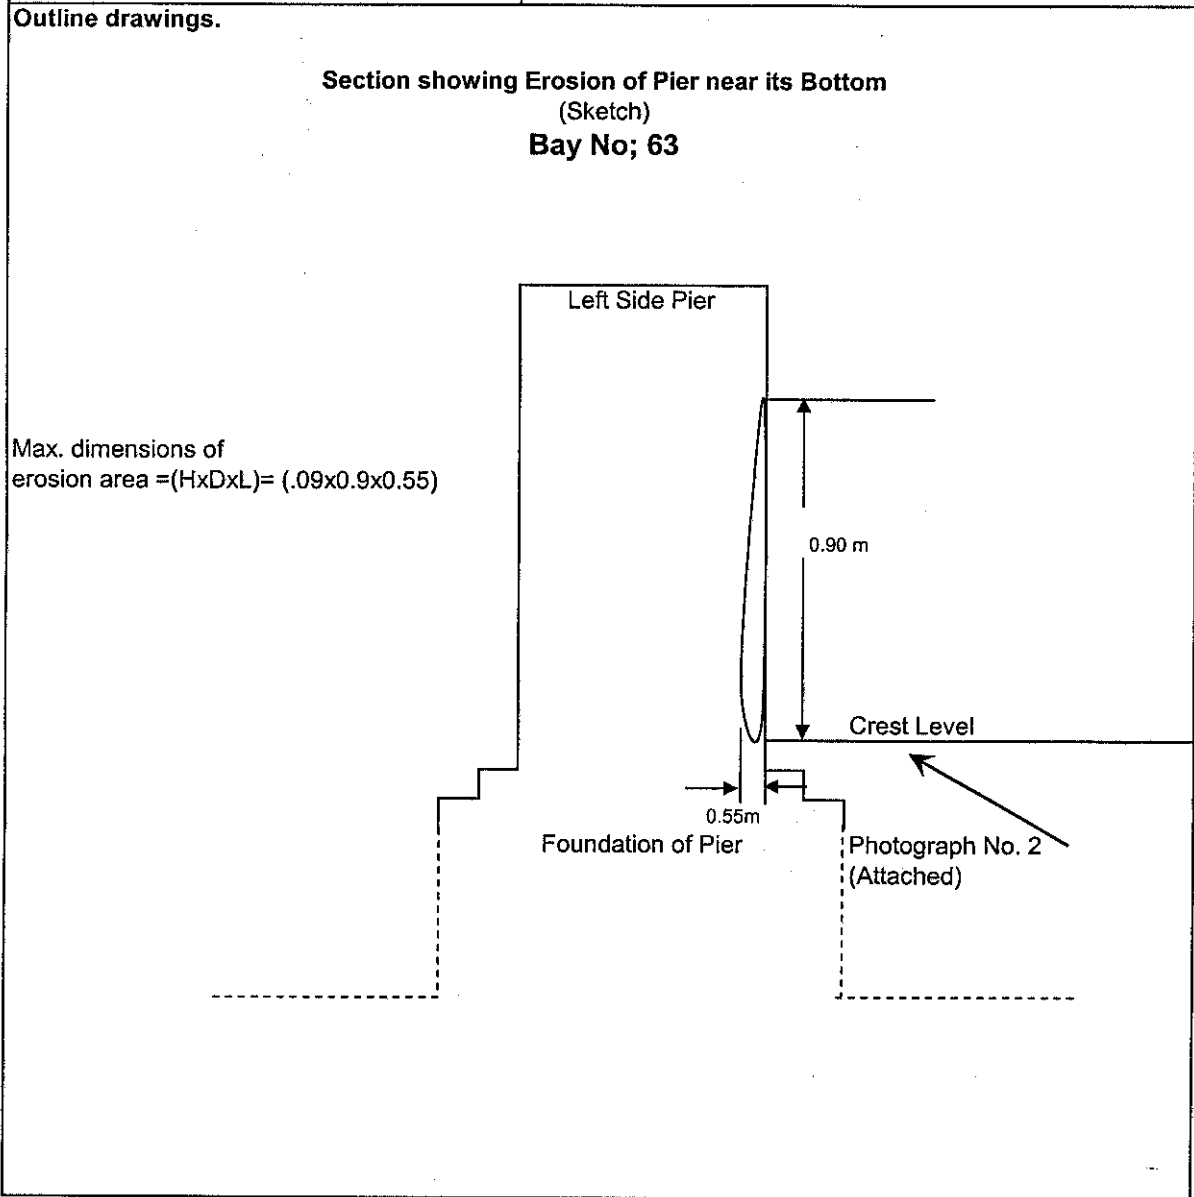
Ref No; Point No;02	Survey date: 14-01-2004
Location. D/S of 63rd Gate/Bay from left side. (Position diagram). Given below.	Outline of damage. Erosion of Pier due to high velocity flow passing down below the gates.

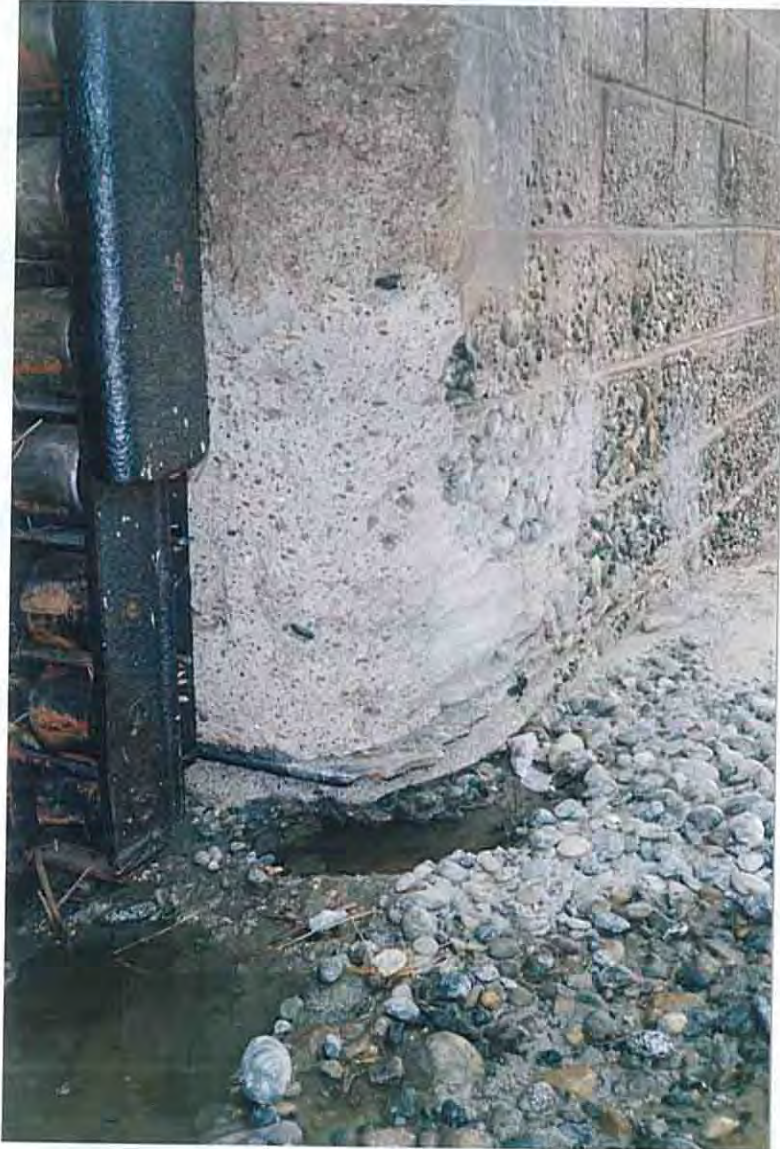
Photograph No. 02

Erosion of piers due to high velocity flow passing down below the gates

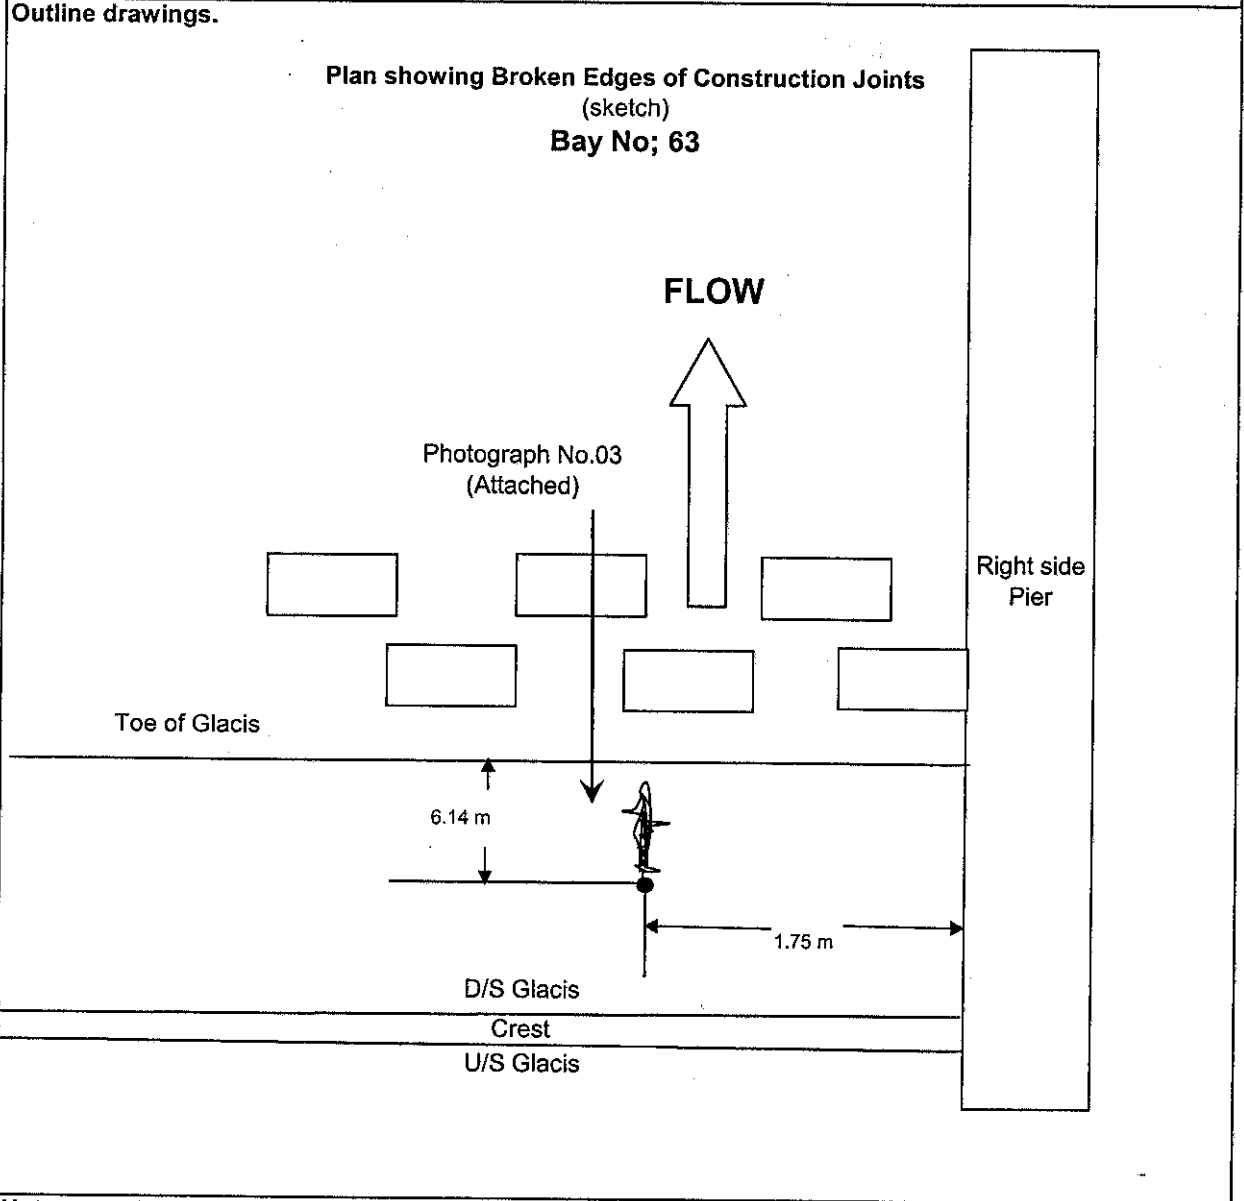
Ref No; Point No;03	Survey date: 14-01-2004
<p>Location.</p> <p>D/S of 63rd Gate/Bay from left side. (Position diagram).</p> <p>Given below.</p>	<p>Outline of damage.</p> <p>Broken Edges of Construction Joint in the Floor - at the Location shown below.</p>

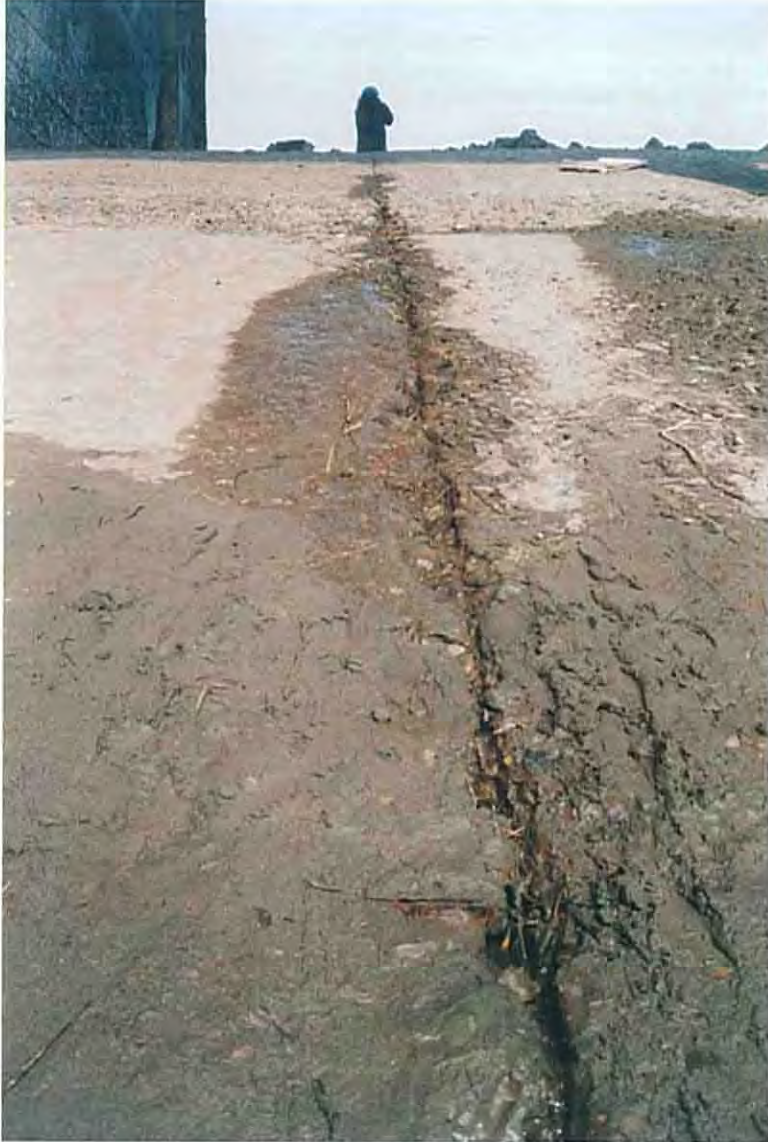
Photograph No. 03

Seeping water from construction joints of D/S glacis

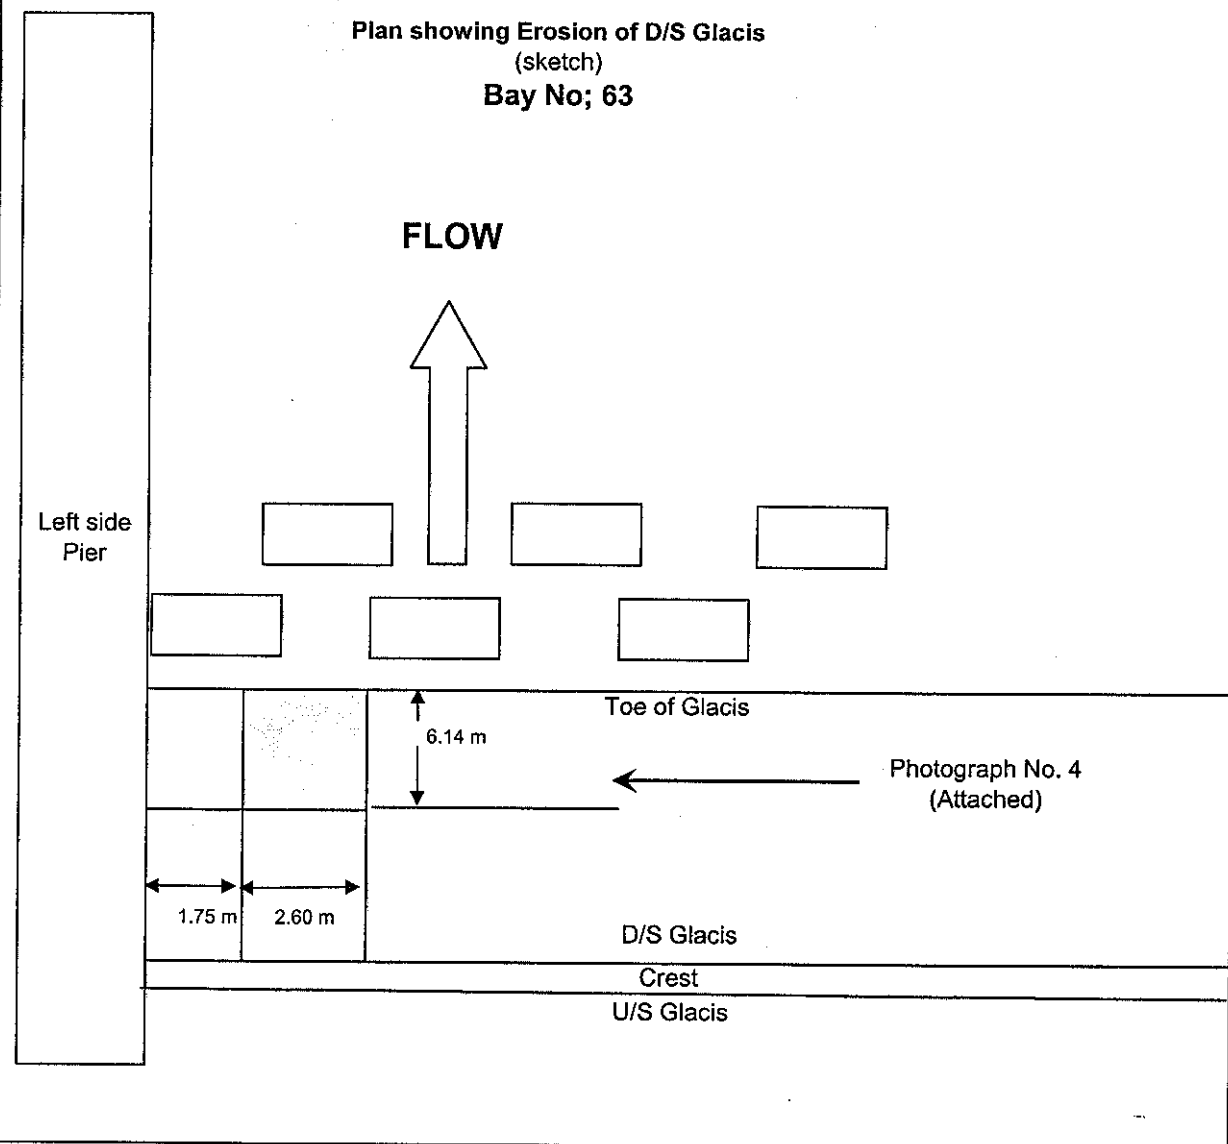
Ref No; Point No;04	Survey date: 14-01-2004
Location. D/S of 63rd Gate/Bay from left side. (Position diagram). Given below.	Outline of damage. Erosion of D/S Glacis Surface due to High Velocity Flow at the location shown below:

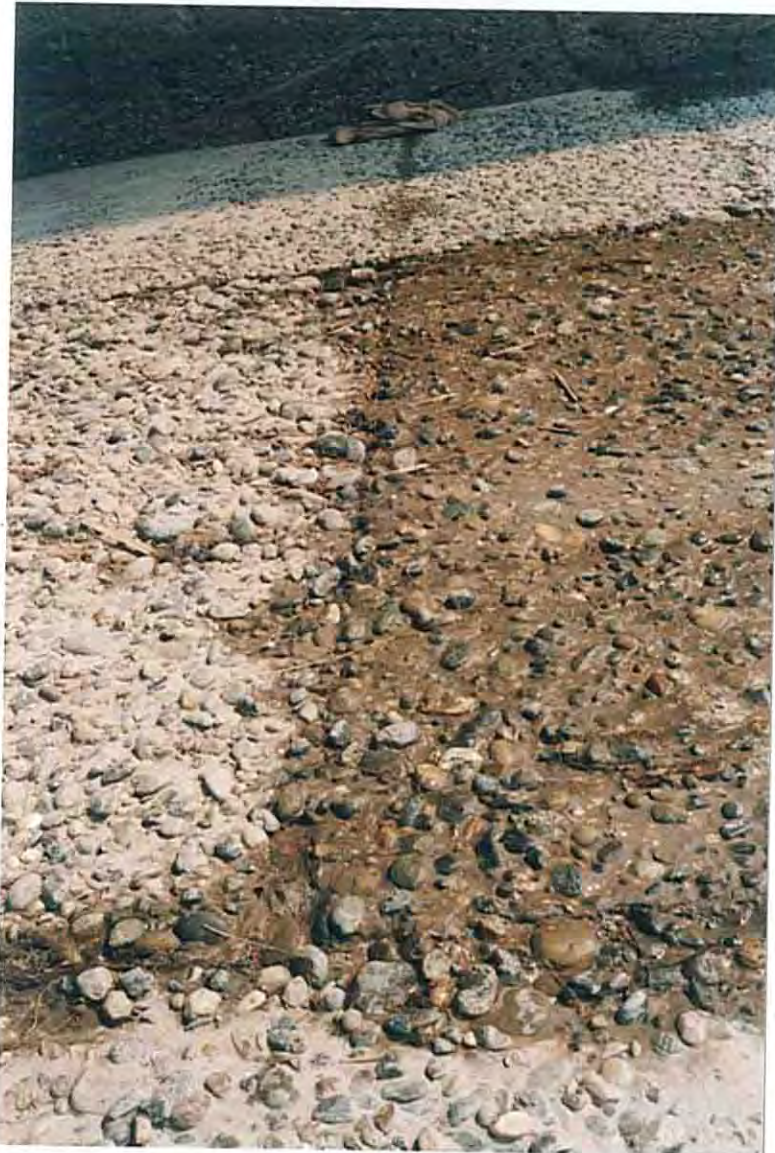
Photograph No. 04

Erosion of D/S glacis due to high velocity flow and Broken construction joints.

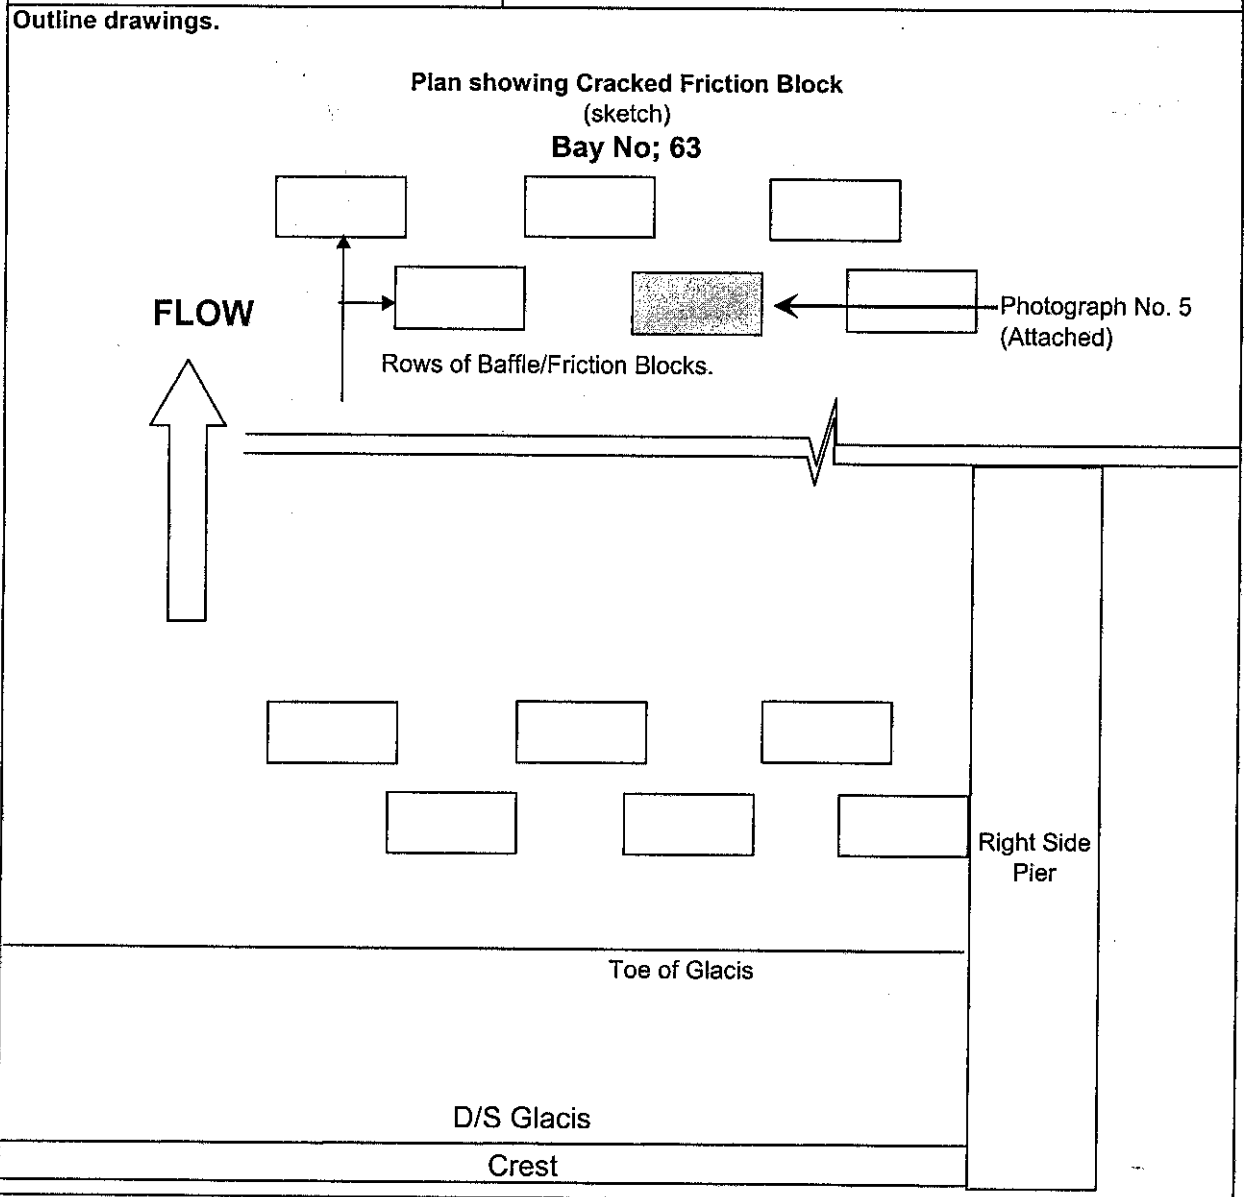
Ref No; Point No;05	Survey date: 14-01-2004
<p>Location.</p> <p>D/S of 63rd Gate/Bay from left side. (Position diagram). Given below.</p>	<p>Outline of damage.</p> <p>Uprooting/Cracking of Friction/Baffle Block due to un-dissipated energy of high-velocity jet (under conditions of excessive retrogression on the D/S side) - at the location shown below:-</p>

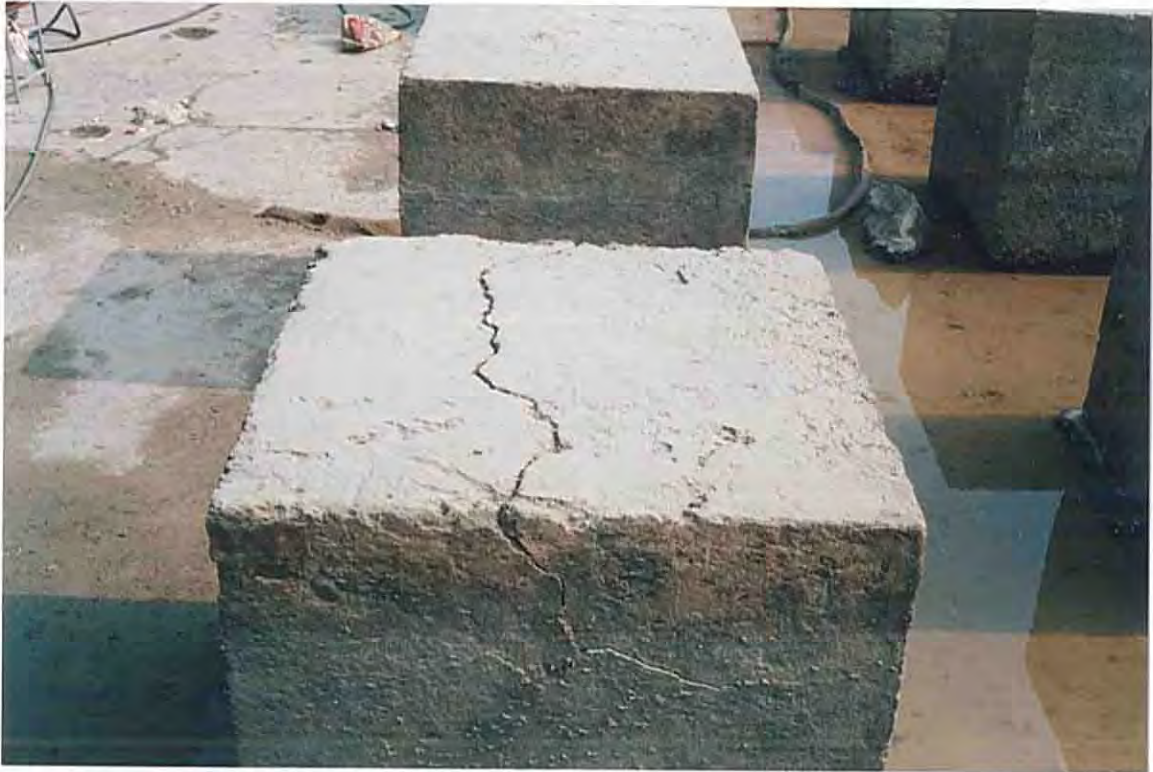
Photograph No. 05

Uprooting/damage to the friction/baffle blocks due to undissipated energy of high velocity
(under condition of excessive retrogression on the D/S side)

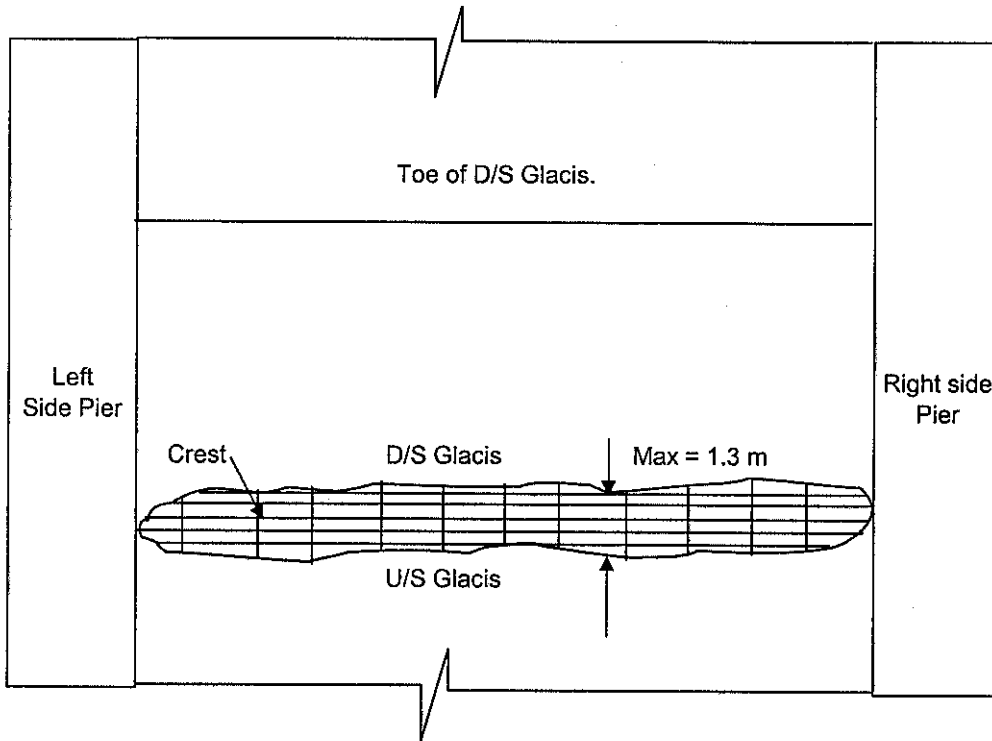
**Plan showing area at the Crest
(sketch)
Bay No; 63**

Ref No; Point No;06	Survey date: 14-01-2004
<p>Location.</p> <p>D/S of 63rd Gate/Bay from left side. (Position diagram). Given below.</p>	<p>Outline of damage.</p> <p>Due to High Velocity flow the skin concrete at the Crest is eroded and reinforcement steel is exposed.</p>

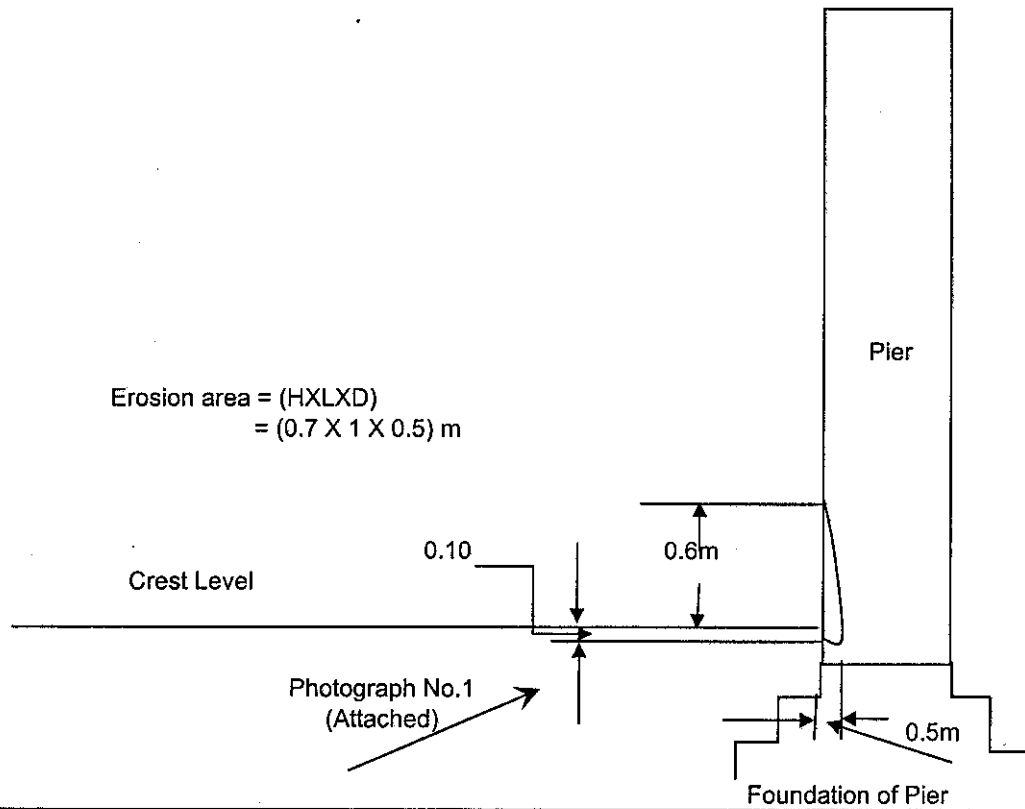
Section showing erosion of Pier near its bottom
 (sketch)
Bay No. 62

Ref No. Point No.01	Survey date: 14-01-2004
Location. D/S of 62nd Gate/Bay from left side. (Position diagram). Given below.	Outline of damage. Erosion of Piers due to high velocity flow near its bottom.

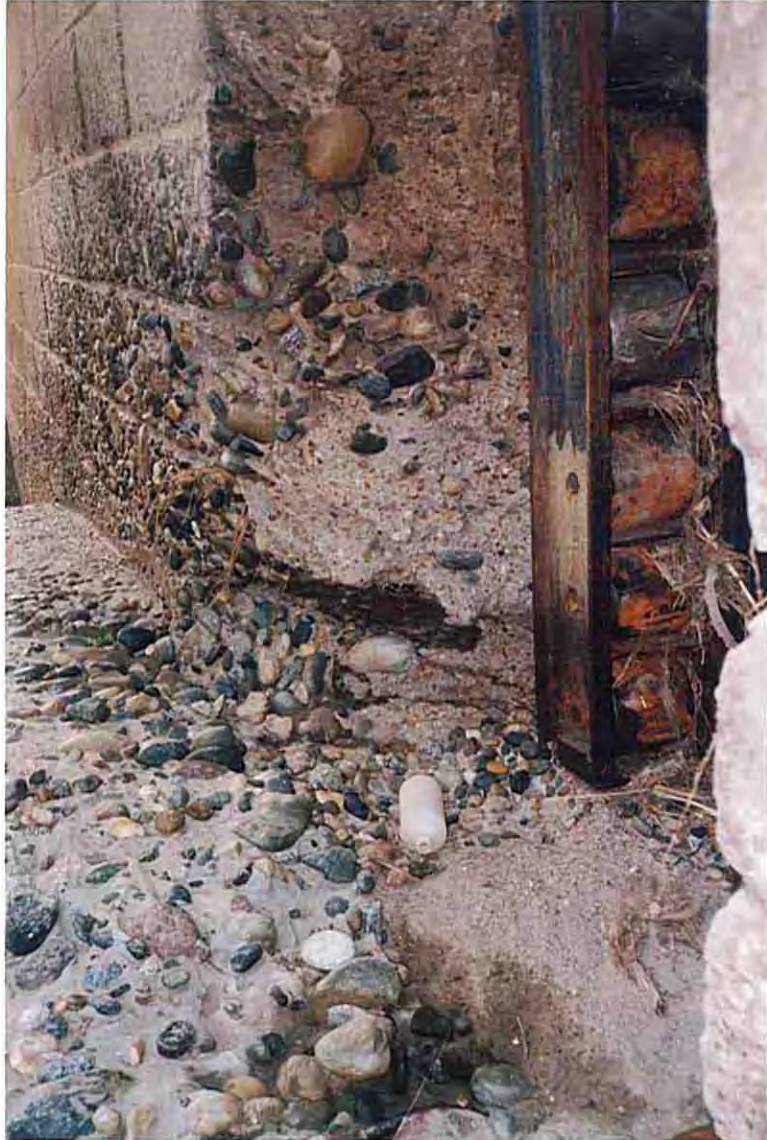
Photograph No. 01

Bay No. 62
Erosion of Pier
Due to high velocity flow
near its bottom

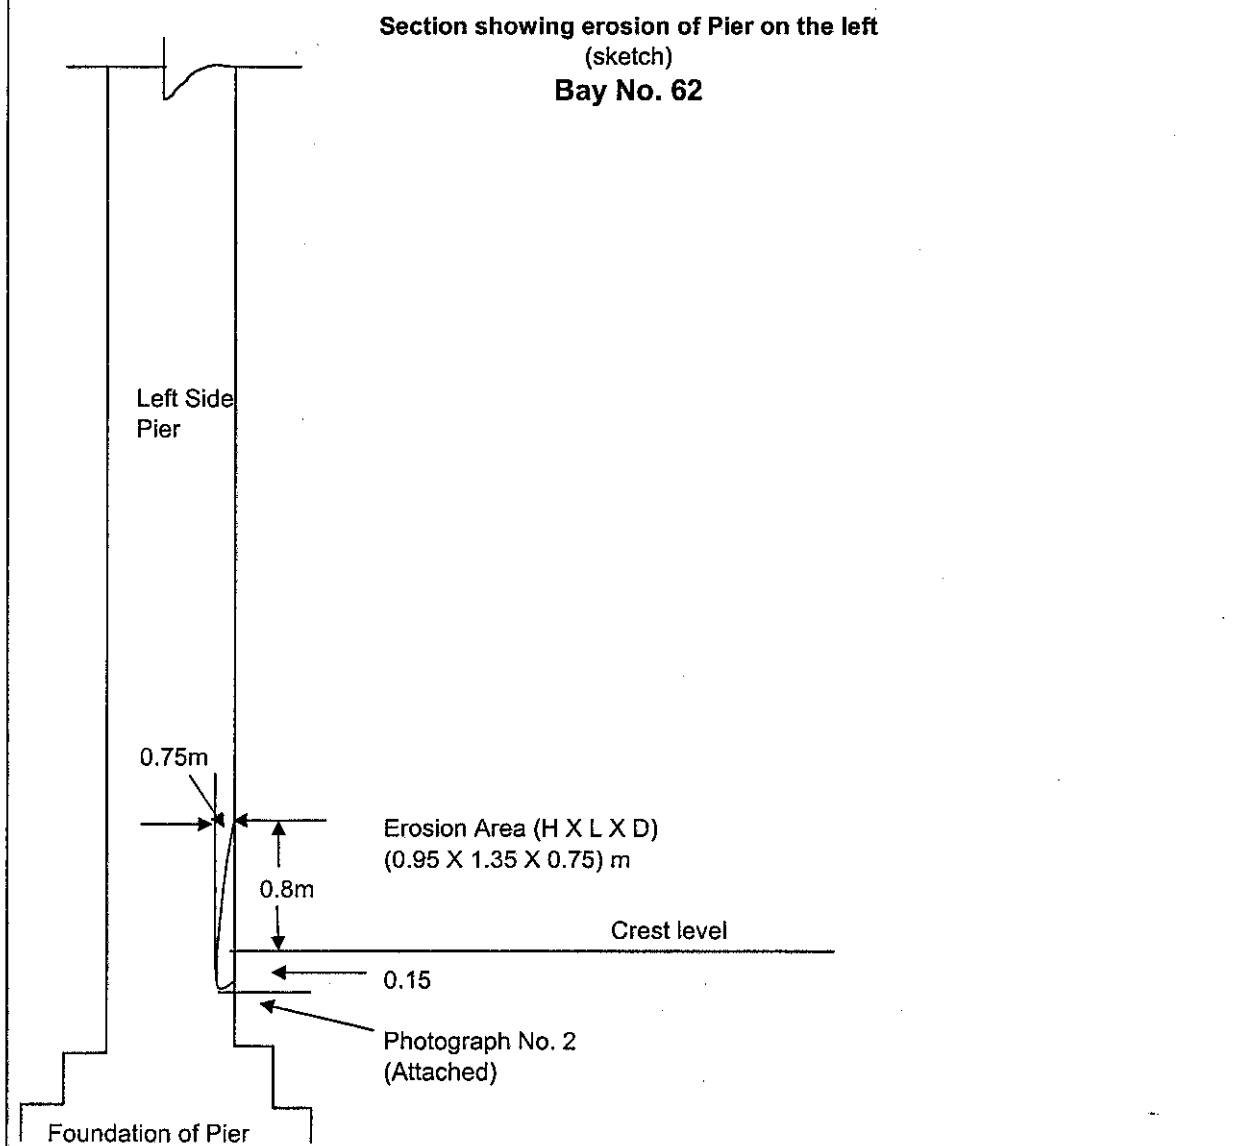
Ref No; Point No.02	Survey date: 14-01-2004
Location. D/S of 62nd Gate/Bay from left side. (Position diagram). Given below.	Outline of damage. Erosion of Pier due to high velocity flow near its bottom

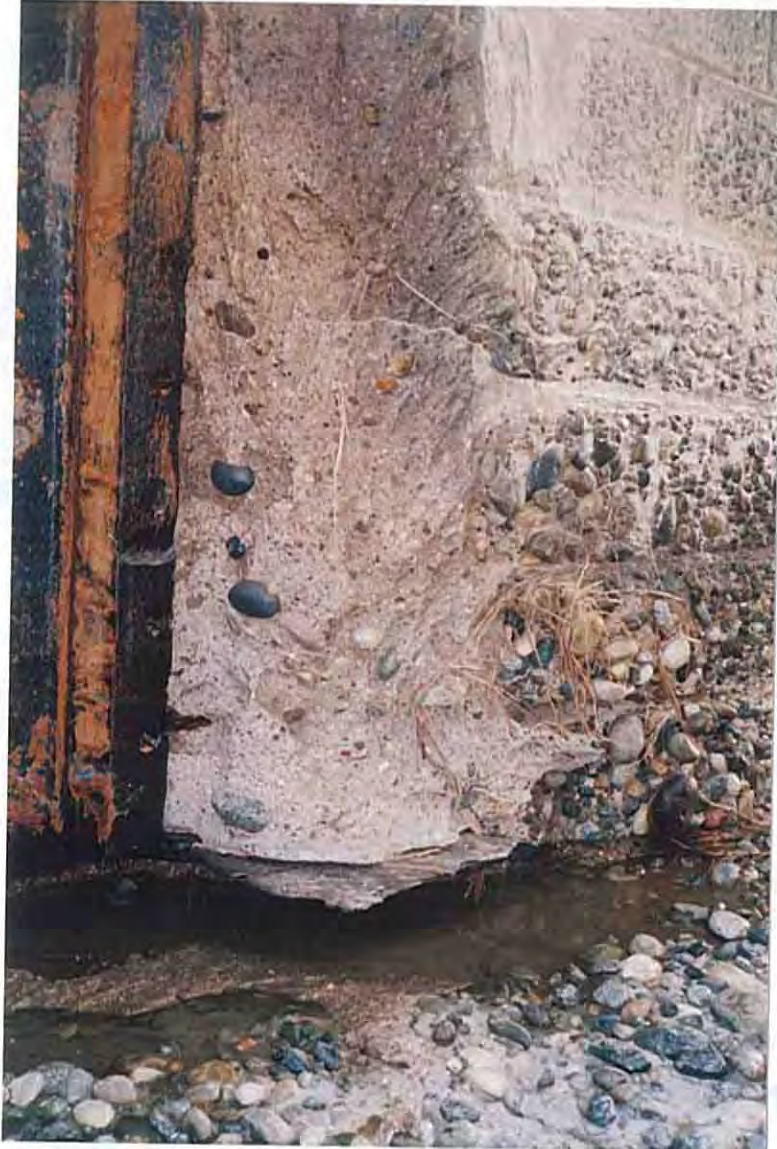
Photograph No. 02

Bay No. 62
Erosion of pier
due to high velocity flow
near its bottom

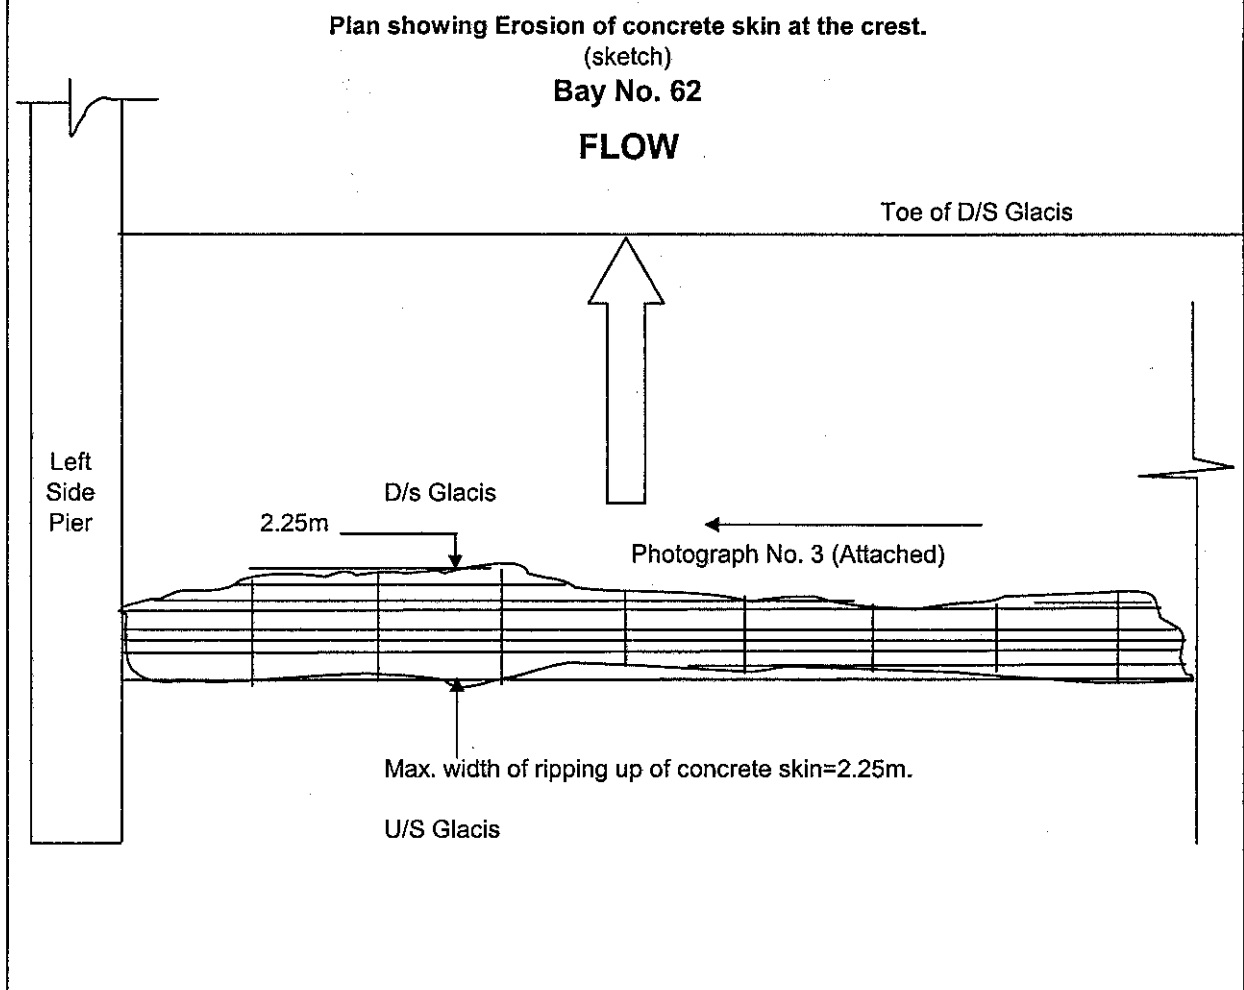
Ref No: Point No.03	Survey date: 14-01-2004
Location. D/S of 62nd Gate/Bay from left side. (Position diagram). Given below.	Outline of damage. Erosion of concrete skin at crest, exposing reinforcement across almost entire width of Bay

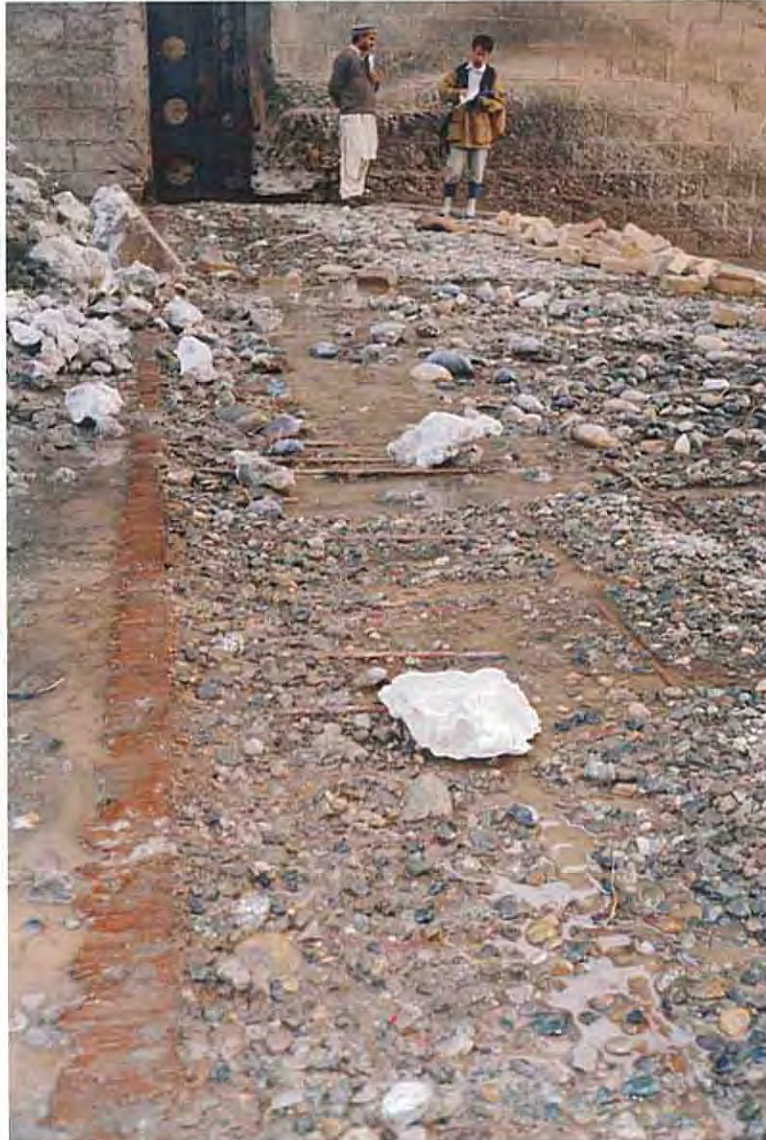
Photograph No. 03

Bay No. 62
Erosion of concrete
skin at the crest

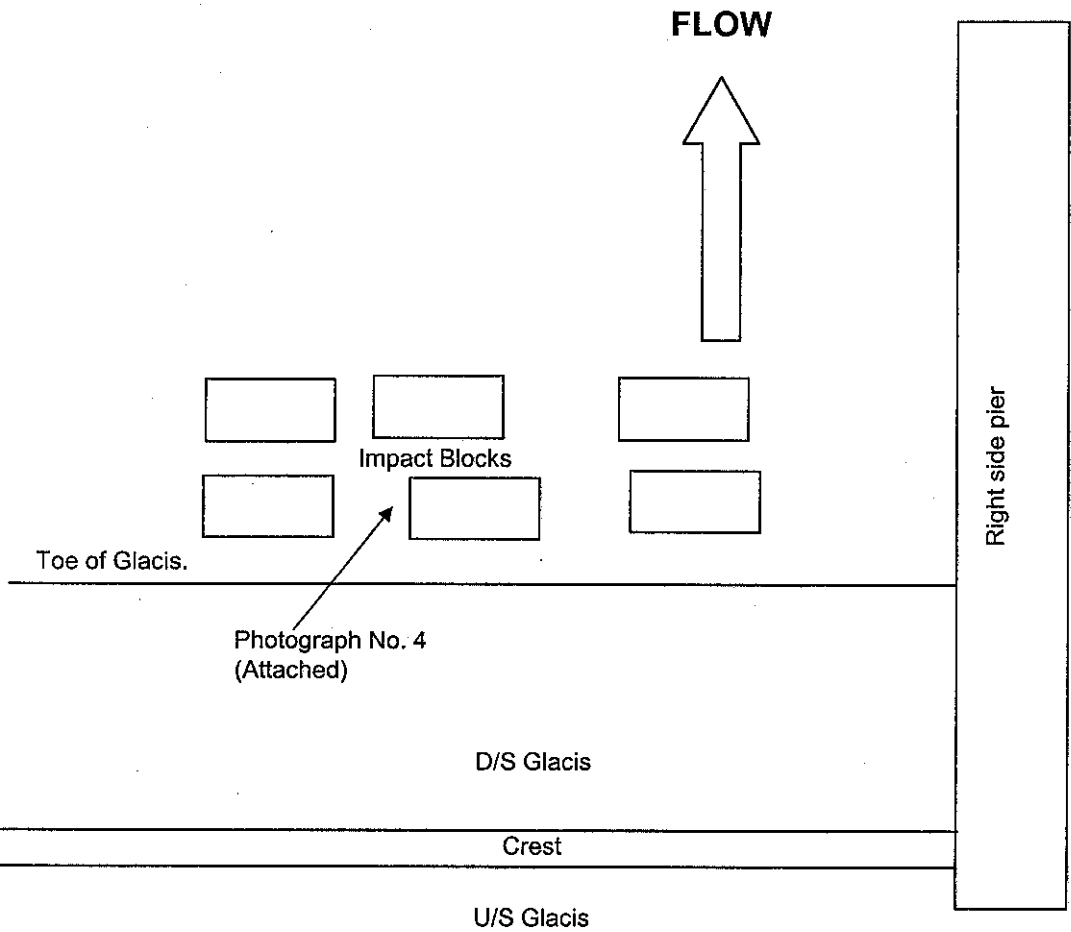
**Plan showing erosion of impact Blocks
(sketch)
Bay No. 62**

Ref No. Point No. 04	Survey date: 14-01-2004
<p>Location.</p> <p>D/S of 62nd Gate/Bay from left side. (Position diagram).</p> <p>Given below.</p>	<p>Outline of damage.</p> <p>Erosion of Impact Blocks due to high velocity flow with undissipated energy (as a result of excessive retrogression on the D/S side) - at the location shown below:-</p>

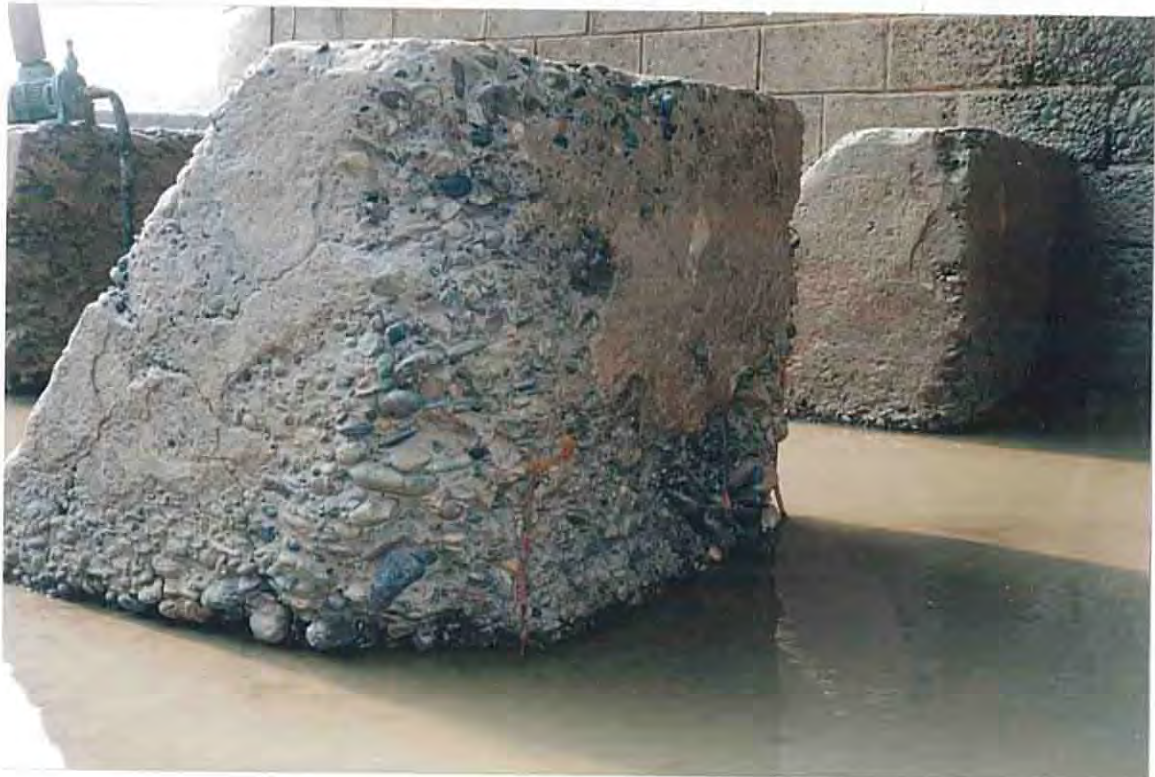
Photograph No. 04

Bay No. 62
Erosion of impact blocks

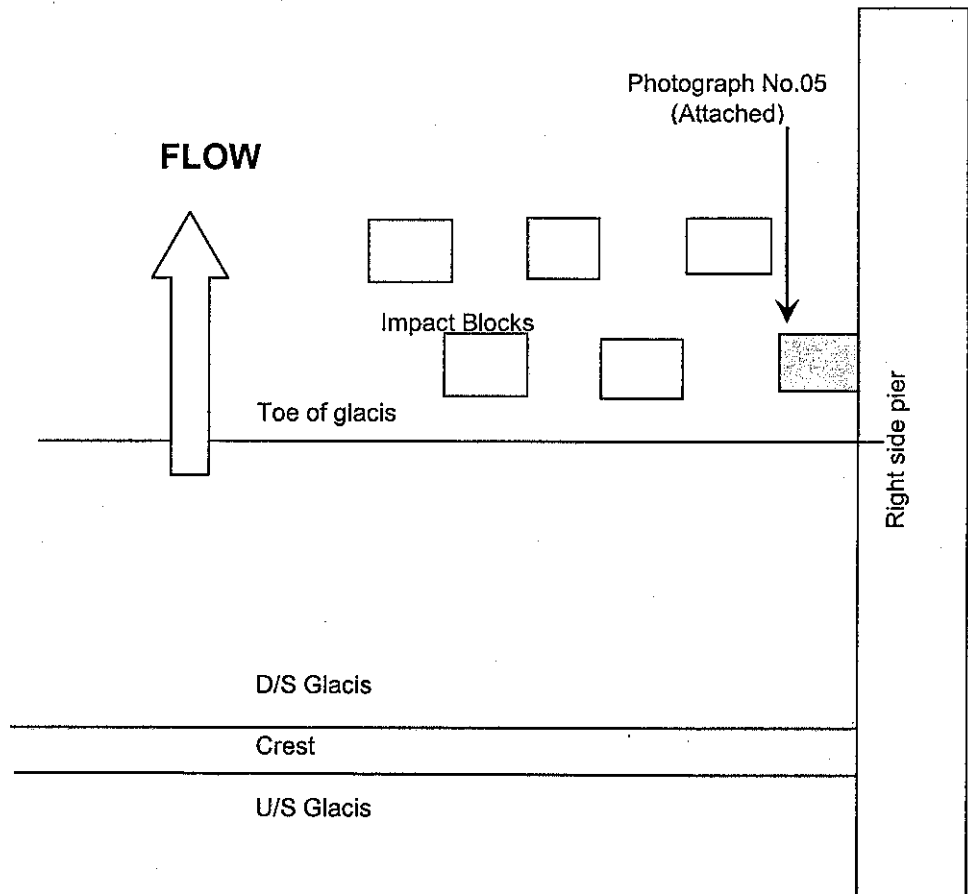
Plan showing erosion of impact blocks.
 (Sketch)
Bay No. 62

Ref No. Point No. 05	Survey date: 14-01-2004
<p>Location.</p> <p>D/S of 62nd Gate/Bay from left side. (Position diagram).</p> <p>Given below.</p>	<p>Outline of damage.</p> <p>Erosion of Impact Blocks due to high velocity flow with undissipated energy (as a result of excessive retrogression on the D/S side) - at the location shown below:-</p>
