ANNEX. II

FORMATS OF DAMAGE CONDITIONS

BAY NO. 65

FORMATS OF DAMAGE CONDITIONS-BAY NO. - 65

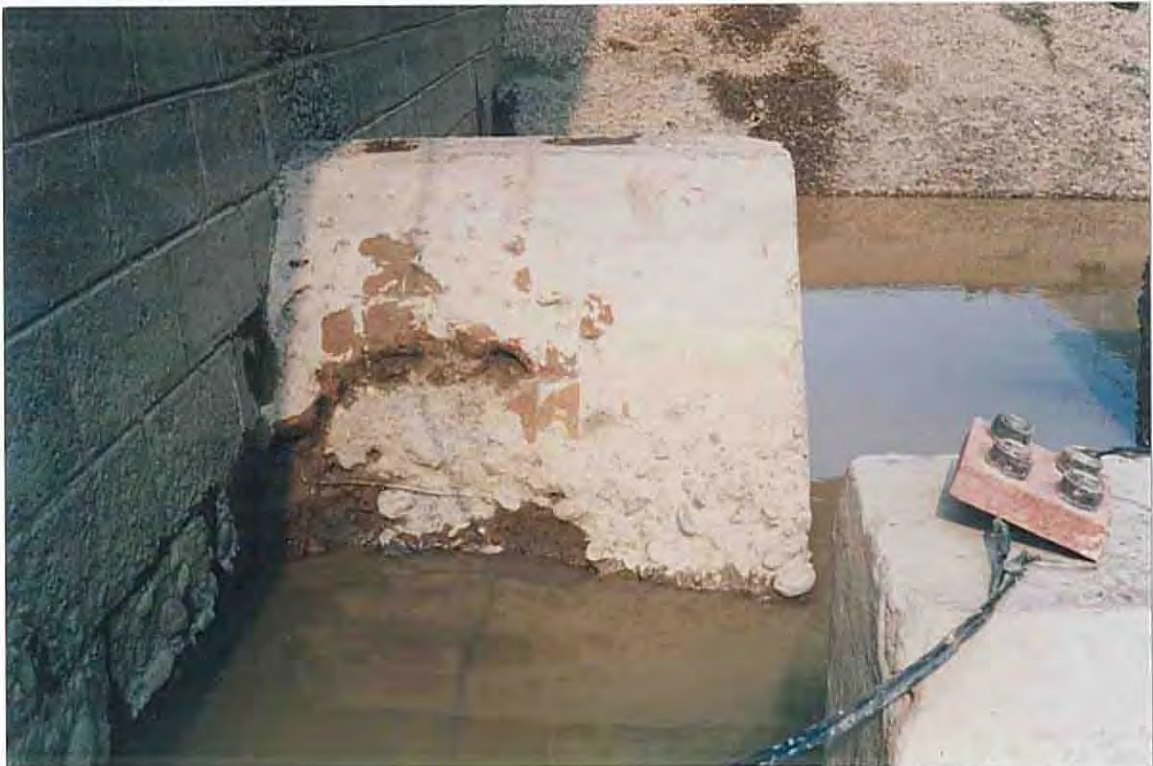
Photograph No. 05

Bay No. 62
Erosion of impact blocks
