ANNEX. VI

FORMATS OF DAMAGE CONDITIONS

FORMATS OF DAMAGE CONDITIONS-BAY NO. - 37

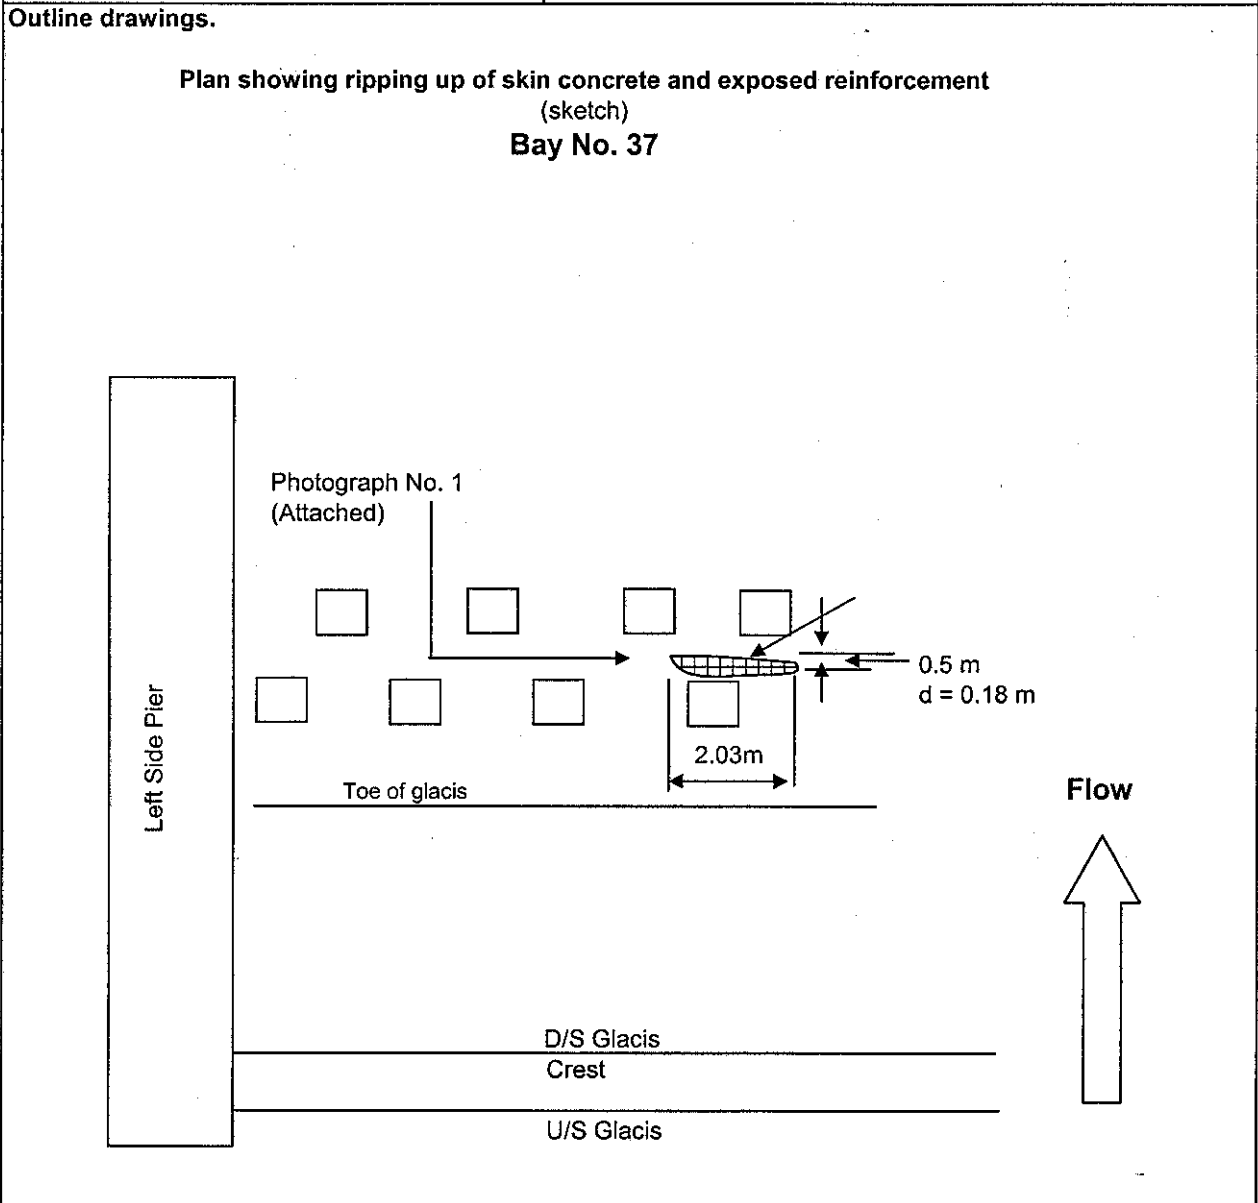
Ref No. Point No. 01	Survey date: 14-01-2004
Location. D/S of 37th Gate/Bay from left. (Position diagram). Given below.	Outline of damage. Ripping up of skin concrete and exposing the reinforcement

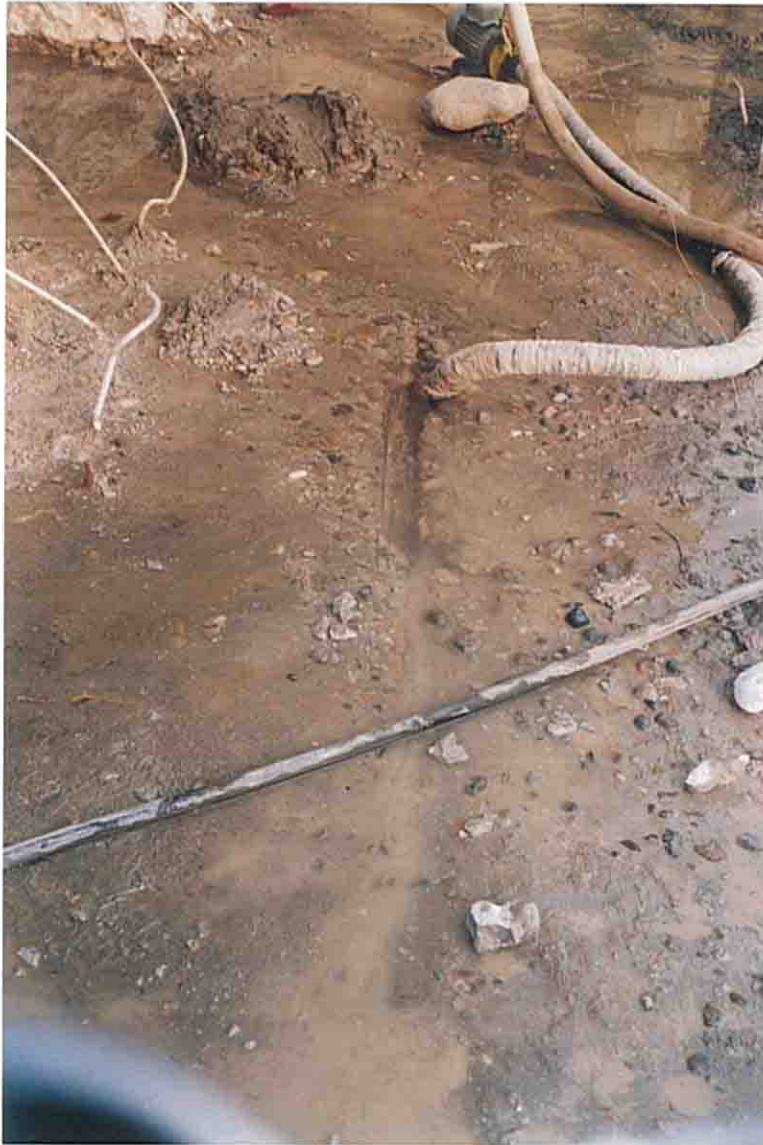
Photograph No. 01

Ripping up of skin concrete and
exposing the reinforcement

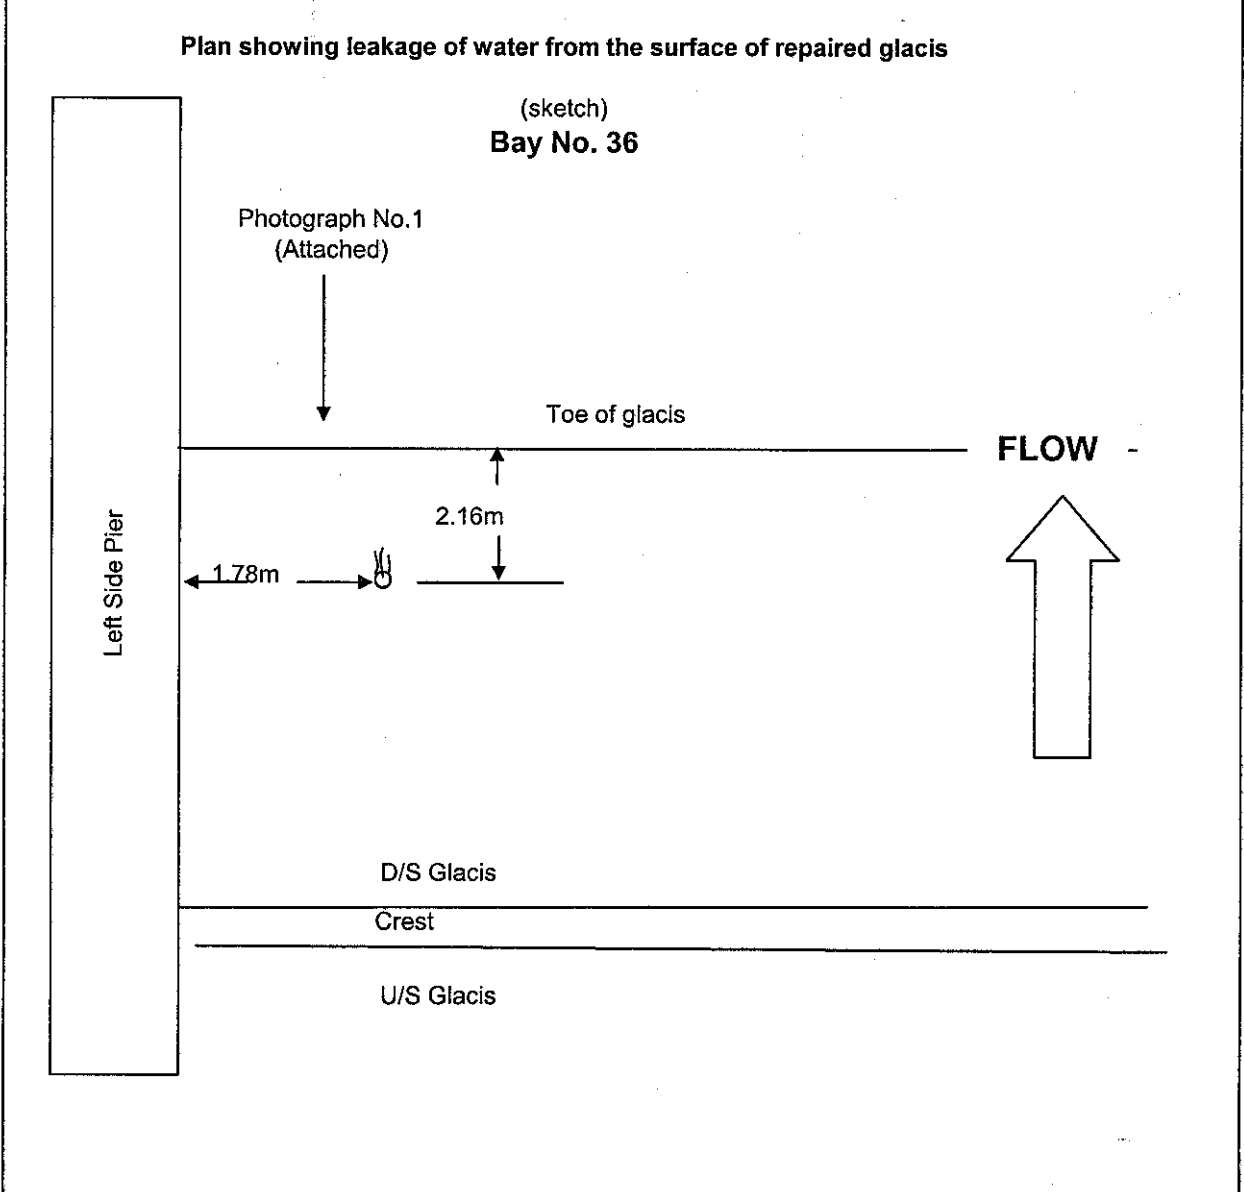
Outline drawings.

Ref No. Point No.01	Survey date: 14-01-2004
Location. D/S of 36th Gate/Bay from left (Position diagram). Given below	Outline of damage. Leakage of water from the repaired D/S glacis

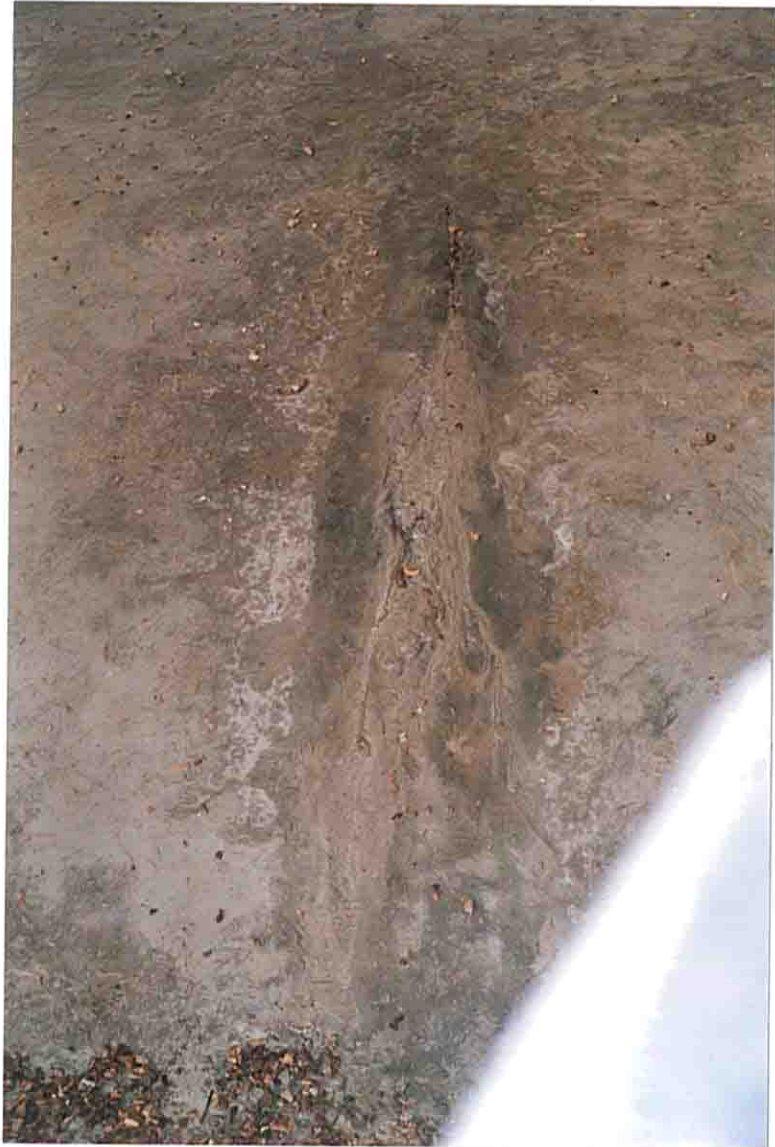
Photograph No. 01

Leakage of water from the repaired surface of D/S glacis

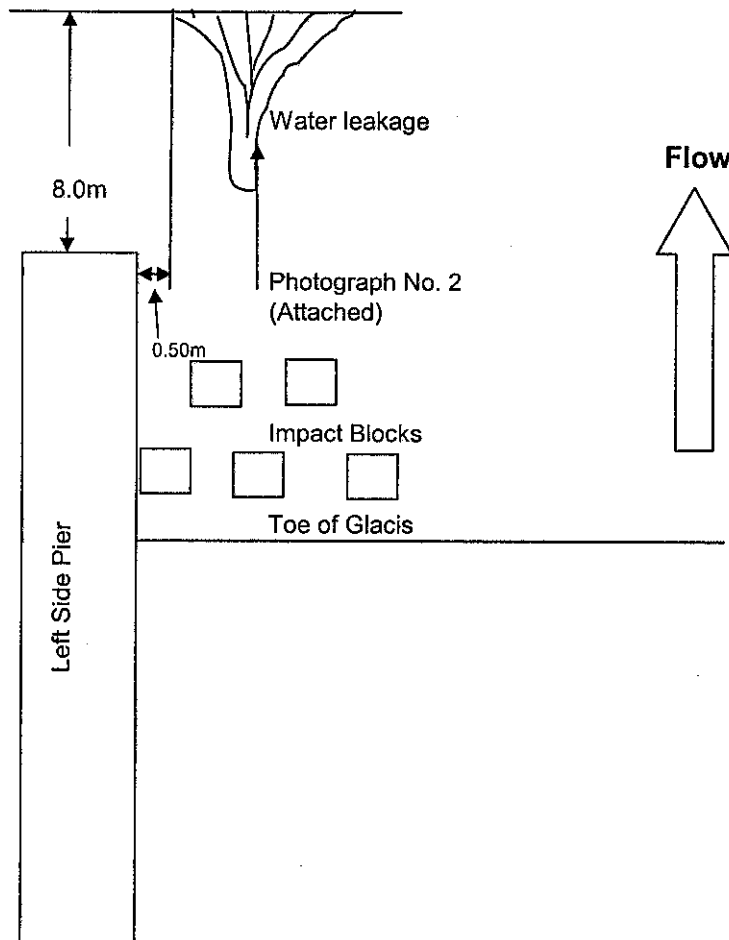
**Plan showing leakage of water from underneath the concrete floor of the stilling basin
(sketch)
Bay No. 36**

Ref No. Point No. 02	Survey date: 14-01-2004
<p>Location.</p> <p>D/S of 36th Gate/Bay from left (Position diagram).</p> <p>Given below.</p>	<p>Outline of damage.</p> <p>Leakage of water from underneath the concrete stilling basin</p>

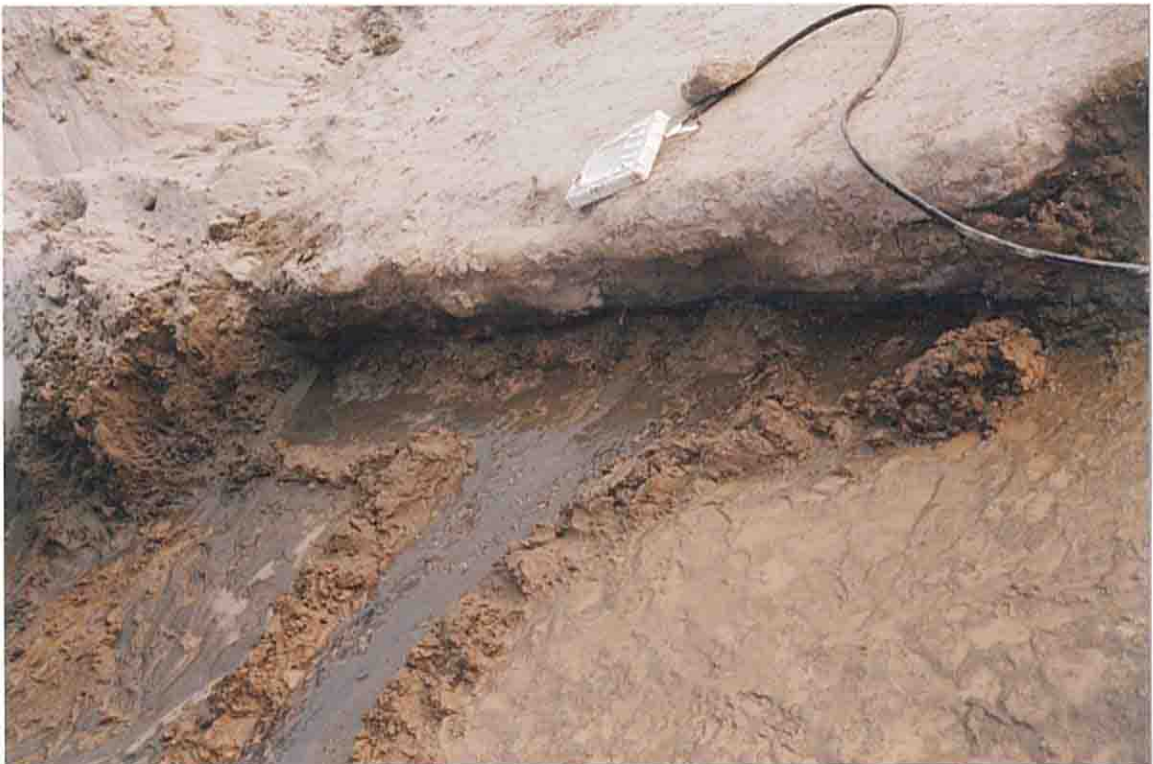
Photograph No. 02

Leakage of water from underneath
the concrete floor of the stilling basin

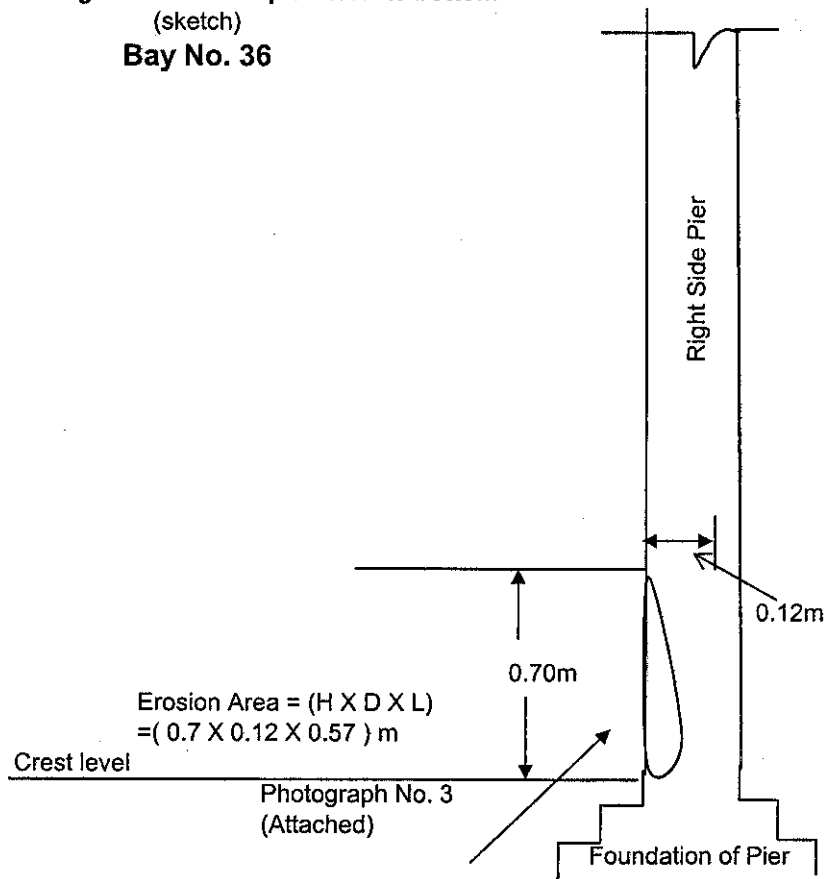
**Section showing the erosion of pier near its bottom
(sketch)
Bay No. 36**

Ref No. Point No.03	Survey date: 14-01-2004
<p>Location.</p> <p>D/S of 36th Gate/Bay from left side. (Position diagram).</p> <p>Given below.</p>	<p>Outline of damage.</p> <p>Erosion of Pier due to high velocity flow near its bottom.</p>

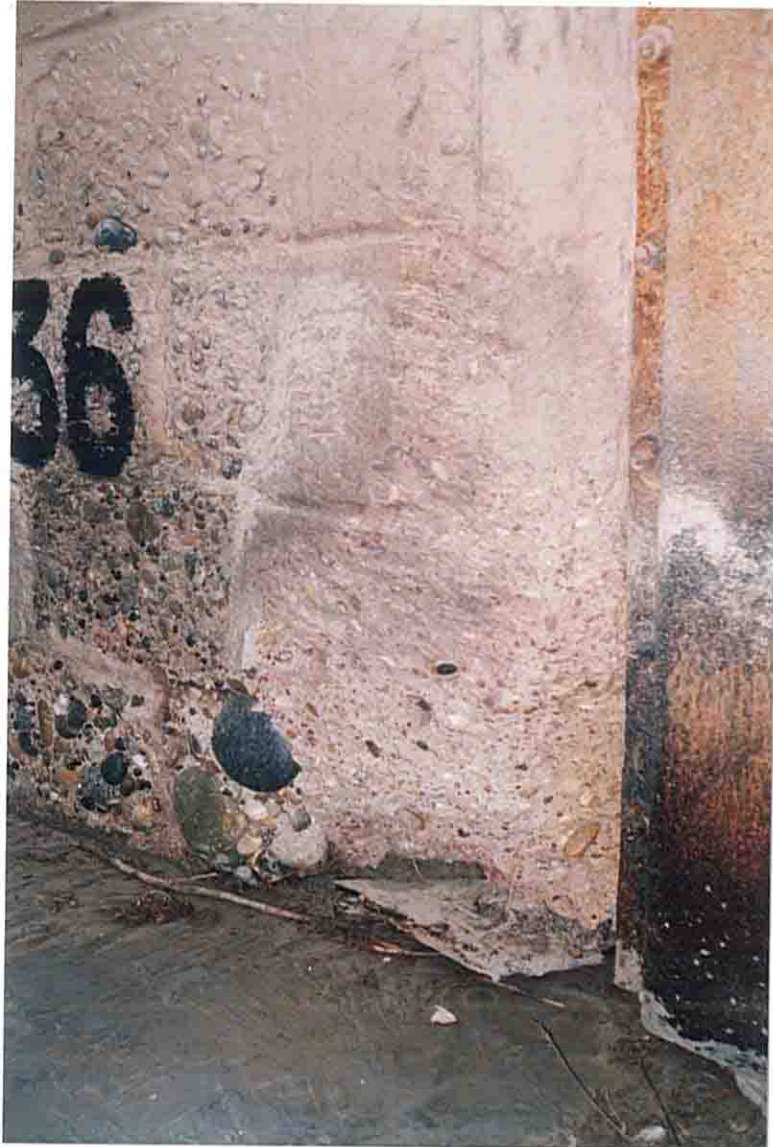
Photograph No. 03

Erosion of piers due the high velocity flow near its bottom

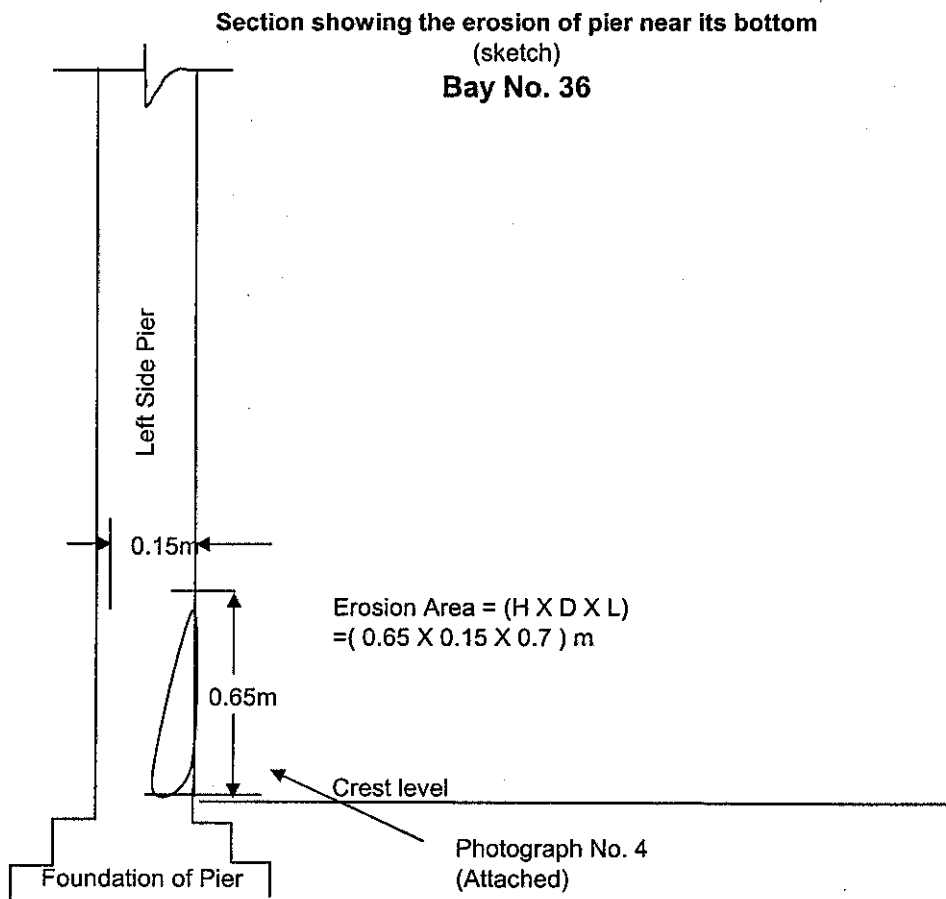
Outline drawings.

Ref No. Point No.04	Survey date: 14-01-2004
Location. D/S of 36th Gate/Bay from left (Position diagram). Given below	Outline of damage. Erosion of Pier due to high velocity flow near its bottom

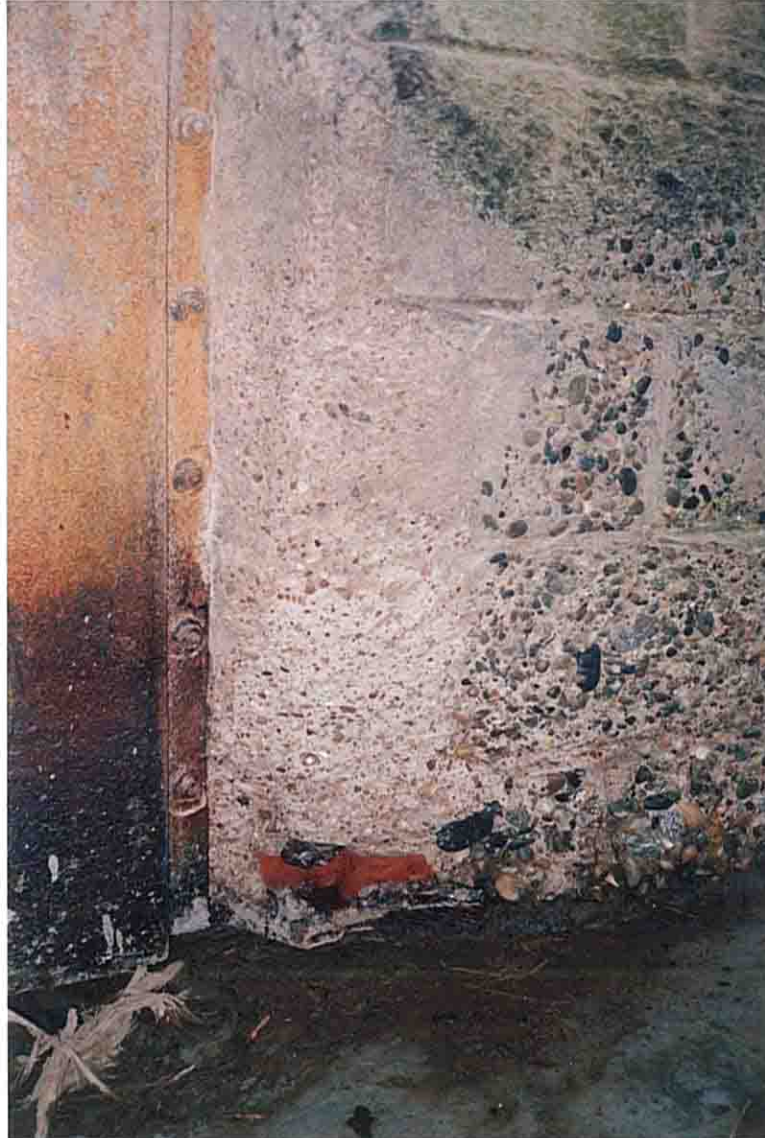
Photograph No. 04

Erosion of piers due the high velocity flow near its bottom

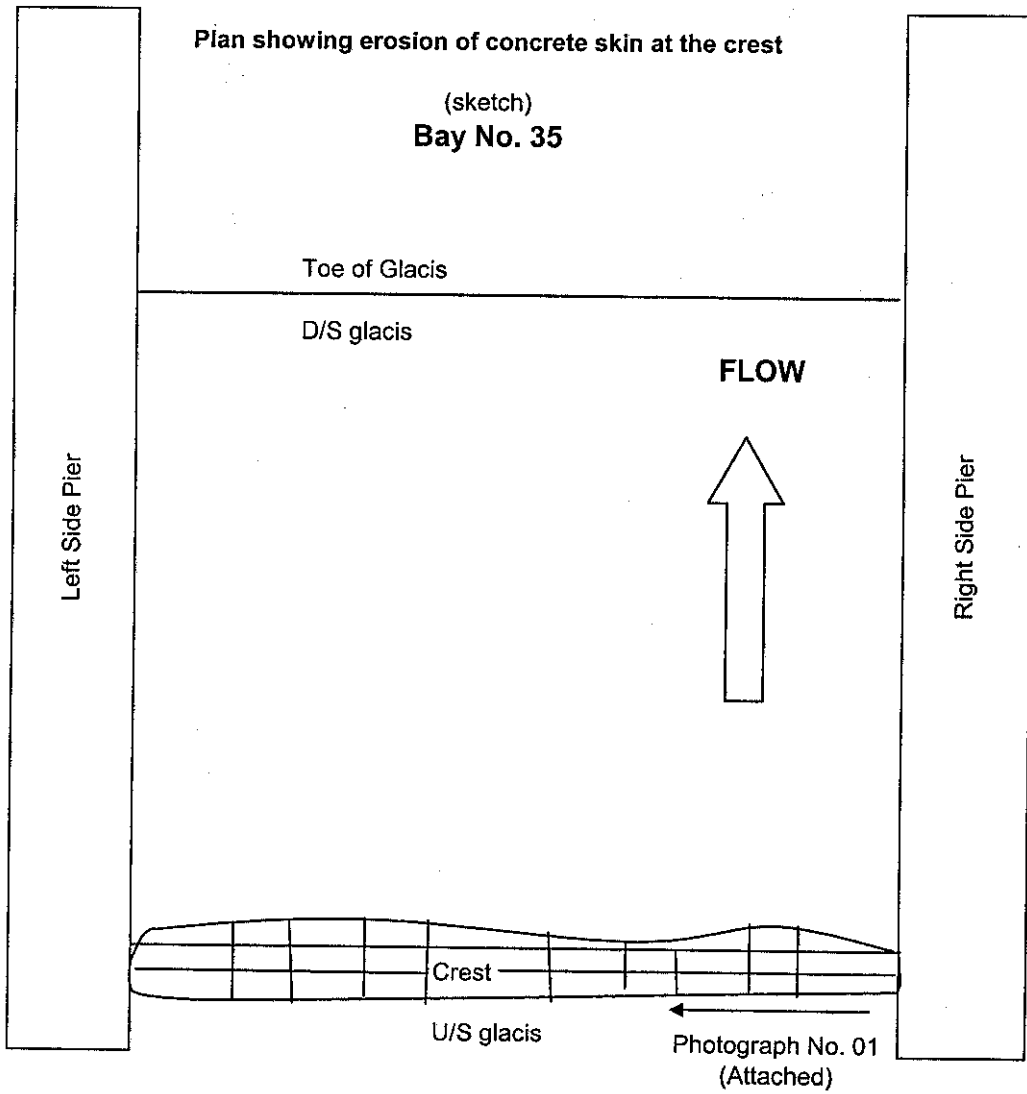
Outline drawings.

Ref No. Point No.01	Survey date: 14-01-2004
Location. D/S of 35th Gate/Bay from left. (Position diagram). Given below.	Outline of damage. Erosion of Concrete skin at crest exposing reinforcement across entire width of the Bay.

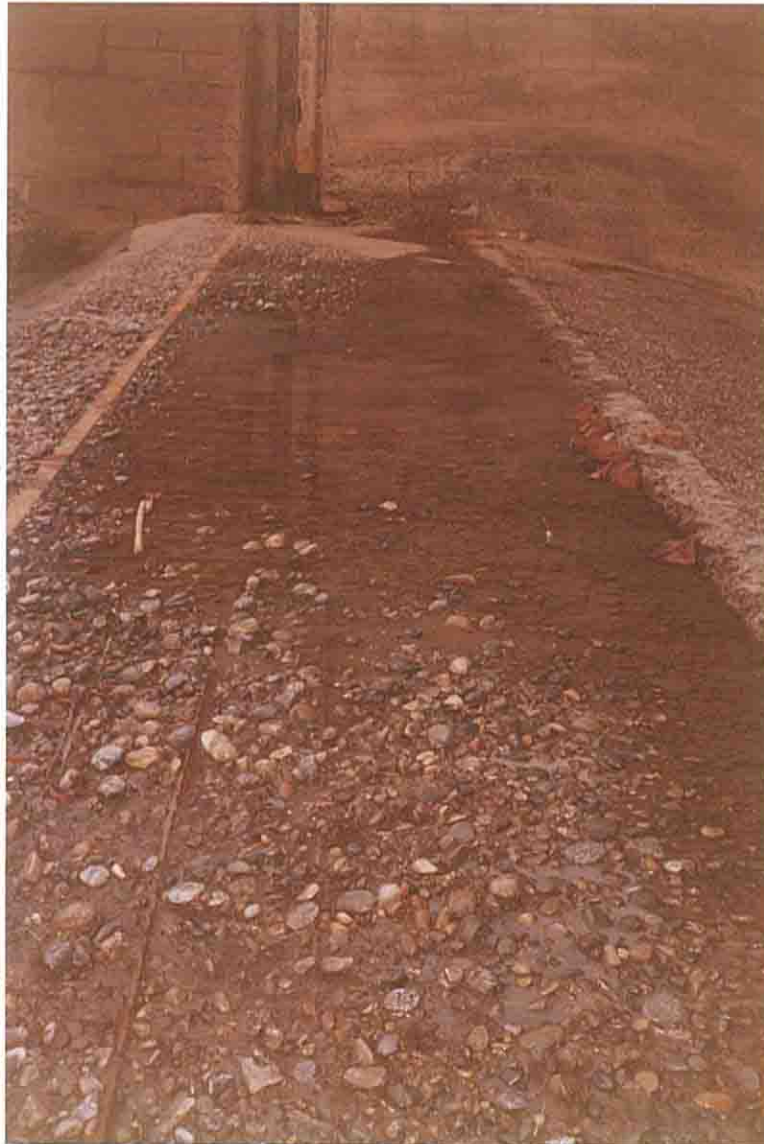
Photograph No. 01

Bay No. 35
Erosion of concrete skin
at the crest

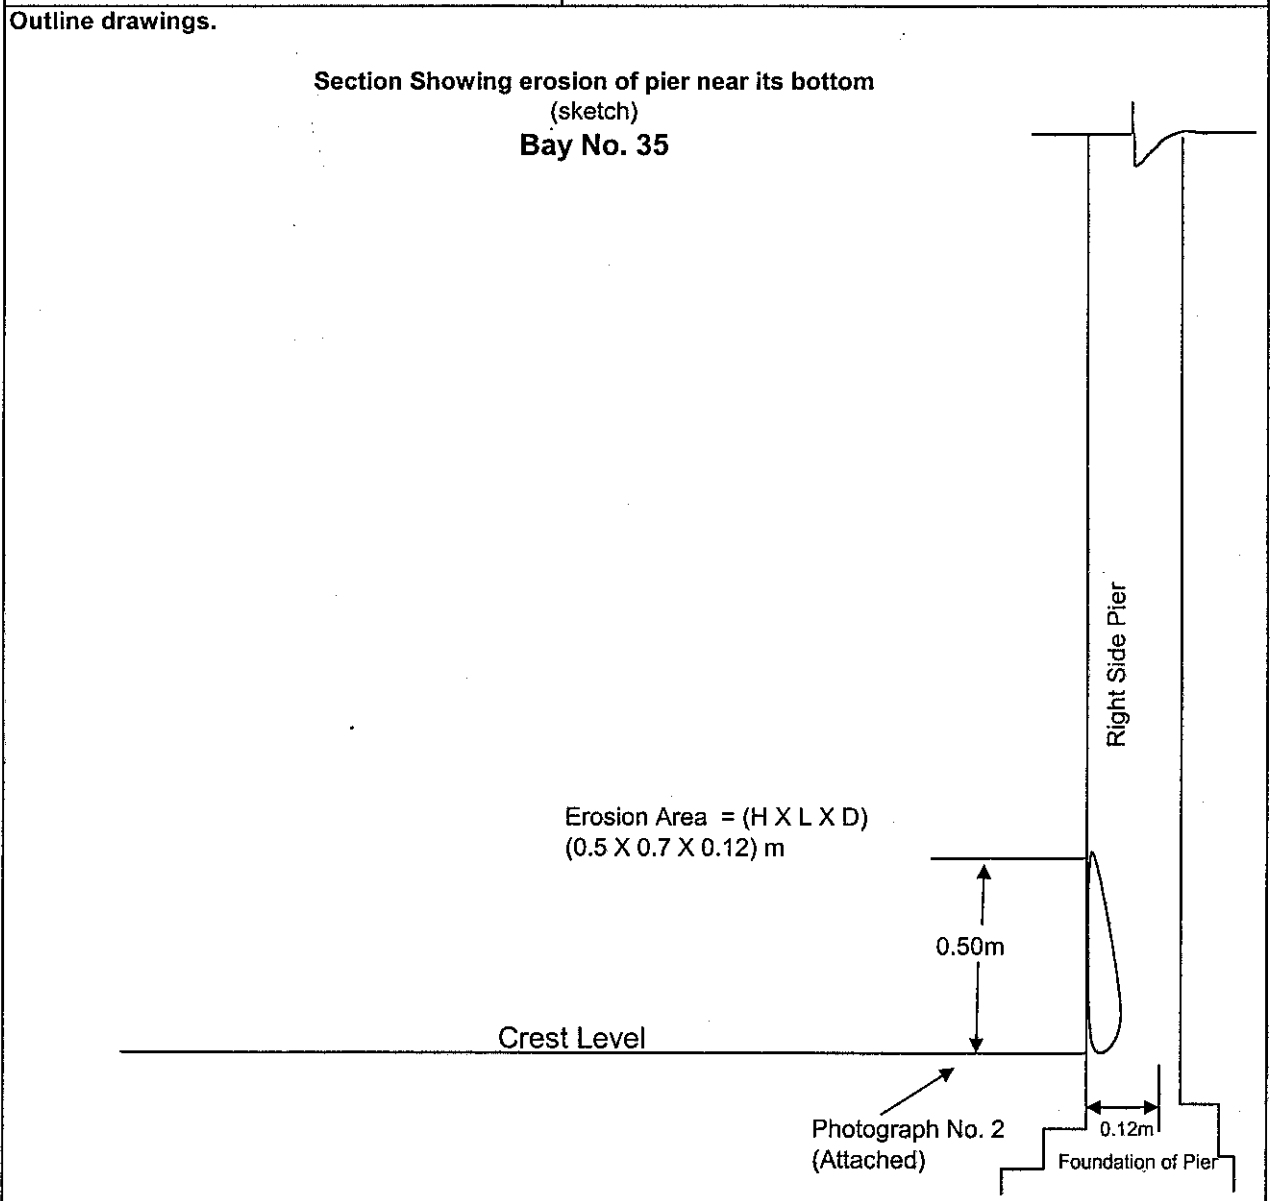
Ref No. Point No.02	Survey date: 14-01-2004
Location. D/S of 35th Gate/Bay from left. (Position diagram). Given below.	Outline of damage. Erosion of Pier due to high velocity flow near its bottom.

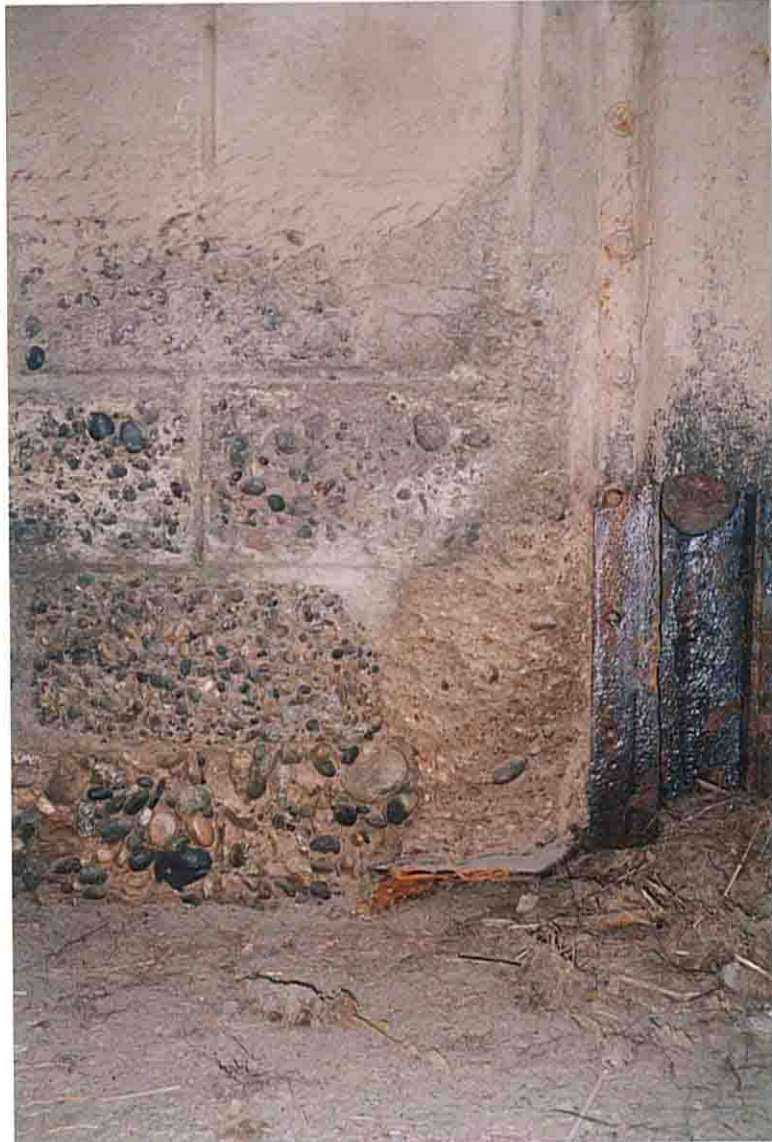
Photograph No. 02

Erosion of piers due to high velocity flow near its bottom

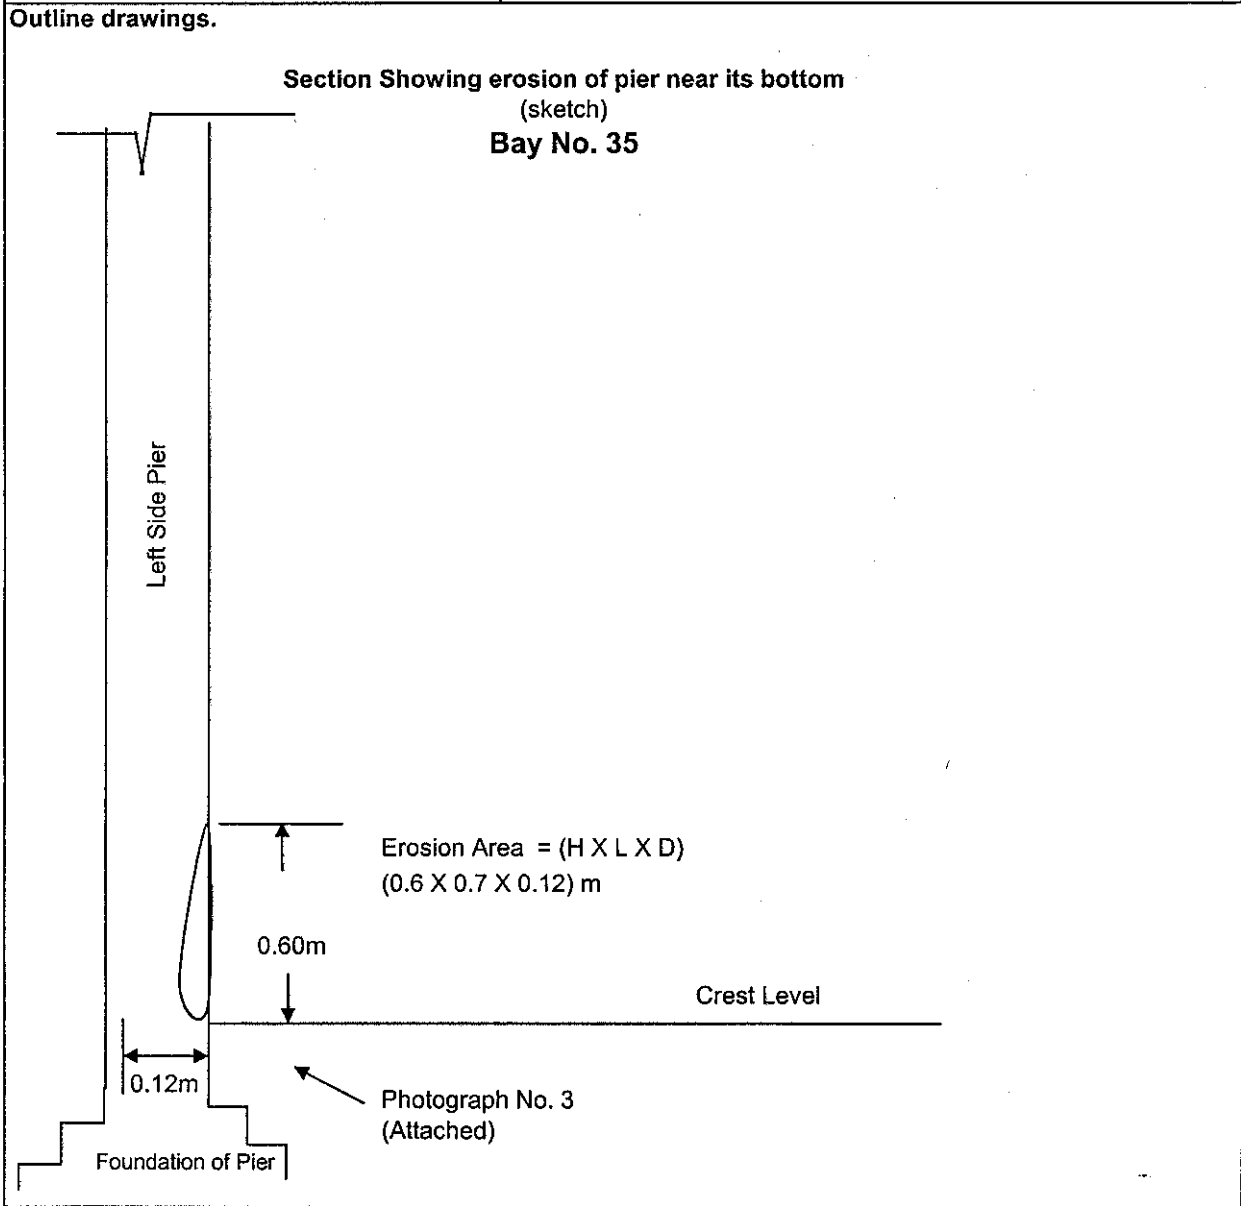
Ref No. Point No.03	Survey date: 14-01-2004
<p>Location.</p> <p>D/S of 35th Gate/Bay from left. (Position diagram).</p> <p>Given below.</p>	<p>Outline of damage.</p> <p>Erosion of Pier due to high velocity flow near its bottom</p>

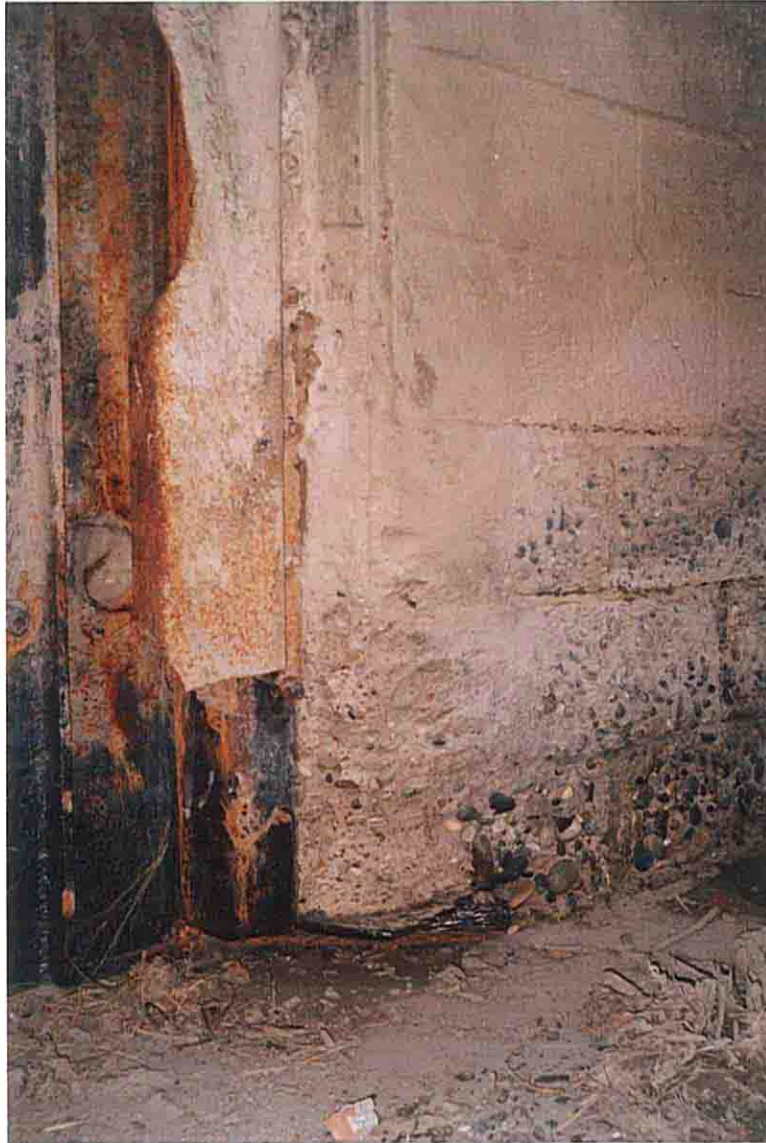
Photograph No. 03

Erosion of piers due to high velocity flow near its bottom

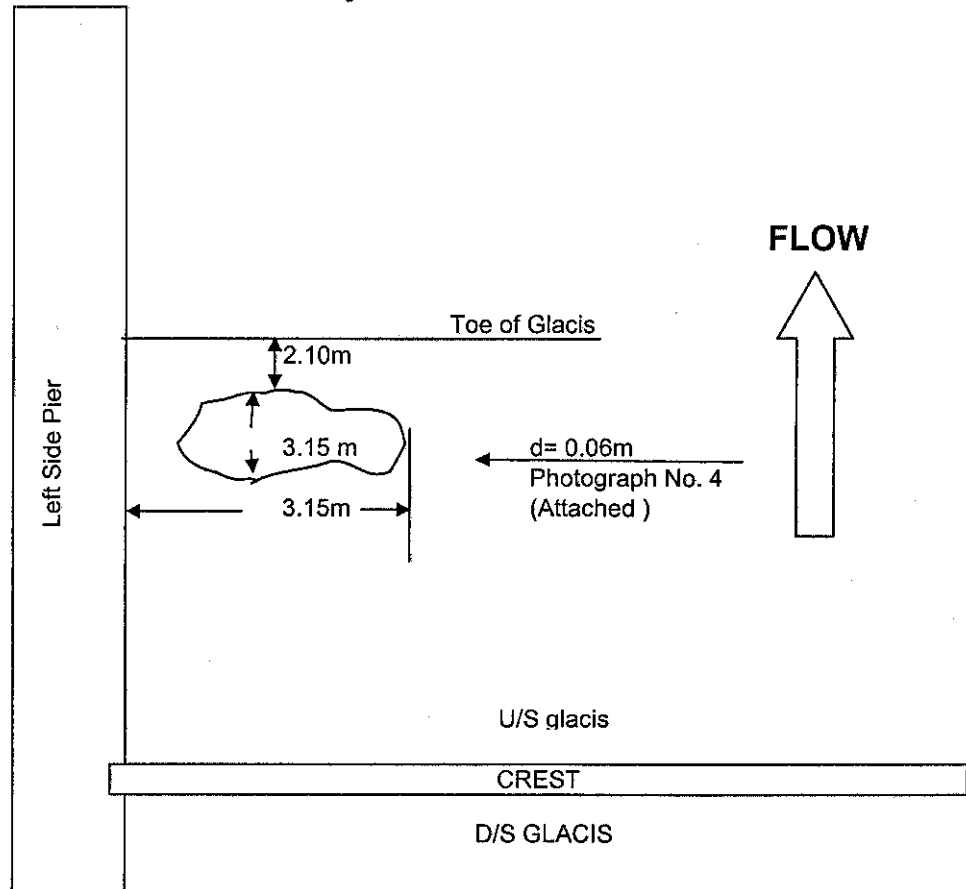
**Plan showing ripping up of skin concrete at D/S glacis
(Sketch)
Bay No. 35**

Ref No. Point No.04	Survey date: 14-01-2004
Location. D/S of 35th Gate/Bay from left (Position diagram). Given below.	Outline of damage. Ripping up of skin concrete upto 0.06m at D/S glacis

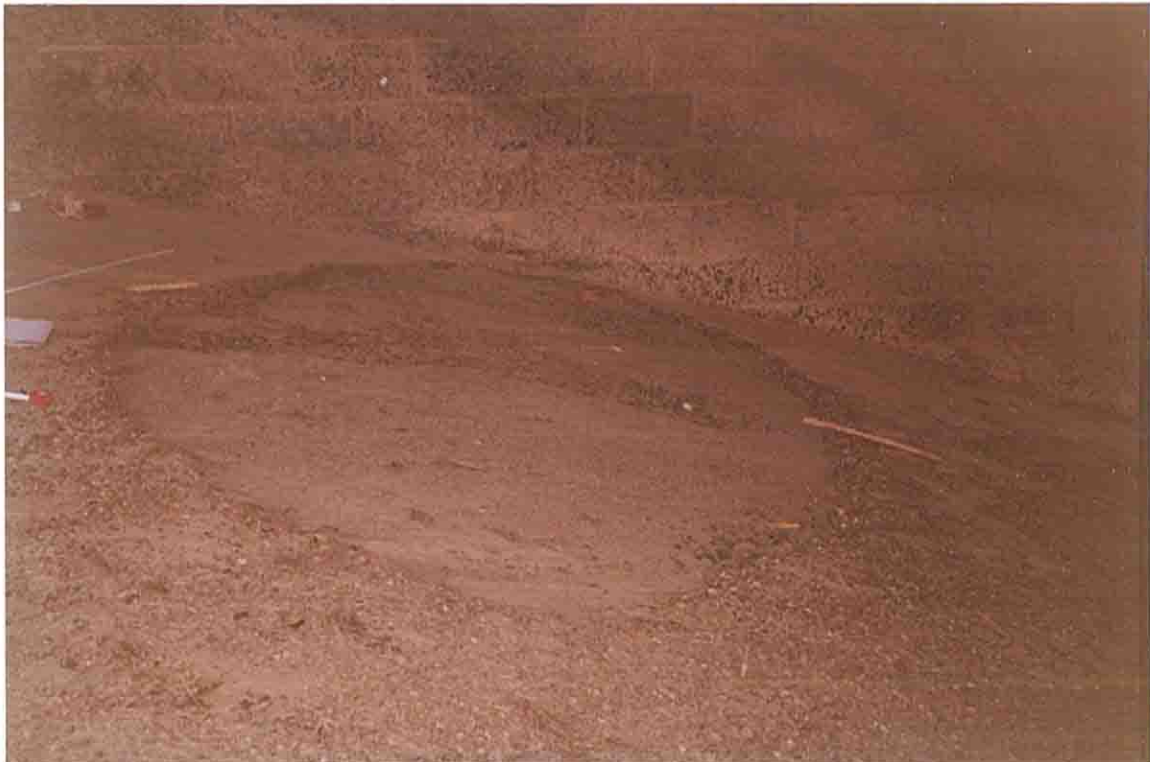
Photograph No. 04

Bay No. 35
Ripping up of skin concrete
at D/S glacis

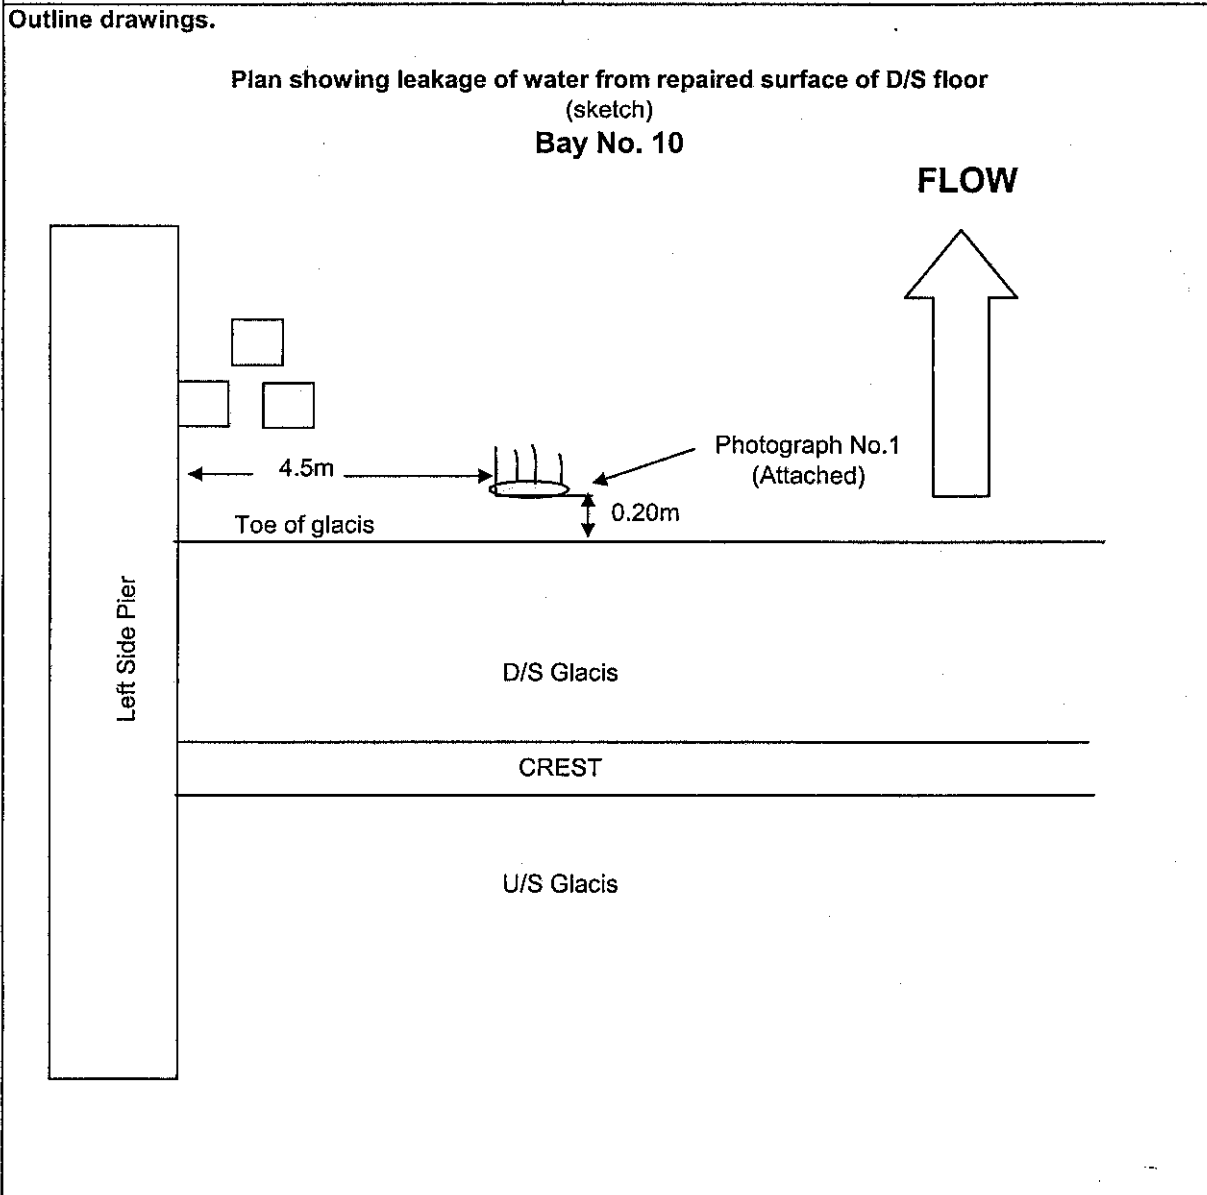
Ref No. Point No.01	Survey date: 14-01-2004
Location. D/S of 10th Gate/Bay from left side (Position diagram). Given below	Outline of damage. Leakage of water from repaired surface of D/S floor

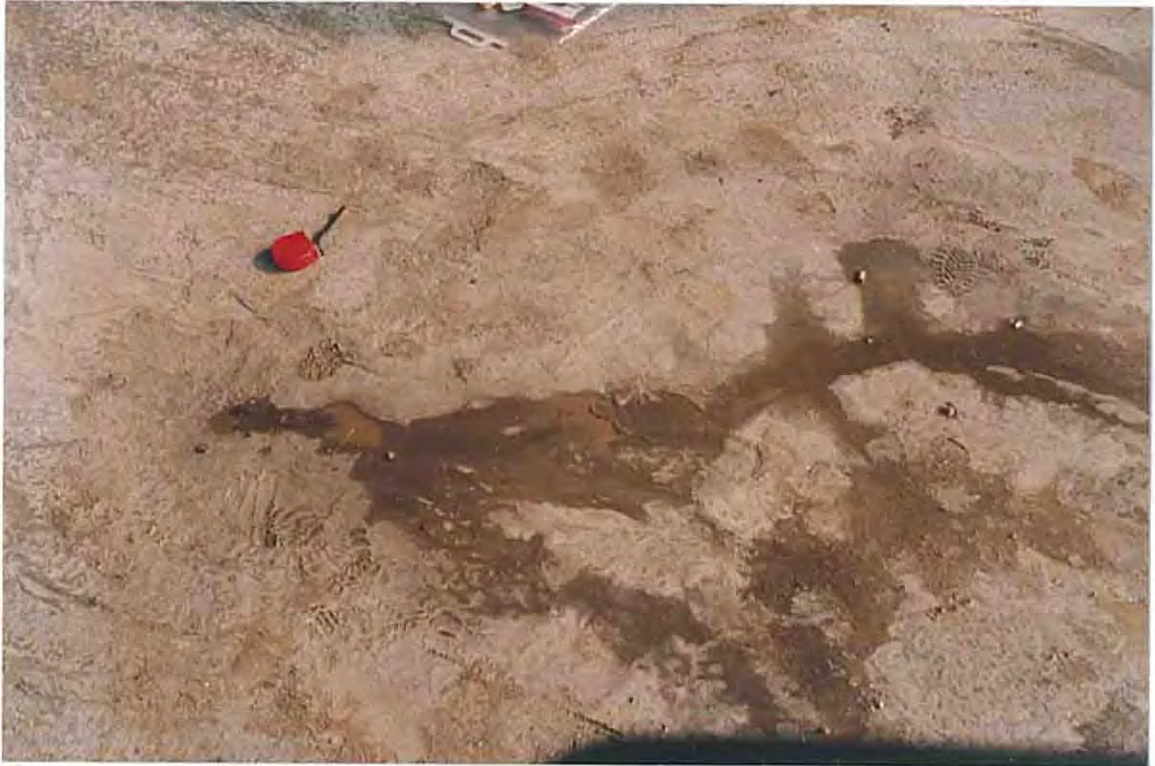
Photograph No. 01

Leakage of water from repaired surface of D/S floor

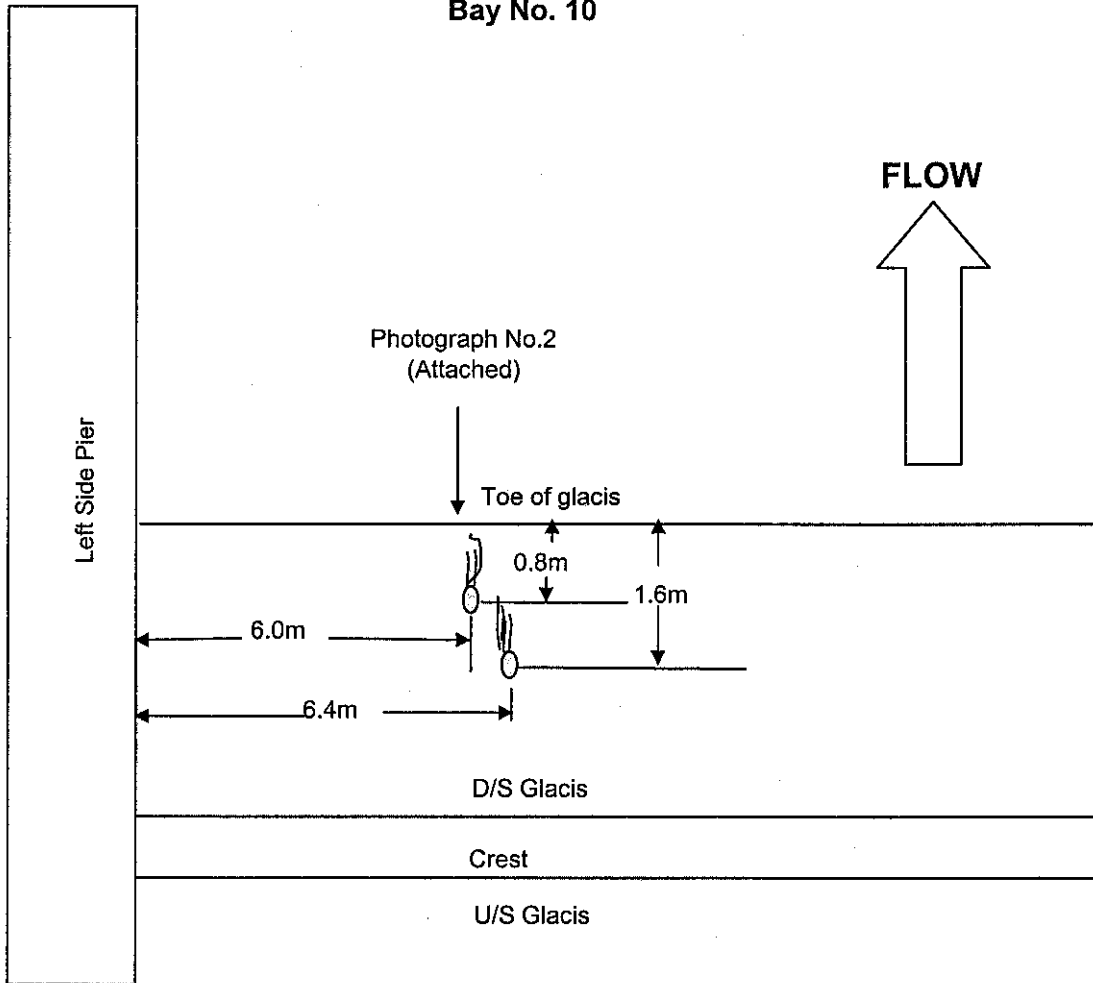
**Plan showing leakage of water from repaired surface of D/S glacis
(sketch)
Bay No. 10**

Ref No. Point No.02	Survey date: 14-01-2004
Location. D/S of 10th Gate/Bay from left (Position diagram). Given below	Outline of damage. Leakage of water from repaired surface of D/S glacis
