ANNEX. VI

FORMATS OF DAMAGE CONDITIONS

FORMATS OF DAMAGE CONDITIONS-BAY NO. - 37

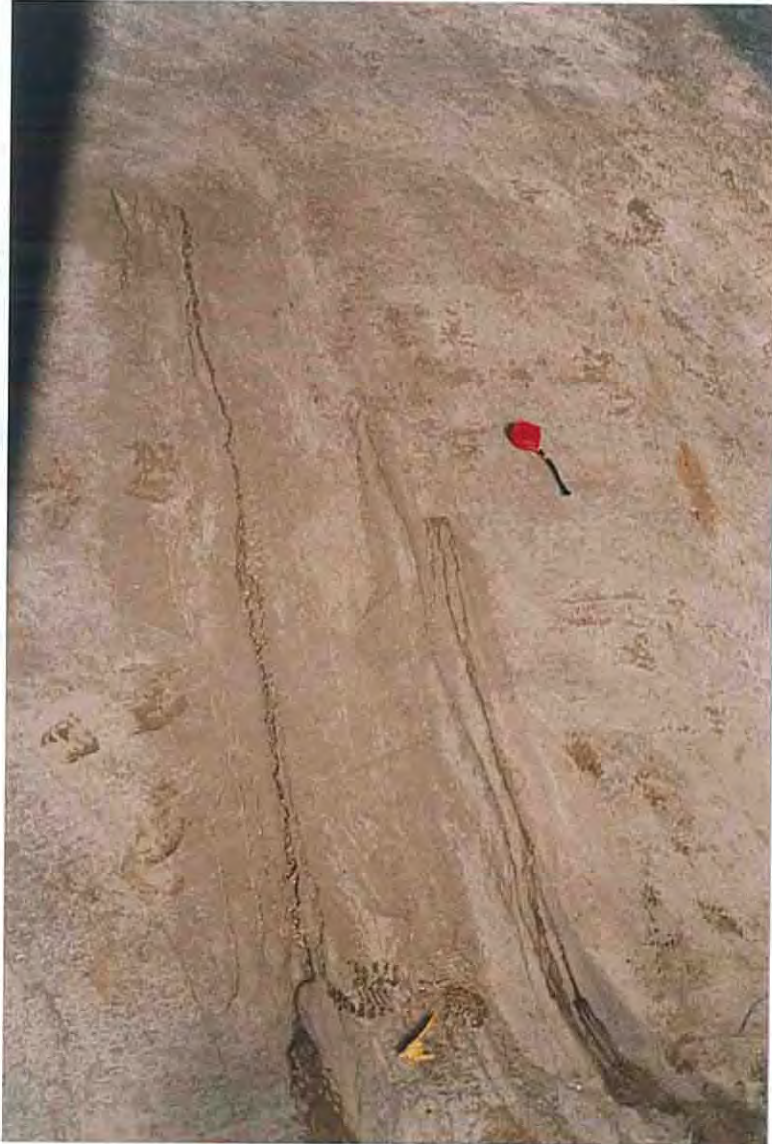
Photograph No. 02

Leakage of water from repaired surface of D/S glacis

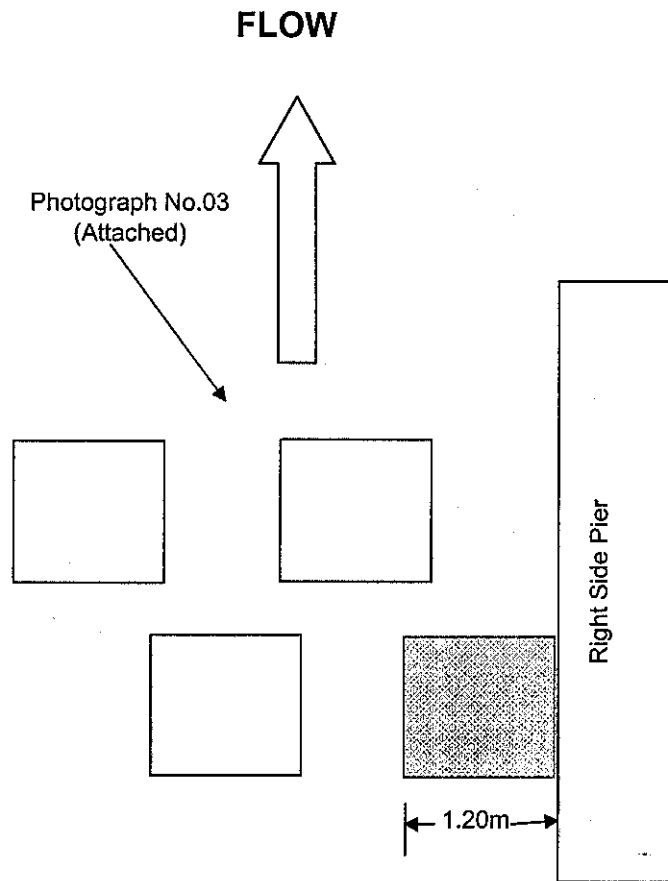
**Plan showing the location of eroded impact block
(sketch)
Bay No. 10**

Ref No. Point No. 03	Survey date: 14-01-2004
Location. D/S of 10th Gate/Bay from left (Position diagram). Given below.	Outline of damage. Erosion of the impact block.

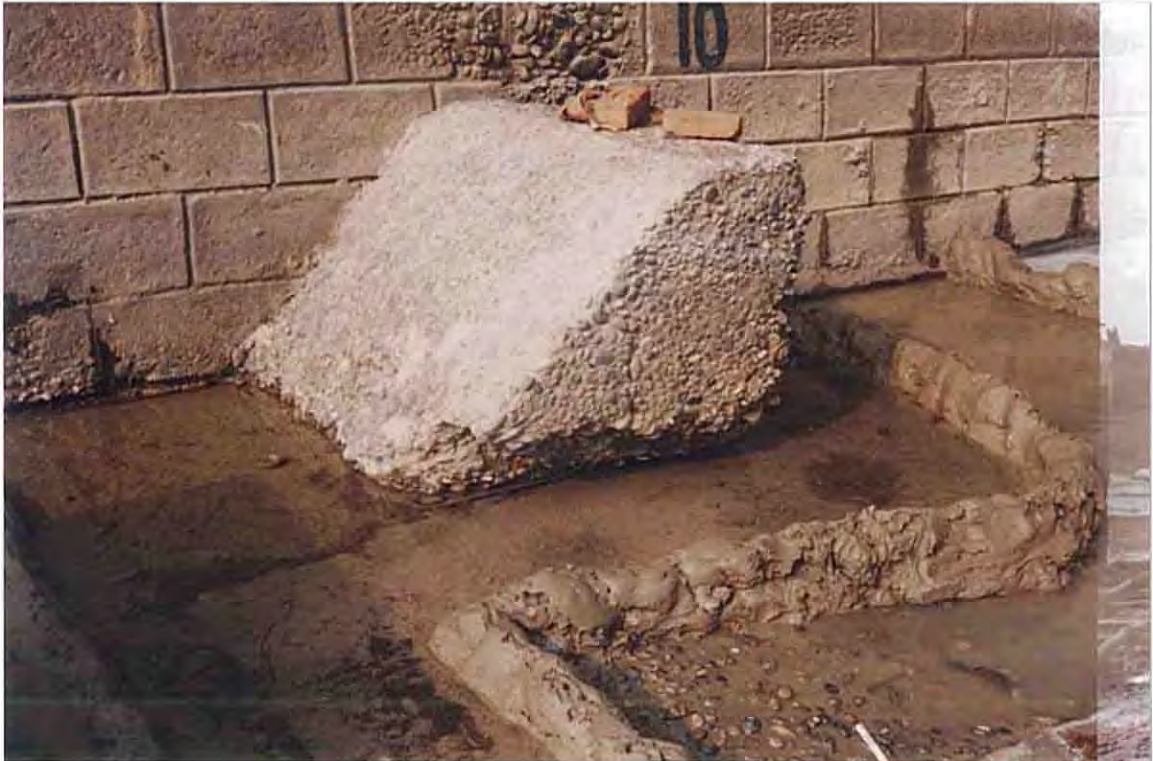
Photograph No. 03

Bay No. 10
Erosion of the impact block

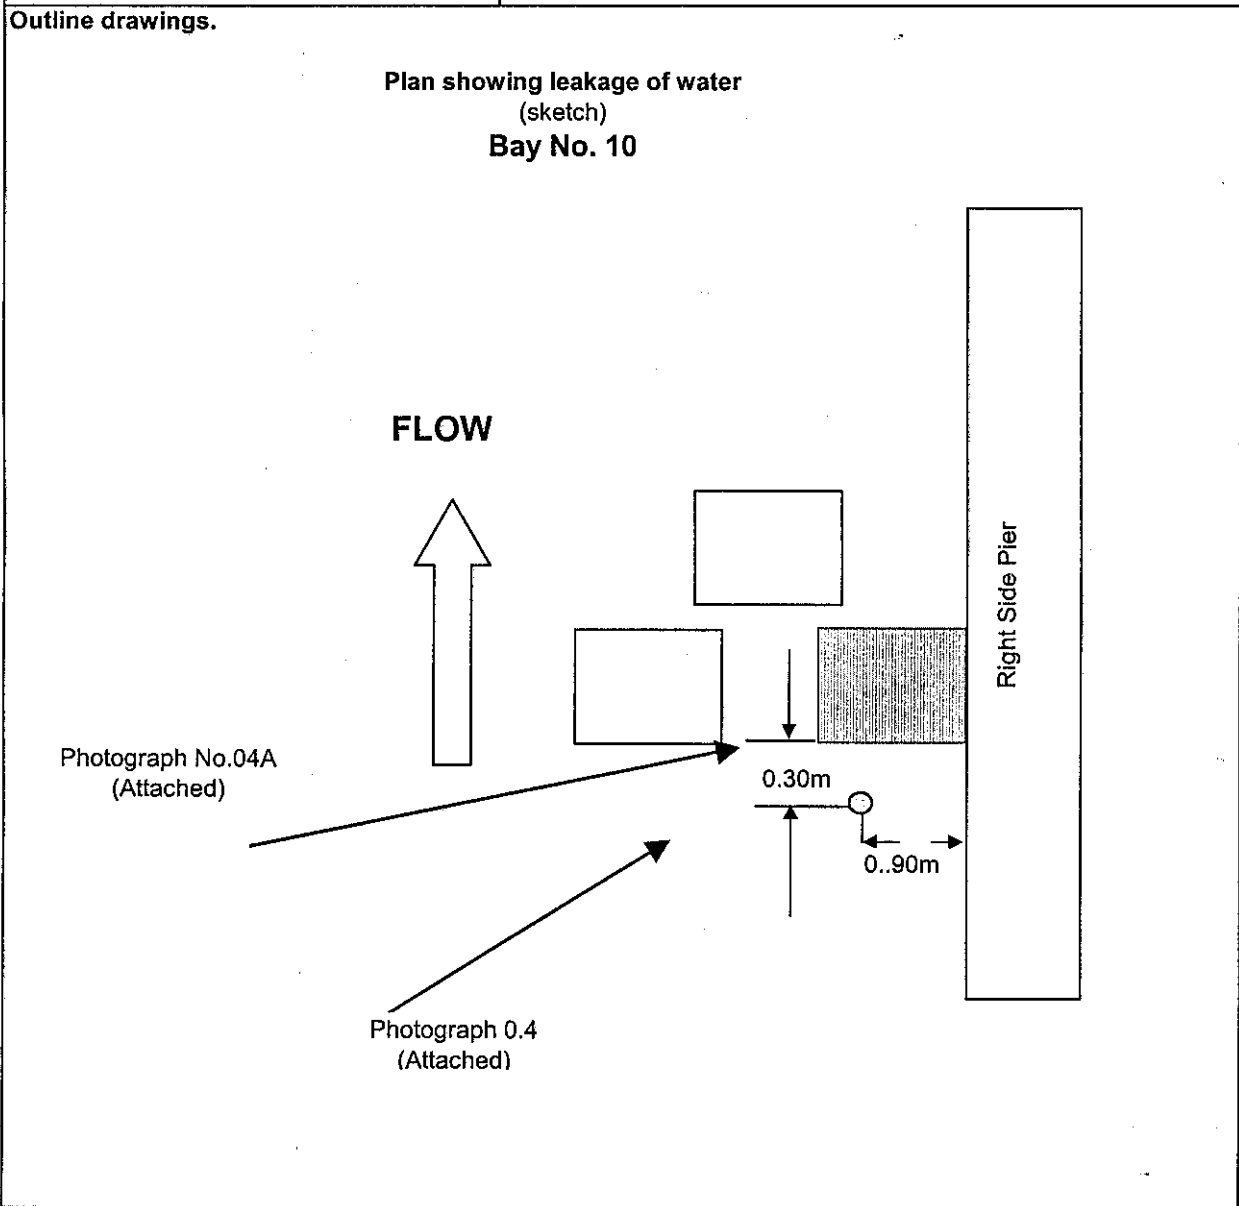
Ref No. Point No. 04	Survey date: 14-01-2004
Location. D/S of 10th Gate/Bay from left (Position diagram). Given below.	Outline of damage. Leakage of water from underneath the D/S floor near the eroded impact block

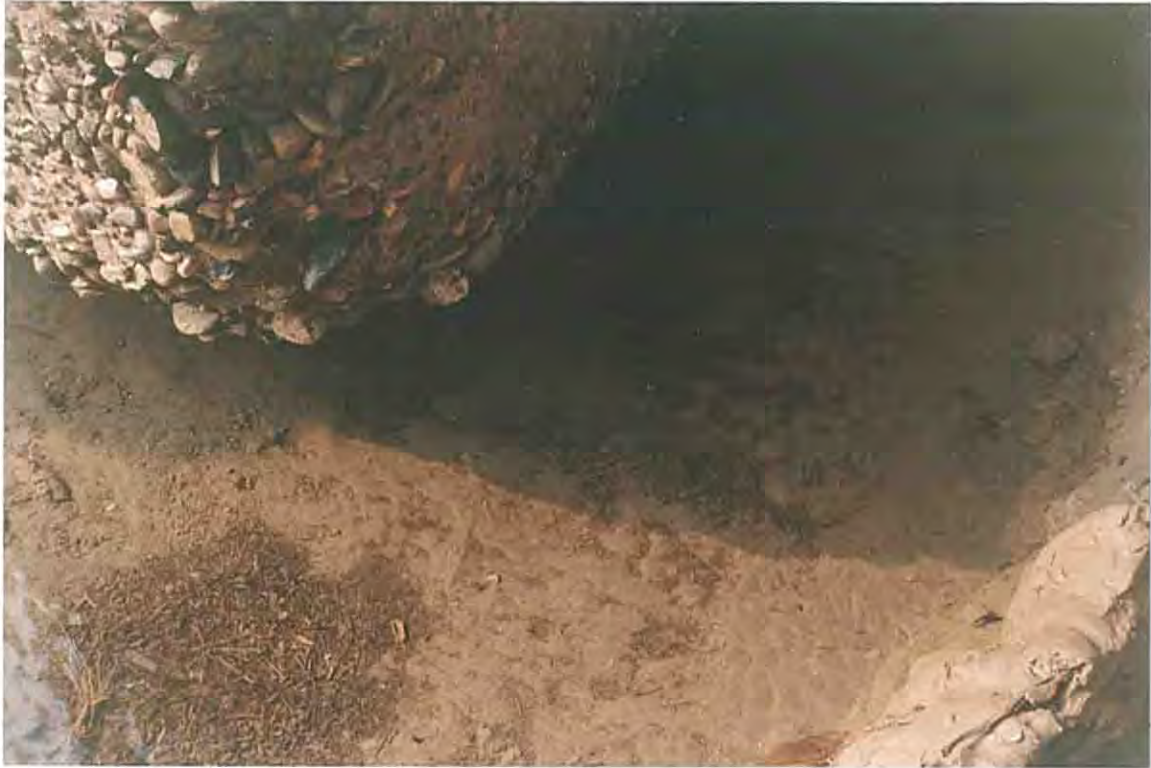
Photograph No. 04

Leakage of water from underneath the D/S floor near the impact block

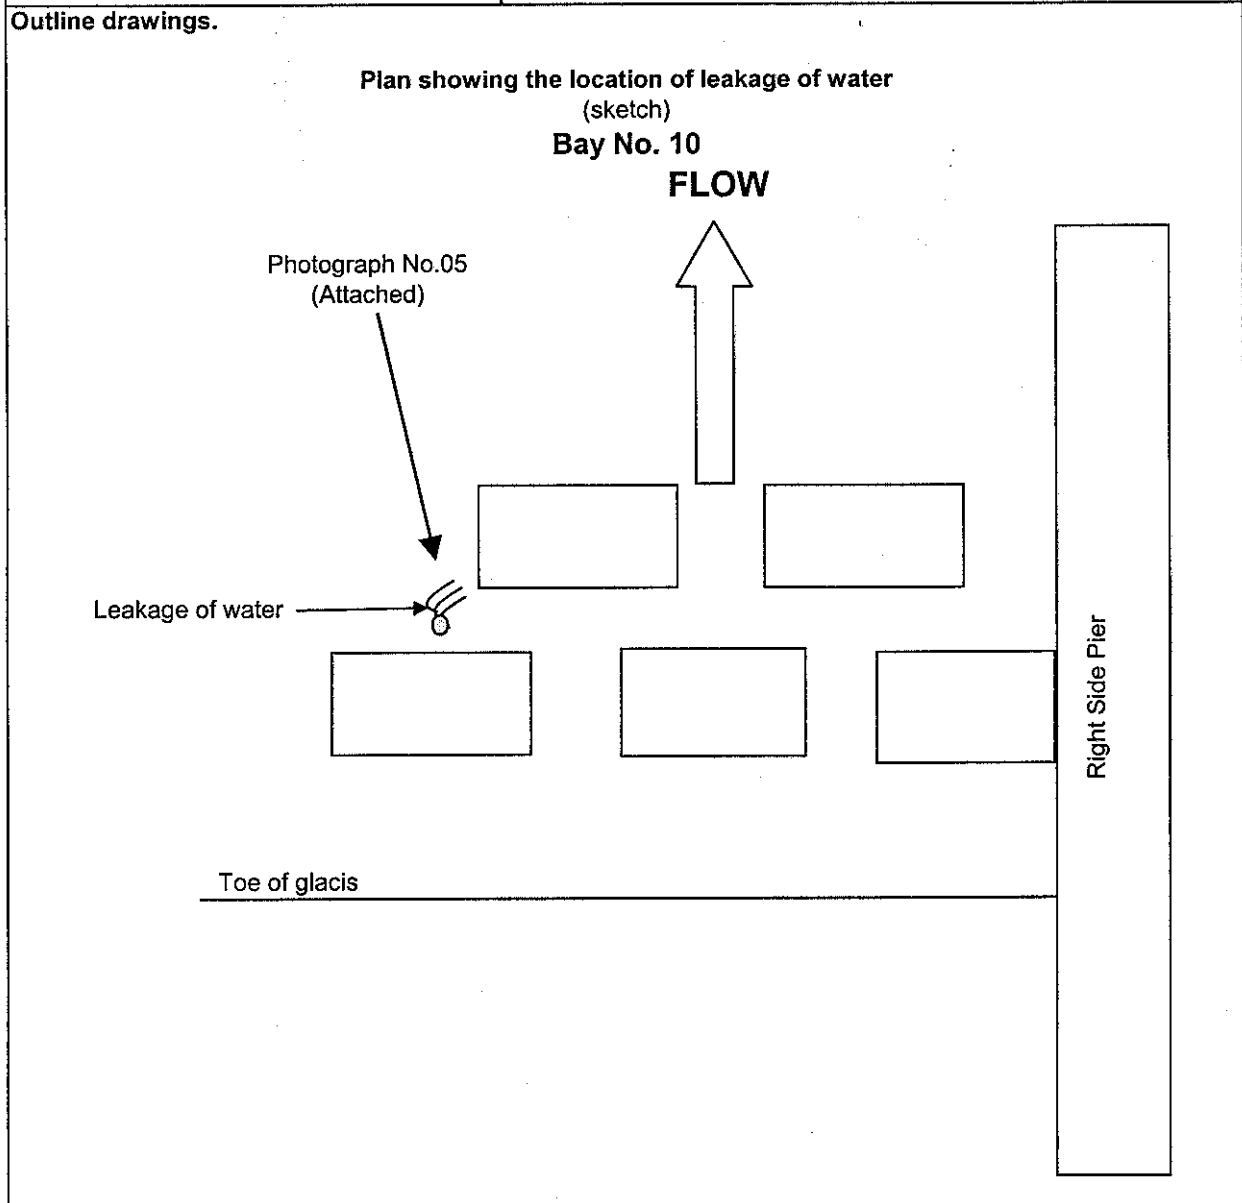
Ref No. Point No. 05	Survey date: 14-01-2004
Location. D/S of 10th Gate/Bay from left (Position diagram). Given below.	Outline of damage. Leakage of water from underneath the D/S floor at the back of the impact block which was broken

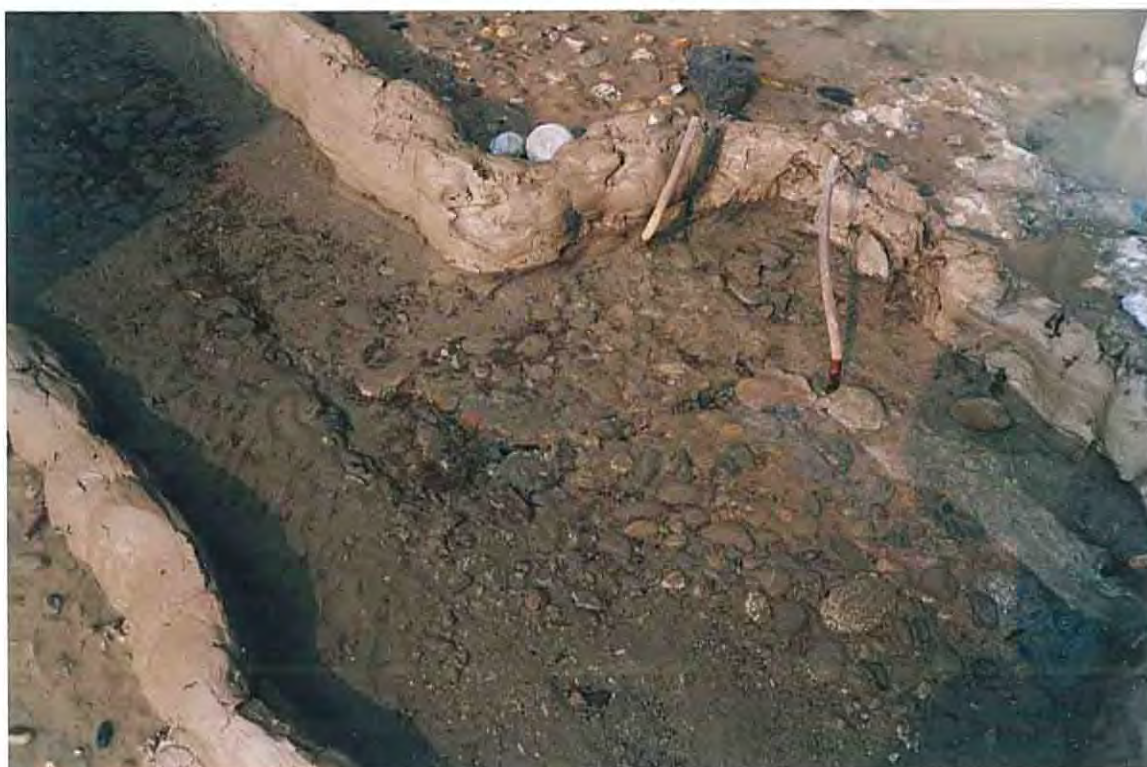
Photograph No. 05

Leakage of water from underneath the D/S floor at the back of the impact block

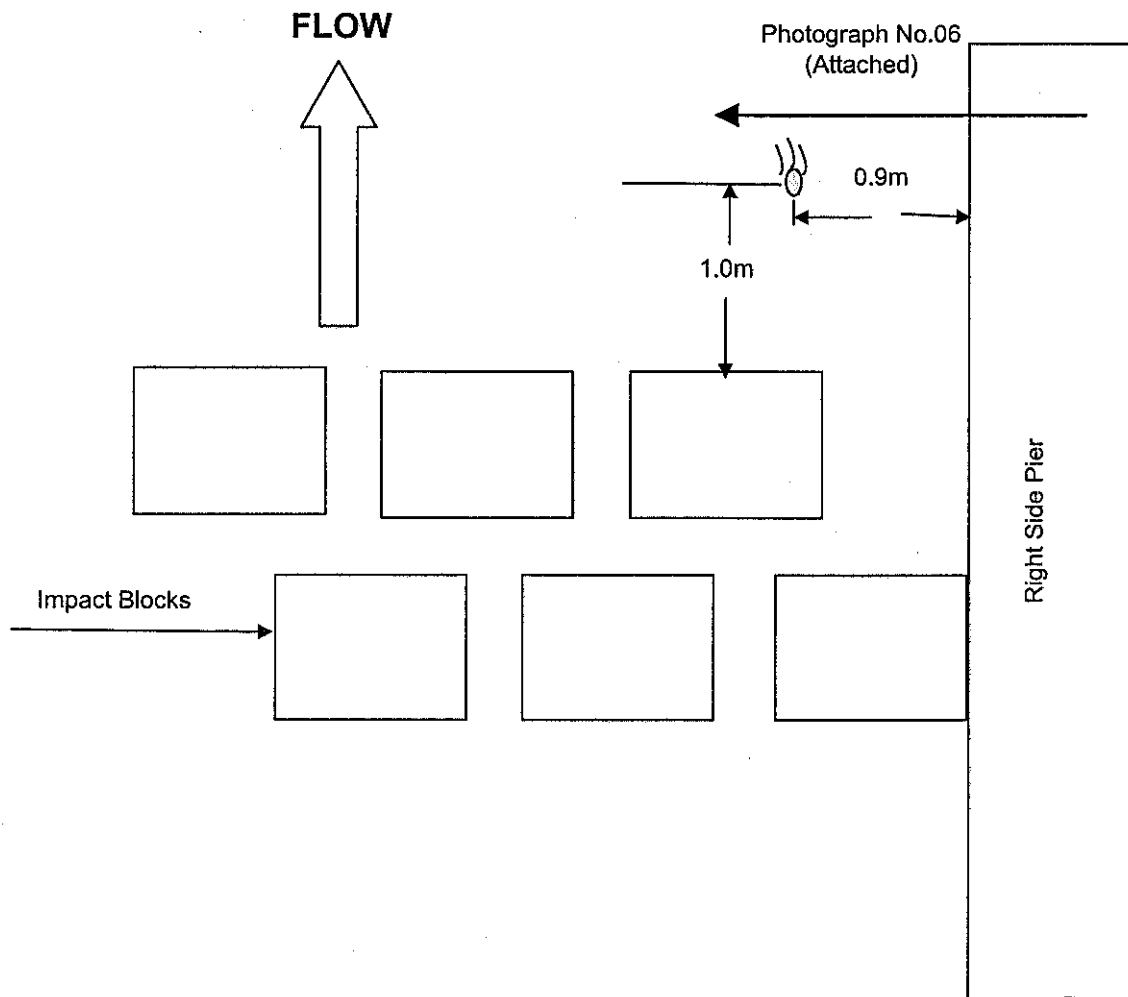
Plan showing boiling water from underneath the D/S floor.
 (sketch)
Bay No. 10

Ref No. Point No. 06	Survey date: 14-01-2004
Location. D/S of 10th Gate/Bay from left (Position diagram). Given below.	Outline of damage. Boiling water from underneath the D/S floor.

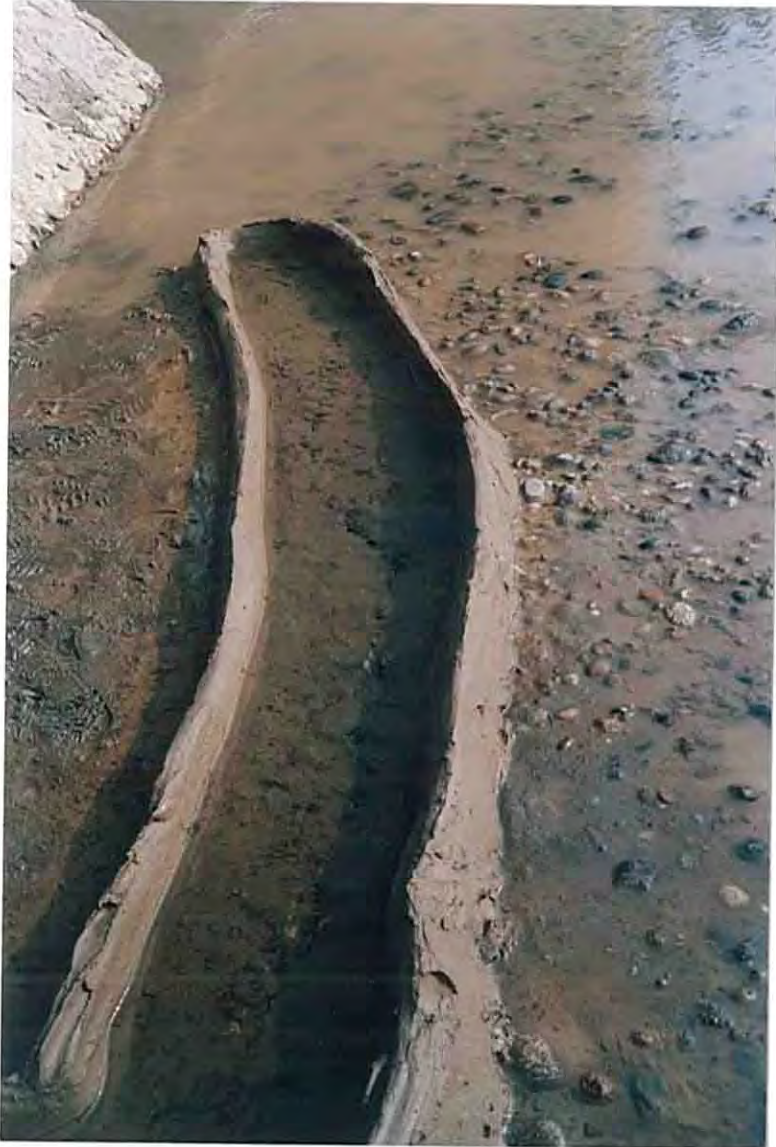
Photograph No. 06

Boiling water from underneath the D/S floor

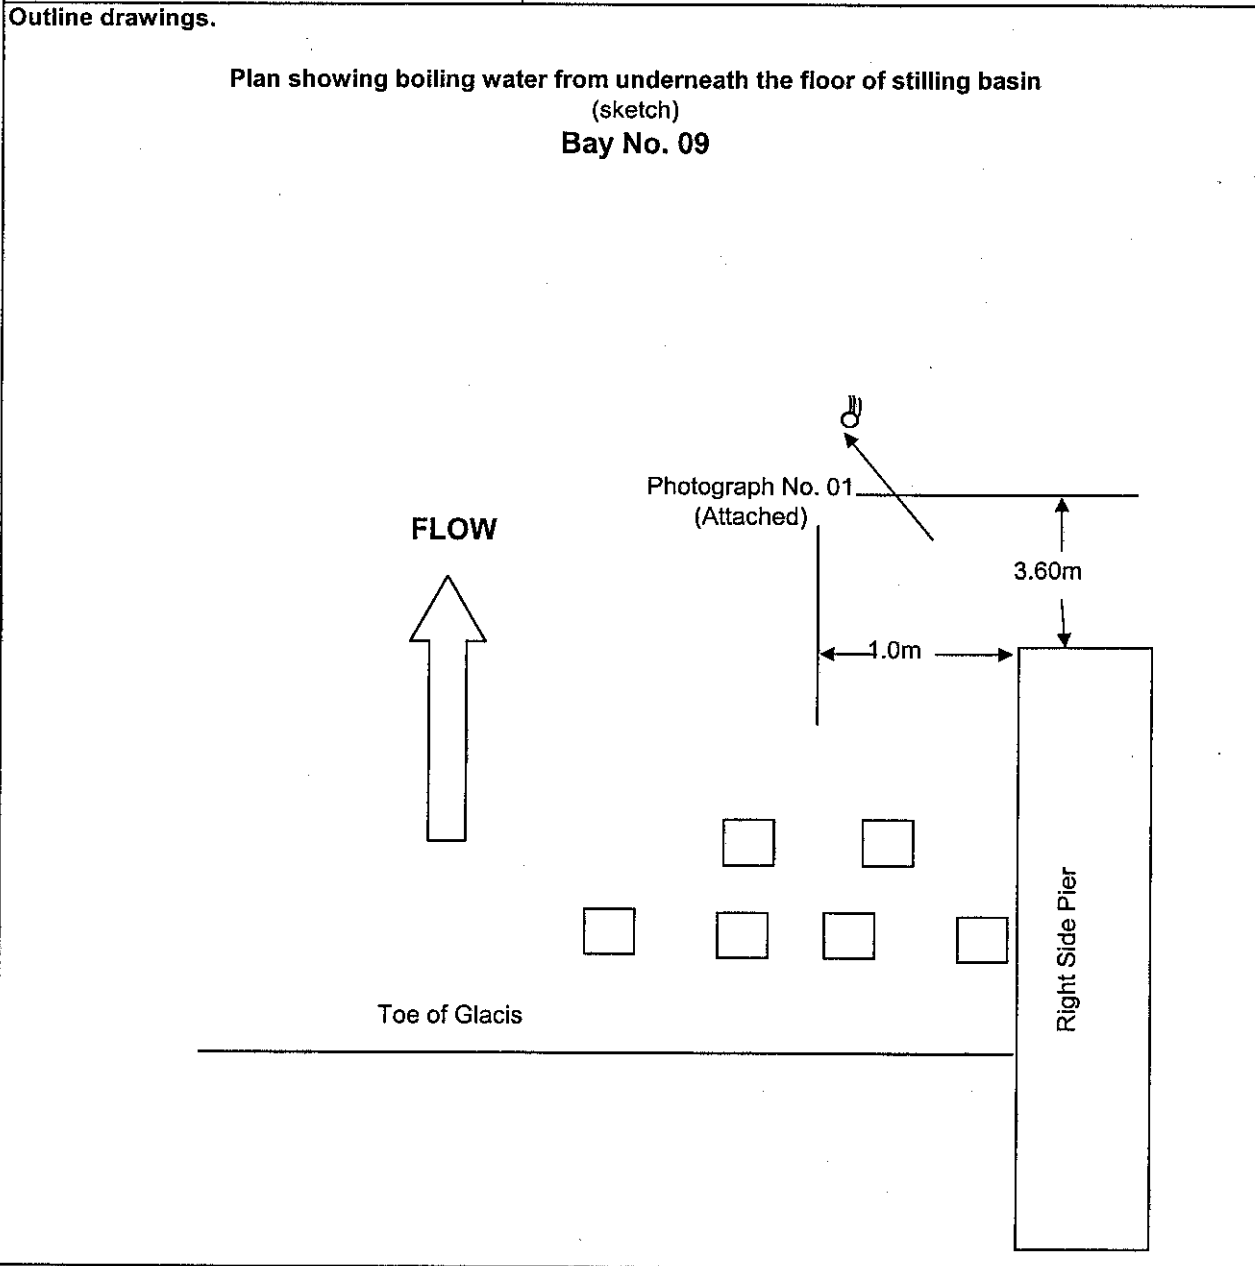
Ref No. Point No.01	Survey date: 14-01-2004
Location. D/S of 9th Gate/Bay from left side. (Position diagram). Given below.	Outline of damage. Boiling water from underneath the floor of stilling basin

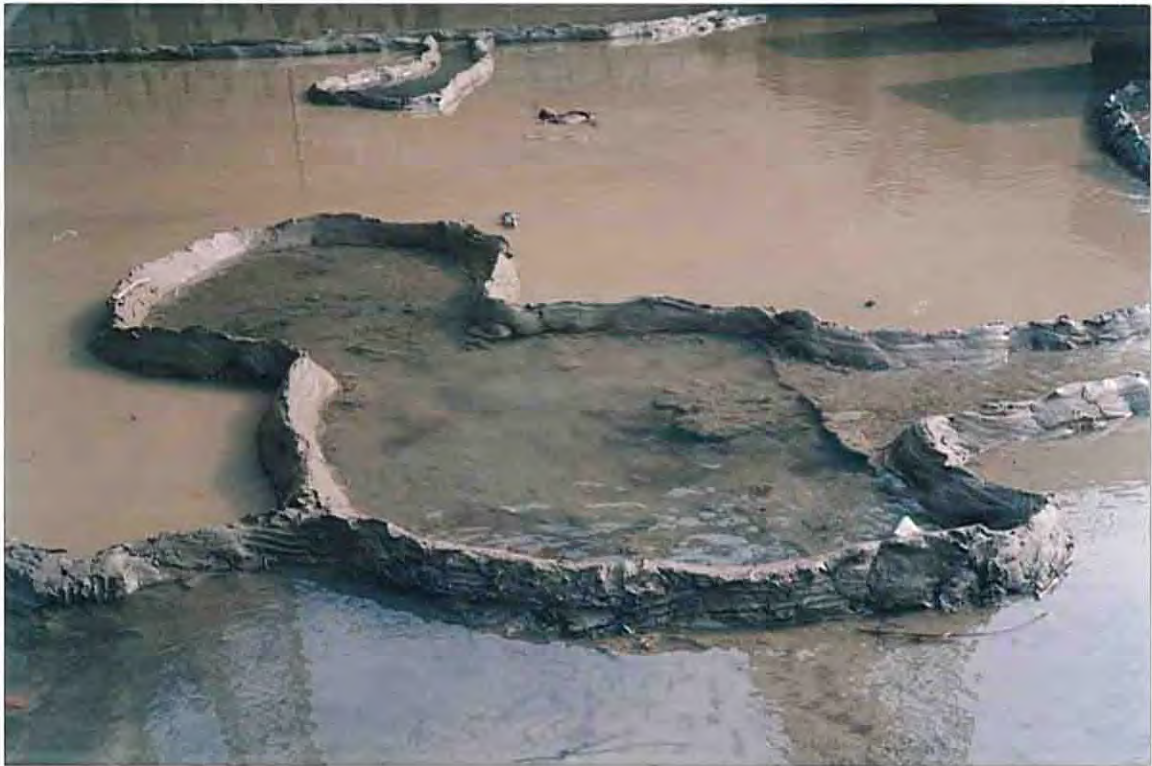
Photograph No. 01

Boiling Water from underneath the floor of stilling basin
