JN3; Results of the site survey

JN3 Geological Map

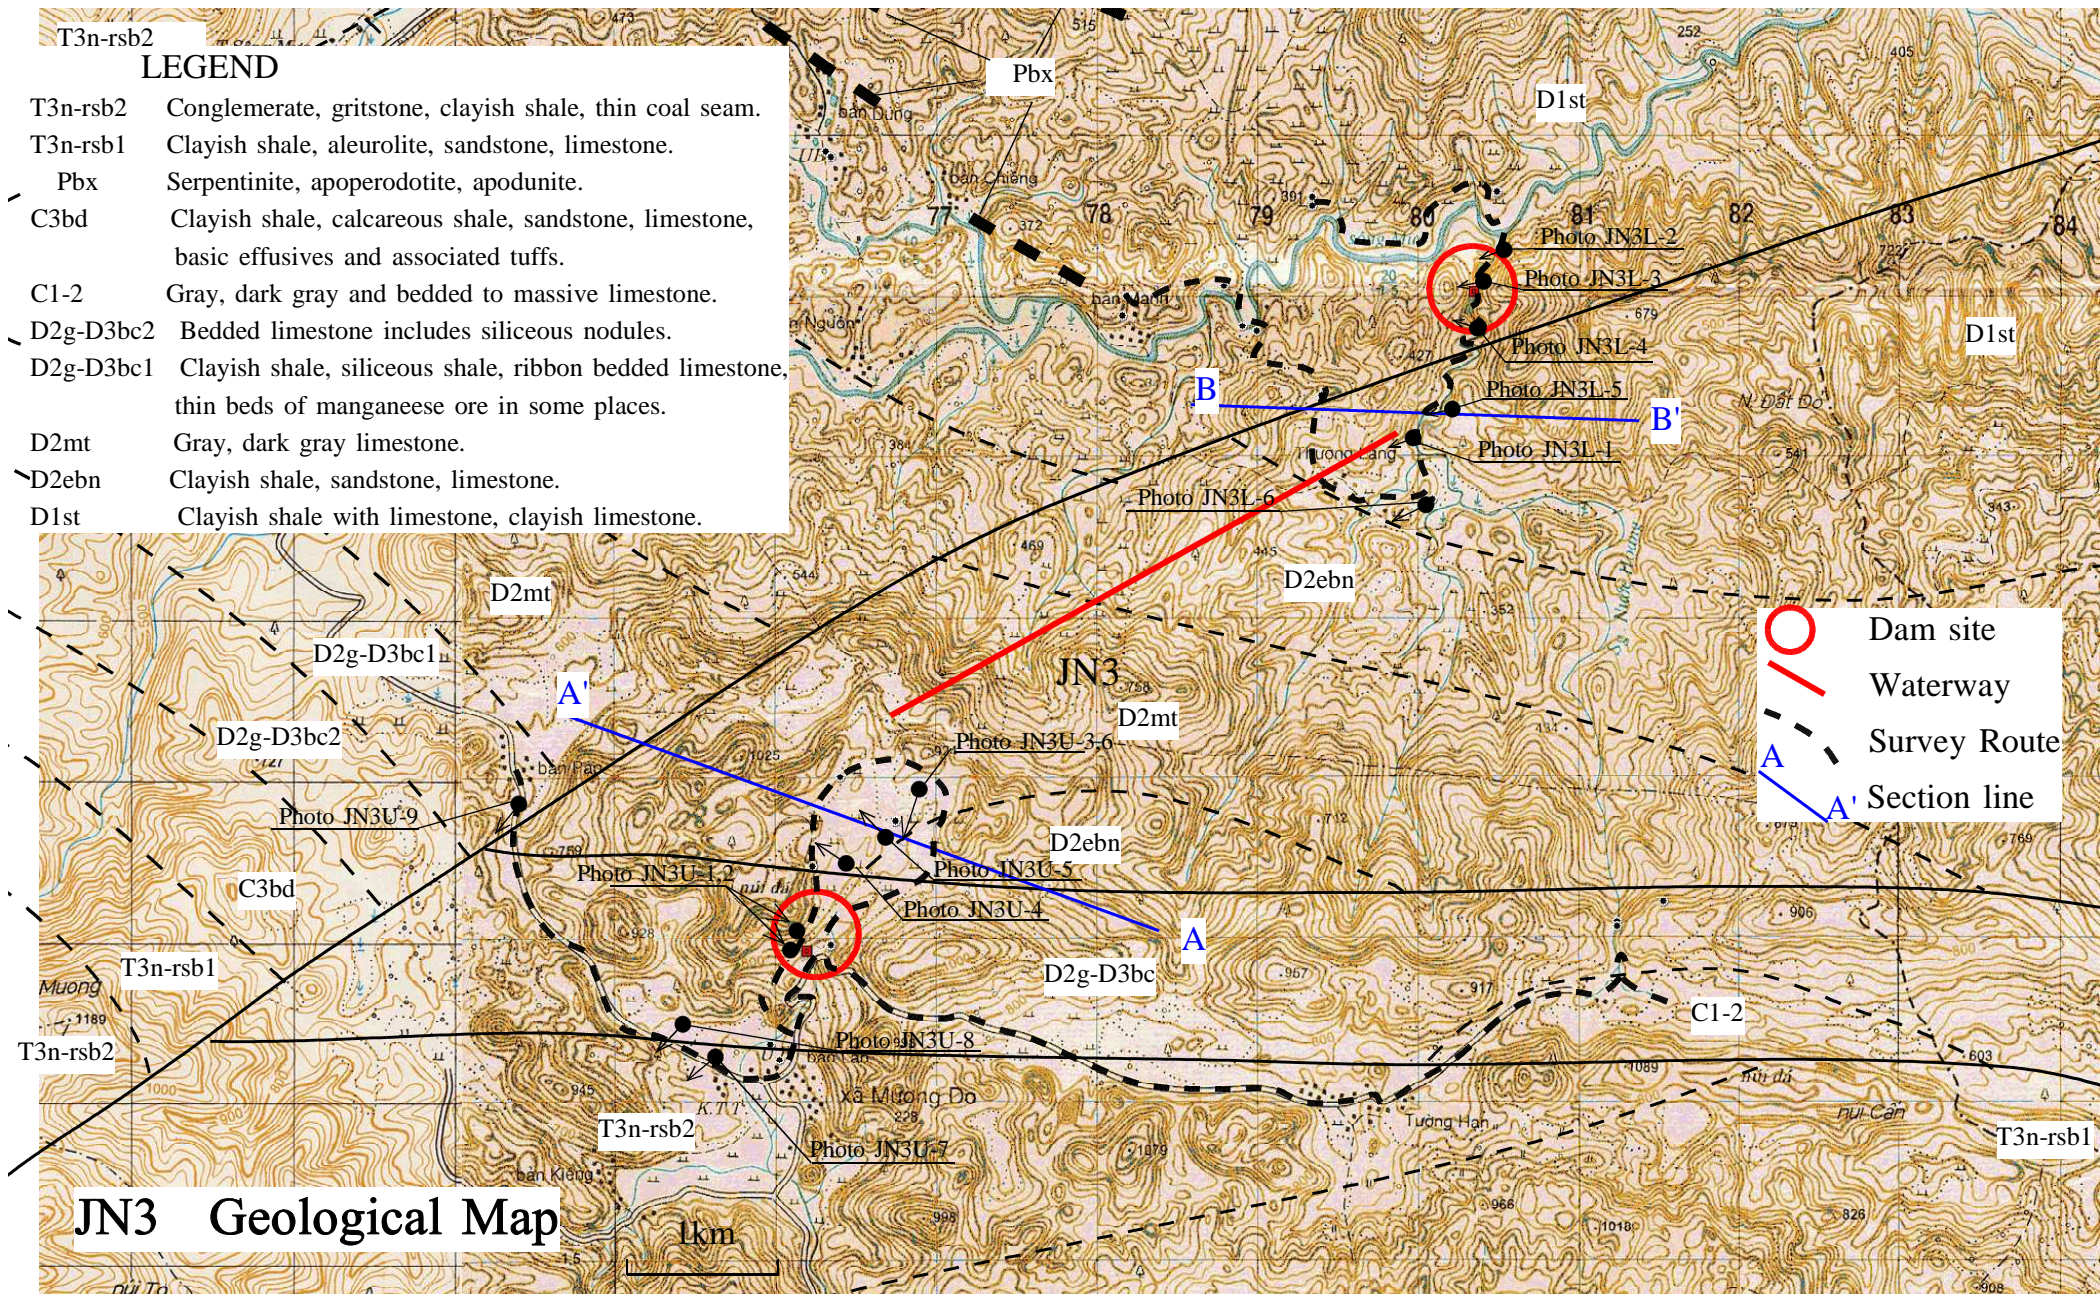
- N-S systems of fault is passing through the upper reservoir, confirming the conditions of fracture zone with the detailed survey will be needed.
- Slightly thicker secondary sediments and deeper weathering in the lower reservoir than upper reservoir.
- Investigation for the distribution of serpentinite zones will be needed.
