**JN5; Results of the site survey**

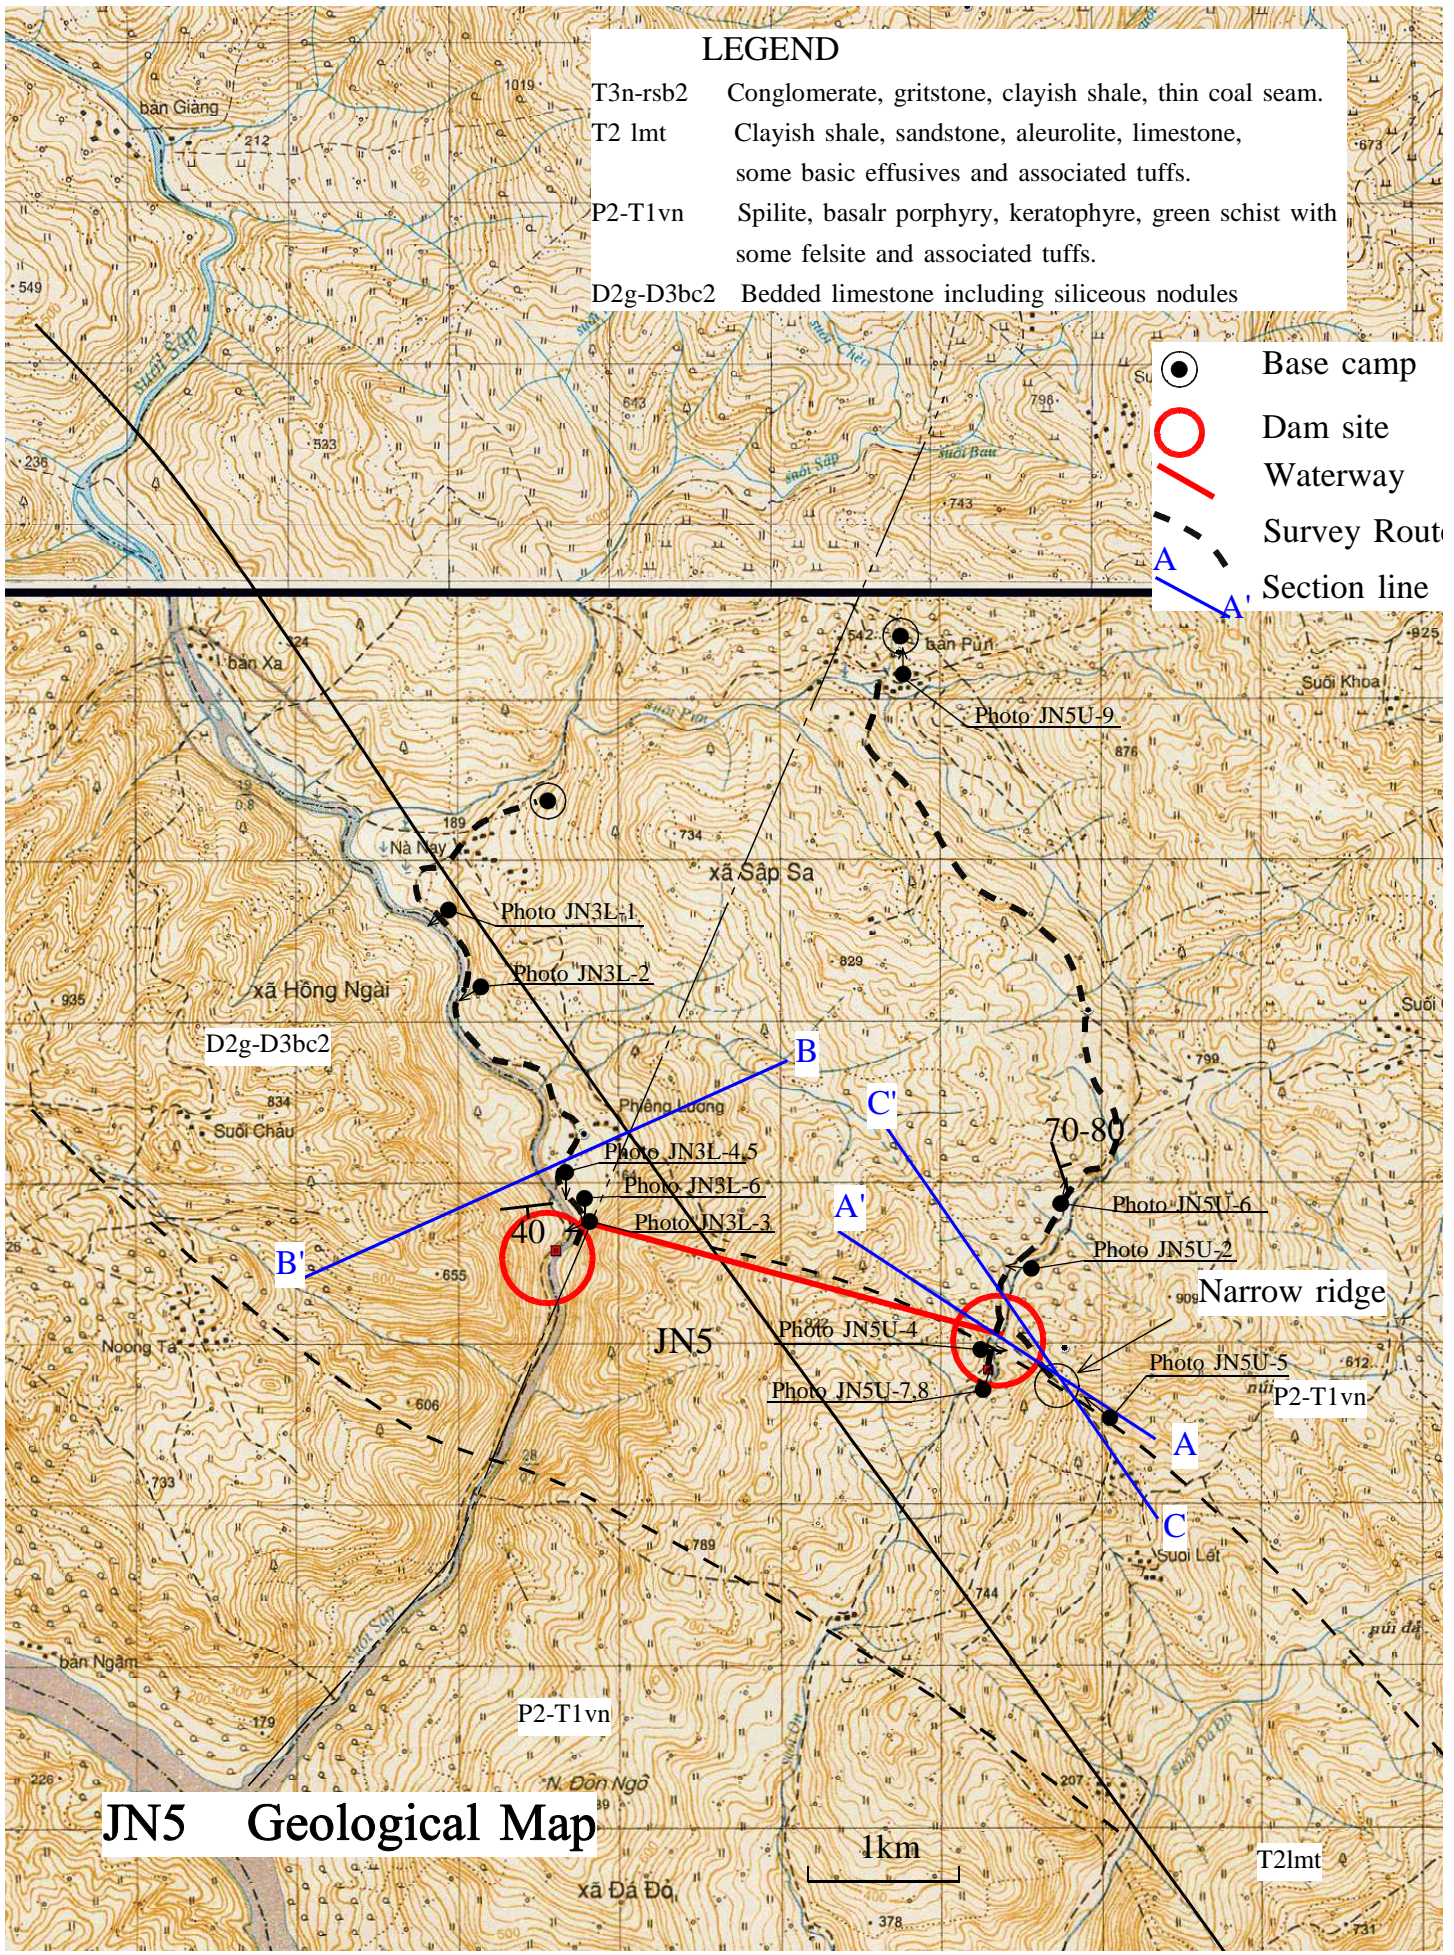
**JN5 Geological Map**

Geology around the Upper Reservoir is hard and massive green schist / basalt porphyry (P2-T1vn) and clayish shale / limestone (T2 lmt) is around the Upper reservoir and Dam site. These formations are contact with NW-SE strikes and the boundary cross the valley of Suoi on.

Hard and massive porphyry and schist outcrops in the river bed. The weathering on the slope of valley is about 5-15m. No spring points are found, but ground water level probably near the elevation of the river according the agriculture. Permeability of rock looks relatively low.

The rock around the geological boundary are limestone/shale and schist, there are no weak zone along the boundary.

There are narrow ridge in the left side of the reservoir, corn firm was found behind this ridge on the higher elevation than bottom of the reservoir level. The top of this field or firm has probably spring points but no seen. This narrow ridge is on the geological boundary of (P2-T1vn/T2 lmt)as NW-SE system, and topographical lineament indicates the weathering covered by surface. This boundary is not clear but probably vertical to slightly north.

Geology around the Lower reservoir is composed of mainly limestone (D2g-D3bc), condition of rock is hard and massive in general. The NW-SE system of structural line along the river is reported in the published map. Both side of the slope beside the river is steep of limestone.

The slope around the Dam site is 20-35 degrees of limestone with many open joints in the

river level. The permeability of rock is high, strength of massive limestone is nearly same as the other sedimentary rocks.

Structural line of NW-SE system along the river is reported in the published geological map, and the NE-SW fault also probably crosses from the river through the lower reservoir to the ban Pun village. There are many fractured outcrops along the road near the village.

Designed waterway route runs under the boundary of limestone and basalt porphyry/schist zone, the conditions of these rocks are massive and hard with some open joints in the limestone. The permeability of rock seems probably high. There are no features of the fault in the surface.

- Investigation for the weathering grade of the geological boundary on Upper Reservoir will be needed.
- Investigation for the conditions of structural line along the river around the Lower Reservoir will be needed.
- Limestone around the Lower Reservoir is hard and massive, probably high permeability.
