## PART II MASTER PLAN

### 6. BRIDGE CONDITION SURVEY AND ASSESSMENT

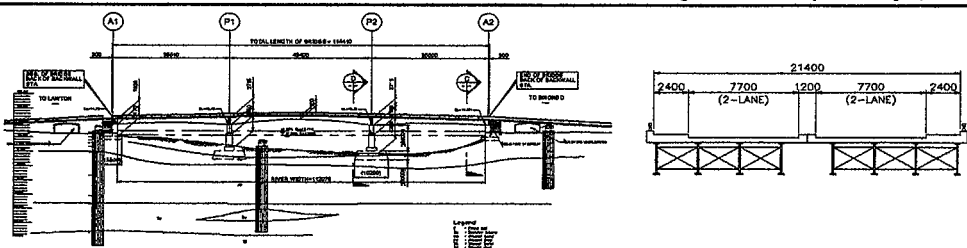
Elevation and Cross Section		Pa2 JONES BRIDGE Exchange Rate: 2.269 (As of May 5, 2003)

Construction Year: 1948    Superstructure Type: 3-Span Continuous Steel Plate Girder Bridge Substructure Type: Abutment: Wall, Pier: Wall, Foundation Type: Abutment: Spread, Pier: (Caisson)	
Alternatives		Repair	Rehabilitation
Major Works	Superstructure	<ul style="list-style-type: none"> <li>* Cleaning/Painting of corroded steel members</li> <li>* Repair of ruptured sway bracings</li> <li>* Repair of ruptured exterior girder by plate patching</li> <li>* Repair of sole plate and girder section at bearing</li> </ul>	<ul style="list-style-type: none"> <li>* Cleaning/Painting of steel structure for whole bridge</li> <li>* Replacement of ruptured sway bracings</li> <li>* Provide additional girder w/ new bearing shoes</li> <li>* Repair &amp; retain existing exterior girder to function as vessel collision protection</li> <li>* Remove and reconstruct deck slab, sidewalk, railing and expansion joint.</li> </ul>

Substructure	-	* Sealing of concrete crack, spalling & exposed rebars
	Foundation	-	-
① Reliability for the structural safety		* RF = 0.00 (Load Rating 0 tons for ruptured girder) * C/Dpl=0.37 (Body of Pier 1) * C/Dpl=0.86 (Foundation of Pier 1) (Less resistance to latest seismic code)	* RF = 1.00 (Load Rating 32.7 tons) * C/Dpl=0.37 (Body of Pier 1) * C/Dpl=0.86 (Foundation of Pier 1) (Less resistance to latest seismic code)
② Construction Period and Difficulty		* 4 Month (easy)	* 18 Months (moderate)
③ Traffic Management during Construction		No disturbance of existing traffic	No disturbance of existing traffic
Navigation Clearance		Less by 15cm than a regulatory clearance of 3.75cm	Less by 15cm than a regulatory clearance of 3.75cm
Construction Cost (MP)		32	161.8
Evaluation		3	1
