## PART III FEASIBILITY STUDY OF THE AYALA BRIDGE

### 13. BRIDGE CONDITION SURVEY AND TESTS

## 14. ASSESSMENT OF EXISTING CONDITION

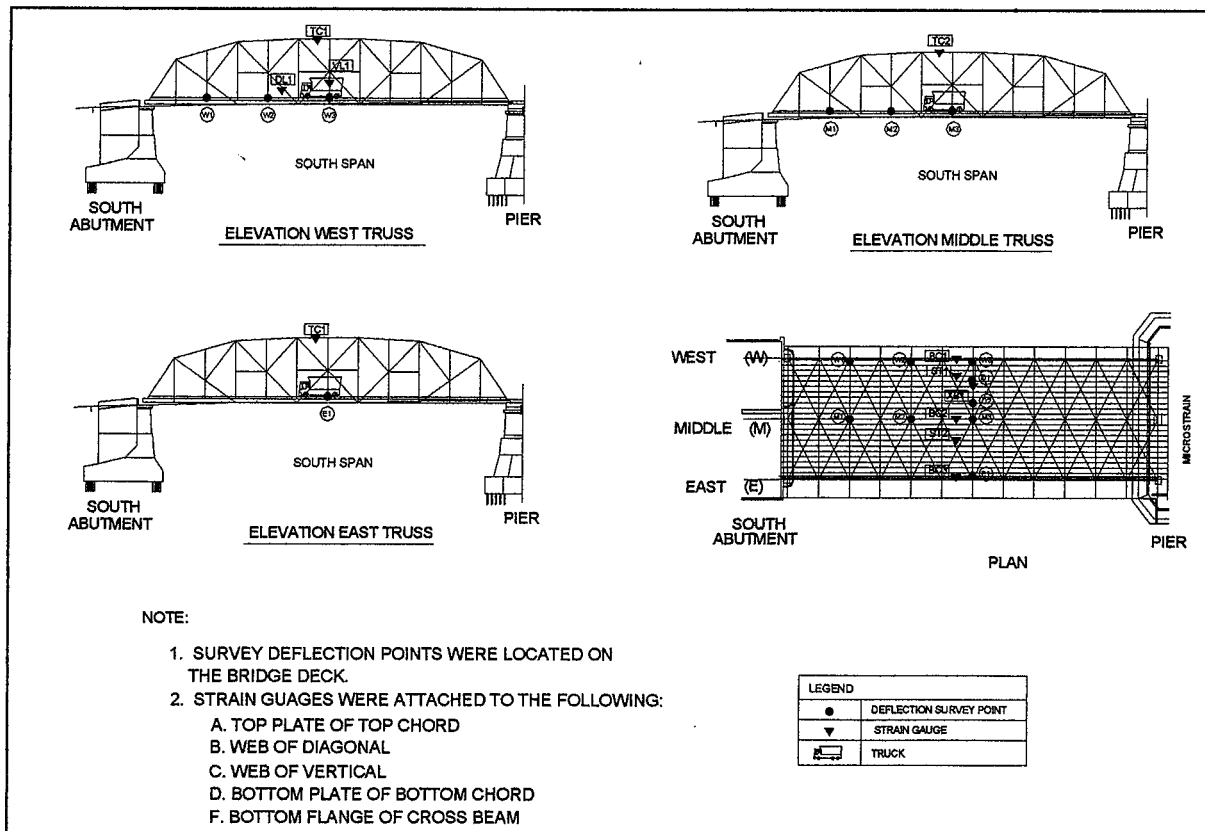
Location of Deflection Survey Points and Strain Gauges

Maximum deflection at the west truss during step load 3 was 7mm near the middle of the roadway.

Strains measured by strain gauges were extremely small and ranged from  $0.6 \mu\epsilon$  to  $6.2 \mu\epsilon$ .

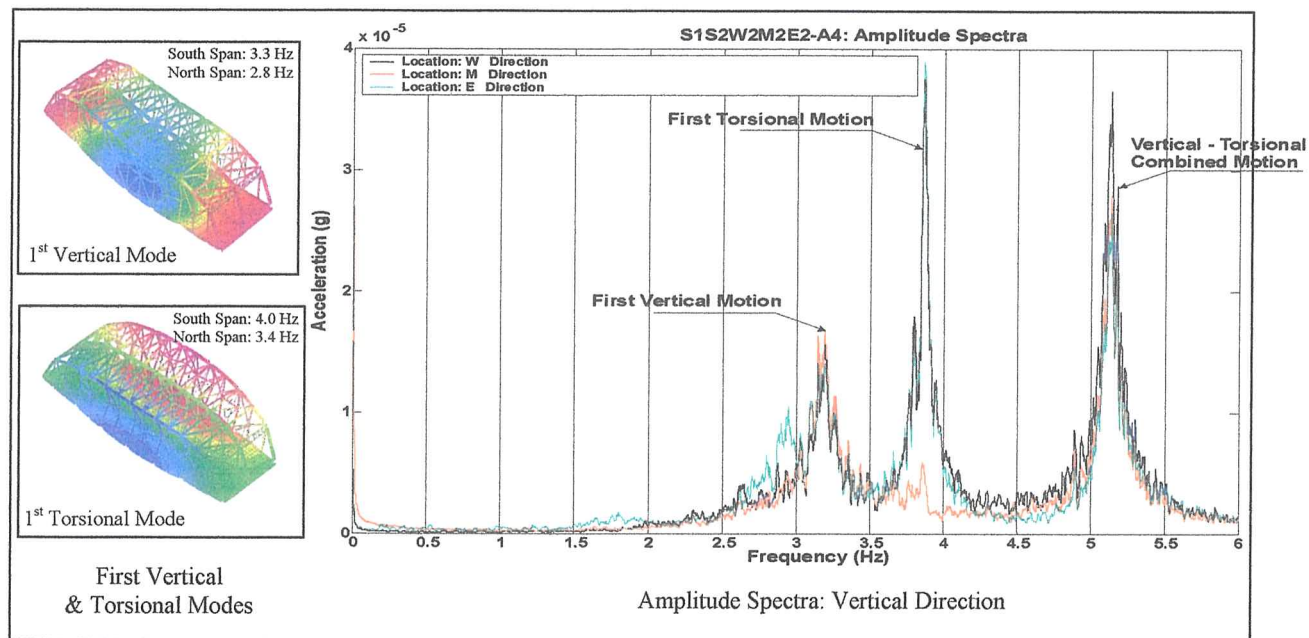
Mode and Frequency by Microtremor Measurement

- For the South Span, the most probable natural frequency of the 1<sup>st</sup> vertical mode is 3.2Hz, and that of the 1<sup>st</sup> torsional mode is 3.9Hz.
- For the North Span, the most probable natural frequency of the 1<sup>st</sup> vertical mode is 2.7Hz, and that of the 1<sup>st</sup> torsional mode is 3.4Hz
- The analysis model for load rating was modified to fit for these natural frequencies.

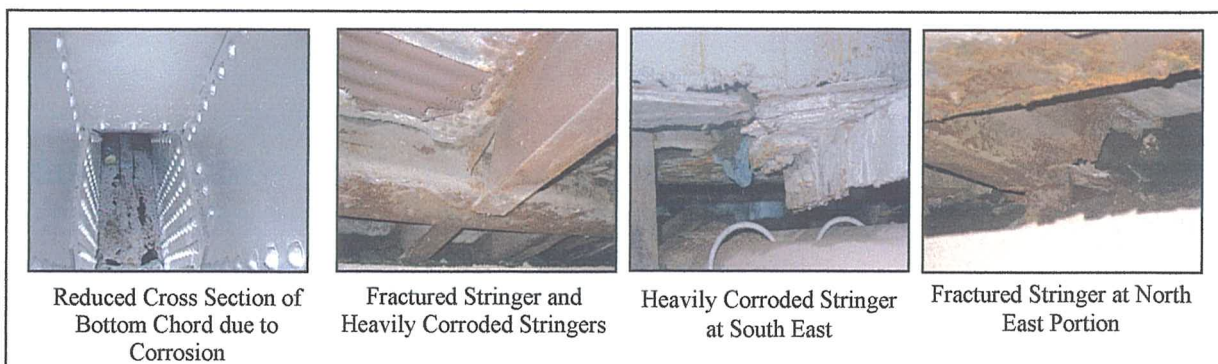
- Abnormal deflection during vehicles passing at the north span was observed.
- Serious section loss of bottom chords was found at the connections.
- Cross beams were heavily corroded.
- Stringers of the east side of north span were completely broken near the abutment.
- A sway bracing at the south span and a stringer at the north span were missing.
- Most of joint areas were heavily corroded.
- Steel bearings didn't function because of cracks and heavy corrosion.
- Substructures were mostly sound, while having small cracks.
- The upper chords were mostly sound, while corrosion at joints being found.

The damage diagnosis reveals the fact that the damages have extremely developed, and the qualitative damage rating justifies the urgent need of improvement of the Ayala Bridge.

Typical Damages

- Replacement of lower chords with new steel members,
- Replacement of fatigued members,
- Replacement of floor system with steel deck slab systems,
- Reconstruction and strengthening of abutments and pier,
- Jacking-up of superstructure by 25 cm to secure the regulatory navigation clearance, and
- Construction of a detour bridge and road during construction.

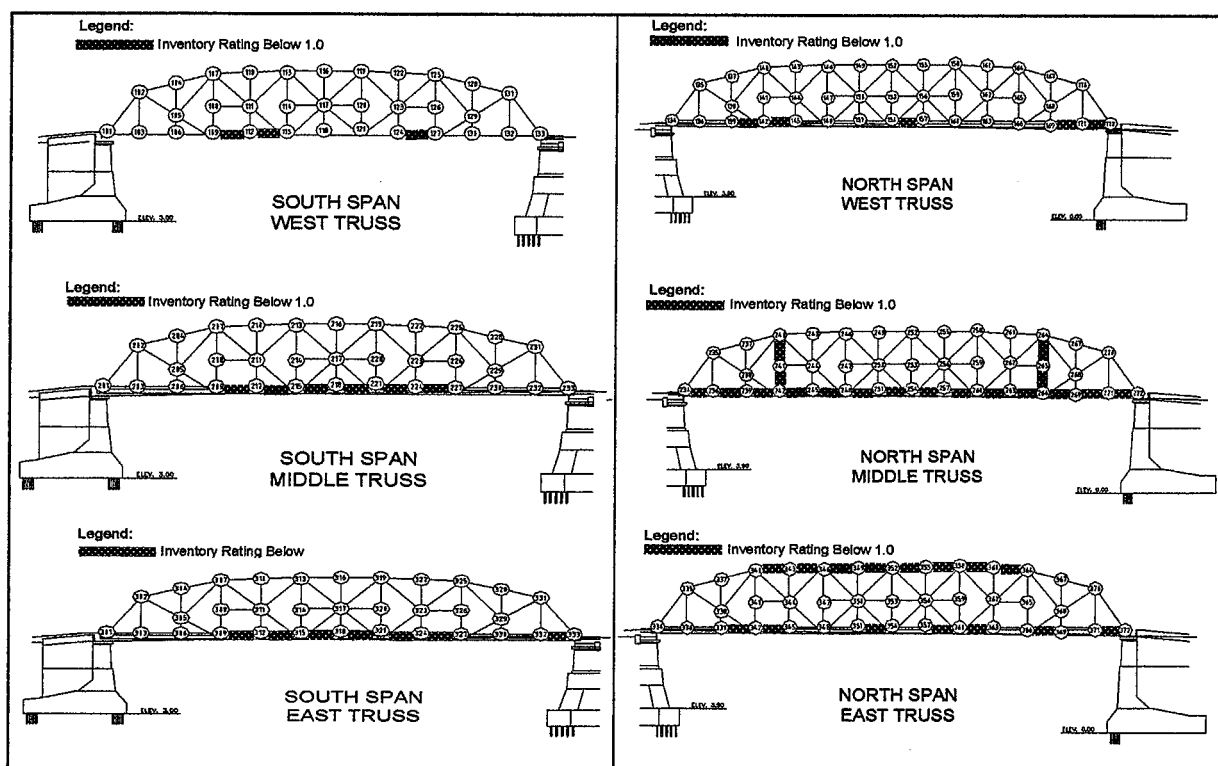
Members Below 1.0 of Rating Factor at Inventory Level

The figure below shows the members below 1.0 of RF which are highlighted for the Inventory Level. This level generally corresponds to the customary design level of stress but reflect the existing damage and material condition with regard to deterioration and loss of section.

- Most of the lower chords show the rating factor, either inventory or operating level, less than 1.0, which means the structural capacity of the bridge is less than 32.7 tons (design load).
- Floor system including cross beams and stringers are heavily corroded or fractured, requiring very urgent replacement.
- The corrosion of members have been heavy due to water from deck slab and aggravated by more number of vehicle and present load of heavy vehicle than expected.

- Tightening the regulation on the present vehicle load limits from 5 to 3 tons should be done, if improvement works are not carried out. However, the drastic improvement works of main members shall be required because  $RF_i$  of the inventory level is still insufficient for any vehicle.
- The drastic improvement works of the bridge should be conducted as soon as possible in order to secure the safety driving and to prevent the potential fall down of the bridge.
- The planning of the improvement works shall be implemented so as to meet the latest design code requirements with consideration of the present traffic conditions.
