THE STUDY  
ON  
THE IMPROVEMENT OF EXISTING BRIDGES  
ALONG PASIG RIVER AND MARIKINA RIVER  
IN  
THE REPUBLIC OF THE PHILIPPINES

FINAL REPORT  
MAIN TEXT (2/3)

JULY 2004

<b>Chapter 13</b>	<b>DETAILED BRIDGE SURVEY AND ASSESSMENT</b>	
13.1	Review of Design and Repair Works .....	13-1
13.1.1	Review of Design.....	13-1
13.1.2	Review of Rehabilitation Works.....	13-3
13.1.3	Historical Background .....	13-5
13.2	Natural Condition Survey .....	13-8
13.2.1	Topographic Survey.....	13-8
13.2.2	Geotechnical Survey.....	13-9
13.2.3	Scour Survey.....	13-10
13.3	Bridge Condition Survey and Identification of Damages.....	13-11
13.3.1	Measurement of Shapes and Dimensions .....	13-11
13.3.2	Close-Up Visual Inspection.....	13-15
13.3.3	Non-Destructive Test of Material .....	13-17
13.3.4	Static Load Test of Superstructure.....	13-19
13.3.5	Microtremor Measurement Survey.....	13-22

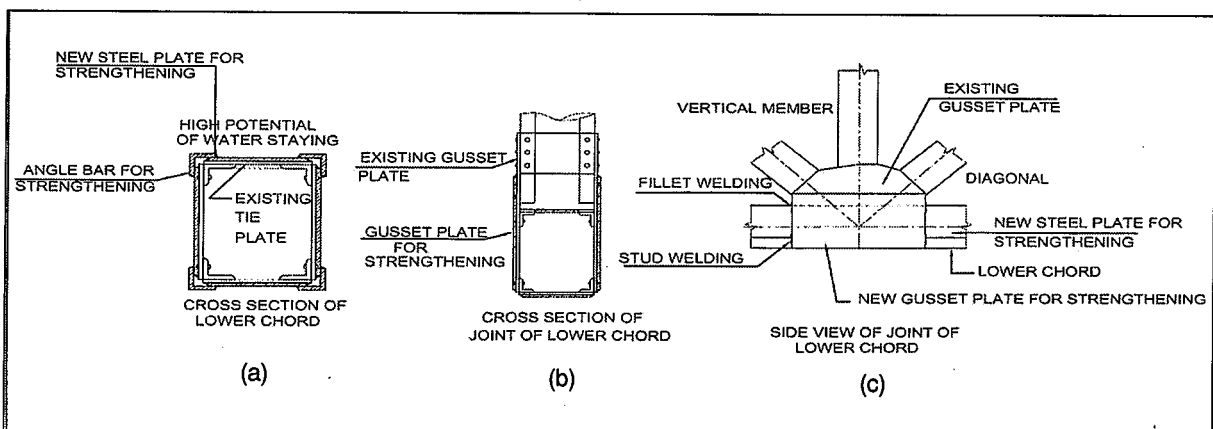
Figure 13.1.2-2 Rehabilitation of Lower Chords

Joint area of lower chords were strengthened by fillet welding of steel plates onto existing gusset plates as shown in Figure 13.1.2-2 (c).

- Stud welding between steel plates strengthening for lower chords and gusset plates is considered to be insufficient for strong tension forces. New gusset plates should overlap with adequate length with new steel plates for strengthening.
- The level of present rehabilitation is considered to be a temporary emergency countermeasure because broken stringers are just supported by only a temporary structure.
- The inner faces of lower chords have high potential for corrosion because they are not closed completely. This will accelerate corrosion of the inner steel plate.
- New steel plate added to existing one of the lower chords is connected by two angle bars on each side as shown in **Figure 13.1.2-2 (a)**. Leaking water will easily stay because water flow is blocked by these angle bars. This will accelerate corrosion of the new steel plate.

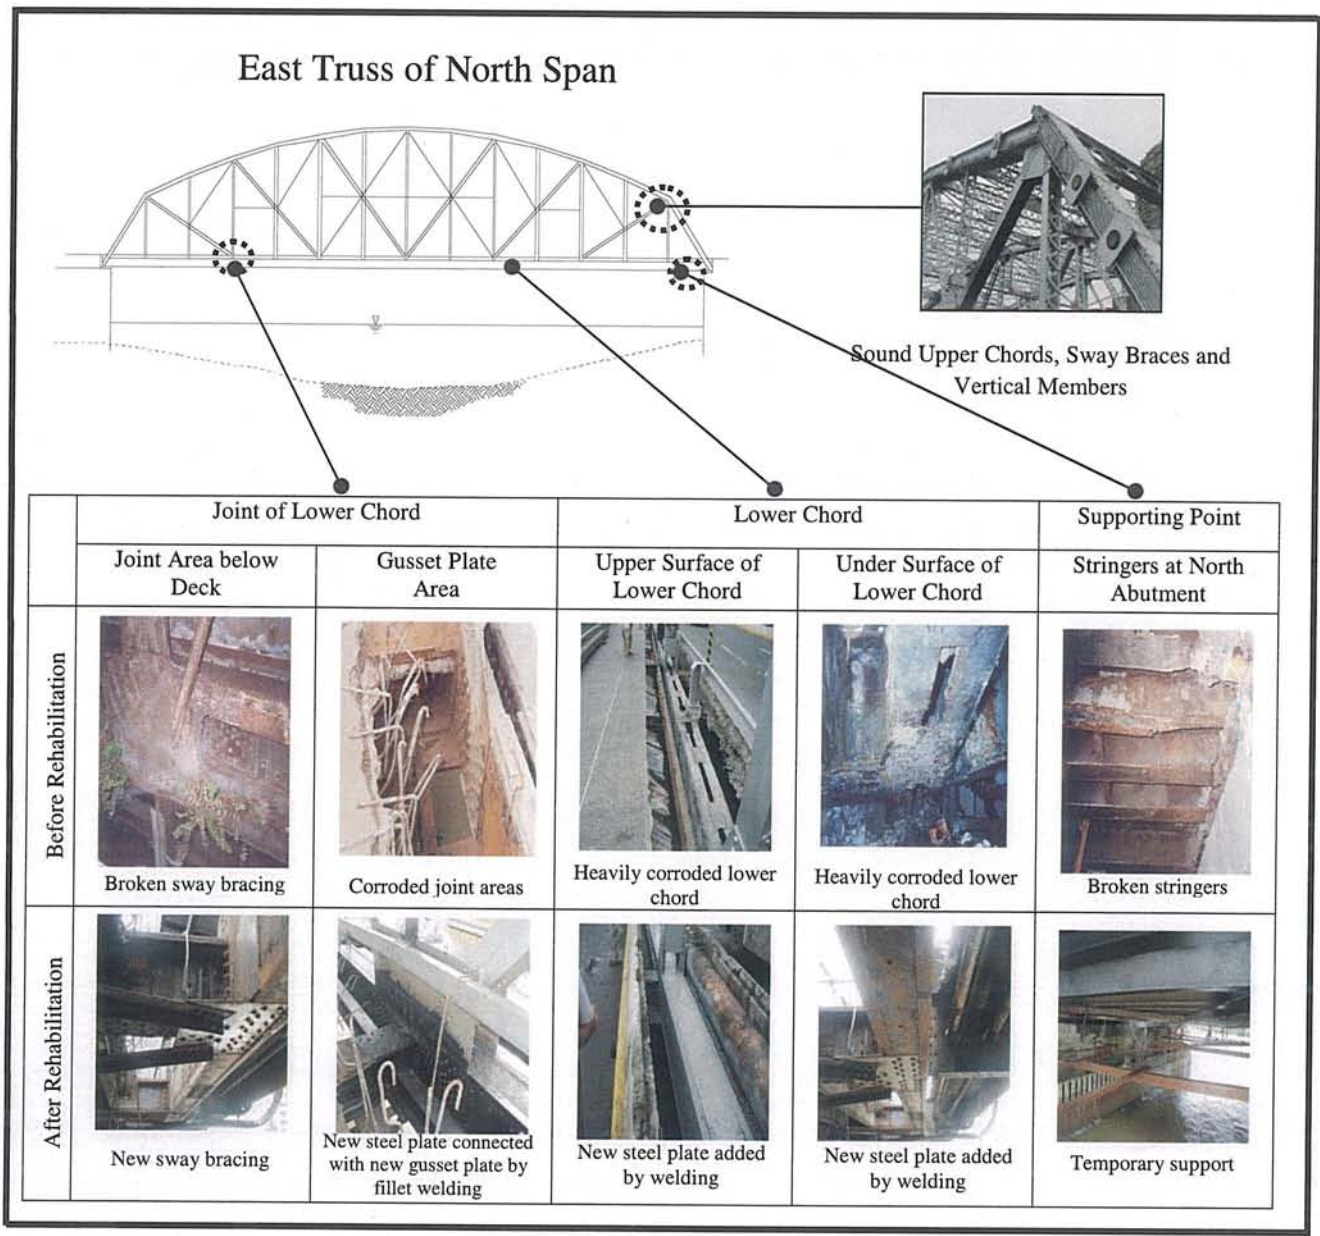
Figure 13.1.2-1 Before and After Rehabilitation Works for Ayala Bridge (Year 2002)

Figure 13.1.2-1 shows a comparison of the bridge condition before and after the rehabilitation works done using local funds for the Ayala Bridge in 2002.

The ends of stringers were heavily corroded and partially broken. Under the rehabilitation works, broken stringers on the upstream side of the north span were supported by a temporary structure support, as shown in **Figure 13.1.2-1**.

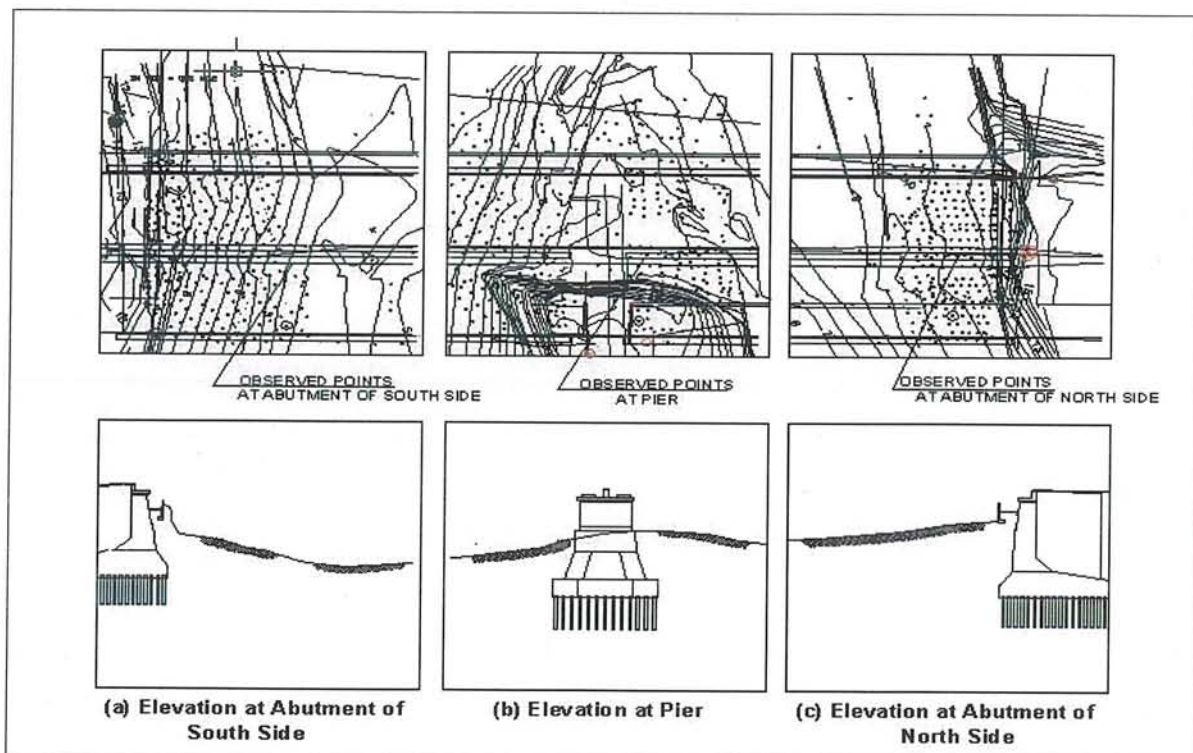
Figure 13.2.3-1 Results of Scour Survey at Abutment and Pier

Sufficient side shots and observations were taken at closer interval around the location of the substructures in order to determine a more detailed riverbed configuration. The scour survey results are illustrated in **Figure 13.2.3-1**.

From these results, scouring around foundation was not observed.
