13.3 BRIDGE CONDITION SURVEY AND IDENTIFICATION OF DAMAGES

13.3.1 Measurement of Shapes and Dimensions

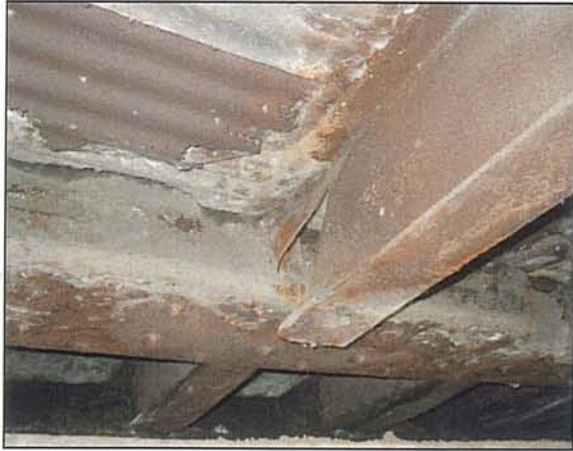
(a) Fractured Stringer and Heavily Corroded Cross Beams

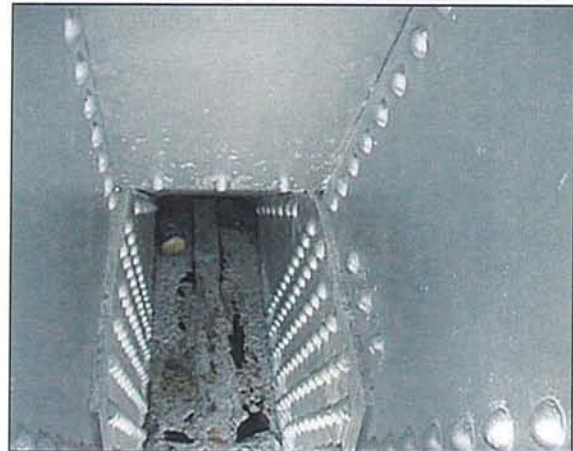
(b) Reduced cross section of Bottom Chord due to corrosion

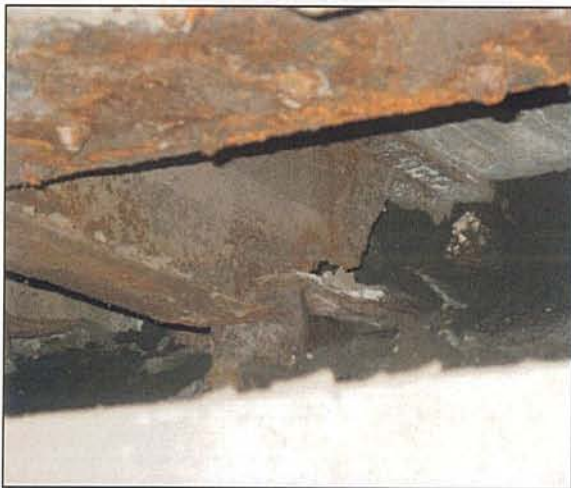
(c) Fractured Stringer at North East Portion

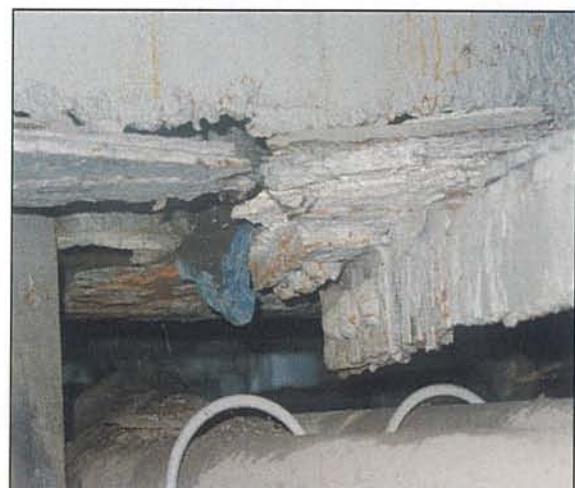
(d) Heavily Corroded Stringer at South East

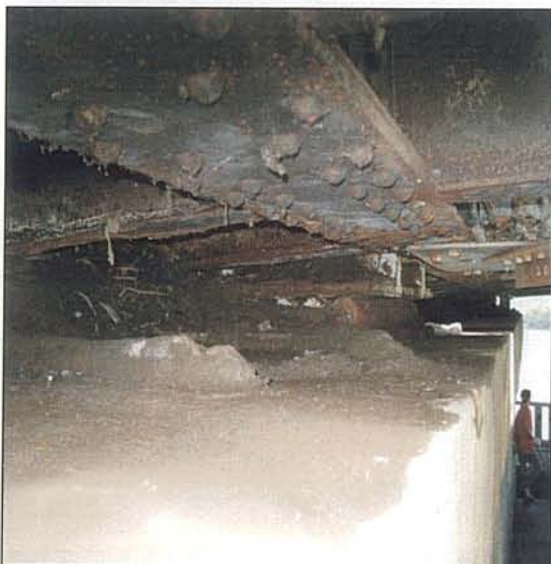
(e) Damaged at Substructures and Bearings, Corrosion and (Abnormal) movement of Bearing at North Abutment. Roller most likely stuck-up

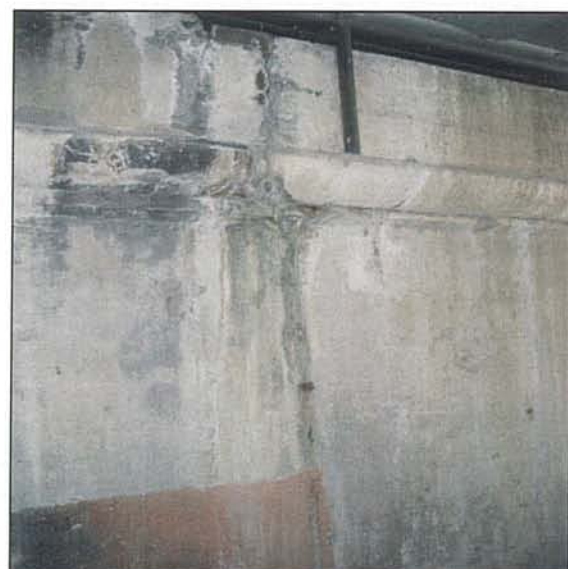
(f) Cracks and Concrete Spalling at Abutment (View South)

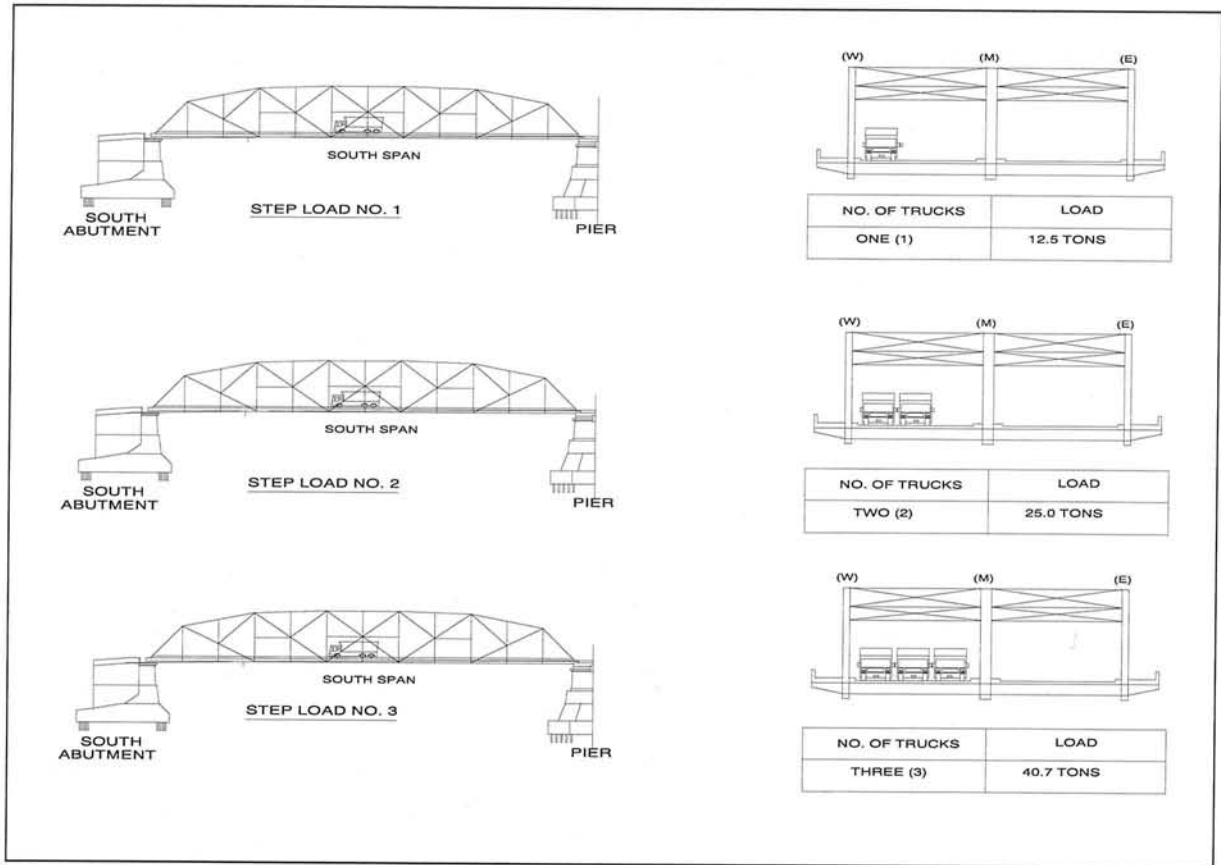
Figure 13.3.4-2 Step Load Pattern of Trucks

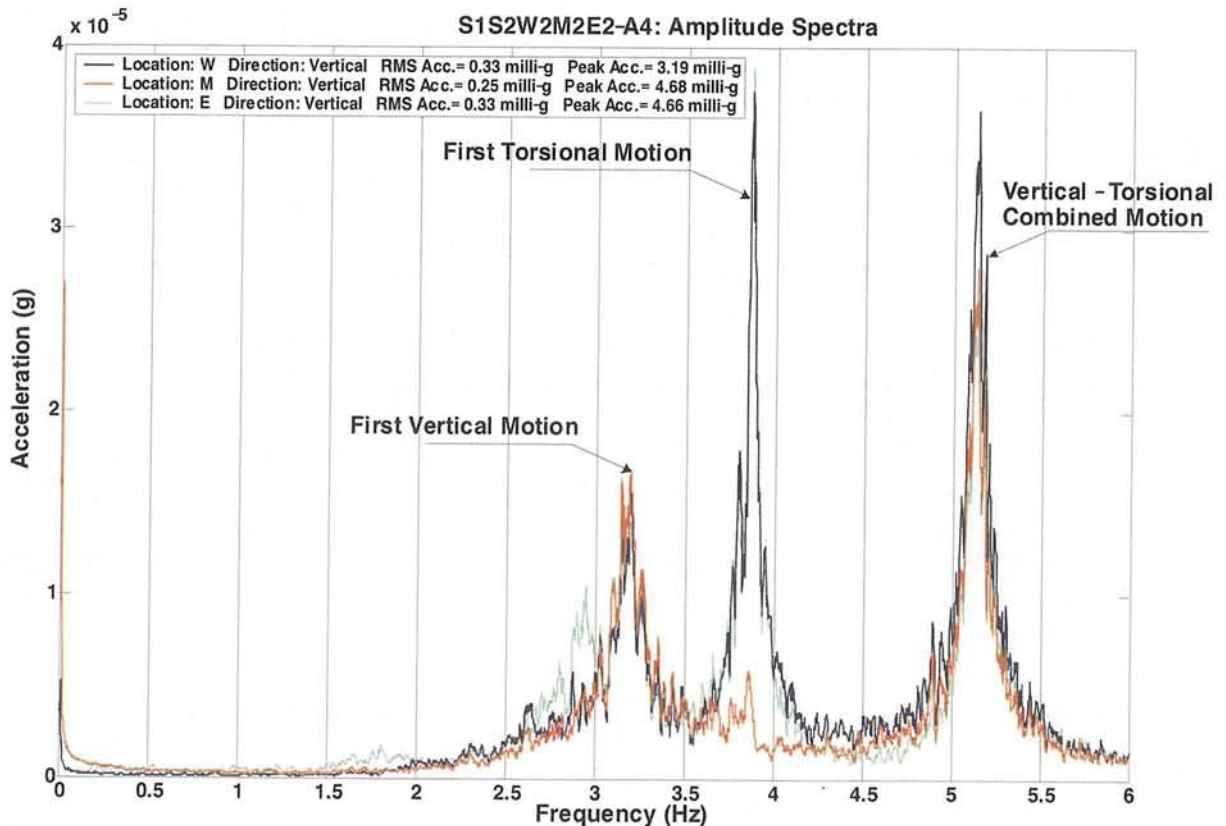
Figure 13.3.5-3 South Span Sample Amplitude Spectra: Vertical Direction

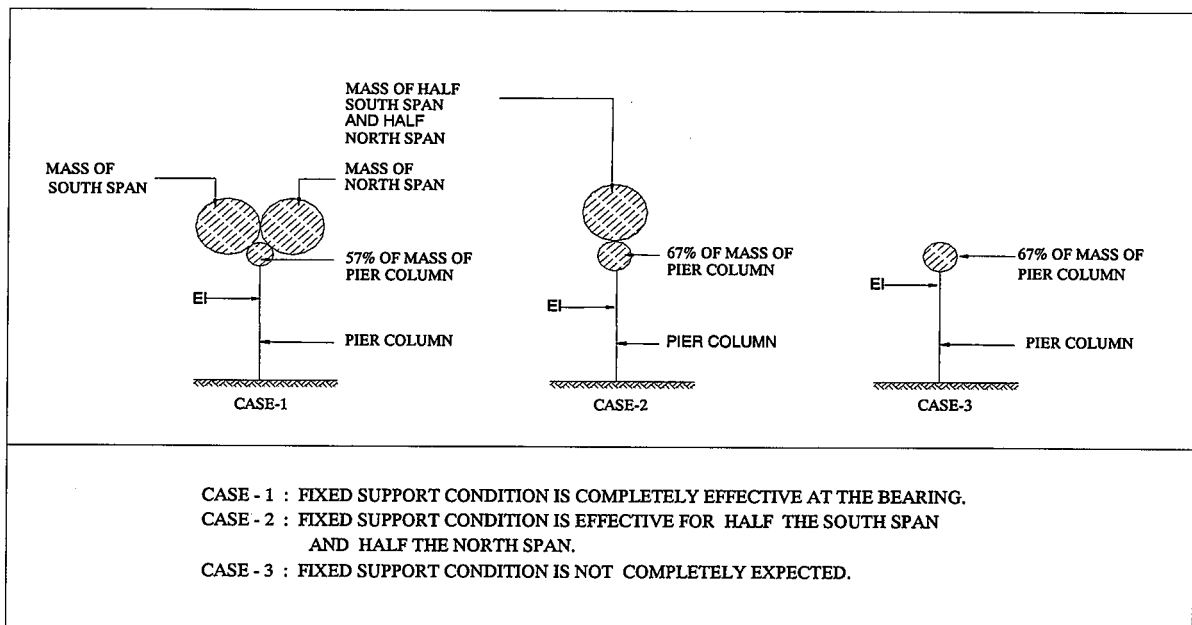
Figure 13.3.6-3 Cases for Eigenvalue Analysis

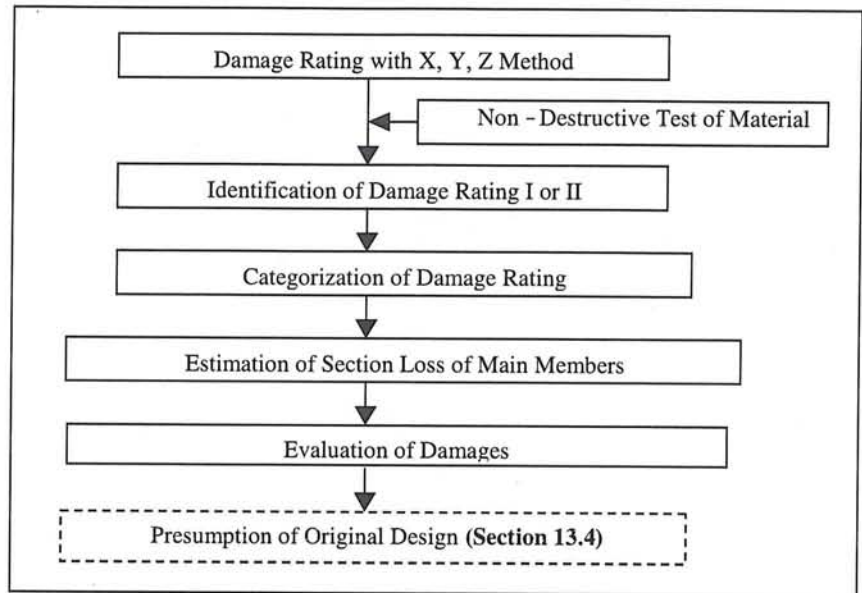
Figure 13.3.7-1 Procedure of Diagnosis for the Soundness of Bridge

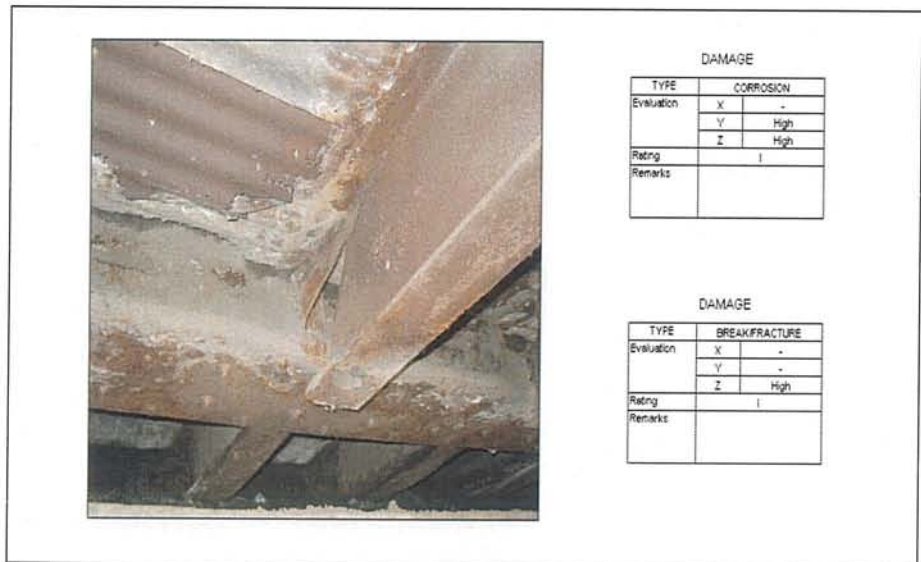
Figure 13.3.7-2 Damage Rating Example Adopting the X, Y, Z Method

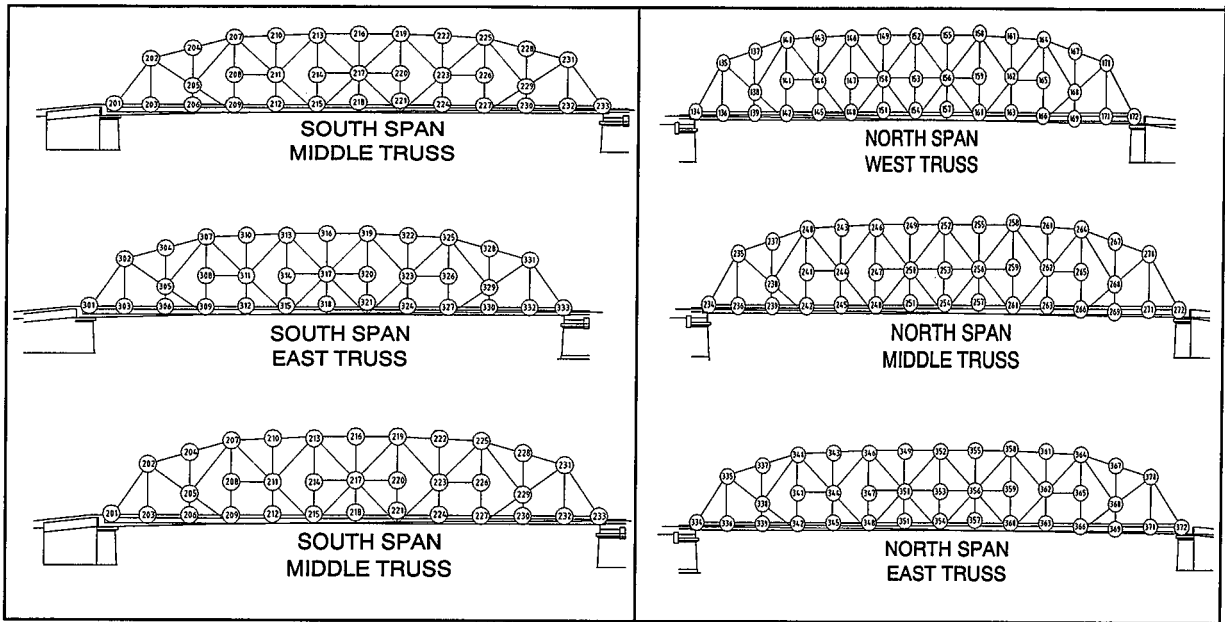
Figure 13.3.7-4 Node Numbers for Reference

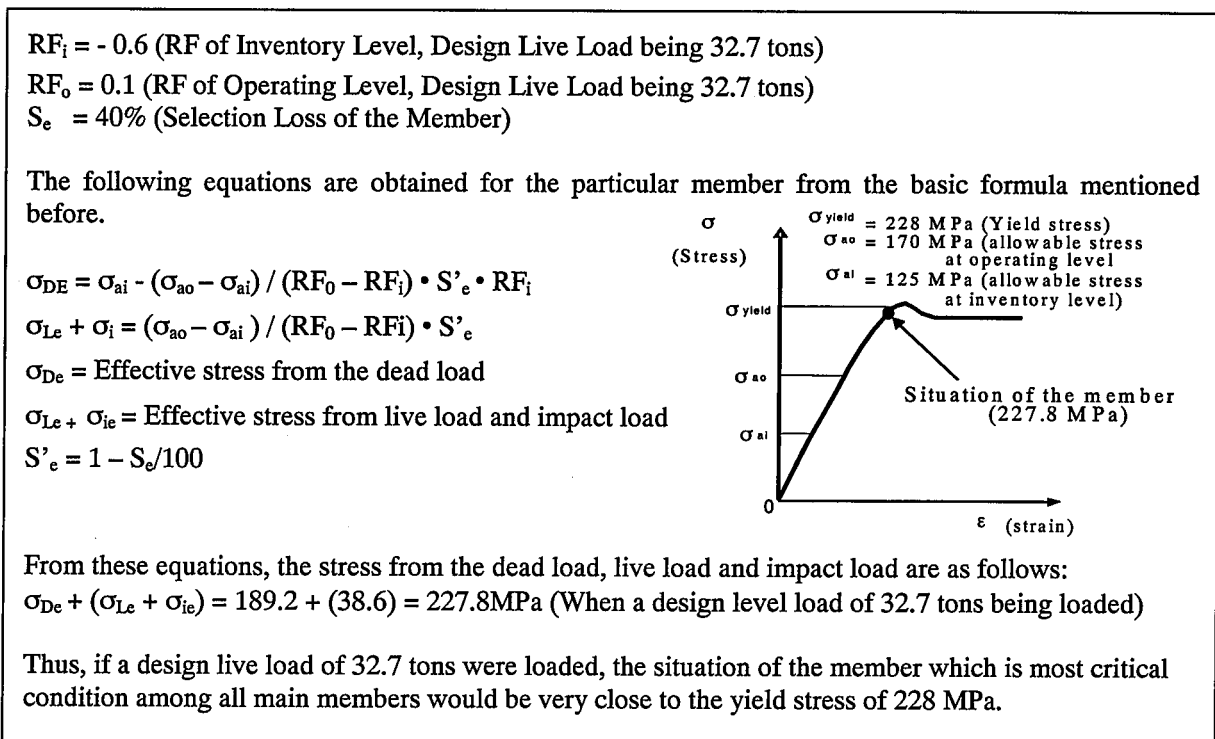
Figure 13.4.3-3 Effective Stress for Members with Section Loss

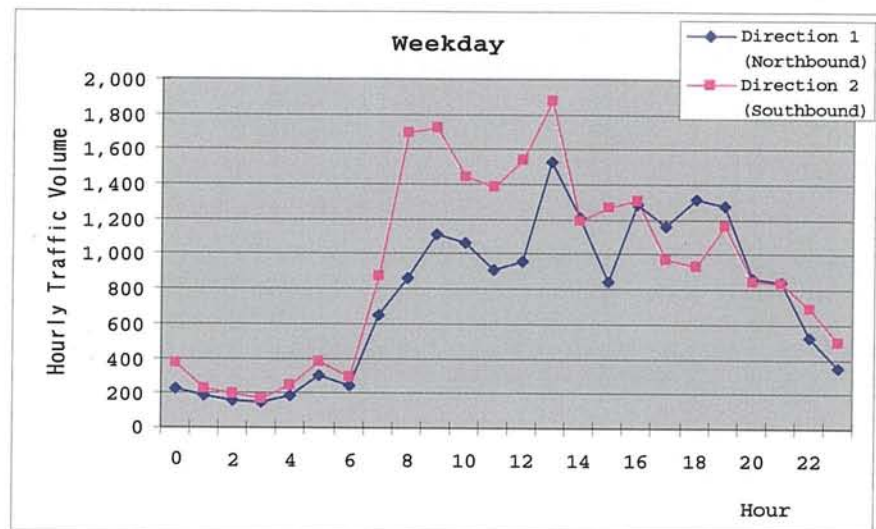
Figure 13.5.1-1 Hourly Traffic Volume Variation
