FEASIBILITY STUDY OF JONES BRIDGE REHABILITATION PLAN

20.1 DETAILED BRIDGE SURVEY AND ASSESSMENT

20.1.3 Bridge Condition Survey and Identification of Damages

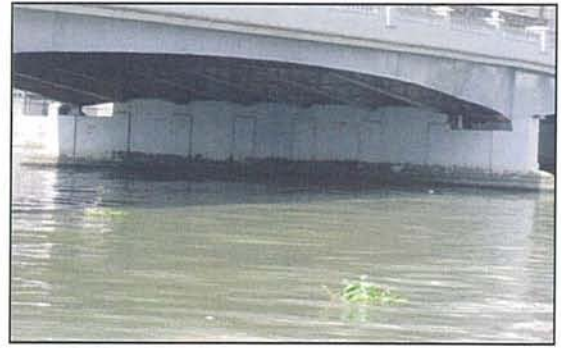
Photo 20.1.1-2 Shear keys as shown on Top of Piers and Abutment are part of ERP Retrofit Program in 1997.

Shear keys on top of the piers were also constructed to properly transmit the forces from superstructure to the substructure. The support condition of the girders at Pier P2 (near Binondo side) was changed from roller condition to hinge condition.

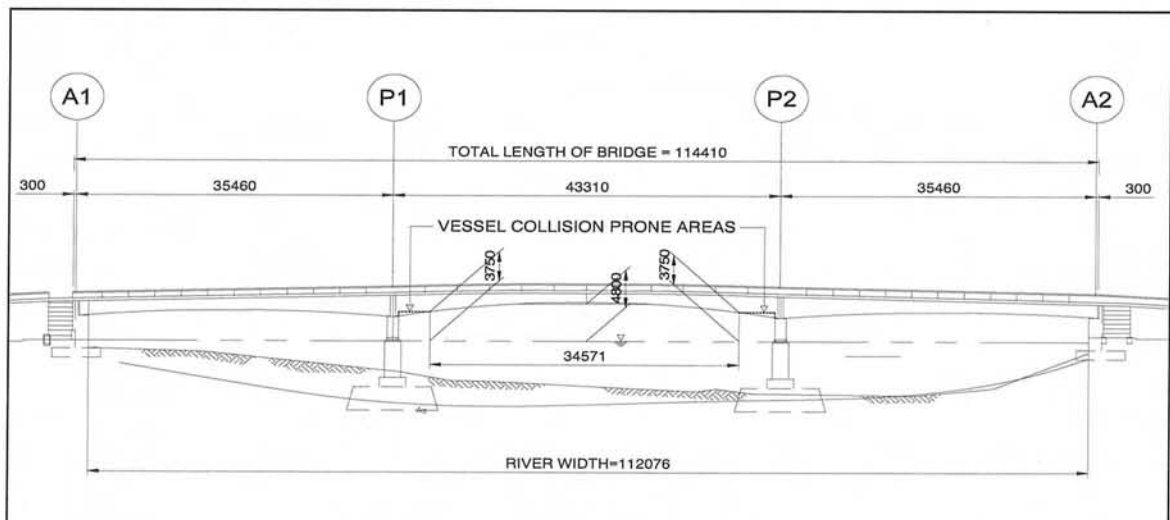
Figure 20.1.1-1 Navigational Clearance of Jones Bridge

- Deck slab were fully replaced, and no major damage or defect was detected in this study.
- The exterior girders at upstream & downstream sides were temporarily repaired, and they are still prone to vessel collision because of the lower vertical clearance at near piers.
- The existing vertical clearance near the piers is 3.6m, which is lower than the regulatory vertical clearance of 3.75m as shown in **Figure 20.1.1-1** and was not improved during the rehabilitation.

- From the above configurations, it can be seen that the exterior girders are prone to vessel collision as proven by the rupture of existing girder on the upstream side and the out-of plane deformation of the exterior girder on the downstream side.
- It should be noted that no previous rehabilitation was done on Pier walls and existing foundation connection. This connection is insufficient as far as the requirement of the latest code is concerned.

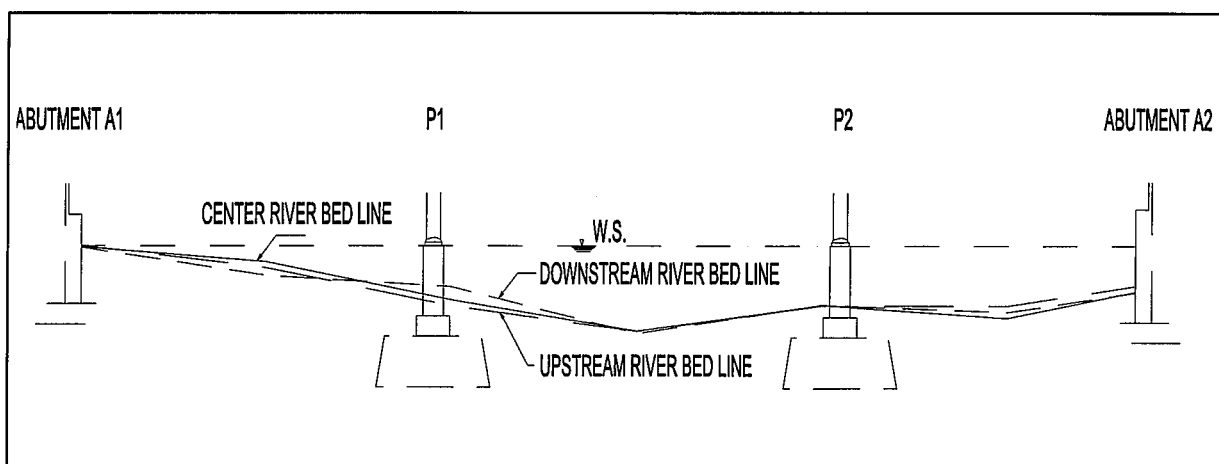
Figure 20.1.2-1 Result of Scour Survey Conducted in Jones Bridge

As shown in **Figure 20.1.2-1**, scouring around substructures were not found.

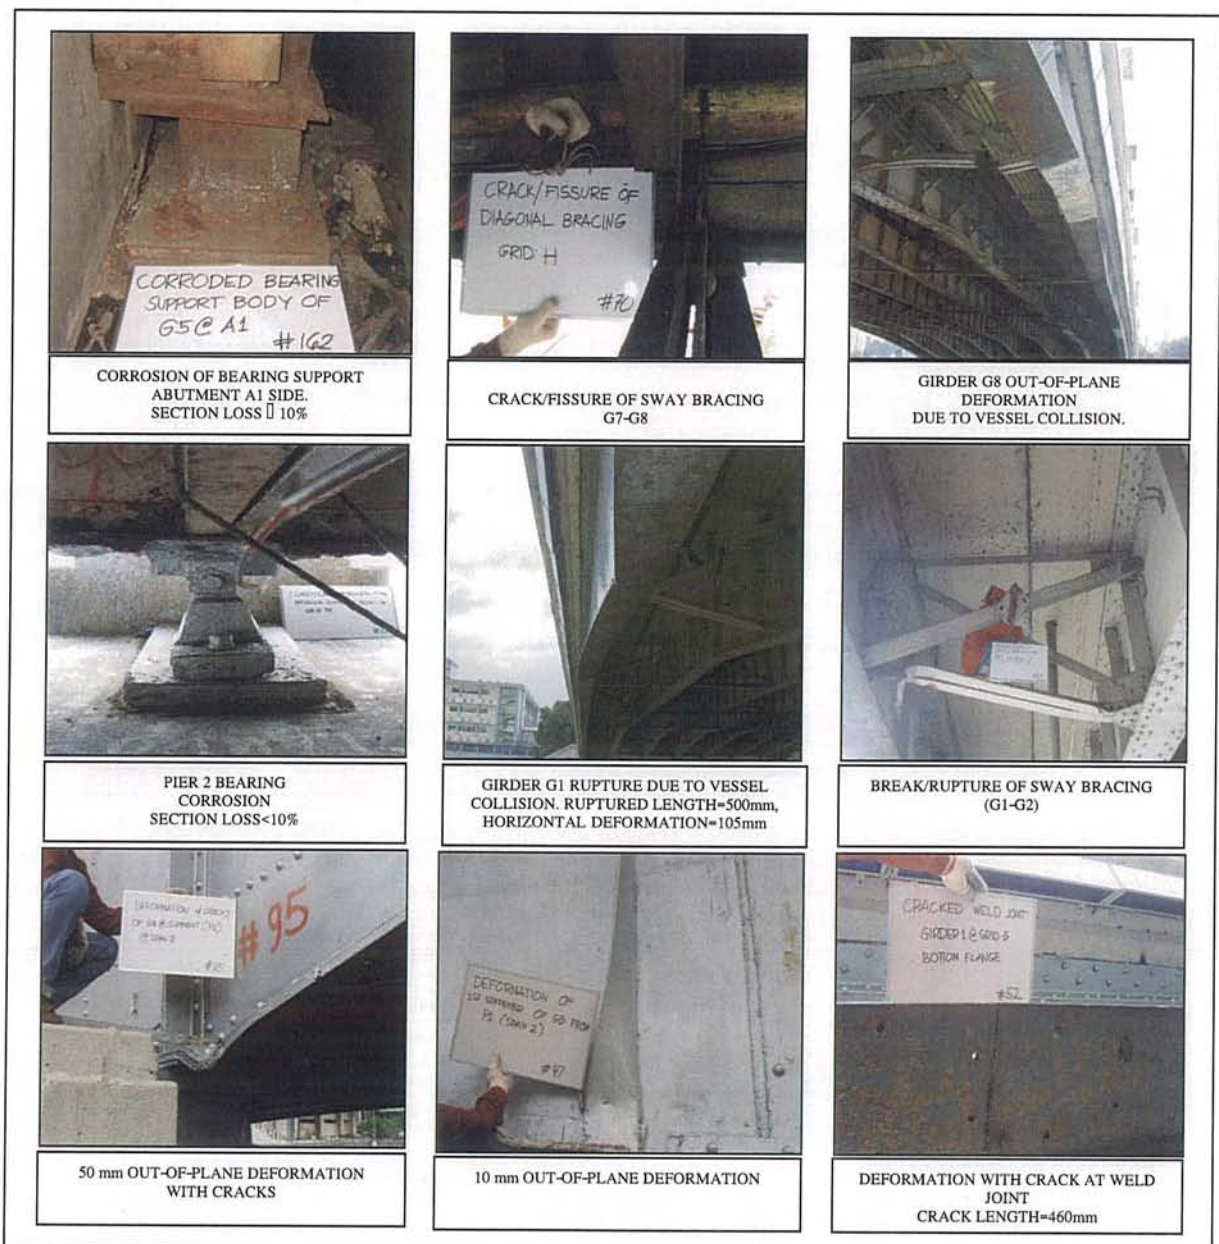
Figure 20.1.3-2 Close-up Visual Inspection of Major Damages in Jones Bridge

- There was no damage found on deck slab roadway of Jones Bridge except for some minor damages of concrete post and railing.
- Bearings on Abutment A1 and Pier P2 are heavily corroded.
- The exterior girders were heavily damaged or ruptured by collision of vessels.

- A ruptured girder on upstream side was once repaired but again damaged by vessel causing a 500 mm vertical rupture on web.
- Buckling of downstream exterior girder vertical stiffener are also noted.
- A large horizontal deformation on exterior girders was found as shown in **Figure 20.1.3-1**.
- The lower flange of exterior girder at point of bearing support has settled down by 50 mm, which has also revealed cracks after conducting non-destructive testing.
- Local buckling of sole plate and bottom flange at bearing positions are observed.
- The major damages of Jones Bridge are shown in **Figure 20.1.3-2**. The damage rating of main members based on Close-up Visual Inspection is shown on **Table 20.1.3-2**.

| Component | Item | Member / Location | Damage Rating *1 | Description |
|---|---|---|---|---|
| Superstructure | Shape and Dimension, Material Damage | Girder 1, Span 2 | I | Girder 1 break rupture of bottom flange to 1/3 web depth and 105mm out-of-plane deformation due to vessel collision |
| | Shape and Dimension | Sway Bracing (G1-G2) | I | Break rupture of sway bracing |
| | Material Damage | Girder 1, Span 2 | I | Crack at welded joint of bottom flange |

- Additional girders should be installed adjacent to the existing exterior girders to take its structural functions.
- The existing ruptured (G1) and deformed (G8) exterior girders should be repaired and reinstalled to function as vessel collision protection of the superstructure. In addition, retention of the exterior girders is consistent with NHI's policy of preserving the bridge's original configuration.
- Restoration of ruptured sway braces are necessary.
- Missing bolts and sway brace members should be replaced.
- Corrosion of steel members particularly bearing shoes at top of Pier 2 and Abutment A1 should be eliminated to prevent further deterioration.
- Pier walls and foundation based on the structural analysis made does not conform with the latest code requirements. A retrofit measure is necessary to strengthen the substructure to meet the latest code requirement.

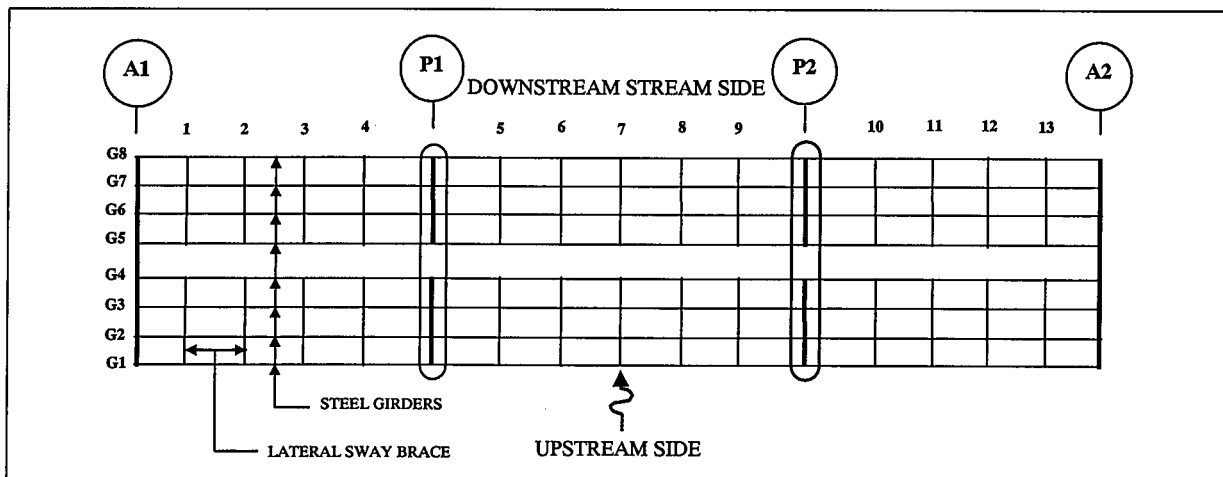
Table 20.1.3-6 Evaluation of Major Damages on Jones Bridge

| | Location | | Evaluation Based on Field Survey | | | | Evaluation Based on Non-Destructive Test | Evaluation Based on Special Test | |
|--|---|---|---|---|---|---|---|--|--|
| Superstructure | G1, Span 2 | 9 | B/R | I | A | 40% | <ul style="list-style-type: none"> • Ultrasonic Thickness Gauging - No Defects • Brinell Hardness Test - No Defects, Tensile Strength Conforms to A36 Materials • Dye Penetrant Test - Crack at Weld Joint of Main Girders G1 Length = 10.5", G7 Length = 9", G8 Length = 7" | <ul style="list-style-type: none"> • Micro-tremor Test - OK | |

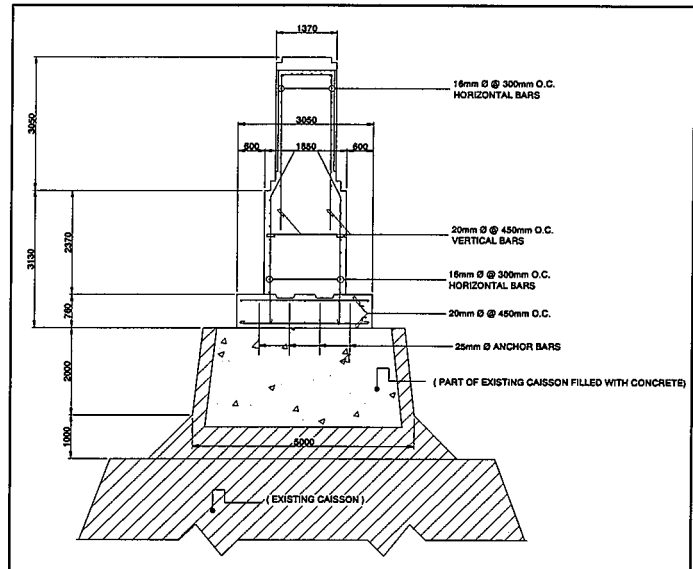
Figure 20.1.4-1 Detail of Existing Pier Wall

The existing superstructure is supported by wall-type pier. This type of support could easily attain collapse mechanism due to lack of support redundancy. Pier Wall is connected to the existing caisson foundation by 1" diameter dowel bars (see **Figure 20.1.4-1**). Large seismic forces cannot be resisted by this connection.

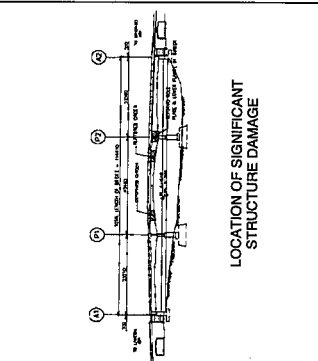
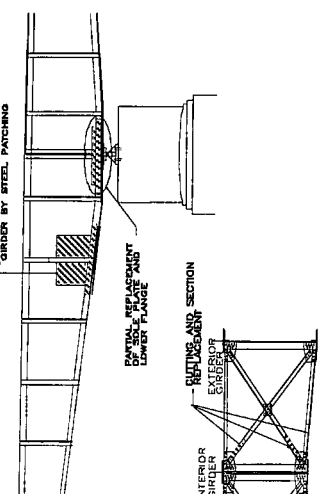
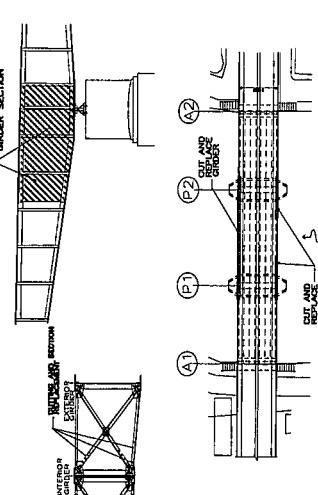
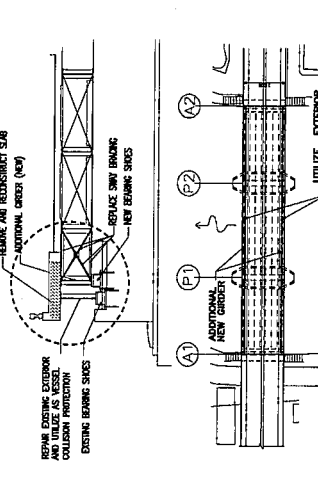
| IMPROVEMENT TYPE | PROPOSED SCHEMES | | | RATING |
|---|--|---|---|---|
| (1) STRUCTURAL ASPECT (30%) | <p>LOCATION OF SIGNIFICANT STRUCTURE DAMAGE</p> | <p>REPAIR OF RUPTURED GIRDER BY STEEL PATCHING</p> <p>PARTIAL REPAIR/REPLACEMENT OF SOLE PLATE AND LOWER FLANGE</p> <p>REFURBISH AND REPAIR EXISTING SECTION</p> | <p>REPAIR AND REPLACE CUT GIRDER SECTION</p> <p>CUT AND REPAIR SECTION</p> | <p>REMOVE AND RECONSTRUCT SUB-STRUCTURAL GIRDER (W/S)</p> <p>REMOVE EXISTING EXTERIOR AND UTILE AS VESSEL COLLISION PROTECTION</p> <p>EXISTING BEARING SHOES</p> <p>REPLACE NEW BRACING PER BEARING SHOES</p> <p>ADDITIONAL MAIN GIRDERS</p> <p>UTILE EXTERIOR GIRDER FOR VESSEL PROTECTION</p> |

- Cleaning and painting corroded sections
- Repair of ruptured sway/bracing
- Repair of ruptured girder (web and lower flange) by steel plate patching
- Repair of sole plate and girder bottom flange at bearing location by partial replacement
