FEASIBILITY STUDY OF QUEZON BRIDGE REHABILITATION PLAN

21.1 DETAILED BRIDGE SURVEY AND ASSESSMENT

21.1.1 Review of Design and Repair Works

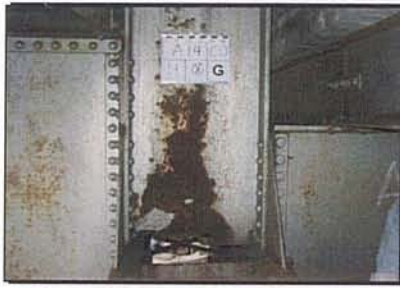
Photo 21.1.3-10 Vertical Hanger, Damage-Corrosion
10 □ Section Loss < 30%

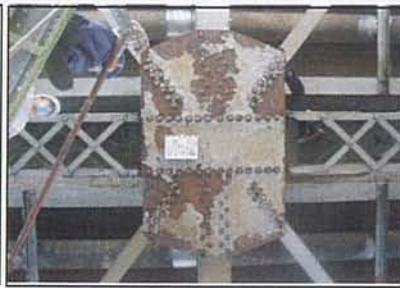
Photo 21.1.3-11 Gusset Plates, Damage – Corrosion
10 □ Section Loss < 30%

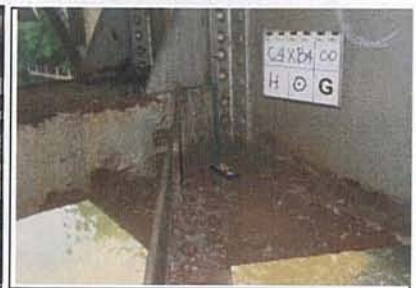
Photo 21.1.3-12 Deck Frame End Braces, Damage – Corrosion
Section Loss □ 30%

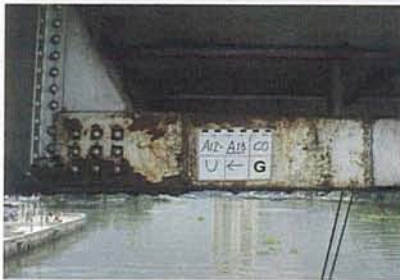
Photo 21.1.3-13 Longitudinal Tie Beam, Damage – Corrosion
10 □ Section Loss < 30%

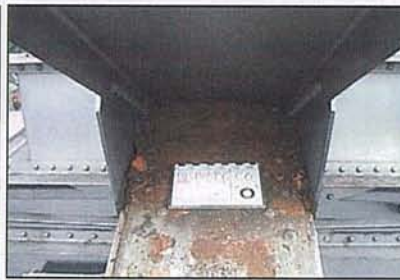
Photo 21.1.3-14 Arch Bottom Chord, Damage – Corrosion
10 □ Section Loss < 30%

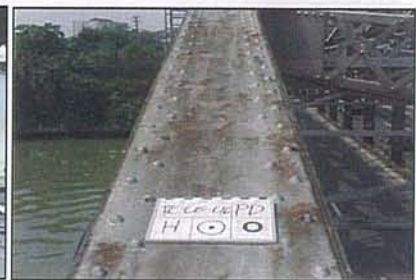
Photo 21.1.3-15 Arch Top Chord Damage – Corrosion
Section Loss < 30%
