FEASIBILITY STUDY OF GUADALUPE BRIDGE REHABILITATION PLAN

FEASIBILITY STUDY OF GUADALUPE BRIDGE (BOTH SIDES) REHABILITATION PLAN

23.1 DETAILED BRIDGE SURVEY AND ASSESSMENT

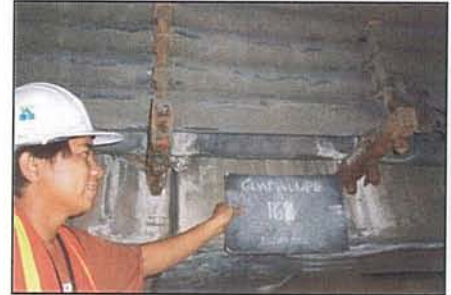
Photo 23.1.3-7 Utilities

Miscellaneous structure, including non-structural elements, were noted and photographs of these were taken. These includes 20 - ϕ 100mm PVC Telecommunication Pipe attached on the downstream side of exterior girder of upstream bridge. (See **Photo 21.1.3-7**).

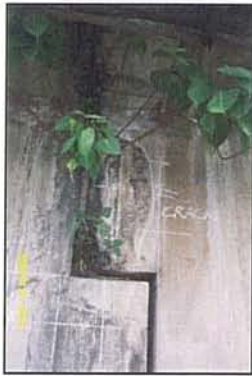
Girder 1, Gerber Hinge
Damage – Crack Width
0.5mm – 1mm

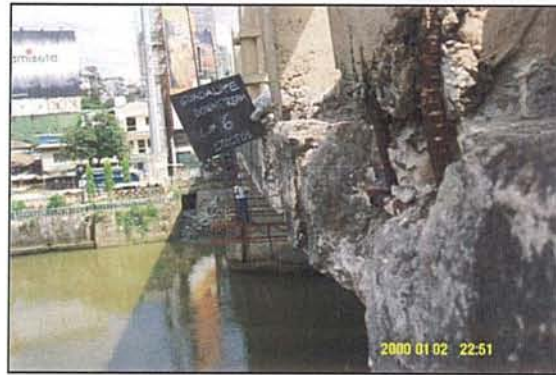
Photo 23.1.3 Sidewalk Fascia Damage –
Exposed Rebar

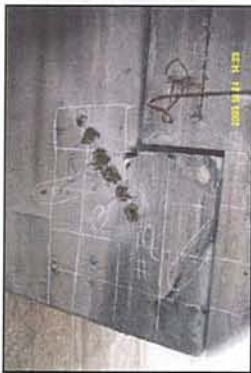
Girder 1, Gerber Hinge
Damage – Crack Width
0.5mm – 1mm

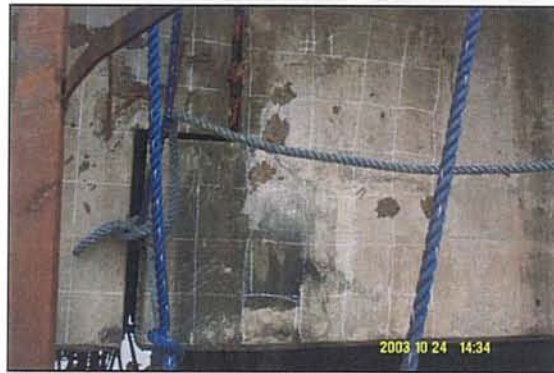
Girder 8, Gerber Hinge Damage – Crack
Width 2.0mm

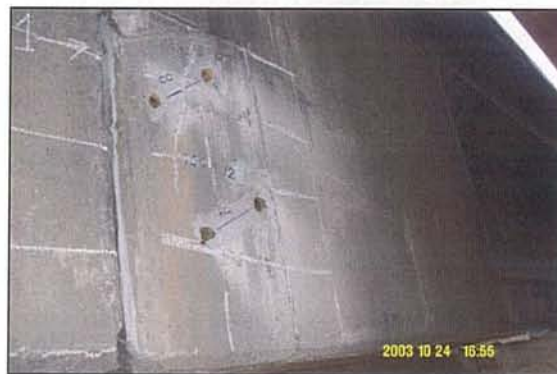
Girder 5, Gerber Hinge Damage – Crack
Width 2.0mm – 5.0m

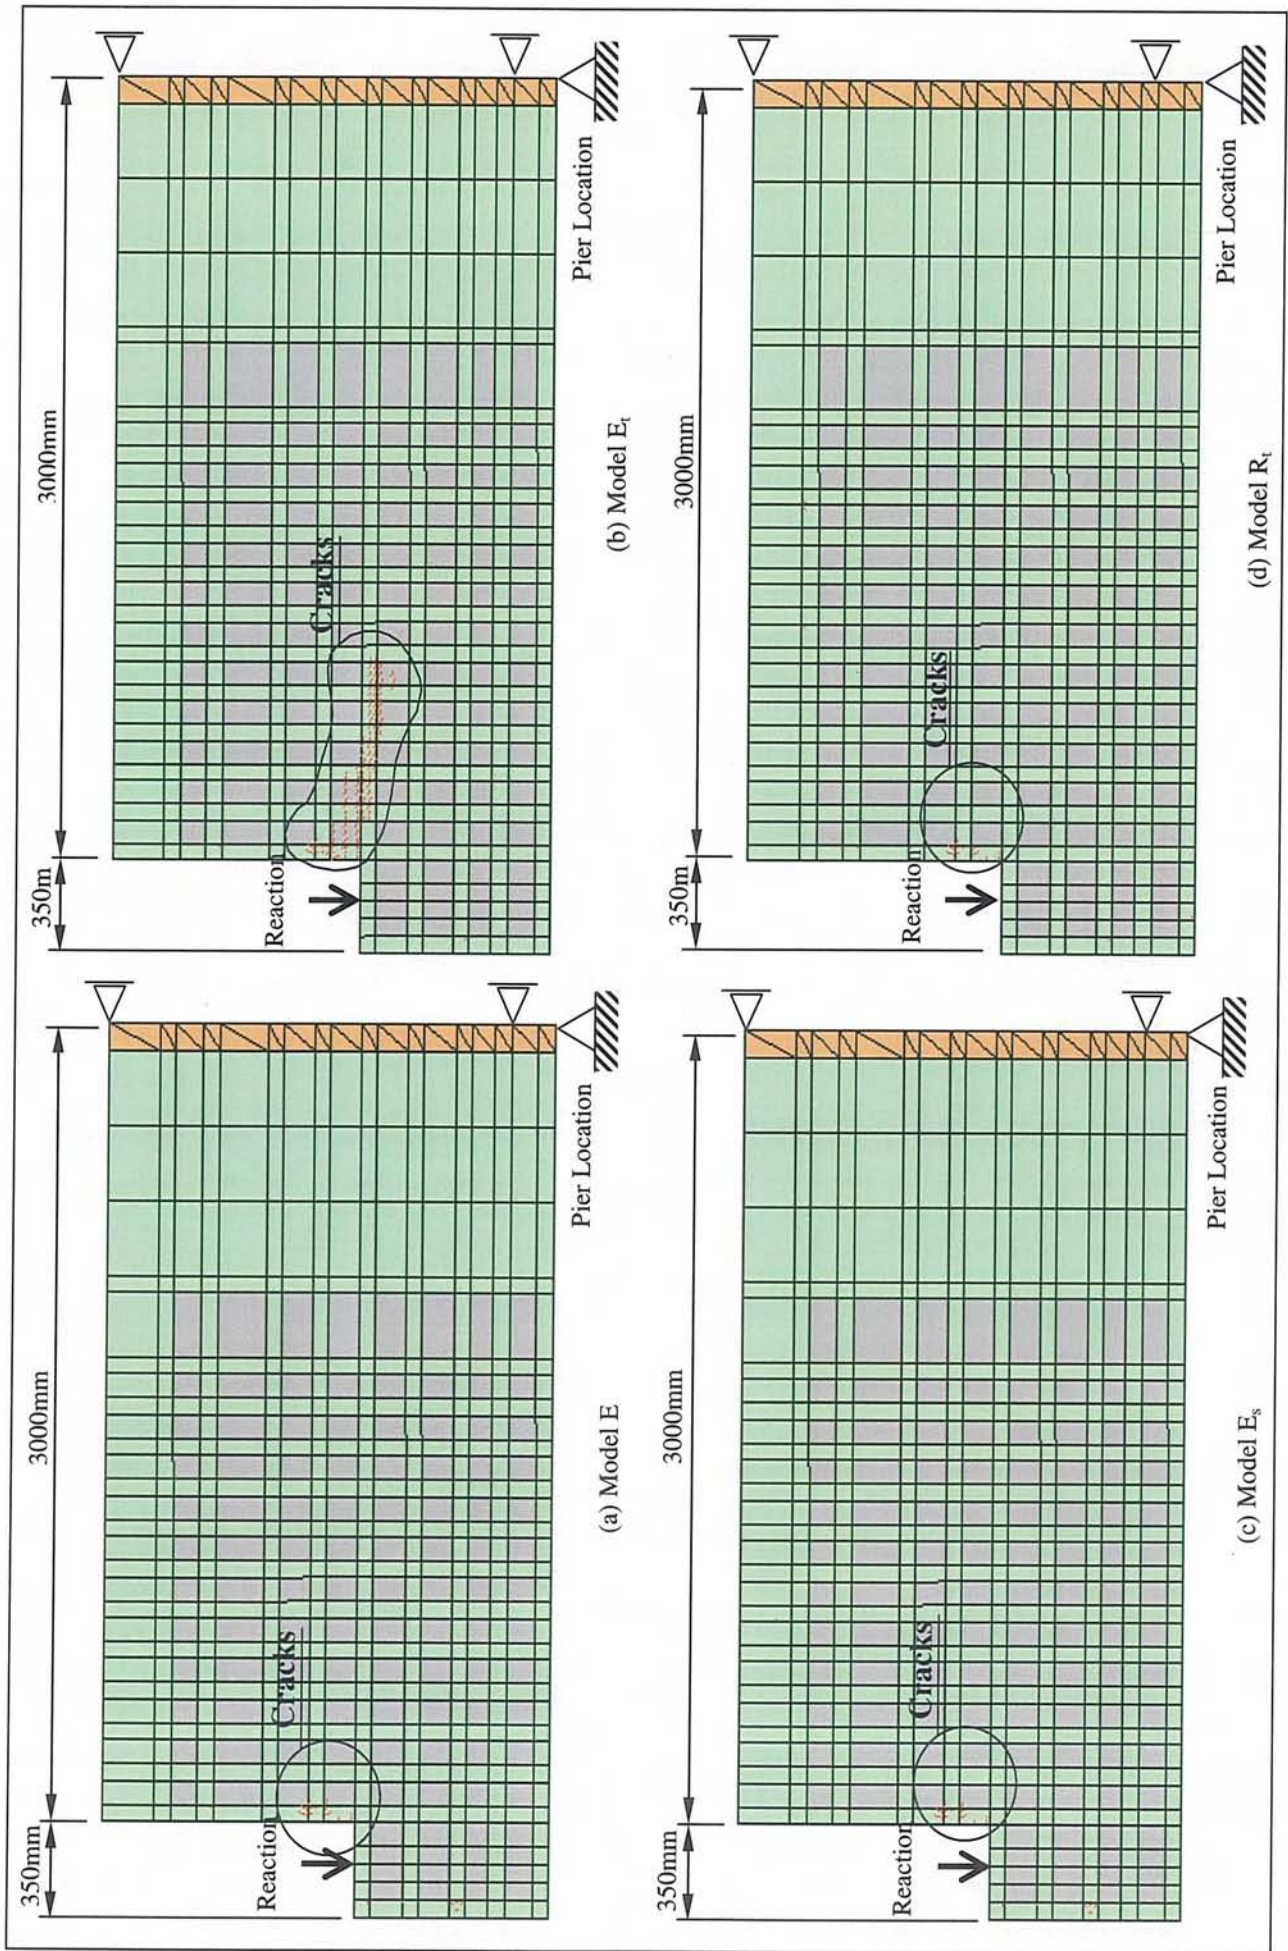
Figure 23.1.5-2 Crack Patterns and Locations at Service Load in Each Model

Figure 23.1.5-2 show the patterns and locations of cracks for each Model; those observed cracks are shown in **Figure 23.1.5-4** for comparison. From these figures, the following were observed :

- The most probable model to explain the observed crack pattern is Model Et.
- This suggests that effective post-tensioning under construction were smaller than that specified in the design.
- The effective post-tensioned forces affect the occurrence of cracks more than the amount of reinforcement as compared to the results of Model Et and Es.
- The rehabilitation measure recommended in **Section 23.2.4** is revealed to be effective.

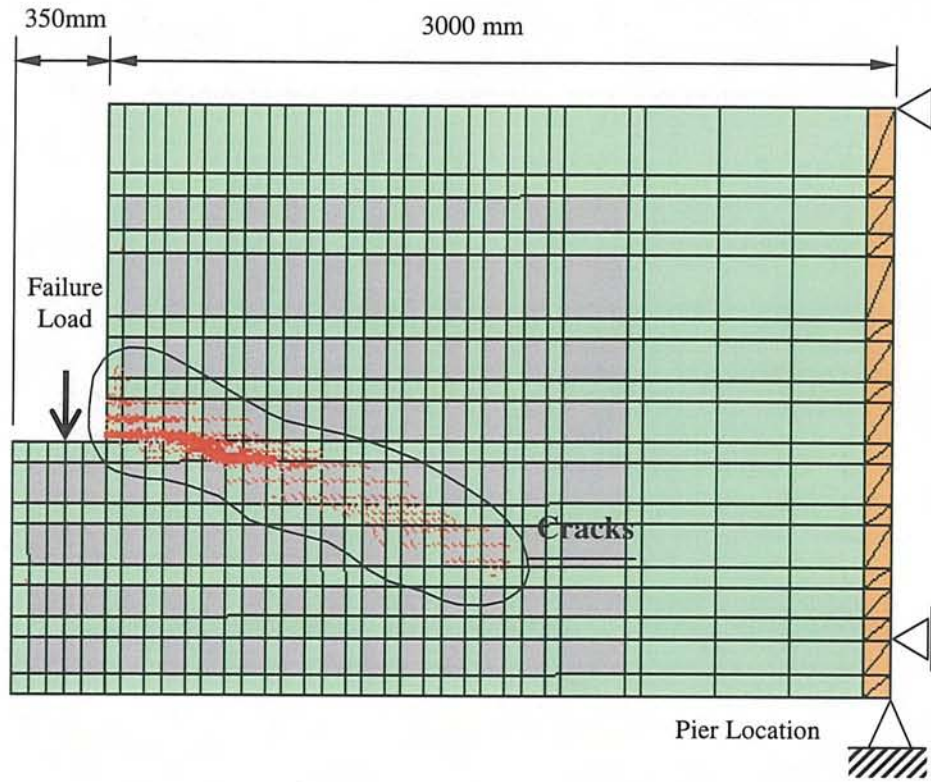
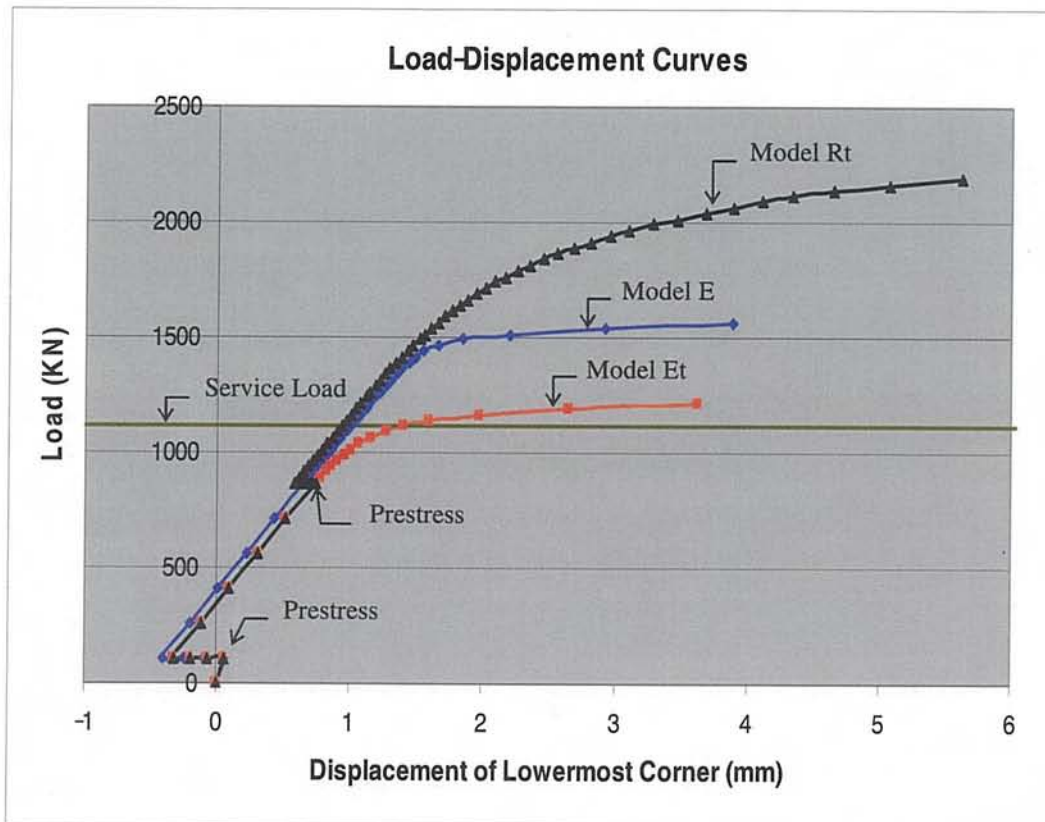
Figure 23.1.5-3 Crack Pattern Prior to Failure and Load-Deflection Relationship at Reaction Force Loaded Point.

Figure 23.1.5-3 indicates the crack pattern prior to failure of Model Et and load-deflection relationship at the loaded point.

- In case of Model Et which simulates well the existing crack condition among analysis models, integrated behavior is under the situation of yield zone or almost failure zone when the service load (design live load) is loaded.
- Model Rt presenting rehabilitation measure is very effective to increase the capacity of gerber hinge part.
- The integrated behavior of rehabilitated gerber hinge part is still within the elastic zone.
- Even at load level prior to failure, any crack occurrences at girder on top of the pier did not appear.

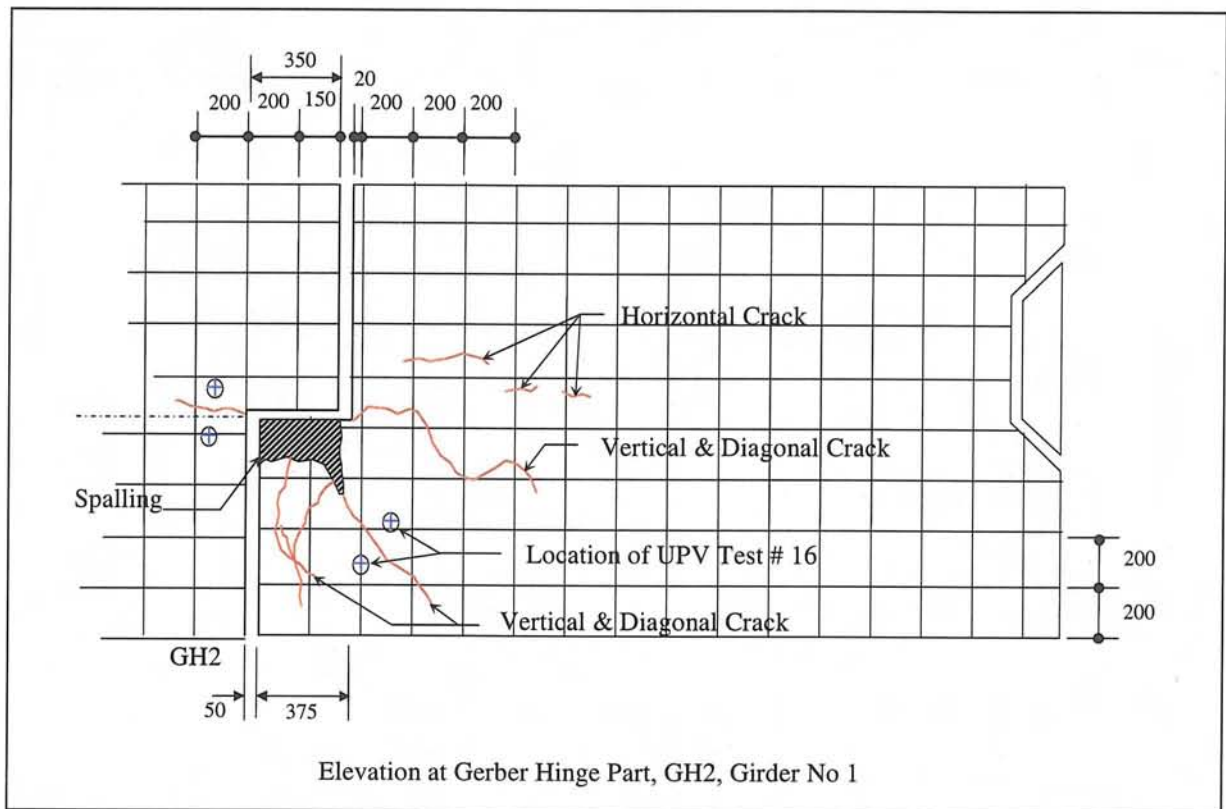
Figure 23.1.5-4 Observed Crack Pattern in Gerber Hinge Part of Guadalupe Bridge

- The outer faces of exterior girders at gerber hinge parts have many cracks. Most of the cracks were full depth as tested non-destructively. These cracks are due to insufficient flexural and shear reinforcement and unforeseen losses of prestressing forces.

- Improvement work in the gerber hinge part is necessary to improve the durability of the existing superstructure.
- As for the substructure, a retrofit measure is recommended to conform with the requirement of the latest code.
