FEASIBILITY STUDY OF VARGAS BRIDGE REHABILITATION PLAN

24.1 DETAILED BRIDGE SURVEY AND ASSESSMENT

Photo 24.1.1-1 Panoramic View of Vargas Bridge (Upstream)

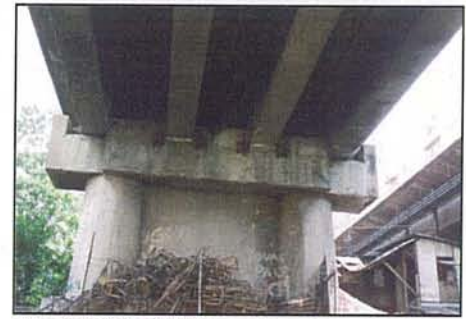
Photo 24.1.1-2 Shear keys on all piers and vertical cable restrainers on Pier 1

- To make deck continuous with reconstruction of end diaphragms.
- To install vertical cable restrainers on abutments & Piers (see **Photo 24.1.1-2**).
- To add shear keys at top of piers to adequately transmit seismic forces from the superstructure to the substructure (see **Photo 24.1.1-2**).
- To drive four steel piles at each pier footing to reduce seismic forces being absorbed by the existing piles.
- To provide footing overlay to accommodate new piles and to increase flexural and shear capacity of the footing (see **Photo 24.1.1-3**).

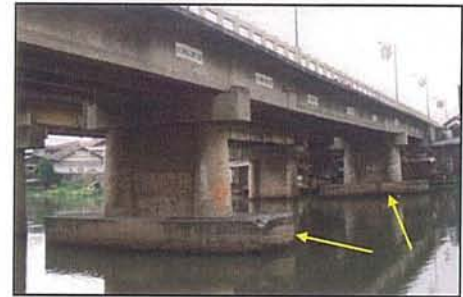
Photo 24.1.1-3 Enlarge pile cap and additional piles (not seen on picture)

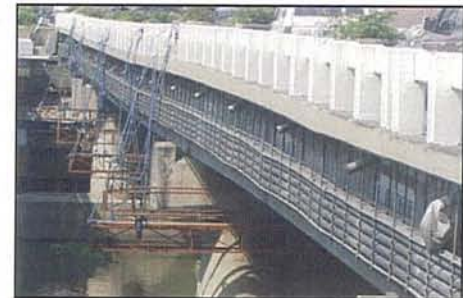
Previous rehabilitation works made no improvement measure in the deflection of girders (see **Photo 24.1.1-4**) and propagation of cracks in PC girders. Cracks on girders are evident at top of piers and gerber hinge parts.

Photo 24.1.1-4 Deflection of Girders

- Flexural cracks of girder on top of pier 2 and pier 3 were caused by tension stresses on top fiber at service loads.
- Large deflections at the cantilever portion were due to insufficient number of longitudinal tendons.

- Repair and sealing of concrete cracks, honeycomb and spalling.
- Partial replacement of deck slab over pier support.
- Rehabilitation of gerber hinge portion with slanted P/S cables.
- Reconstruction of diaphragm and slab at gerber hinge.
- Installation of external cables on each side of the girder to counter the deflection.

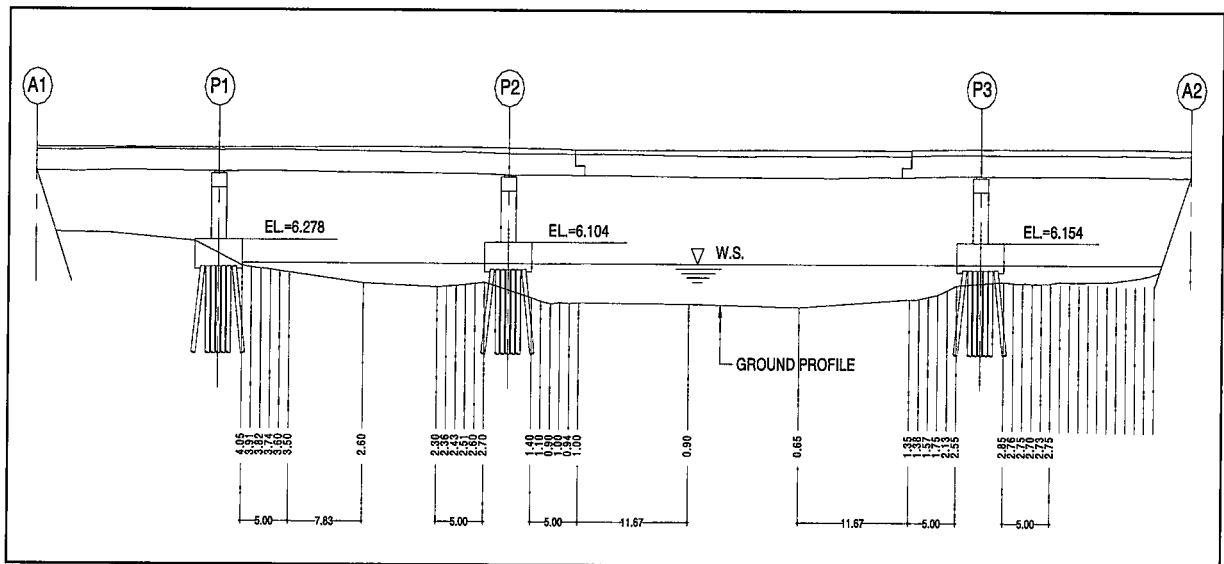
Figure 24.1.2-1 Result of Scour Survey conducted on Vargas Bridge

As shown in **Figure 24.1.2-1**, scouring around substructures is not evident.

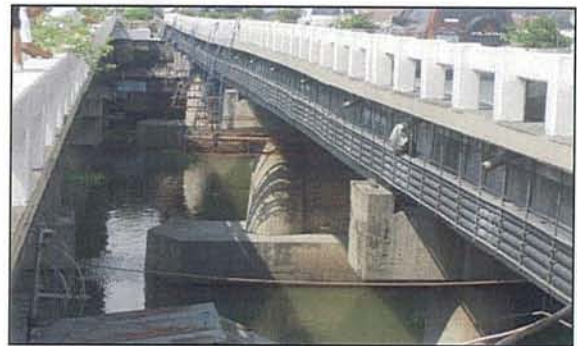
Miscellaneous structure, including non-structural elements, were noted and photographs were taken. These includes 8-100 mm ϕ PVC Telecommunication Lines as shown in **Photo 24.1.3-5**.

Photo 24.1.3-5 Miscellaneous / Utilities - PVC pipe lines attached at side of exterior girders

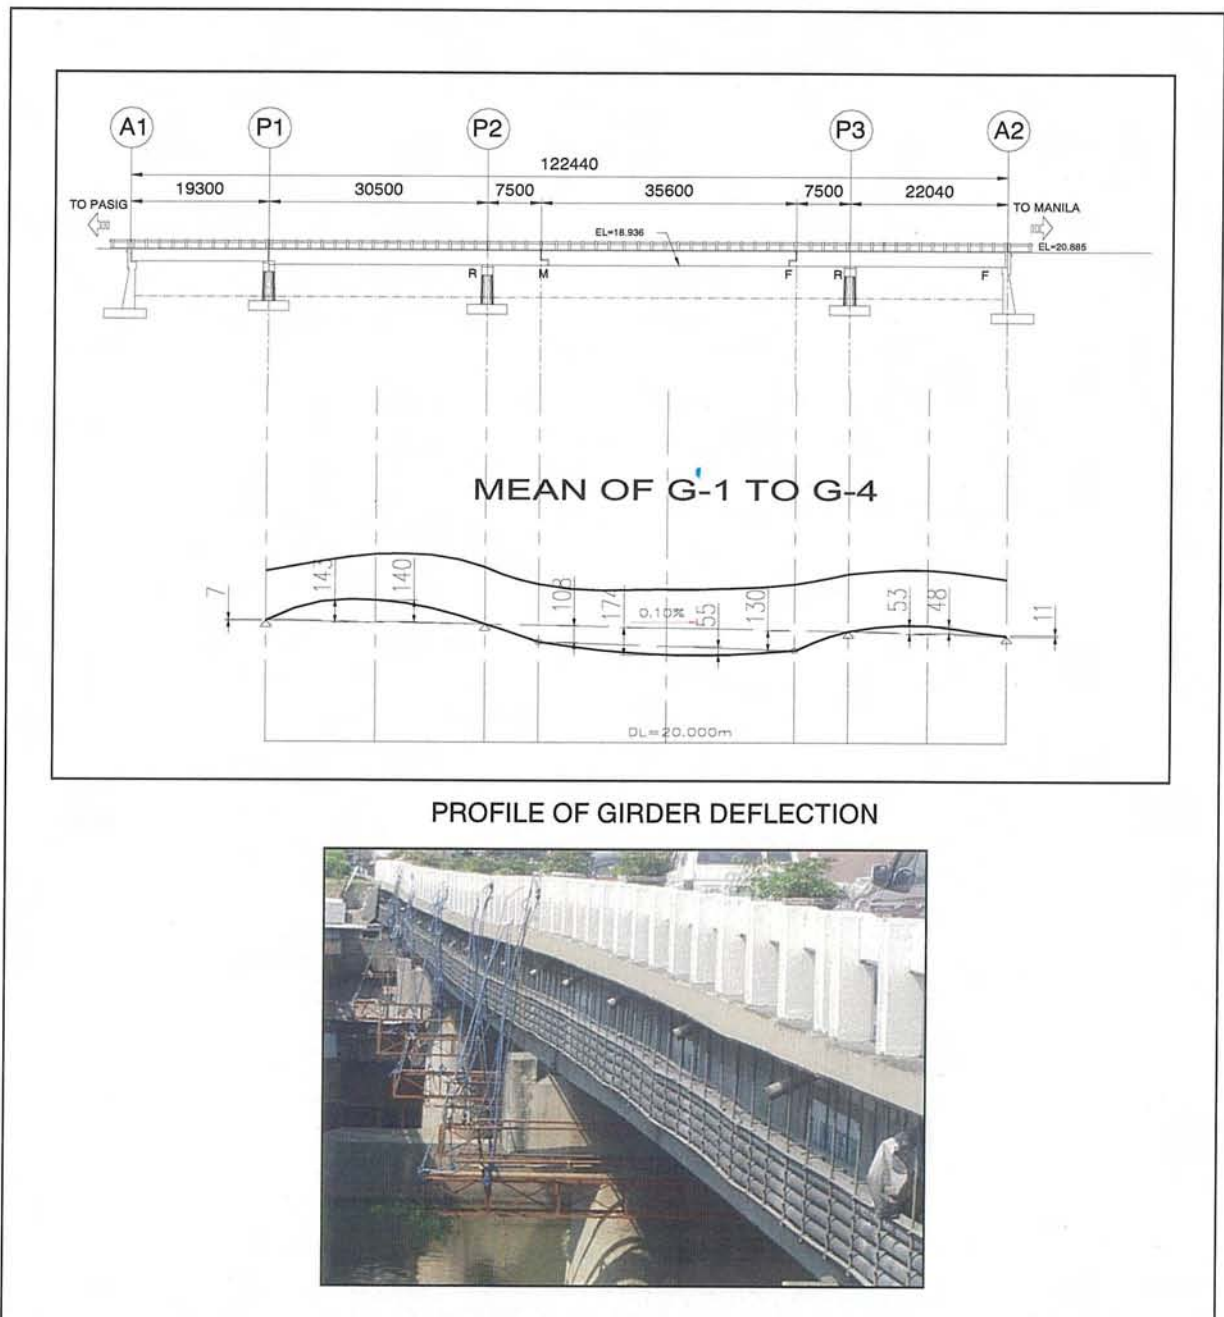
Figure 24.1.3-1 Result of Measurement on Deflection of PC Girders on the above figure can be seen evidently along the side of the superstructure (see photo)

- Damages found were mostly cracks on gerber hinge parts. The cracks were drawn in a matrix as part of documentation.
- The Bridge have noticeably large deflection problem. The largest of which is located at the cantilever portion of the girder.
- The vertical restraining cables at abutments were provided for falling prevention against longitudinal displacement of girders and not for uplift/hold down purposes.
- The damages of the Bridge are shown in **Figure 24.1.3-2**. The damage rating of main members based on Close-up Visual Inspection is shown on **Table 24.1.3-2**.

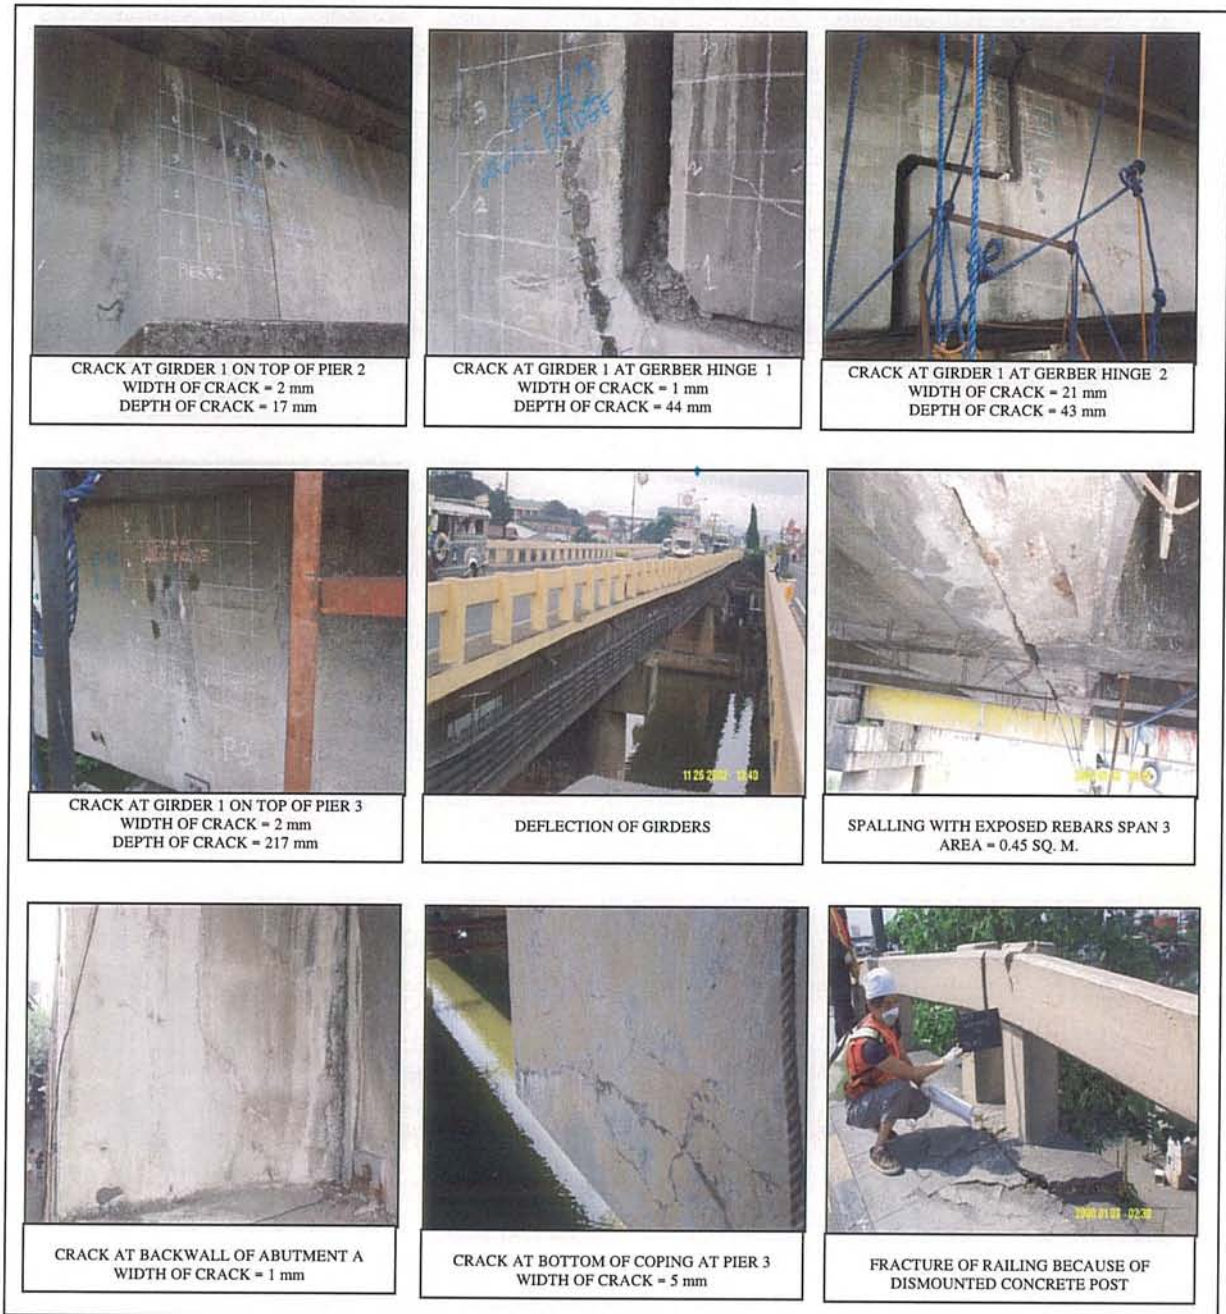
Figure 24.1.3-2 Close-Up Visual Inspection of Damages in Vargas Bridge (Upstream)

- Cracks were evident on gerber hinge parts and an immediate counter-measure is necessary to stop its propagation
- Major cracks on girder at top of piers 1 and 2 were also evident. Immediate counter-measure is necessary.
- Large rotation/deformation of the suspended spans at the cantilever portion were observed to affect the rideability.
- Cracks, honeycomb and spalling of concrete on deck slab were also observed.

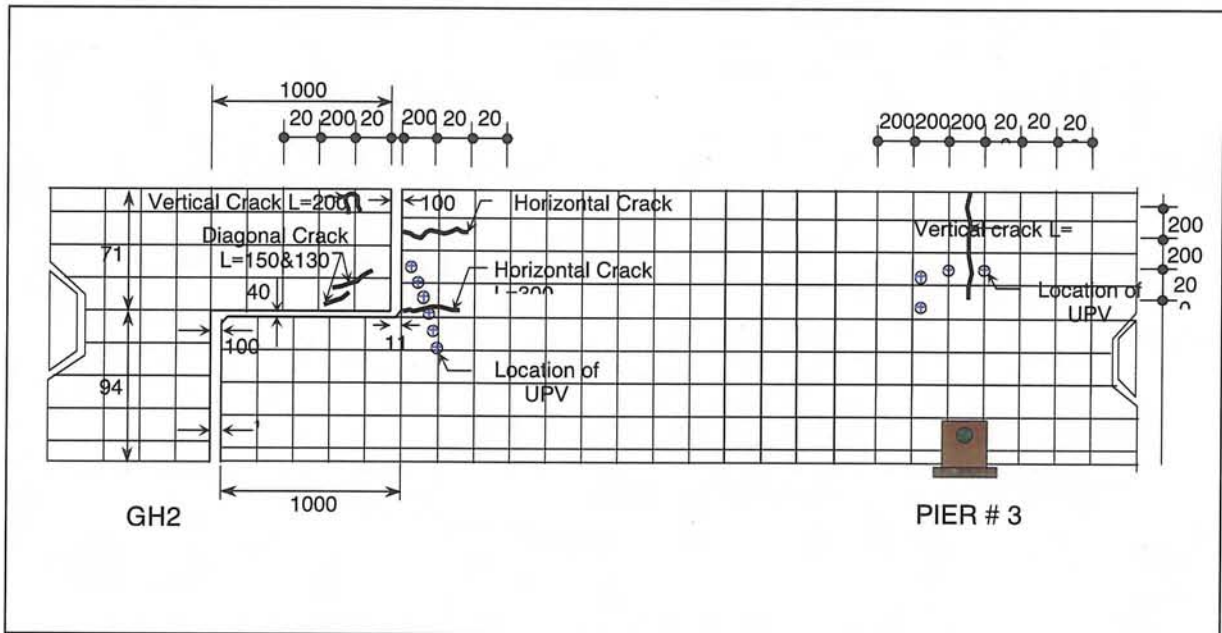
Figure 24.1.5-2 Observed Crack Pattern

The observed cracks in gerber hinge parts and the girder at top of Pier are shown in Figure 24.1.5-2; Figure 24.1.5-3 shows patterns and locations of cracks in each model for comparison. From these figures, the following can be deduced:

- The most probable model to explain the observed crack pattern is Model Et.
- This suggests that effective post-tensioning under construction were smaller than that specified in the design.
- The effective post-tensioned forces affect the occurrence of cracks more than the reduced amount of reinforcement as compared to the results of Model Et and Es.
- The rehabilitation measure recommended in **Section 24.2.4** is shown to be effective.

- Cracks in gerber hinge parts observed were caused by insufficient hanger reinforcement provided on the girder and unforeseen losses of prestressing forces.

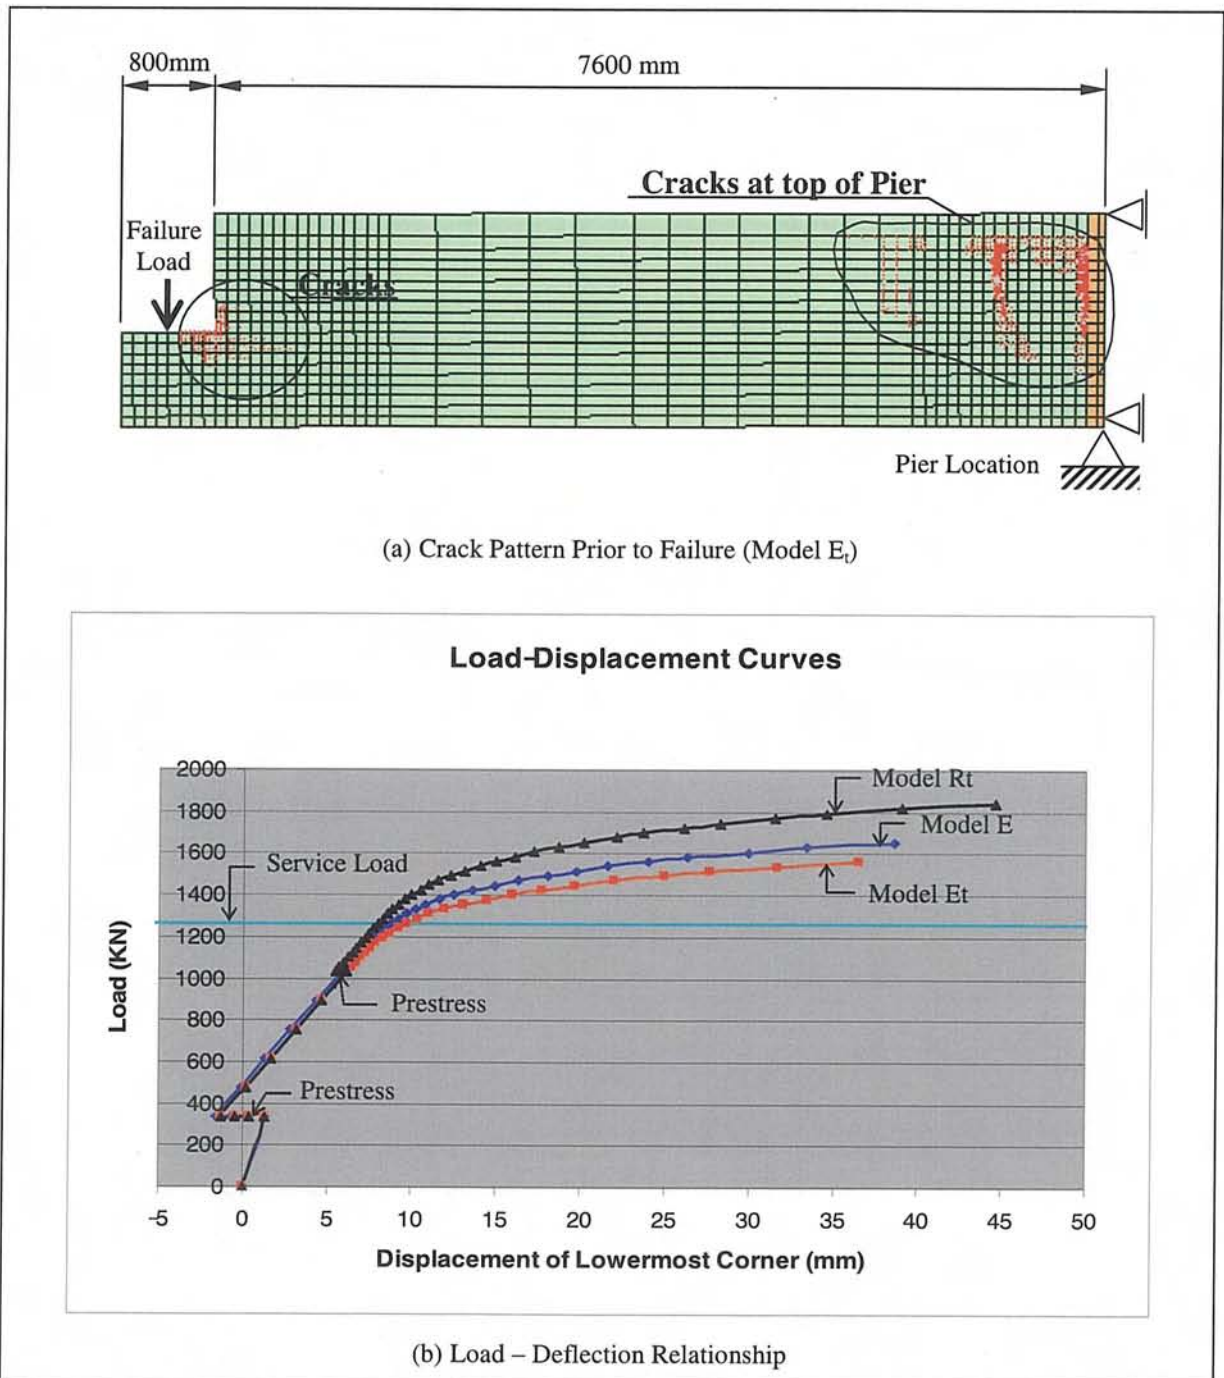
Figure 24.1.5-4 Crack Pattern Prior to Failure and Load-Deflection Relationship at Reaction Force Loaded Point.

- In case of Model Et which simulates well the existing crack condition among the analysis models, integrated behavior is under the yield zone condition or almost failure zone when the service load (design live load) is loaded.
- Model Rt presenting rehabilitation measure is very effective to increase the capacity of gerber hinge part.
- The integrated behavior of rehabilitated gerber hinge part is under the elastic zone condition.
- Even at load level prior to failure, any crack occurrences at girder on pier top were not identified.
