CHAPTER 25

PROJECT IMPLEMENTATION

25.1 PROJECT IMPLEMENTATION PROGRAM

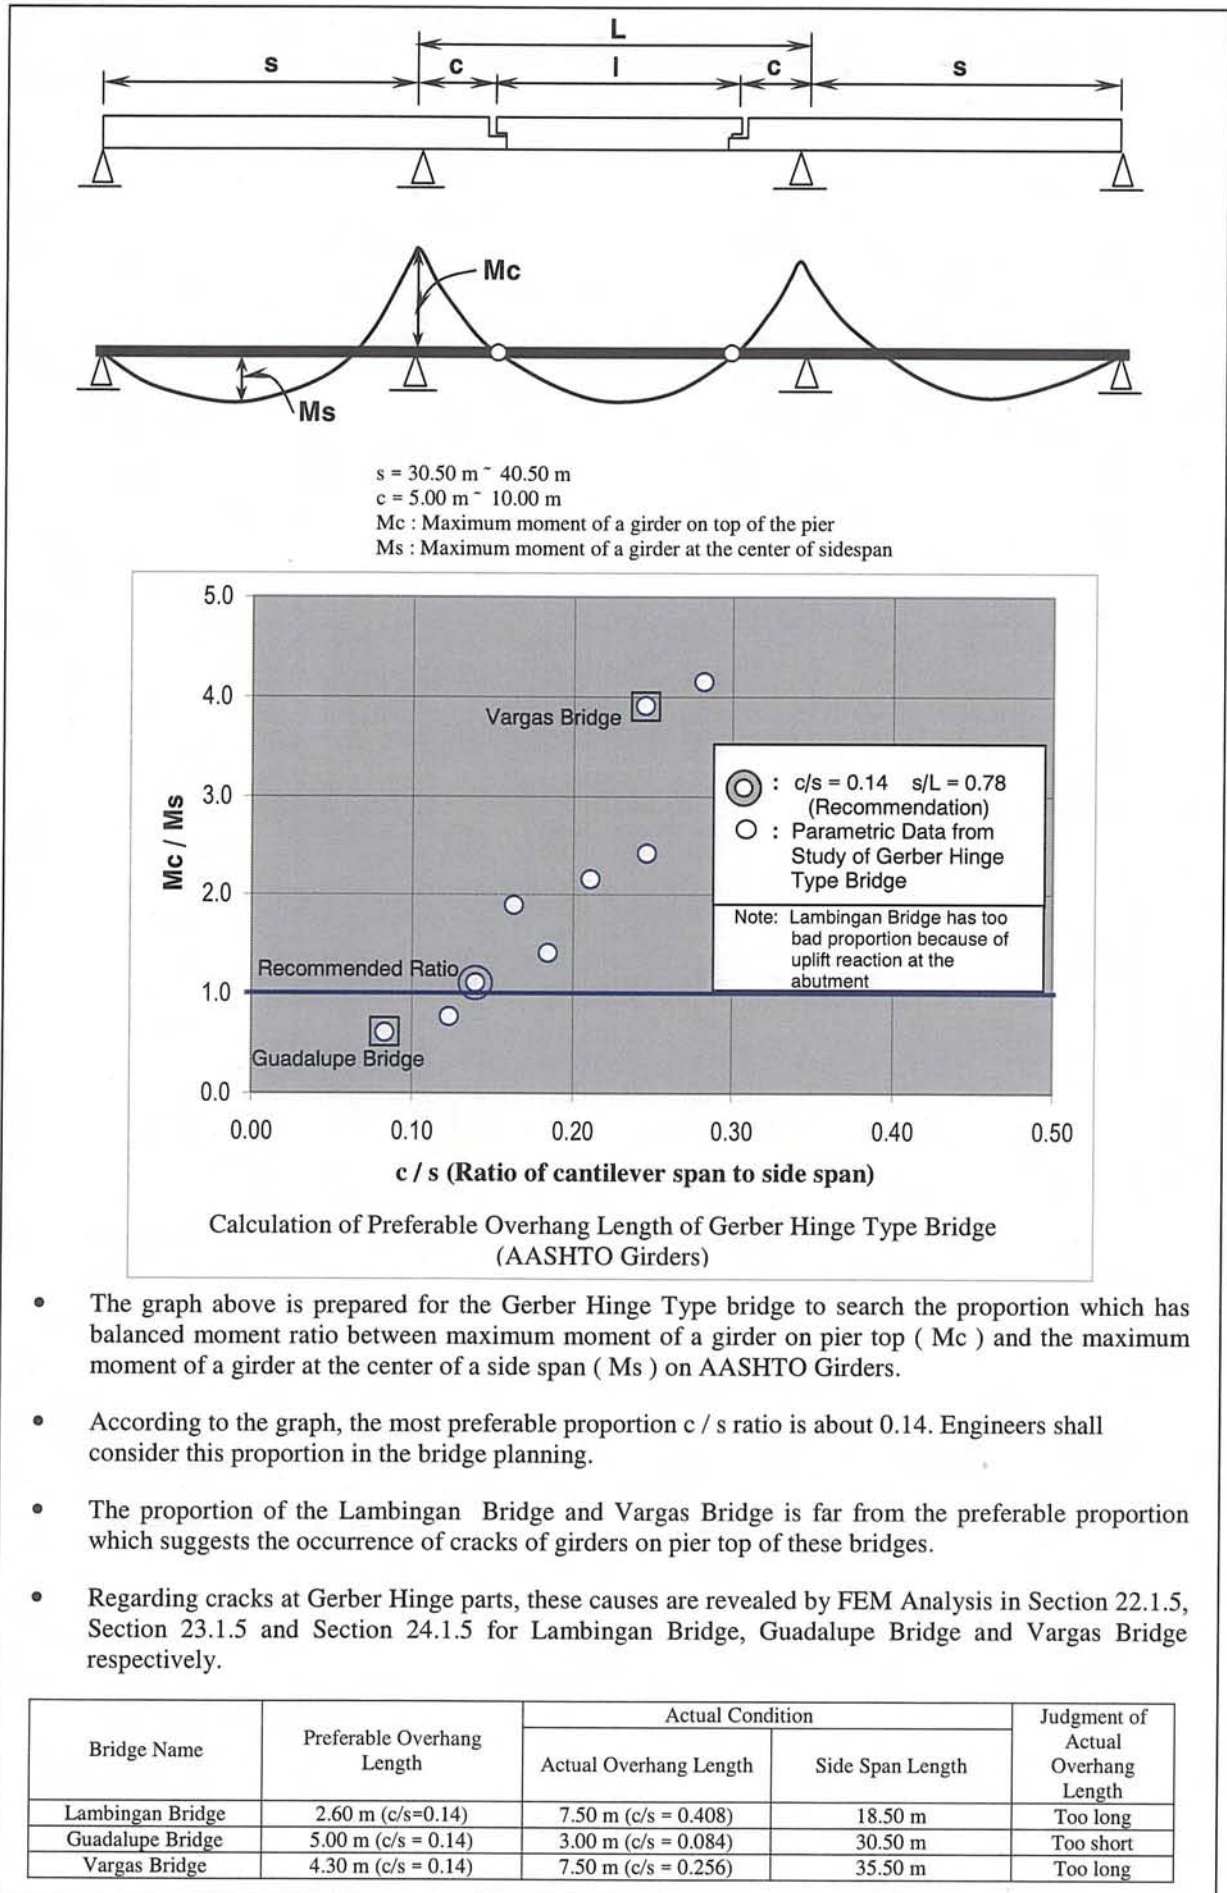
Figure 26.1.2-1 Study on Bridge Planning for Gerber Hinge Type

- Vessel collision with girders: Insufficient vertical clearance
 - Ayala Bridge and Jones Bridge
- Serious cracks at gerber hinge parts and girders on pair-top: Bridge planning and design (Refer to **Figure 26.1.2-1**)
 - Lambingan Bridge, Guadalupe Bridge and Vargas Bridge
- Vertical deformation of girders: Bridge planning and construction quality.
 - Lambingan Bridge and Vargas Bridge
- Uplift reaction at abutments: Bridge planning
 - Lambingan Bridge
- Heavy corrosion of steel joint connections: Water leaking from the deck slab and poor maintenance of expansion joints.
 - Ayala Bridge and Quezon Bridge
- Heavy corrosion of bearings on pier and abutment: Water leaking.
 - Ayala Bridge, Jones Bridge and Quezon Bridge
- Cracks on deck slab: Fatigue stress associated with the increase of traffic axle load and volume.
