CHAPTER 8

OVERALL EVALUATION OF BRIDGE CONDITION

Appendix 8.6.1-1 (1/20)
OVERALL EVALUATION OF BRIDGE CONDITION

Reference/Bridge Name		Pa1.1 DELPAN BRIDGE (UPSTREAM)			
Location/Name of Road		Manila City Bonifacio Drive	Year Constructed	1965	
Elevation					
	Length of Bridge	203.70m. (26.65 + 46.00 + 58.40 + 46.00 + 26.65)		No. of Lane Lane Width	4 3.70m
Superstructure Type		PC Gerber Box Girder Bridge (5-Span)		Substructure Type	Abutment: Wall ((timber pile), Pier: Wall ((timber pile))
Structural Soundness	Superstructure	PC BOX GIRDER	*Span 1: Bottom of box girder (Abut 1)	H	0.5m ³ spalling of concrete with exposed rebars observed due to insufficient vertical clearance, 4.38m x 4.9m x 5.0m, for passing trucks resulting to collision.
			*Span 1: Bottom of box girder at midspan	H	More than 2m ² of honeycomb was measured at bottom of girder.
	*Span 1: Bottom of box girder		H	3.85m ² of spalling was observed with exposed rebars due to insufficient vertical clearance for passing trucks resulting to collision.

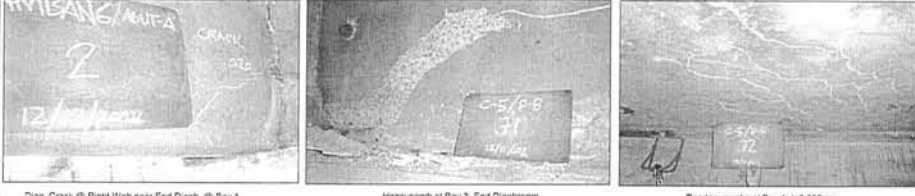
Reference/Bridge Name		Pa11 C5 BRIDGE			
Location/Name of Road		Pasig City	Year Constructed	1997	
Elevation

<p>Diag Crack @ Right Web near End Diaph. @ Bay 1 Honeycomb at Bay 3, End Diaphragm Random cracks at Bay 1, 1x0.203mm</p>				
Length of Bridge	272.960 m. (24.85 + 24.95 + 25.12 + 25.0 + 24.85 + 45.88 + 22.21 + 26.95 + 26.70 + 26.45)			No. of Lane Lane Width 6 3.00m	
Superstructure Type	PC I Girder Bridge (10-Span)		Substructure Type	Abutment: Wall Type (spread, bored pile), Pier: Column Type (bored pile)	
Structural Soundness	Superstructure	PC GIRDER	Span 6: Top flange at Bay 1 above Pier 6	H	0.3m Φ pothole with remarkable depth above P1 and 0.7m Φ pothole near P2
			Span 6: Bottom of girder flange	H	1.80m ² honeycomb on one location
			Span 6: Girders 4 & 6 near Pier 6 Support	M	0.45 - 1.65m ² honeycomb on 2 locations
			Span 9: End block upstream	M	2.261mm crack is just construction joint which enabled free lime occurrence in the exterior joint

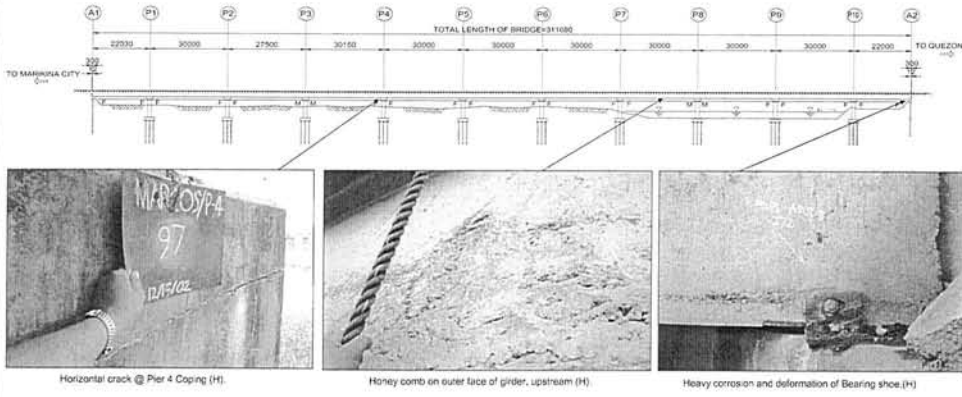
Reference/Bridge Name		Ma3 MARCOS BRIDGE			
Location/Name of Road		Marcos Highway Marikina City	Year Constructed	1980	
Elevation

Length of Bridge	311.680m (22.03+30.0+27.5+30.15+6@30.0+22.0)		No. of Lane Lane Width 6 3.00m	
Superstructure Type		PC I Girder Bridge (11-Span)		Substructure Type Abutment: Wall Type ((RC pile)), Pier: Column Type ((RC pile))	
Structural Soundness	Superstructure	PC GIRDER	Span 1 at Bay 7: Bottom flange of Girder 8	M	A = 0.15m2 honeycomb
			Span 2 at Bay 7: Top flange of Girder 7	M	A = 0.15m2 spalling with exposed rebar
			Span 2 at Bay 8: Face of Girder 8	M	A = 0.15m2 honeycomb
			Span 3 at Bay 5: Top flange of Girder 6	M	A = 0.30m2 spalling with exposed rebar
			Span 5 at Bay 2 at Pier 5: Top flange of Girder 3	M	A = 0.12m2 spalling with exposed rebar
			Span 5 at Bay 11 at Pier 4: Bottom flange of Girder 9	M	A = 0.15m2 spalling with exposed rebar
			Span 6 at Bay 7 at Pier 6: Bottom of Girder 8	M	A = 0.12m2 spalling with exposed rebar

Span 7 at Bay 10 at Pier 6: Bottom flange of Girder 11	M	A = 0.15m2 spalling
			Span 8 at Bay 10 at Pier 7: Bottom of Girder 10	M	A = 0.16m2 spalling with exposed rebar
			Span 10 : Outside face of Girder 12	M	A = 0.18m2 spalling with exposed rebar
Substructure	DECK SLAB	Span 4 at Bay 11 at Pier 3: Bottom of slab	M	A = 0.40m2 spalling	
		Span 4 at all bays: Bottom of Slab	H	A > 3.0m2 thin concrete cover	
		Span 5 at Bay 2 at Pier 5: Bottom of Slab	M	A = 0.30m2 spalling	
		Span 5 at Bay 3 at Pier 5: Bottom of Slab	M	t = 0.381mm random cracks at 3 locations	
		Span 6 at Bay 11 at Pier 6: Bottom of Slab	H	A = 1.320m2 spalling with exposed rebar	
		Span 9 at Bay 1: Bottom of Slab	H	A = 0.72m2 spalling with exposed rebar	
		PIER	Spans 1, 2, 3 & 4: Copping of Piers 1, 2, 3, & 4	H	t = 0.30mm to t = 5.00mm random cracks are caused by lack of reinforcing bars. 4 locations
			Spans 1, 2, 3, 4 & 5: Copping of Piers 1, 2, 3, 4 & 5	M	t = 0.10mm to t = 0.30mm random cracks are caused by alkali aggregate reaction. 5 locations

Spans 1, 2, 4, 5 & 6: Copping of Piers 1, 2, 4, 5 & 6	H	t = 0.30mm to t = 10.00mm vertical/horizontal crack are mainly caused by lack of reinforcing bars. 5 locations
			Spans 1, 2, 3, 4, 5 & 7: Copping of Piers 1, 2, 3, 4, 5 & 7	M	t = 0.10mm to t = 0.30mm vertical/horizontal crack are caused by alkali aggregate reaction. 6 locations
Foundation		S	Maximum inclination is 0.57 degree transverse at A1 & P10.		
Accessory	Bearing plate and prevention devices	S	Minimum rust		
Diagnosis Evaluation *2	Category "C"	* Repair of concrete cracks needed * In-depth study not necessary			
Vulnerability to Disaster	Seismic Resistance	* No as-built plans. Pier sufficient under present seismic design requirements. Moderate vulnerability			
	Wind Resistance	Not critical to wind action. Low vulnerability			
	Flood Resistance	Not critical to flood overtopping. Low vulnerability			
	Evaluation	* Not critical to wind and flood action * Sufficient to seismic action under assumed reinforcement
