CHAPTER 21

FEASIBILITY STUDY OF QUEZON BRIDGE REHABILITATION PLAN

Appendix 21.1.2-1

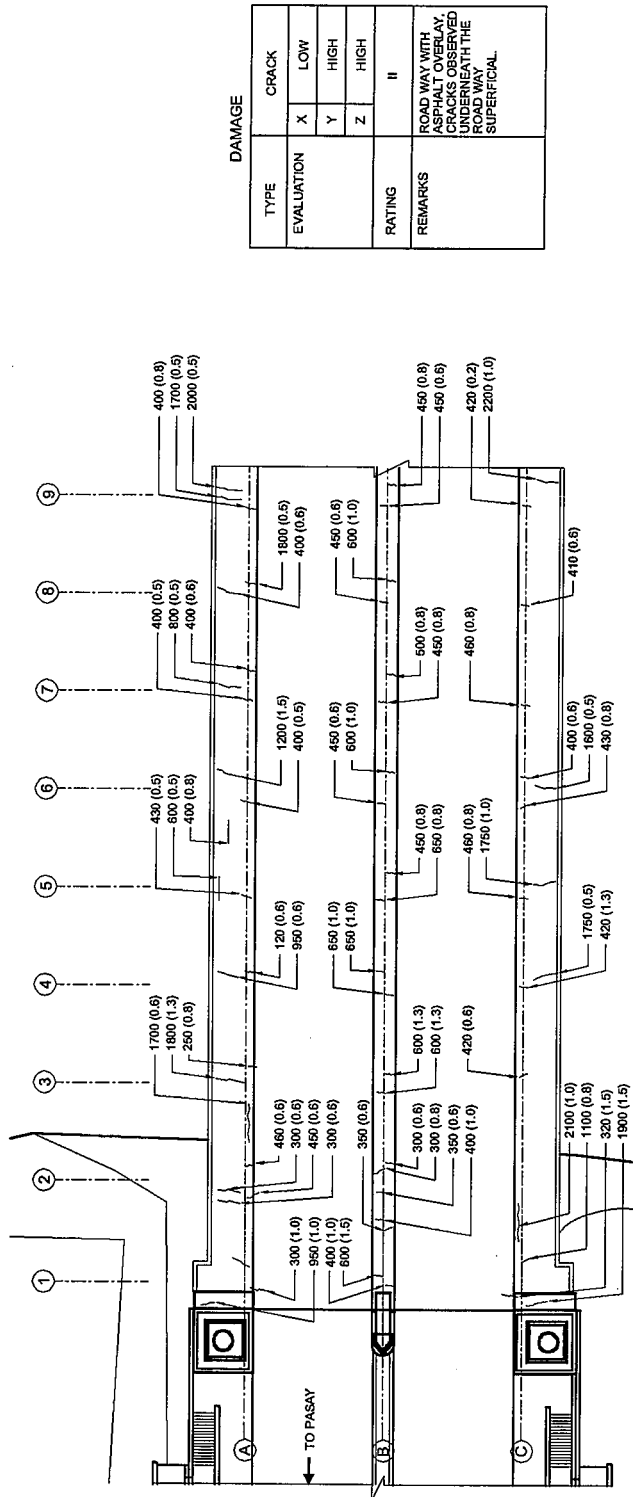
CRACKS ON SIDEWALK AND MEDIAN FROM GRID LINE 1 TO GRID LINE 9

| DAMAGE | | CRACK |
|---|--|---|
| REMARKS | ROAD WAY WITH ASPHALT OVERLAY. CRACKS OBSERVED UNDERNEATH THE ROAD WAY WITH SUPERFICIAL. | |

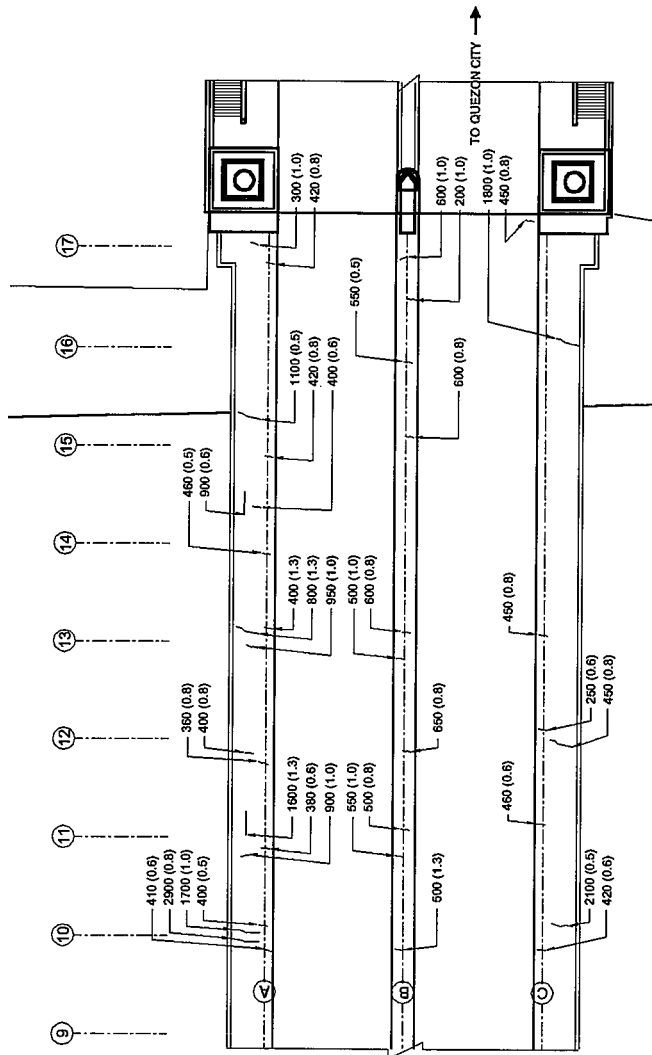
CRACKS ON SIDEWALK AND MEDIAN FROM GRID LINE 9 TO GRID LINE 17

| DAMAGE | | CRACK |
|---|--|---|
| REMARKS | ROAD WAY WITH ASPHALT OVERLAY CRACKS OBSERVED UNDERNEATH THE ROAD WAY SUPERFICIAL. | |

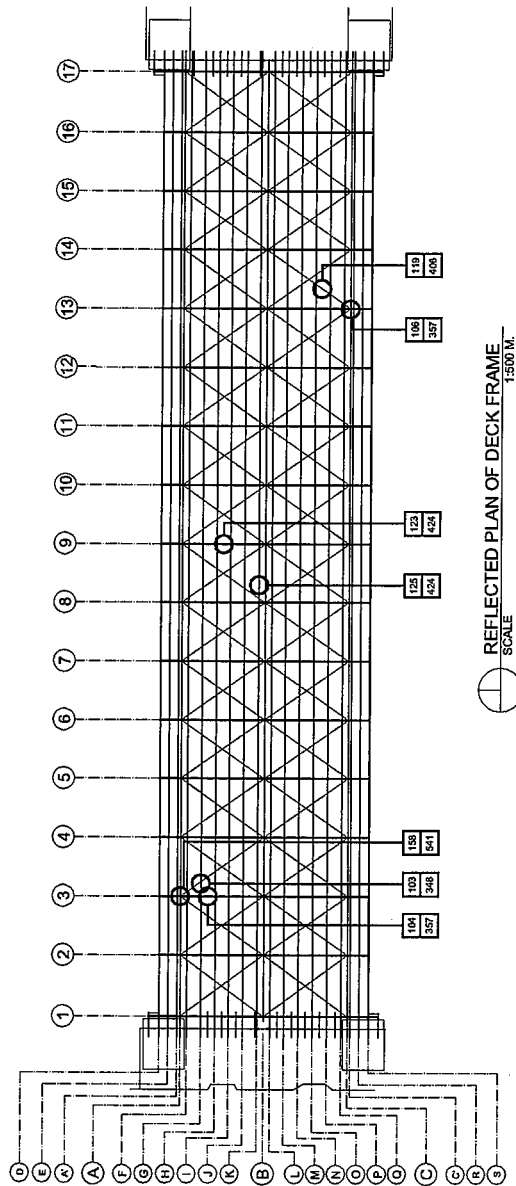
SUMMARY OF TEST RESULTS FOR HARDNESS OF TRUSS A, B & C

1. NO SIGNIFICANT DEFECTS (INTERNAL DEFECTS OR DISCONTINUITIES) WERE FOUND ON ALL TESTS LOCATIONS.
2. TEST LOCATIONS (APPROX. 0.3 M X 0.3 M.) WERE WITHIN THE 2.0 M MIDSPAN SEGMENTS OF THE MEMBERS.
3. PORTIONS TESTED WERE AS FOLLOWS:
 - A. SIDE PLATE OF BOTTOM CHORD & TIE
 - B. FLANGE OF DIAGONAL & HANGER

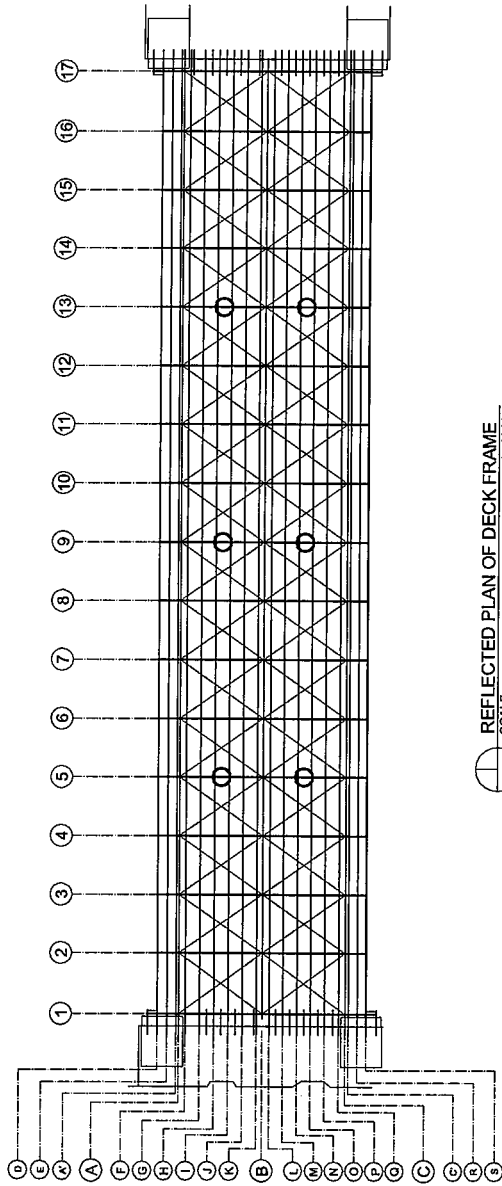
SUMMARY OF TEST RESULTS FOR UFD OF TRUSS A, B & C

1. NO SIGNIFICANT DEFECTS (INTERNAL DEFECTS OR DISCONTINUITIES) WERE FOUND ON ALL CROSS BEAMS TESTED.
2. TEST LOCATIONS (APPROX. 0.3 M X 0.3 M.) WERE WITHIN THE 2.0 M MIDSPAN SEGMENTS OF THE CROSS BEAMS.
3. PORTIONS TESTED WERE BOTTOM FLANGES.

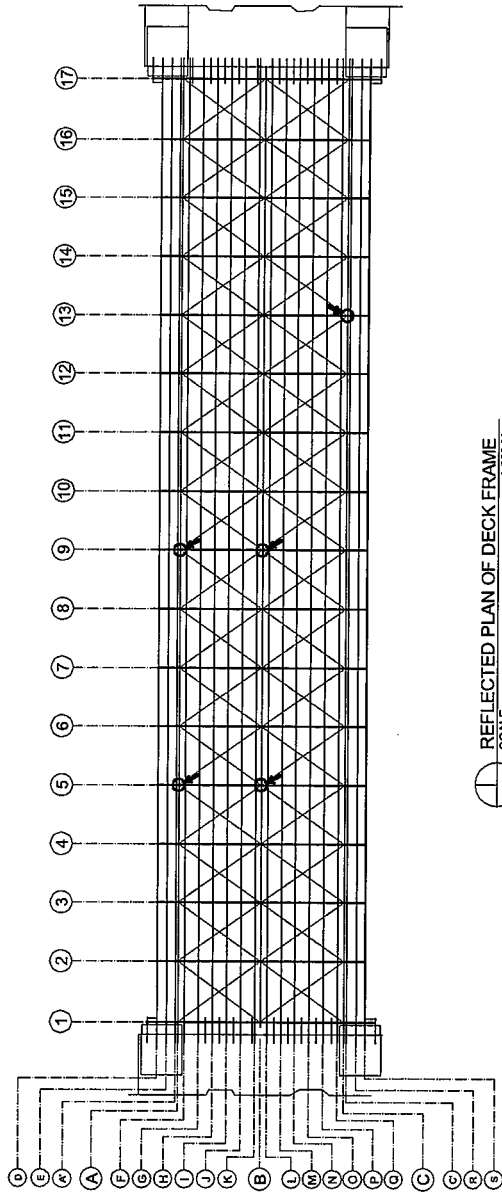
SUMMARY OF TEST RESULTS FOR DPT OF TRUSS A, B & C

1. NO SIGNIFICANT DEFECTS (INTERNAL DEFECTS OR CRACKS) WERE FOUND ON ALL TESTS LOCATIONS.
2. EACH TEST (APPROX. 0.9 M IN LENGTH) WAS PERFORMED ON CROSS BEAM WEB NEAR CONNECTION TO HANGER AS INDICATED BY AN ARROW.
