案件名：エリトリア国アスマラーマッサワ道路橋梁架け替え計画基本設計調査

**Memorandum of the Rehabilitation of Bridges on the Asmara – Massawa Road in the State of Eritrea at the second site survey conducted from January to February 2004, regarding bridge design and repair works**

Memorandum regarding the Rehabilitation of Bridges on the Asmara – Massawa Road in the State of Eritrea at the second site survey conducted from January to February 2004.

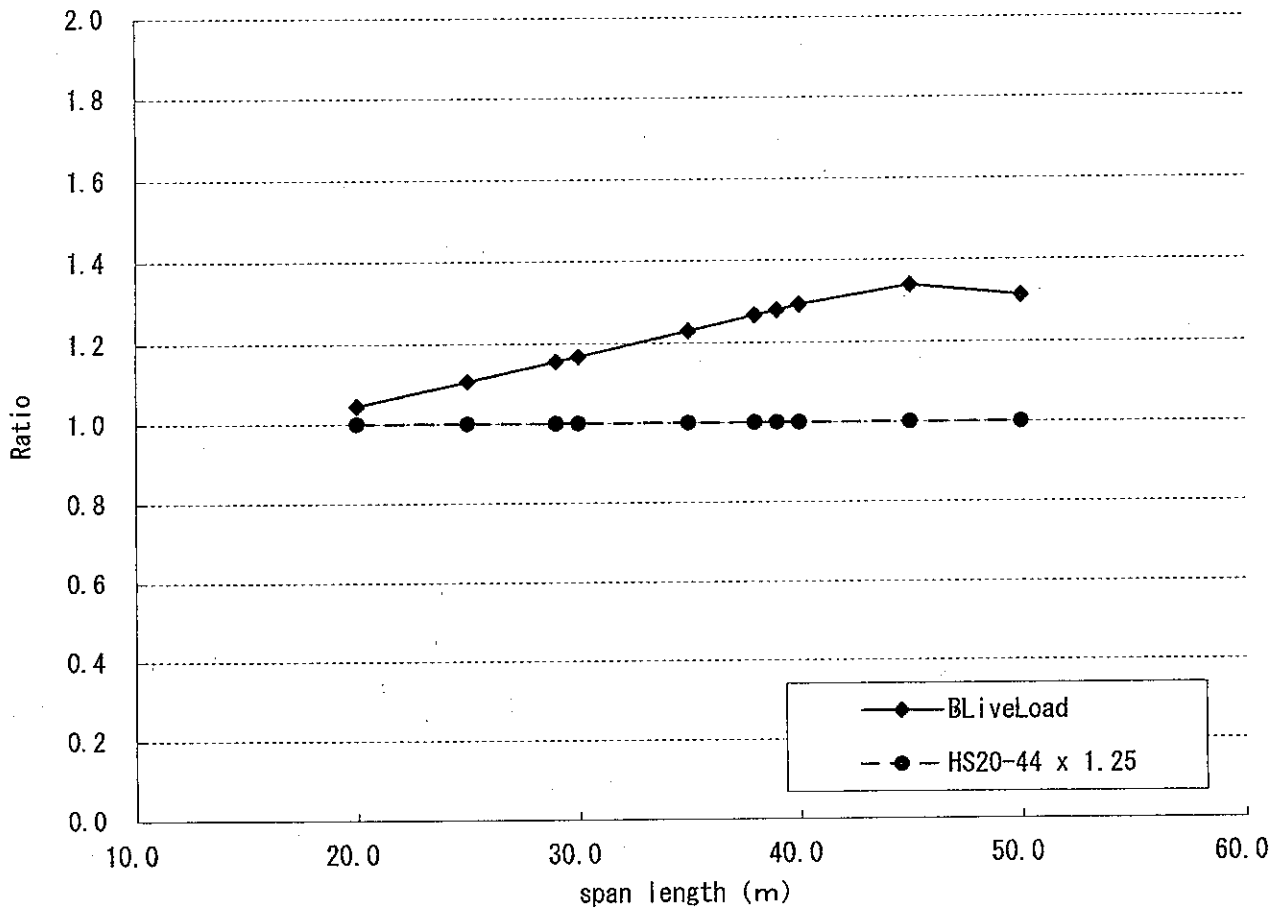
Ratio : Bending moment

span L (m)	span L (feet)	ASSHTO (HS20-44)		Japan Standard (BLiveLoad <sup>※1</sup> )	Ratio <sup>※2</sup>
		Mmax (kNm)	x 1.25 (kNm)	Mmax (kNm)	
20.000	65.617	1,542	1,928	2,017	1.046
25.000	82.021	2,014	2,517	2,784	1.106
29.000	95.144	2,383	2,979	3,442	1.155
30.000	98.425	2,475	3,094	3,612	1.167
35.000	114.829	2,928	3,660	4,501	1.230
38.000	124.672	3,196	3,995	5,064	1.267
39.000	127.953	3,285	4,107	5,257	1.280
40.000	131.234	3,374	4,217	5,452	1.293
45.000	147.638	3,864	4,830	6,466	1.339
50.000	164.042	4,598	5,747	7,544	1.313

※2 Ratio: BLiveLoad/HS20-44 x 1.25

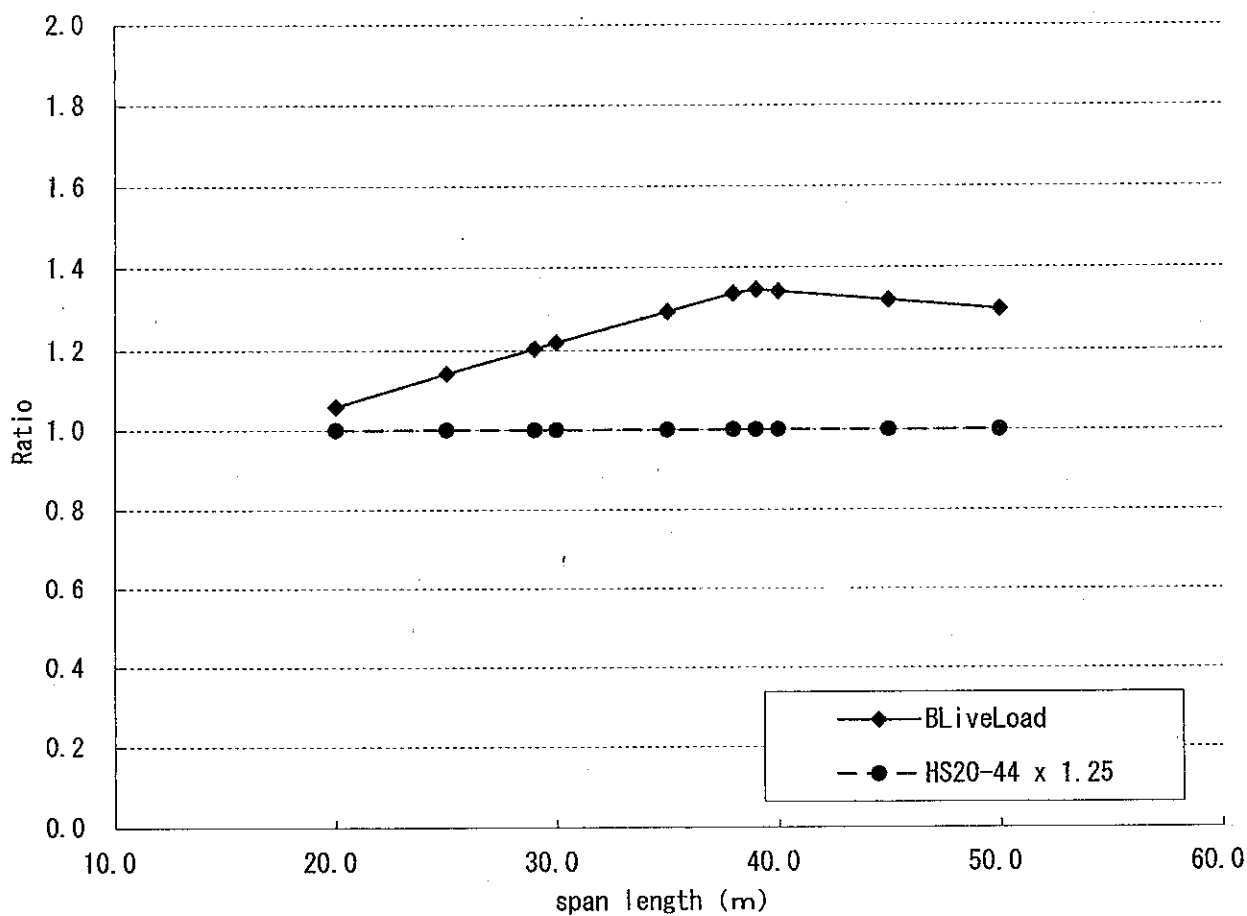
Ratio : shearing force

span L (m)	span L (feet)	ASSHTO (HS20-44)		Japan Standard (B LiveLoad <sup>※1</sup> )	Ratio <sup>※2</sup>
		Smax (kN)	x 1.25 (kN)	Smax (kN)	
20.000	65.617	347	433	458	1.057
25.000	82.021	352	440	503	1.142
29.000	95.144	354	443	534	1.204
30.000	98.425	355	443	541	1.219
35.000	114.829	356	444	574	1.292
38.000	124.672	356	445	593	1.335
39.000	127.953	357	446	600	1.345
40.000	131.234	361	452	606	1.341
45.000	147.638	386	482	636	1.319
50.000	164.042	410	512	665	1.298

※2 Ratio: B life load / HS20-44 x 1.25

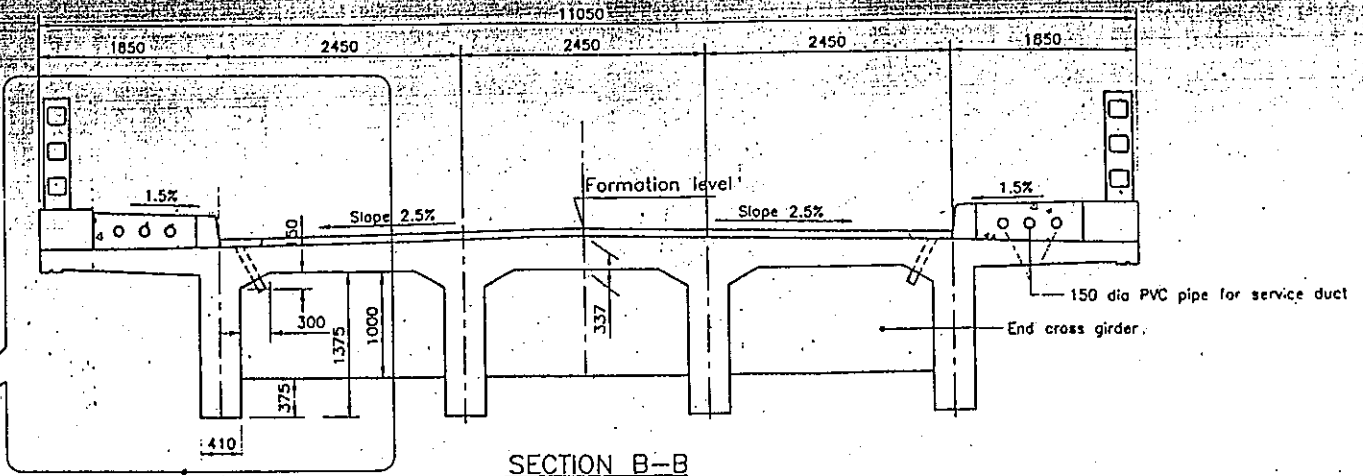
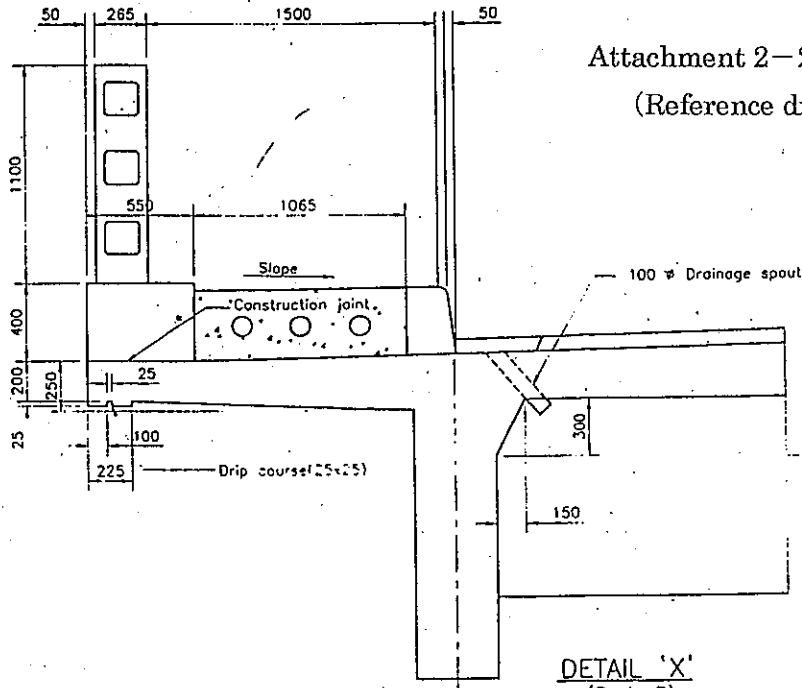
**Attachment 2-2-2-1**

(Reference drawings in other project such as Kna-Fna Bridge)

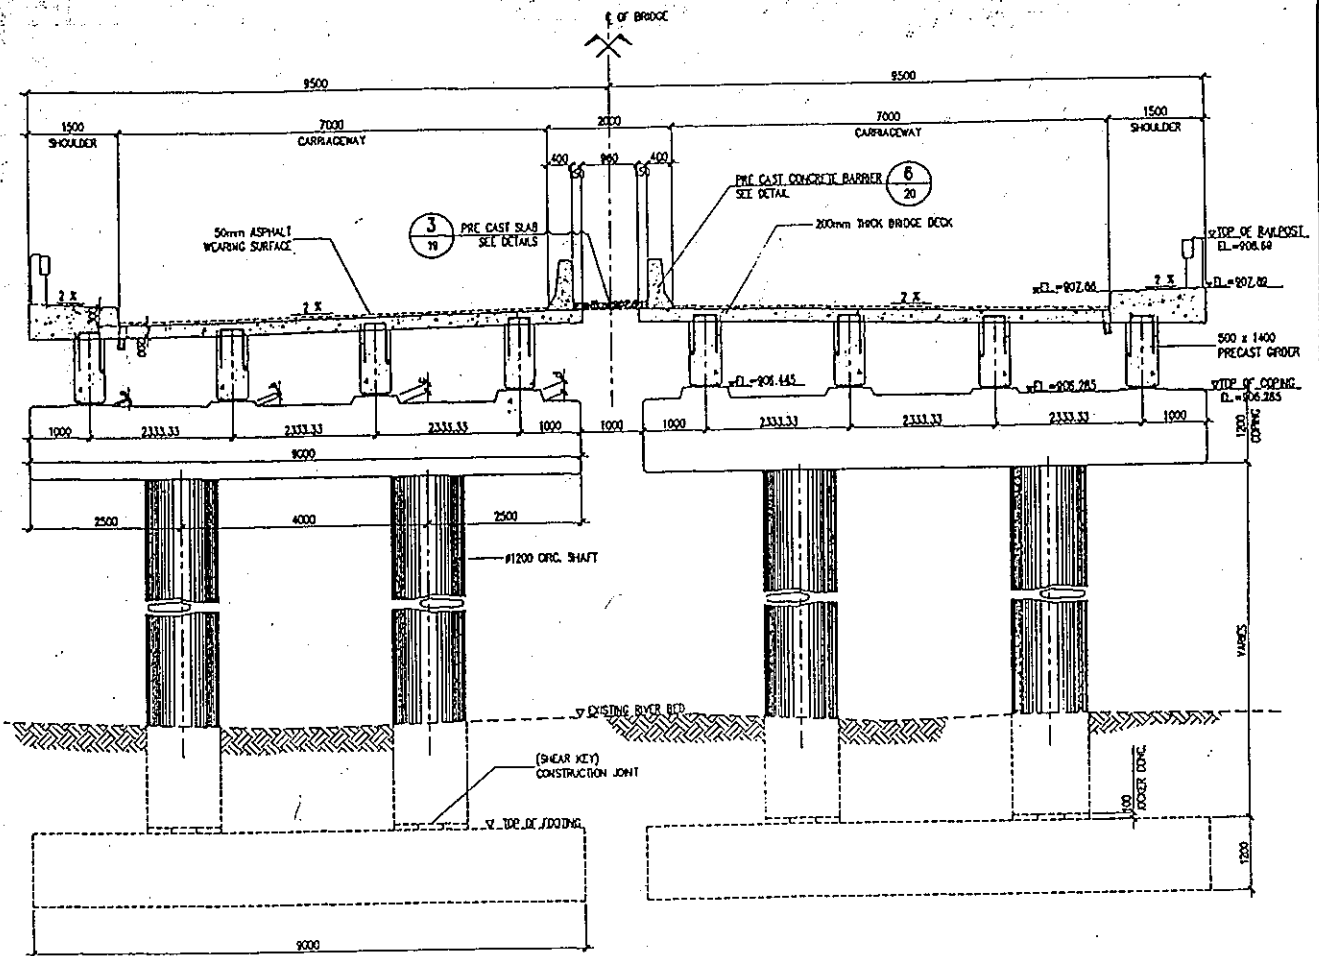
Attachment 2-2-2-2

(Standard cross section as reference drawings in Ghindae Bridge / 4 lane traffic in By-Pass Plan)

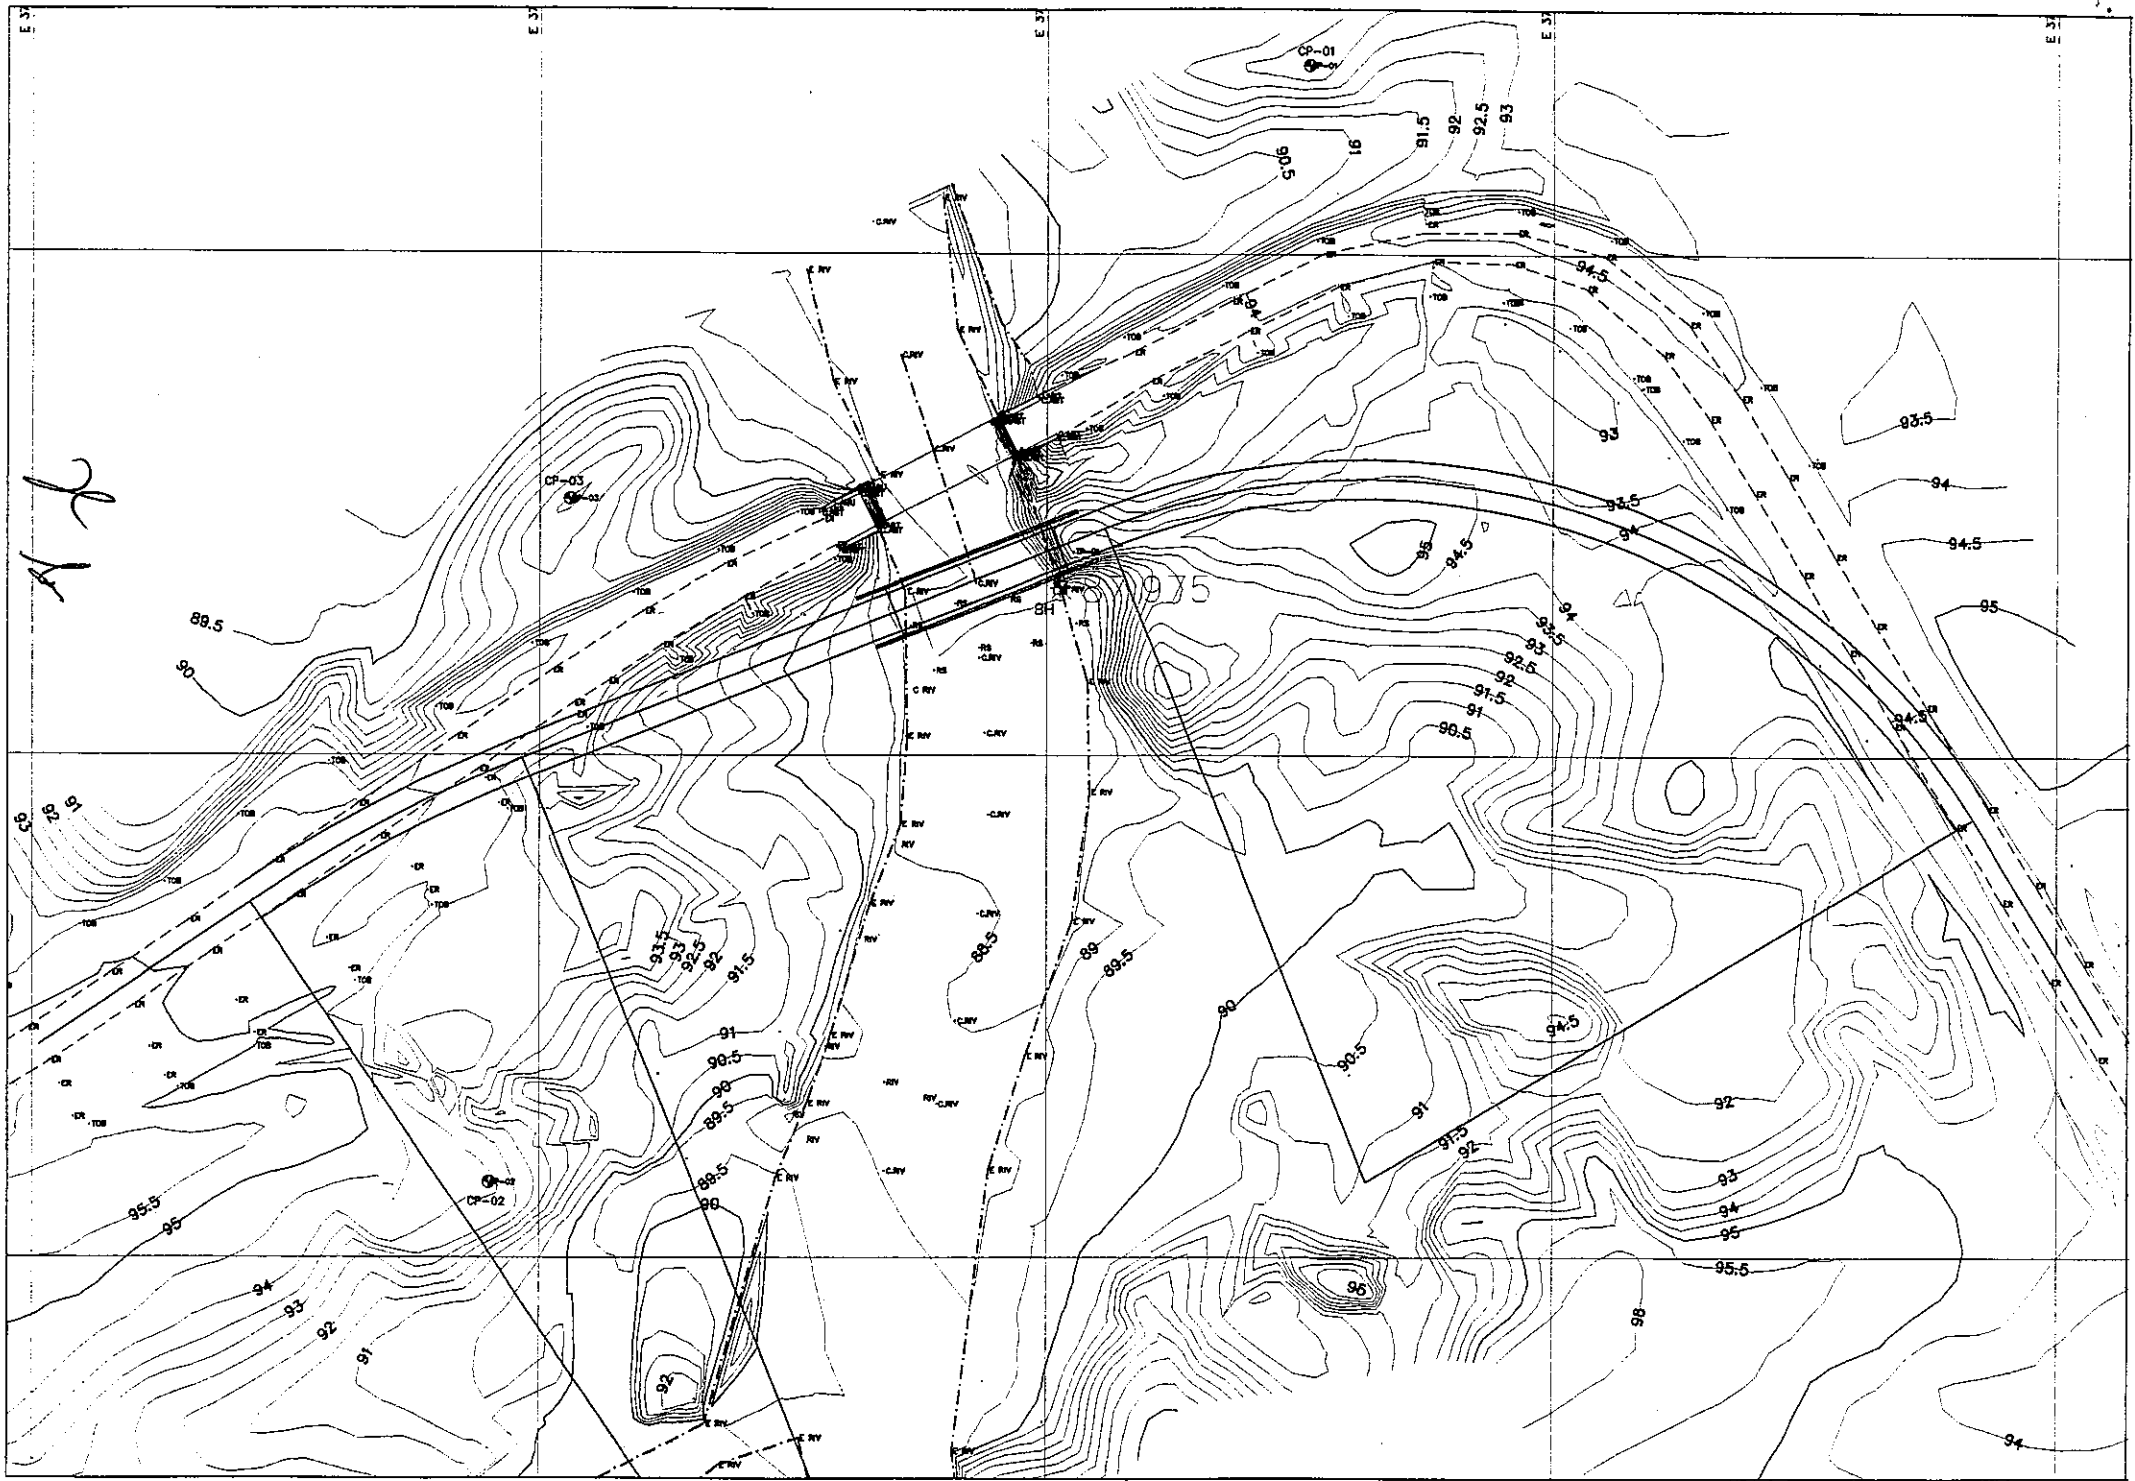
Attachment 3-2  
(Location of bridge)

3-2 Bridge location of Dogali 2 Bridge  
Planned bridge's location is shown in attached topographical survey conducted by Japanese Consultant.
