Attachment 5
(Present condition)

No.6 Emculu Bridge

Attachment 6
(Present condition and repair work plan)

No.4 Dogali 1 Bridge

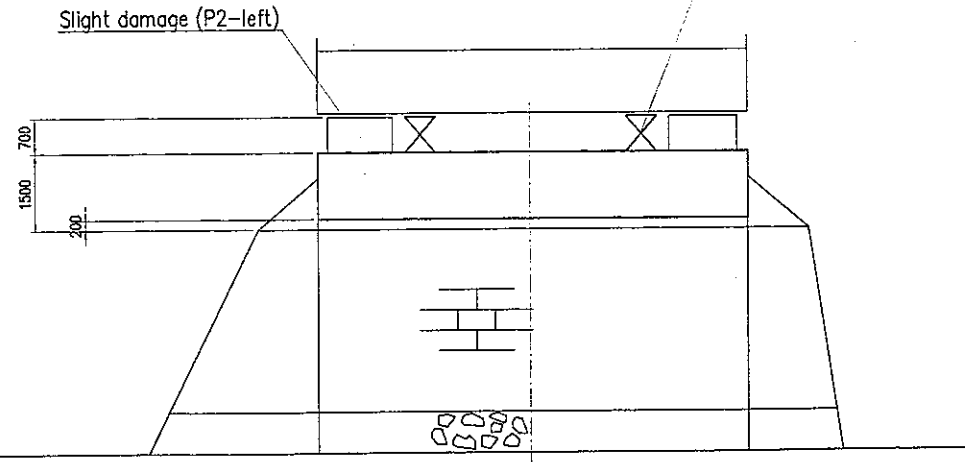
Slight damage (P2-left)

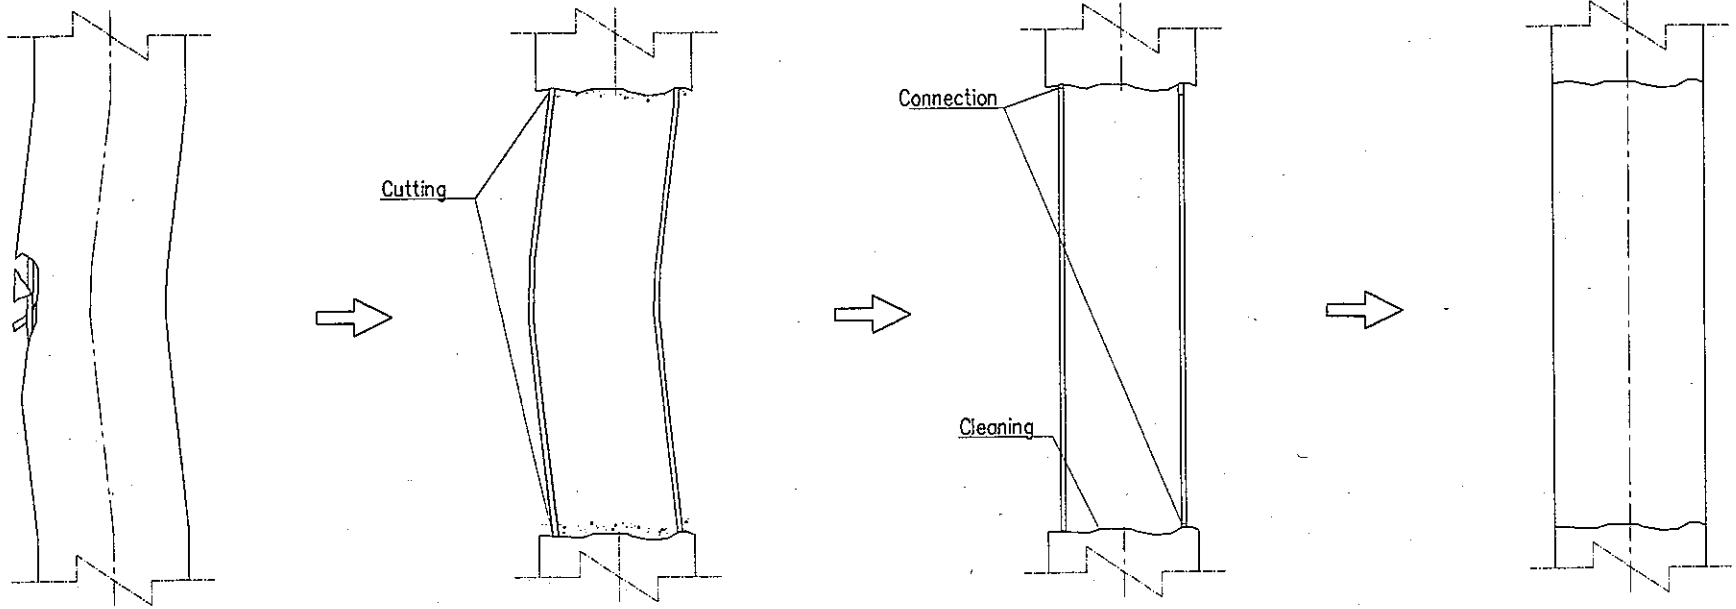
Terrible damage (Mid RV-4)

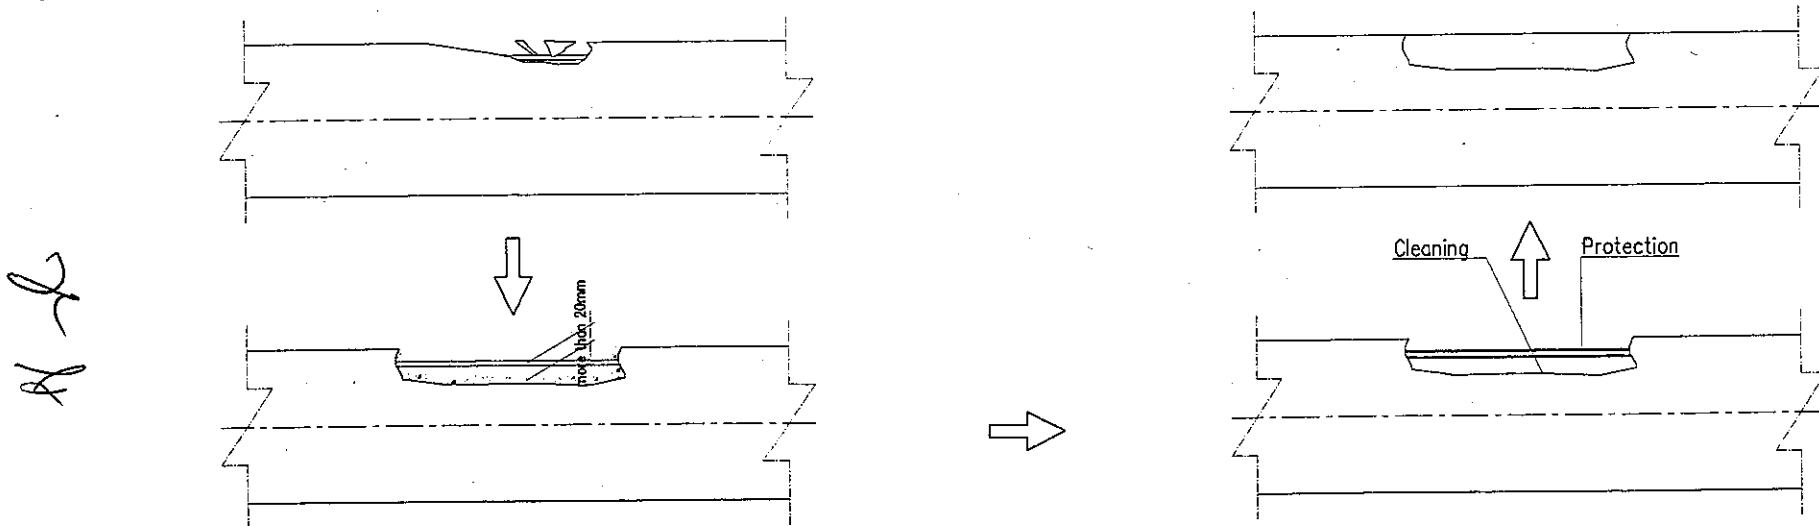
Slight damage (Asm side UCB-6/Mid LC-7,CF-1,UCB-8)

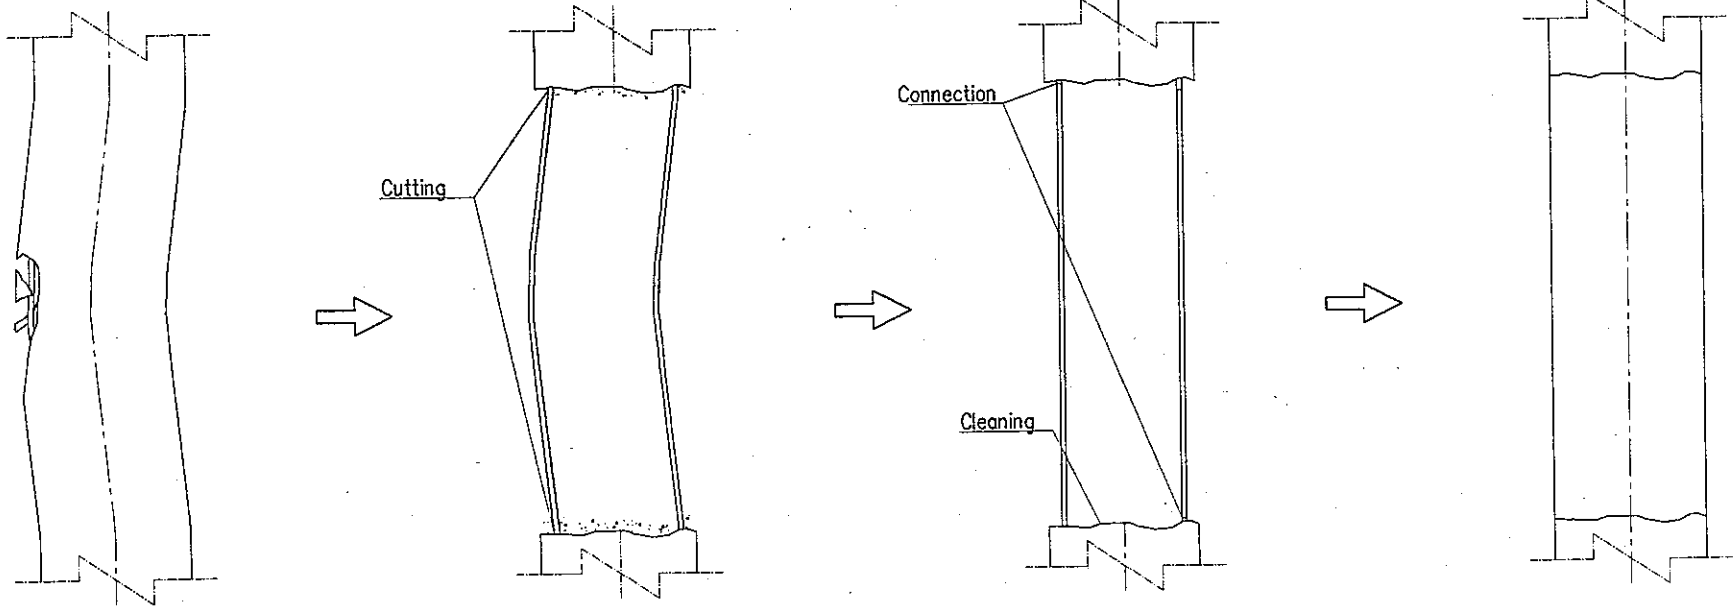
Terrible damage (Asm side LV-5,S-1,CF-11)

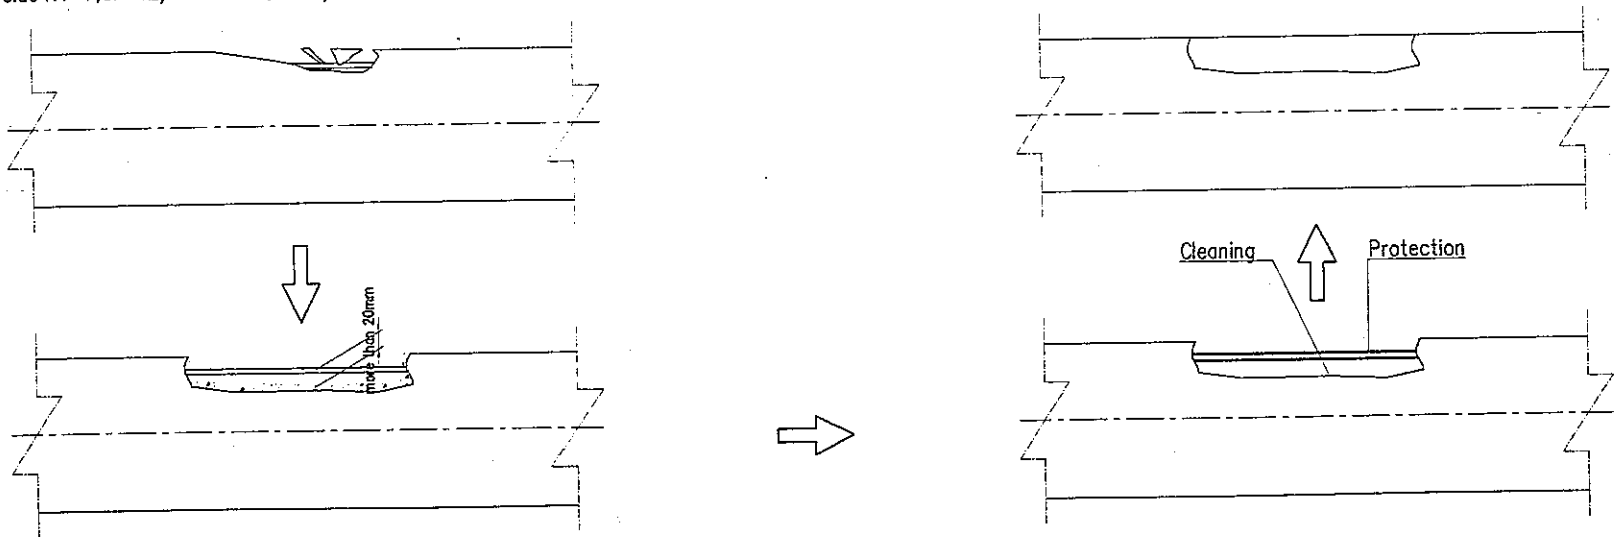
Slight damage (Asm side RV-7,CF-12/Mid RC-10,RV-6/Msw side RC-10,LV-4)
