8. 3 測量・地質調査

GINDAE BRIDGE

## 8. 4 目視観察調査による健全度評価

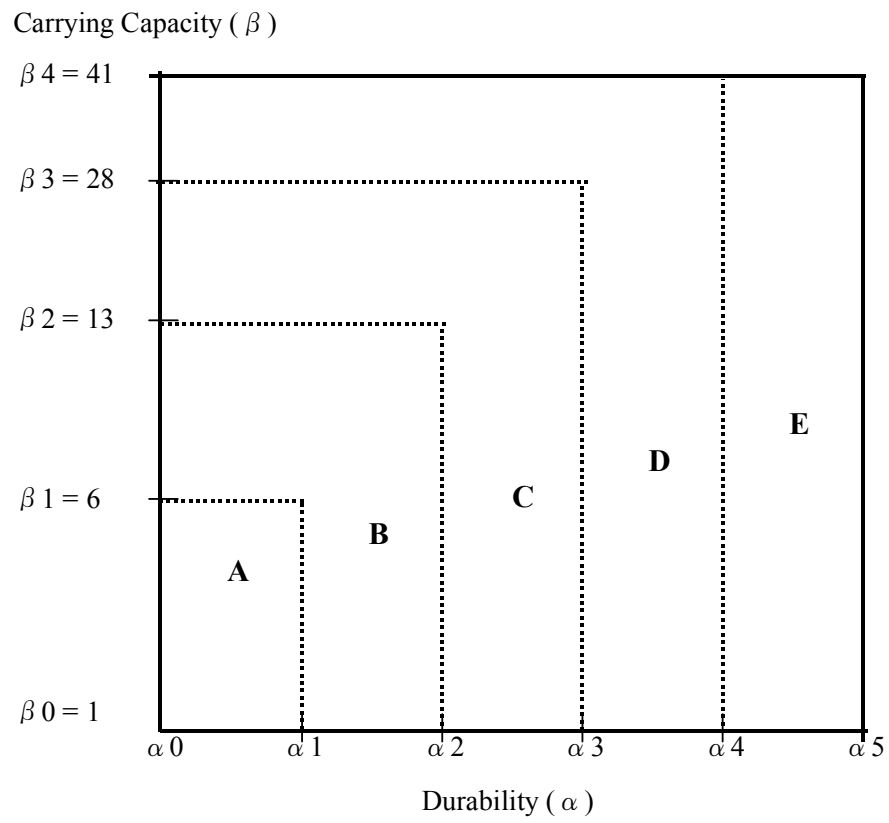
図 1 - 3 総合評価判定図

No.	Name of Bridge	Durability ( $\alpha$ )	Carrying Capacity ( $\beta$ )
1	Gindae	3.35E+18	6.56
2	Gahteral-1	1.64E+21	6.56
3	Gahteral-2	1.08E+13	6.56
4	Dogali-1	4.22E+16	6.56
5	Dogali-2	3.51E+25	6.56
6	Emculu	9.50E+18	6.56

判定方法は、総合健全度判定式で算定した耐久性 ( $\alpha$ )、耐荷力 ( $\beta$ ) の数値を以下に示した総合評価判定図の縦軸と横軸にプロットし、その交点が A~E のどこのゾーンに入るかで判定する。なお、耐久性 ( $\alpha$ ) および耐荷力 ( $\beta$ ) は、下表中の境界値で A~E のゾーニングによる。
