(3 alternatives on repair works of portal member and evaluation of 3 alternatives)

(Observation Results of Movable Bearing Emculu Bridge / Dogali 1 Bridge)

Attachment 5-3-2
(Repair work plan on bearing)

Attachment 5-4
(Repair work plan on main members)

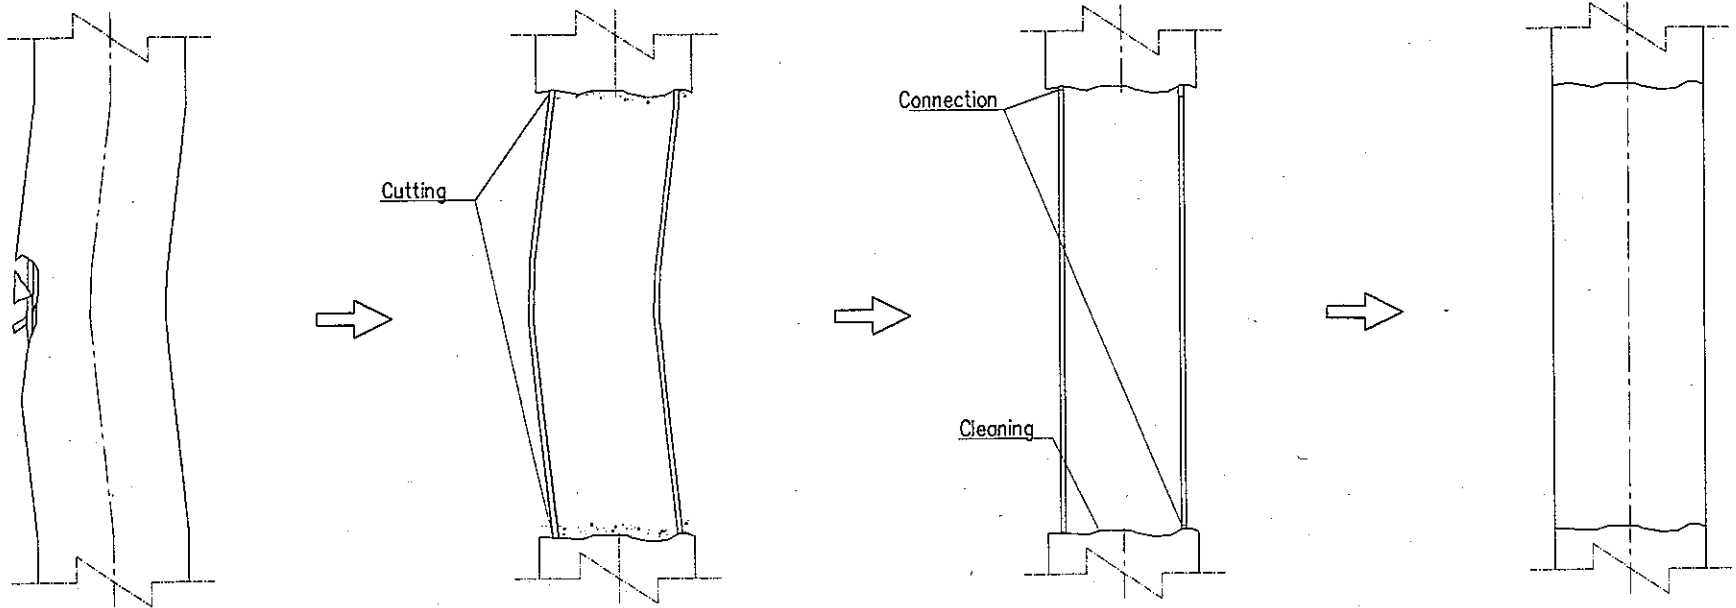
Terrible damage (Mid RV-4)

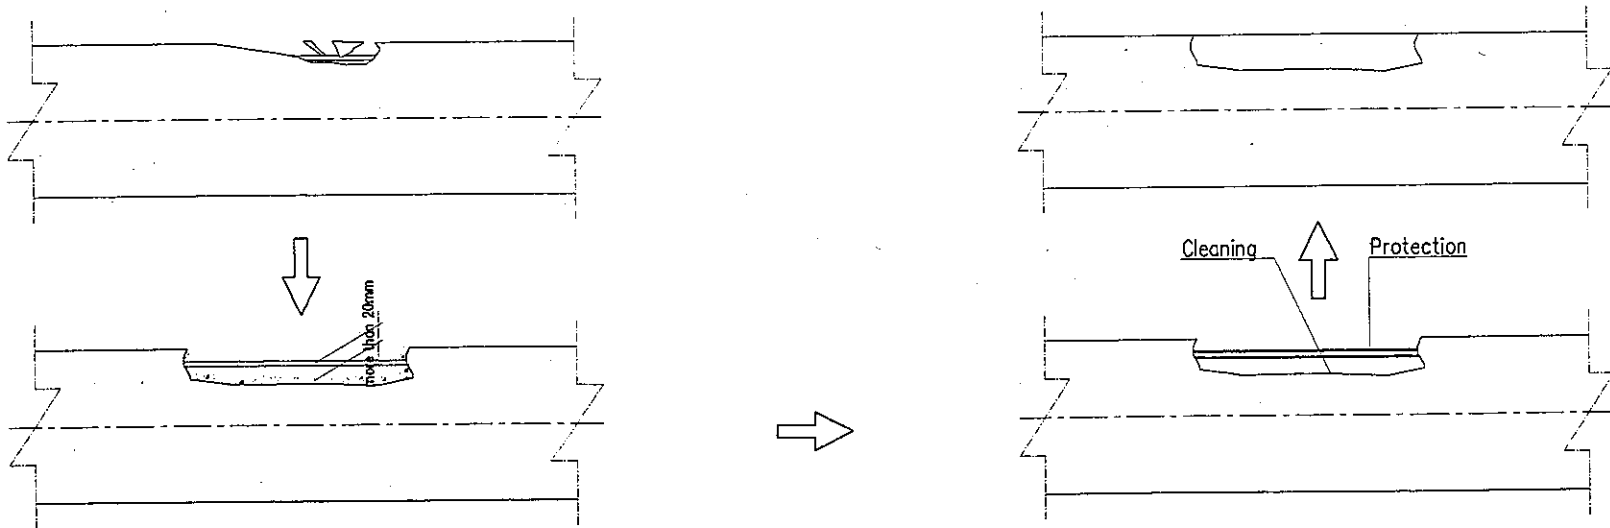
Slight damage (Asm side UCB-6/Mid LC-7,CF-1,UCB-8)
