グアシロペ橋の技術的考察

Technical Paper on Puente Agua Caliente

CA-5 道路の橋梁 2 案件 (11 橋) の現況

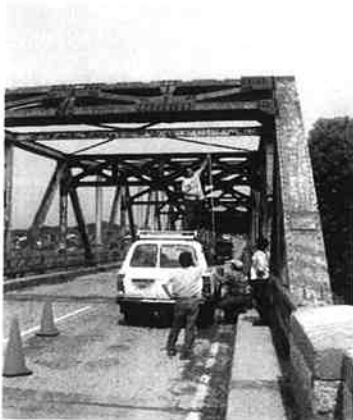
Overhead clearance of minimum 4.5m between road surface and head of bridge was confirmed by measuring as shown in photo below. And also about 0.7m allowance between top of trailer and head of bridge was measured during the survey.

Warning signs of 4.5m posted at the both ends of the bridge were confirmed by both parties. Also illegal overloaded vehicles were not observed during 1 day-long survey along CA-1 and CA-3 from Goascoran to Guasaule. There is no any problem at all about clearance of the bridge and overloaded vehicles, and also no any damages to bridge members due to clearance.

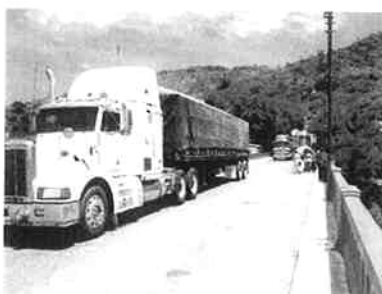
Vibration check on Puente Amatillo

Puente Guacirope has bigger rigidity than Puente Amatillo. The bigger vibration was felt to human bodies on Puente Amatillo than on Guacirope. The reason is that Puente Guacirope has bigger steel dimension and less impact than Puente Amatillo.

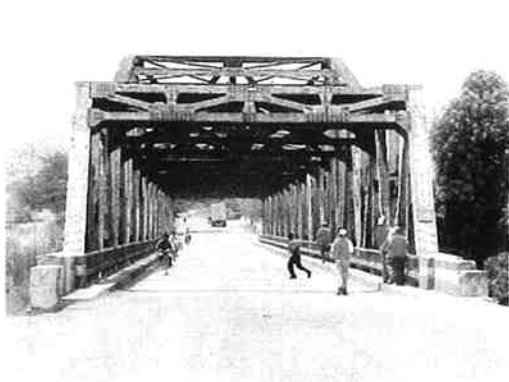
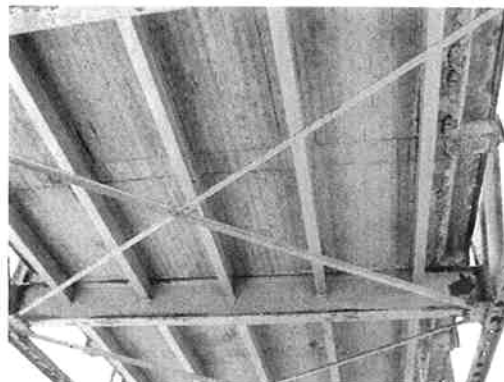
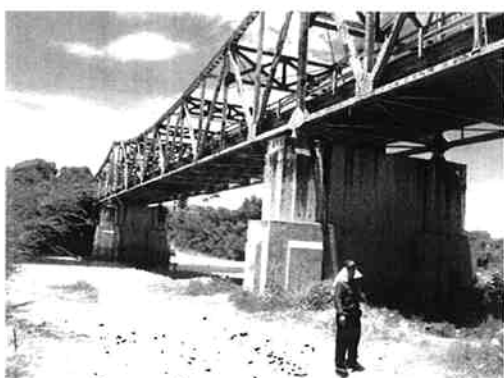
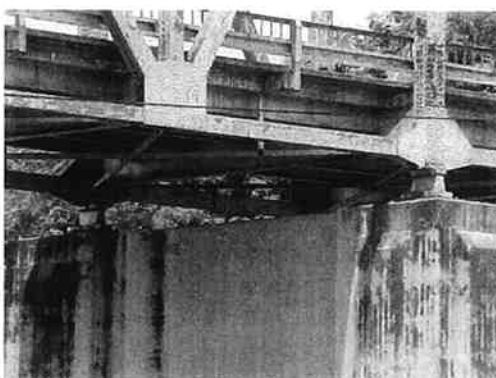
Other structure members of bridge have no any damages at present as shown on photos.

Good maintenance has been carried out by SOPTRAVI.

The continuous inspection and maintenance of AC pavement, paint on steel and other structure members are required.

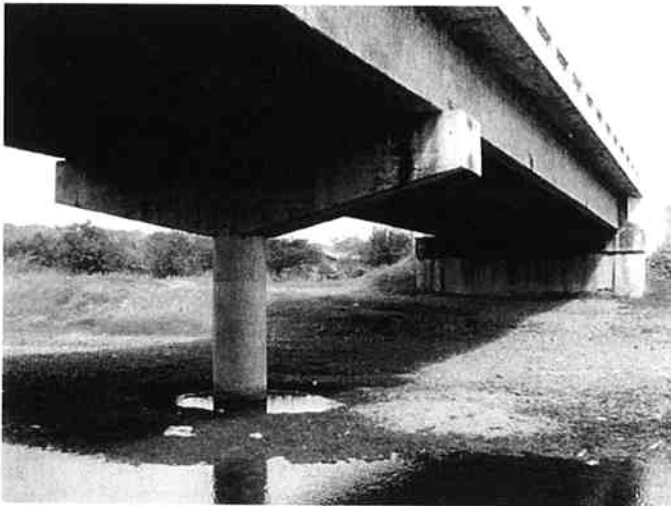
Pier column and its foundation

Pier column diameter is only 1.0m and the footing is 2.9m square and 0.8m thick. The footing is supposed to be founded on the top of lime soil layer, not penetrated directly into lime stone bedrock. Furthermore, the lime layer has been weakened by hot spring erupted around pier.

Accordingly, there are many problems such as buckling and shear strength on pier column and also stability on the footing. Pier and footing may be collapsed and fallen by the live load of 37ton semi-trailer over the bridge. It seems very dangerous since nobody can see underground.

(3) Pier Column and its Footing

Pier column and footing shall be enlarged in the way as shown in the following page:

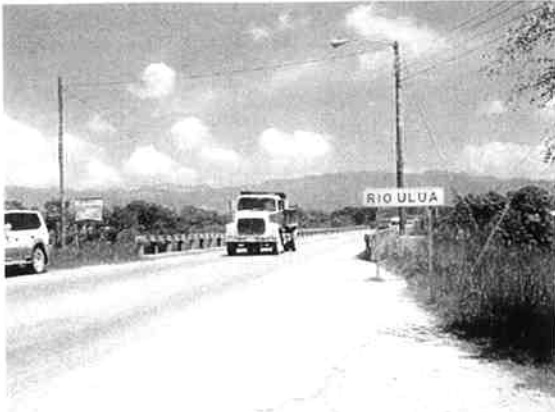
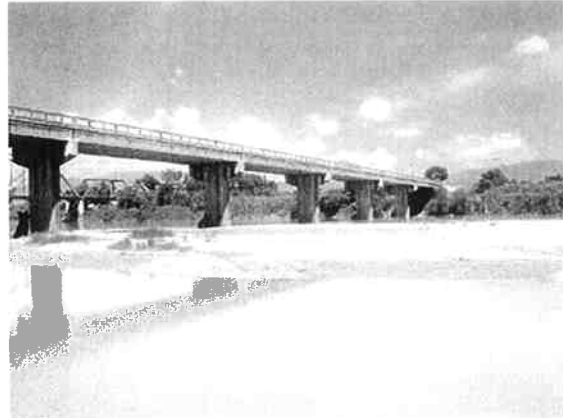
Puente Pimienta on Rio Ulua

ミッチで約 2.5m 冠水したが現在も健全である。

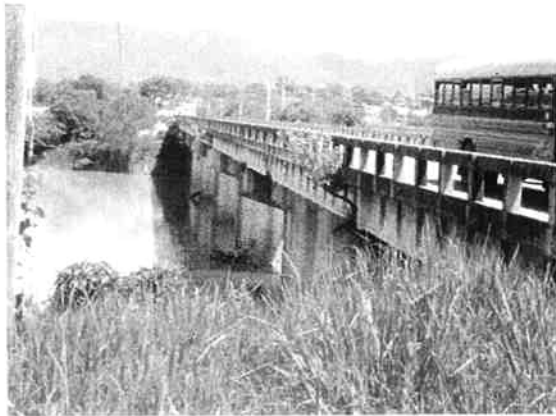
上流（左）からの流木が耳桁を損傷した。

補修は行われていない。

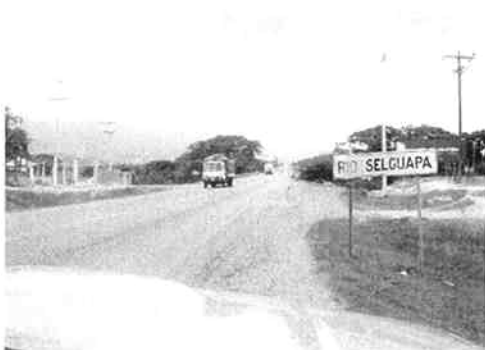
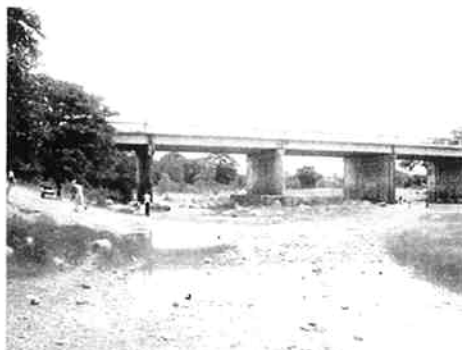
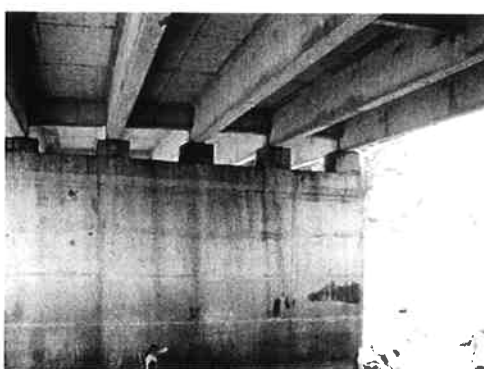
Puente Selguapa

一見普通の床版に見えるが。

北側第1橋脚基礎が洗掘され上端が大きく右に傾斜した。
即床版をジャッキアップし沓座で高さ調整された。
しかしあくまで仮の補修で極めて危険である。

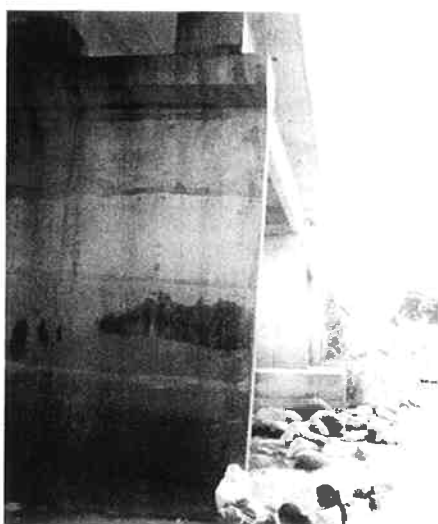
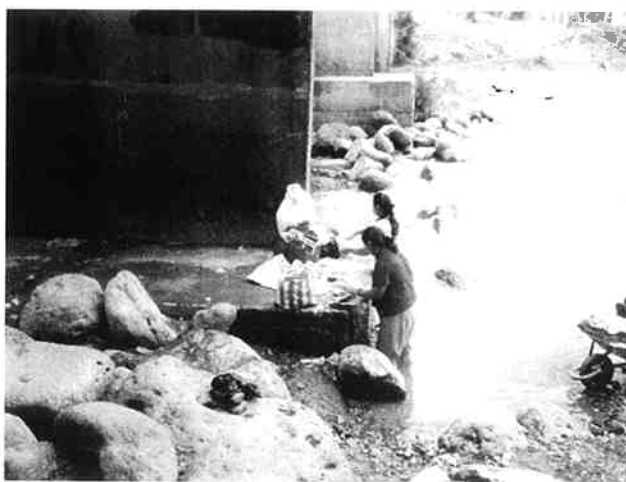
傾斜した橋脚。利用者に不安感を持たせる。

この橋は改良する道路上にあるが、BIDはこの橋が損傷激しいこと認識していない。

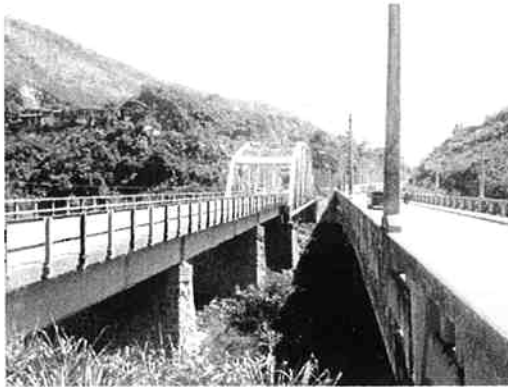
行き車線 (鋼トラス、1943年完成)

しかし、鋼トラス橋(南行き)は寿命60年を超え、またPCゲルバー橋+PC I桁(北行き)は断面が小さく(設計活荷重はHS-15-44で損傷も見られる。

近い将来、両方の橋とも重交通に耐えられなくなると予想される。
