Interview Survey Results on the Rural Water Supply Condition (JICA MCHINJI DISTRICT GROUNDWATER DEVELOPMENT PROJECT)

- (1) TA _____ MLONYENI
- (2) Village name _____ CHAONONGEKA (No. 1-14)

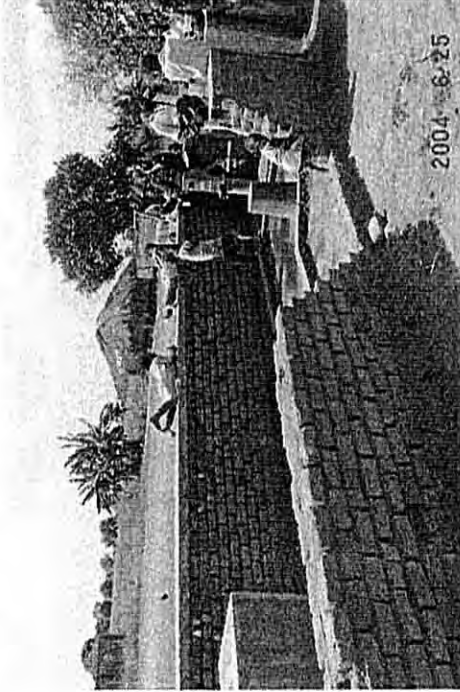
Only 30% of villagers have willingness to pay. At the beginning of the service started, water tariff was collected regularly, but as the treasurer used money for other purposes, villagers refused to pay water tariff. However villagers are trying to prepare budget for repairing by getting the help from NGOs.

Rods, riser pipe are worn down. Not functional since 2months ago. Three times of breakdown have been experienced since 1993. Villagers hope to be helped by NGOs.

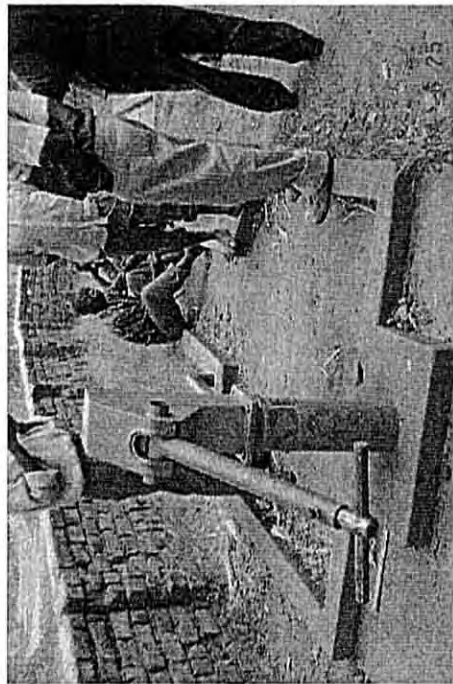
ZULU
 CHAMVEKA
 (NO. 2-92)

current
 The tariff mentioned above was determined by villagers according to CBM principle. In the beginning of the service started, the tariff was collected satisfactory, but the accumulated tariff was disappeared for several years. So, villagers stopped paying tariff. As the enough budget has not been collected so far, villagers decided to prepare money by delivering their maize.

Un functional since February 2004. Five rods and riser pipe are breakdown. Total repairing cost will be estimated around K20,000 to K25,000. Three times of the breakdown have been experienced.

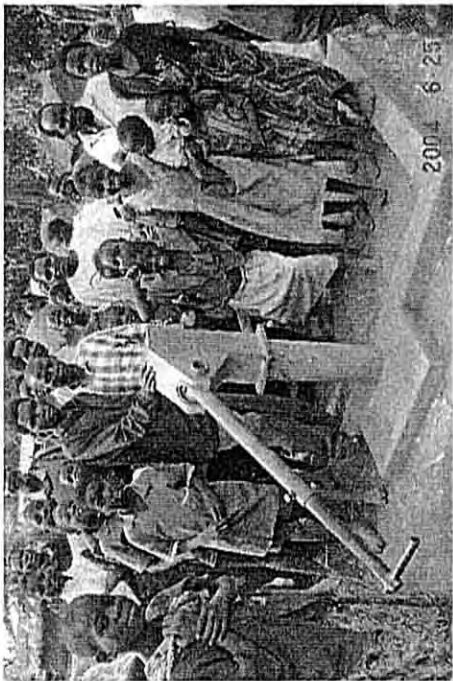
(1) TA ZULU
 (2) Village name KATHYUKA
 (No. 3-08) _____

Tariff has been collected, but accumulated tariff has been used for other purposes by treasurer. So, there is no budget to repair even small parts of the pump. WPC intends to collect temporary tariff from the villagers, but it has not been successful until now.

- (7) Water point type and number
 - a. Deep well with handpump 1 (No. 3-08)
 - b. Unprotected shallow well 2
 - c. River, pond, lake, others _____
- (8) Functional condition
 - a. Functional _____
 - b. Under repair (Breakdown) _____
 - c. Breakdown or Abandoned, Reasons of abandonment below:
 Rubber is worn out. Not functioning before 3 months ago.
 Breakdown has been experienced ten times since 1995.

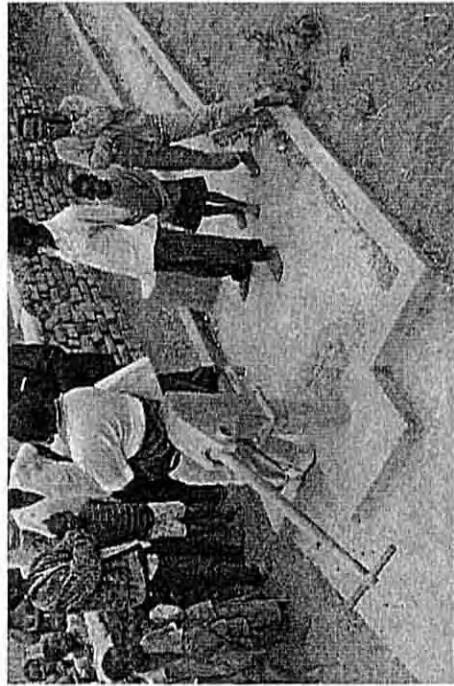
(1) District ZULU
 (2) TA CHIKOLOKA
 (No.3-05)

a. Collection efficiency (%) : Unknown
 b. Water tariff system
 c. by bucket, water tariff by bucket :
 d. by family, monthly water tariff by family : K10 to K20/household/month
 e. Others : Haphazard collection in case of breakdown
 Tariff has been collected, but accumulated tariff has been used for other purposes by treasurer. So, there is no budget to repair the pump. WPC intends to collect temporary tariff from the villagers, but it has not been successful until now.

(7) Water point type and number 1 (No.3-05)
 a. Deep well with handpump
 b. Unprotected shallow well 6
 c. River, pond, lake, others
 (8) Functional condition
 a. Functional
 b. Under repair (Breakdown)
 c. Breakdown or Abandoned, Reasons of abandonment below:
 Six rods worn out. It has broken in 2002. Two times of breakdown has been experienced since 1995.

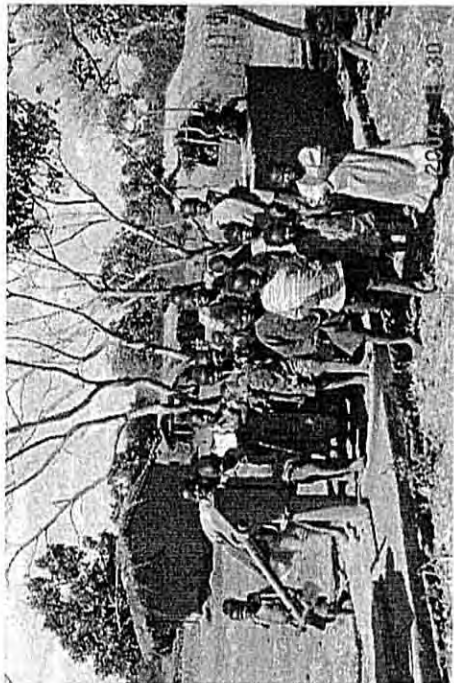
- 1 Location
- (1) TA KHONGONI
 - (2) Village Name KASANDA

- a. Collection efficiency (%) : No tariff collection
- b. Water tariff system -
- c. by bucket, water tariff by bucket :
- d. by family, monthly water tariff by family :
- e. Others : Haphazard collection in case of breakdown Enough money has not been collected yet

- (7) Water point type and number
- a. Deep well with handpump 1 (breakdown)
 - b. "Vonder" Hand drilled well with handpump
 - c. Protected shallow well with handpump
 - d. Gravity fed communal tap
 - e. Motorized communal tap
 - f. Unprotected shallow dug well 4 (Dumbo)
 - g. Spring
 - h. River, pond, lake, others
- (8) Functional condition (if one of a to e is checked in item (5))
- a. Functional
 - b. Under repair
 - c. Abandoned, Reasons of abandonment below: 1
Breakdown at 2001, rehabilitated at 1997, rods & riser main broken now (16/22)

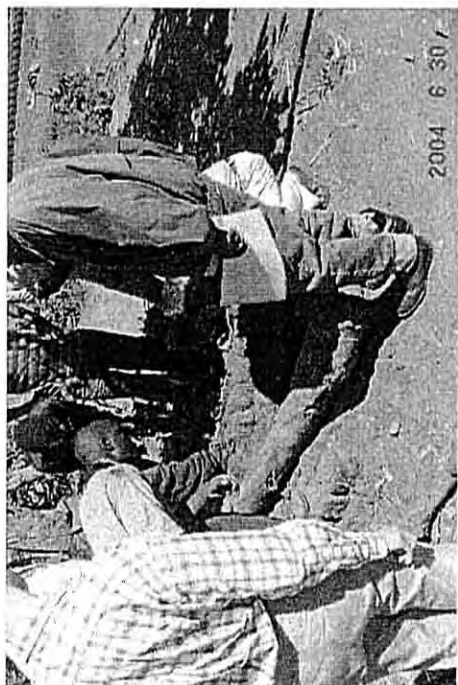
1 Location
 (1) TA KHONGONI
 (2) Village Name MPHANDA

3 Water Supply Facilities
 (7) Water point type and number
 a. Deep well with mechanic or handpump
 b. "Vonder" Hand drilled well with handpump
 c. Protected shallow well with handpump
 d. Gravity fed communal tap
 e. Motorized communal tap
 f. Unprotected shallow dug well
 g. Spring
 h. River, pond, lake, others
 (8) Functional condition (if one of a to e is checked in item (5))
 a. Functional
 b. Under repair
 c. Abandoned, Reasons of abandonment below:
1, dries up in dry season

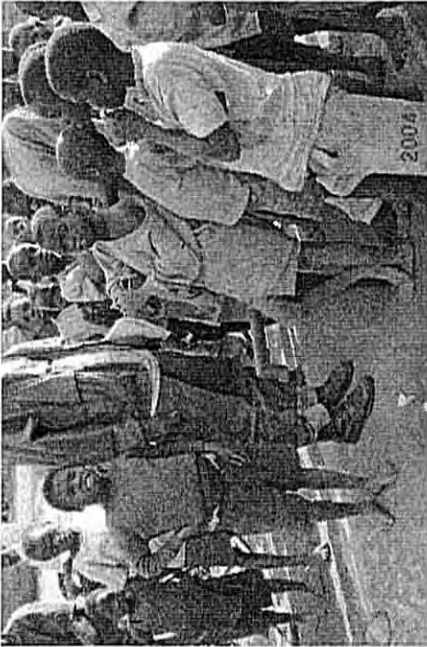
(2) Village Name MATUNDULUZI

7 Others The money (k8,000) for repair was stolen, after that, people has had no willingness to pay for repair.

- a. Functional
- b. Under repair (not working for 3 months) 2
- c. Abandoned, Reasons of abandonment below:
Breakdown at 2000, Rods \$ riser pipes broken
