Bridge Inventory

(4 Luwadzi Bridge)

Damage of Bridges

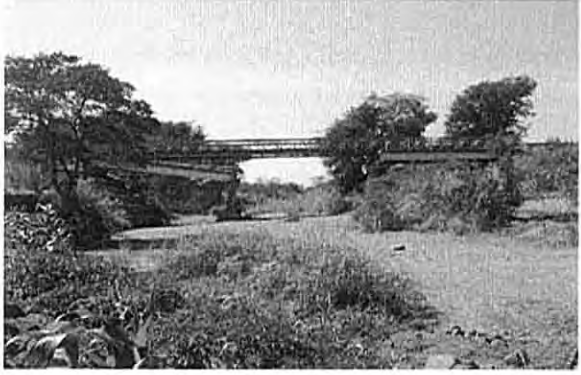
Name of Bridge:	Luwadzi Bridge					
Description	The original bridge of 3-span steel girder bridge had been impassable due to settlement of bridge pier by the flood in January 2002. The single-lane baily bridge had erected as a temporary bridge.					
Date of Survey:	July 24, 2004					
Surveyor:	Takayuki Tsuchida, Kelvin N. Mphonda					
Items	Damage Level					Remarks
	N/A	No Damage	Low Damage	Medium Damage	High Damage	
Road Surface (including Approach Road)	Pavement			X		Temporally Br.
	Crack (Concrete Slab)	X				
Accessories ==>Temporally Bridge	Handrails	X				
	Lighting Facilities	X				
	Bearing					X
	Expansion Joint	X				
	Drainage Facilities	X				
	Traffic Signboard		X			
	Affixed Articles	X				
Buried Articles	X					
Concrete Slab	Crack		X			
	Free Lime		X			
	Corrosion of Re-bar		X			
	Spalling		X			
	Honeycomb			X		
	Others	X				
Concrete Girder	Crack	X				
	Free Lime	X				
	Corrosion of Re-bar	X				
	Spalling	X

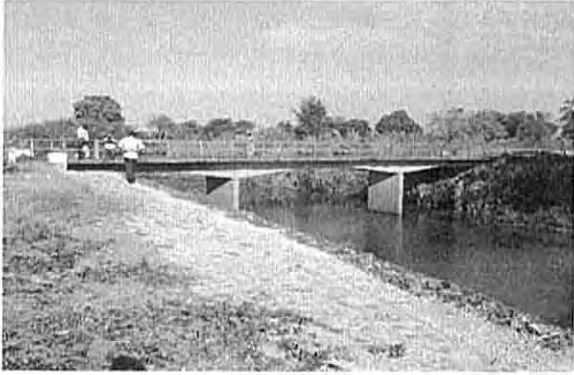
(5 Lifyodzi Bridge)

Name of Bridge:	Lifyodzi Bridge					
Description	During peak periods of the floods, the water flows on the top of the road. The major damages include cracks of the concrete girder. The river banks are well maintained.					
Date of Survey:	July 21, 2004					
Surveyor:	Takayuki Tsuchida, Kelvin N. Mphonda					
Items	Damage Level					Remarks
	N/A	No Damage	Low Damage	Medium Damage	High Damage	
Road Surface (including Approach Road)	Pavement	X				
	Crack (Concrete Slab)	X				
Accessories	Handrails			X		
	Lighting Facilities	X				
	Bearing		X			
	Expansion Joint	X				
	Drainage Facilities	X				
	Traffic Signboard		X			
	Affixed Articles	X				
Buried Articles	X					
Concrete Slab	Crack				X	
	Free Lime		X			
	Corrosion of Re-bar		X			
	Spalling			X		
	Honeycomb			X		
	Others	X				
Concrete Girder	Crack				X	
	Free Lime			X		
	Corrosion of Re-bar		X			
	Spalling		X			
	Honeycomb			X		
	Others	X				
Steel Girder	Lacking	X

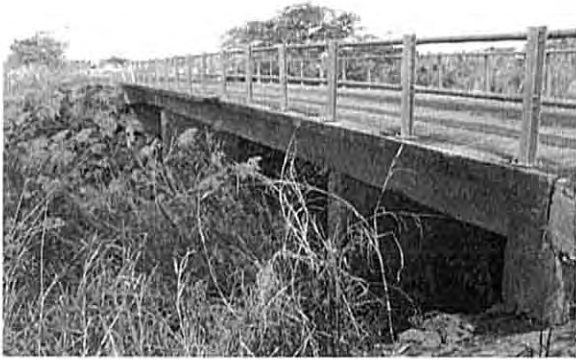
(6 Navikoko Bridge)

Name of Bridge:	Navikoko Bridge					
Description	During peak periods of the floods, the water flows on the top of the road. The major damages include settlement of concrete slab on the side spans. The inadequate repair works of embankment had reduced the river flow area.					
Date of Survey:	July 22, 2004					
Surveyor:	Takayuki Tsuchida, Kelvin N. Mphonda					
Items	Damage Level					Remarks
	N/A	No Damage	Low Damage	Medium Damage	High Damage	
Road Surface (including Approach Road)	Pavement				X	Approach
	Crack (Concrete Slab)				X	
Accessories	Handrails				X	
	Lighting Facilities	X				
	Bearing	X				
	Expansion Joint	X				
	Drainage Facilities	X				
	Traffic Signboard		X			
	Affixed Articles	X				
Buried Articles	X					
Concrete Slab	Crack				X	
	Free Lime		X			
	Corrosion of Re-bar		X			
	Spalling			X		
	Honeycomb		X			
Others					X	Side Span Settled
Concrete Girder	Crack		X			
	Free Lime		X			
	Corrosion of Re-bar		X

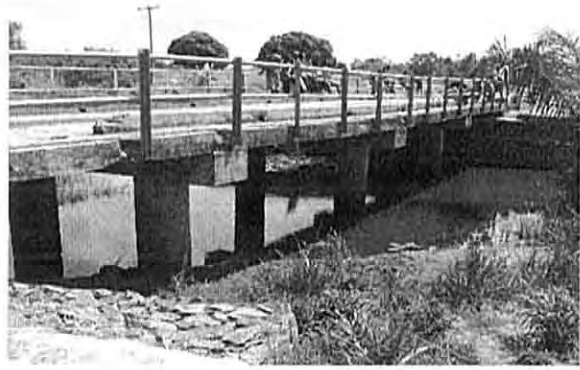
(7 Kanjamwano Bridge)

Name of Bridge:	Kanjamwano Bridge					
Description	During peak periods of the floods, the water flows on the top of the road. There is no major damages except the scouring of downstream of the bridge.					
Date of Survey:	July 22, 2004					
Surveyor:	Takayuki Tsuchida, Kelvin N. Mphonda					
Items	Damage Level					Remarks
	N/A	No Damage	Low Damage	Medium Damage	High Damage	
Road Surface (including Approach Road)	Pavement			X		Approach
	Crack (Concrete Slab)		X			
Accessories	Handrails		X			Collapsed
	Lighting Facilities	X				
	Bearing	X				
	Expansion Joint	X				
	Drainage Facilities	X				
	Traffic Signboard				X	
	Affixed Articles	X				
Buried Articles	X					
Concrete Slab	Crack		X			
	Free Lime		X			
	Corrosion of Re-bar		X			
	Spalling			X		
	Honeycomb		X			
	Others	X				
Concrete Girder	Crack	X				
	Free Lime	X				
	Corrosion of Re-bar	X				
	Spalling	X				
	Honeycomb	X				
	Others	X				
Steel Girder	Lacking	X

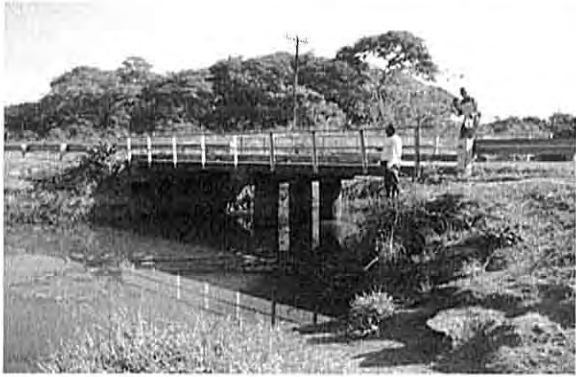
(8 Chamakuwa Bridge)

Name of Bridge:	Chamakuwa Bridge					
Description	During peak periods of the floods, the water flows on the top of the road. Major damages include the exposed foundation piles of the both abutment and the scouring of downstream of the bridge.					
Date of Survey:	July 22, 2004					
Surveyor:	Takayuki Tsuchida, Kelvin N. Mphonda					
Items	Damage Level					Remarks
	N/A	No Damage	Low Damage	Medium Damage	High Damage	
Road Surface (including Approach Road)	Pavement	X				
	Crack (Concrete Slab)		X			
Accessories	Handrails		X			
	Lighting Facilities	X				
	Bearing	X				
	Expansion Joint	X				
	Drainage Facilities	X				
	Traffic Signboard		X			
	Affixed Articles	X				
Buried Articles	X					
Concrete Slab	Crack		X			
	Free Lime		X			
	Corrosion of Re-bar		X			
	Spalling		X			
	Honeycomb		X			
Others	X					
Concrete Girder	Crack	X				
	Free Lime	X				
	Corrosion of Re-bar	X				
	Spalling	X				
	Honeycomb	X				
	Others	X

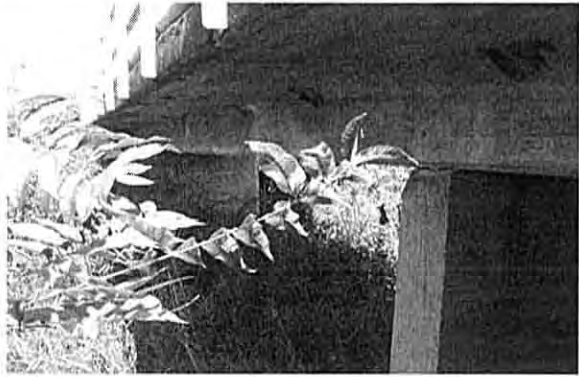
(9 Ling'ona Bridge)

Name of Bridge:	Ling'ona Bridge					
Description	During peak periods of the floods, the water flows on the top of the road. The major damages include settlement of concrete slab on the side spans and exposed foundation piles of bridge piers.					
Date of Survey:	July 23, 2004					
Surveyor:	Takayuki Tsuchida, Kelvin N. Mphonda					
Items	Damage Level					Remarks
	N/A	No Damage	Low Damage	Medium Damage	High Damage	
Road Surface (including Approach Road)	Pavement				X	Approach
	Crack (Concrete Slab)			X		
Accessories	Handrails			X		
	Lighting Facilities	X				
	Bearing	X				
	Expansion Joint	X				
	Drainage Facilities	X				
	Traffic Signboard		X			
	Affixed Articles		X			
	Buried Articles	X				
Concrete Slab	Crack			X		
	Free Lime		X			
	Corrosion of Re-bar		X			
	Spalling		X			
	Honeycomb			X		
	Others				X	Side Span Settled
Concrete Girder	Crack		X			
	Free Lime		X			
	Corrosion of Re-bar		X			
	Spalling		X			
	Honeycomb		X

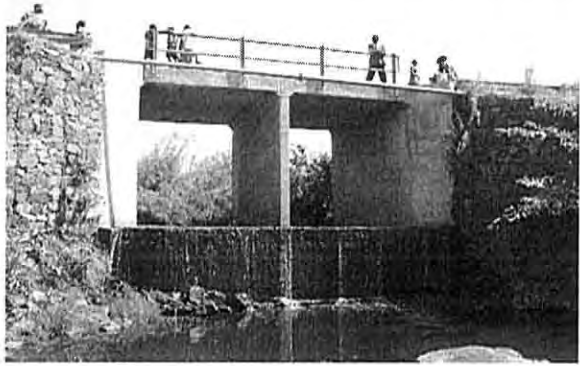
(10 Mchandilo Culvert)

Name of Bridge:	Mchandilo Culvert					
Description	The major damages include scouring of apron of downstream of the box culvert.					
Date of Survey:	July 23, 2004					
Surveyor:	Takayuki Tsuchida, Kelvin N. Mphonda					
Items	Damage Level					Remarks
	N/A	No Damage	Low Damage	Medium Damage	High Damage	
Road Surface (including Approach Road)	Pavement	X				
	Crack (Concrete Slab)		X			
Accessories	Handrails		X			
	Lighting Facilities	X				
	Bearing	X				
	Expansion Joint	X				
	Drainage Facilities		X			
	Traffic Signboard		X			
	Affixed Articles		X			
	Buried Articles	X				
Concrete Slab	Crack		X			
	Free Lime		X			
	Corrosion of Re-bar		X			
	Spalling		X			
	Honeycomb		X			
	Others	X				
Concrete Girder	Crack	X				
	Free Lime	X				
	Corrosion of Re-bar	X				
	Spalling	X				
	Honeycomb	X				
	Others	X				
Steel Girder	Lacking	X				
	Deformation	X				
	Rust or Corrosion	X				
	Painting	X				
	Others	X				
Substructure ==>Concrete Wall	Deformation		X
