## **8.5 ENVIRONMENTAL MONITORING**

### **8.5.1 Monitoring program**

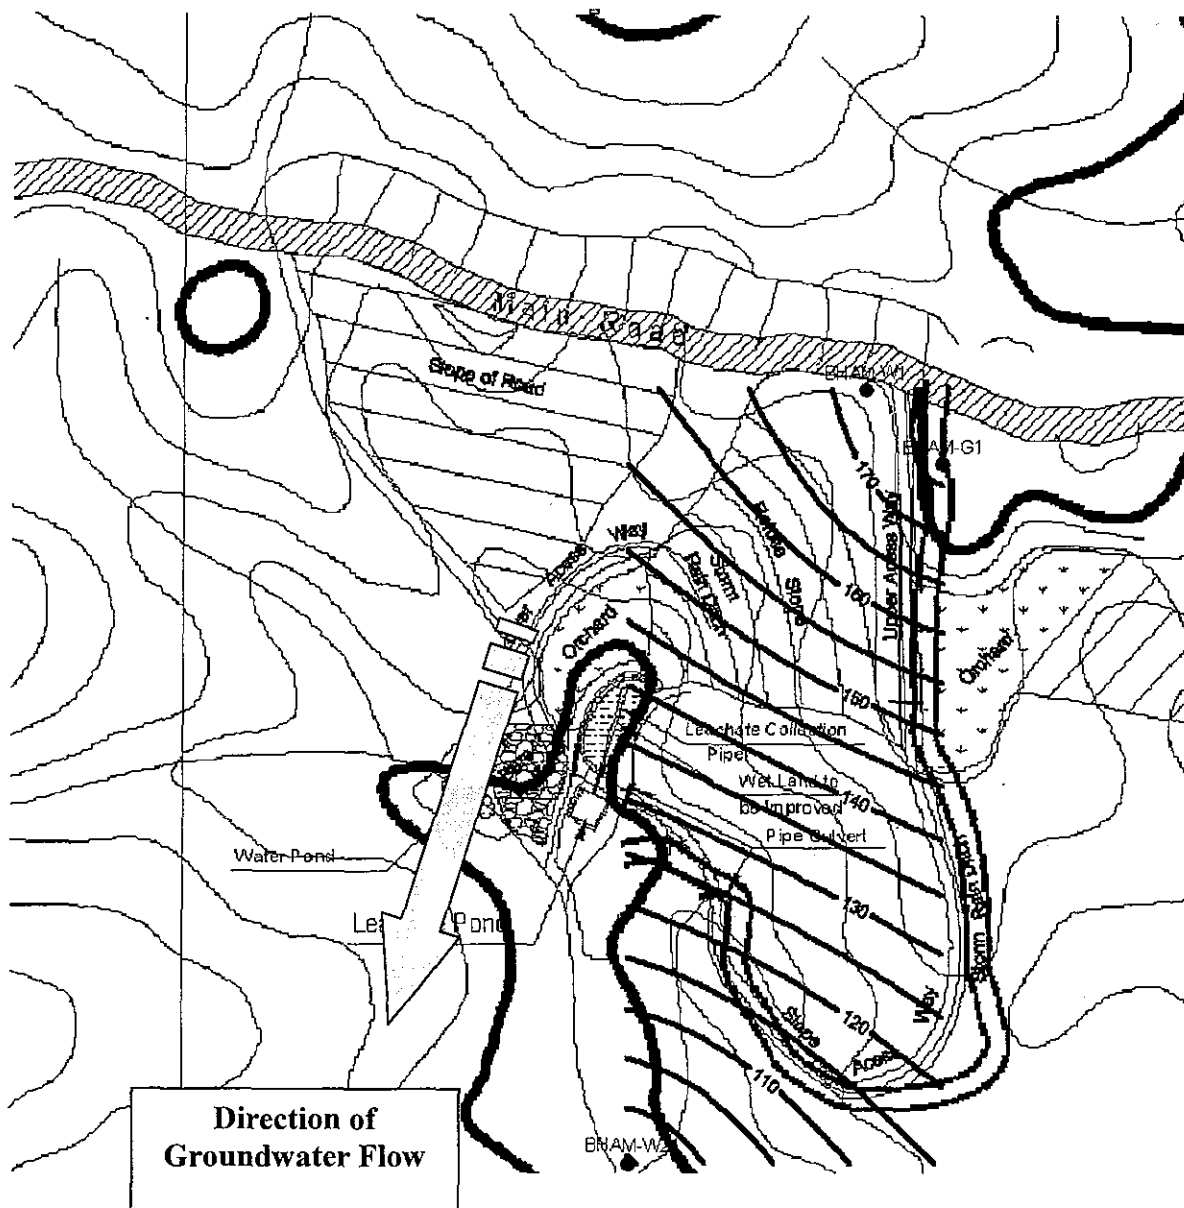
**Figure 8.5.5 Groundwater Level Contour Map, Ampang Jaya PP**

With the groundwater levels, the contour map for groundwater was generated and shown in **Figure 8.5.5**. The direction of groundwater flow is deduced to flow from the north to the south.

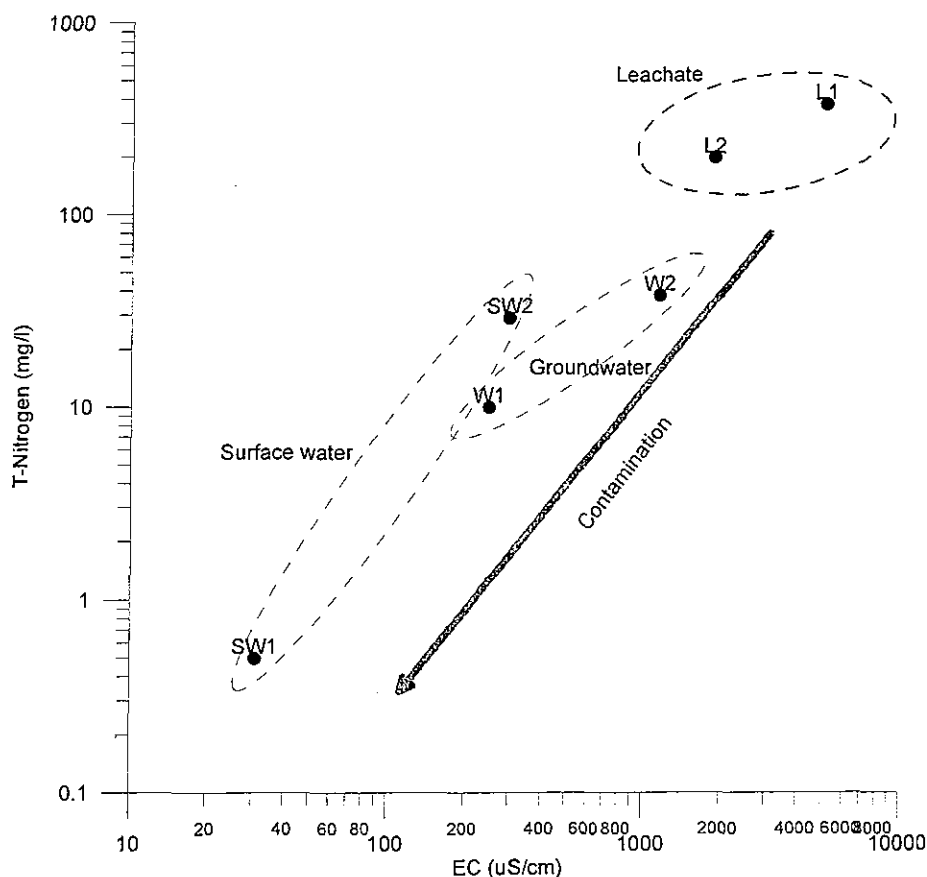
**Figure 8.5.6 Water Quality Relationship - Ampang Jaya PP**

The relationship between the quality of leachate, surface water and groundwater can be expressed by total nitrogen and electric conductivity as shown in **Figure 8.5.6**. As expected, leachate and water qualities are dependent on the location of the sample rather than the types of samples. The results for W1 and SW1 which are located at the upstream showed much better quality than W2 and SW2 which are at the down stream

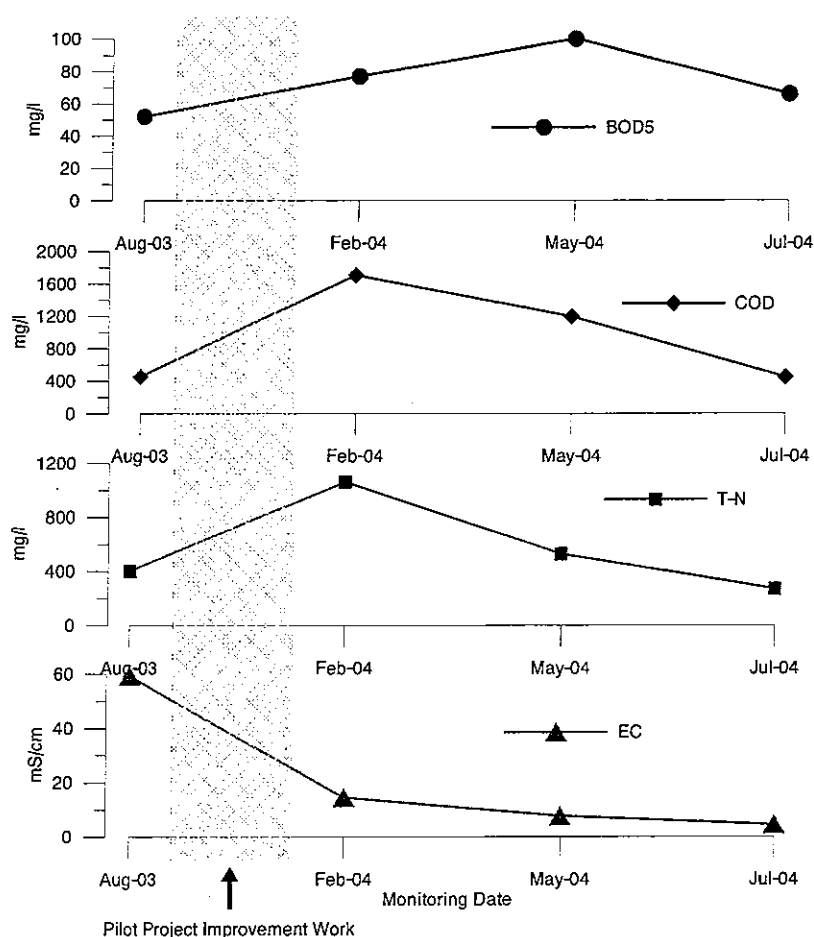
**Figure 9.2.1 Ampang Jajar Leachate (L1) Monitoring Results**

Figure 9.2.1 shows the results of monitoring for BOD<sub>5</sub>, COD, total-nitrogen (T-N) and electric conductivity of AJ-L1. These parameters are considered as basic water quality indicators used to observe the changes in the water quality.

After the PP works, the BOD<sub>5</sub>, COD and total-nitrogen (T-N) increased in concentration during the February, 2004 monitoring. These could be due to the effects of improved rainwater drainage system provided by the PP works. Since lesser surface water got into the waste layers, the leachate concentration temporally increased. However, the COD, total-nitrogen (T-N) decreased for both the May and July, 2004 monitoring. These may indicate the long-term effects of the PP works. The segregation of the rainwater could have increased and promoted the organic degradation inside the landfill layers. Continuous monitoring of these parameters is necessary in order to reach the conclusions the assumption. The BOD<sub>5</sub> results did not show such clear trends of improvement. This may be due to the fact that this section of the landfill site is already quite old and the biodegradable organic are already in low concentration range. The electric conductivity showed consistent improvements.

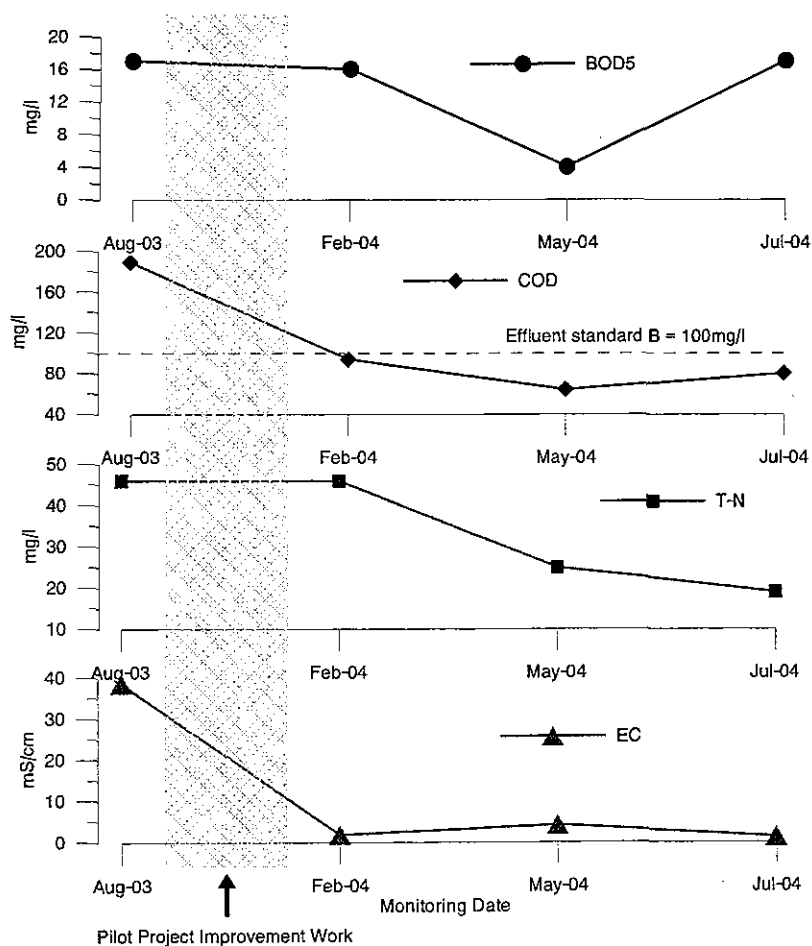
**Figure 9.2.2 Ampang Jajar Surface Water (SW2) Monitoring Results**

Figure 9.2.2 shows the results of monitoring for BOD<sub>5</sub>, COD, total-nitrogen (T-N) and electric conductivity of AJ-SW2. It should be noted that SW2 is small a canal water located downstream of the improved area and of AJ-L1. As expected, the monitoring results of AJ-SW2 were more or less similar to those of AJ-L1, but at the lower (diluted) concentration range. The COD, total-nitrogen (T-N) and electric conductivity value started to decrease from the baseline values immediately after the PP works. This was considered reasonable as lesser surface water seeping into the landfill layers caused the initial increase in the concentration of the leachate, and also resulted in fewer overflow of the leachate into the surface water system.

The COD in AJ-SW2 exceeded the Effluent Standard B limits during the baseline survey in August 2003. After the PP works, the COD results have been constantly lower than the effluent standard B as shown in **Figure 9.2.2**.

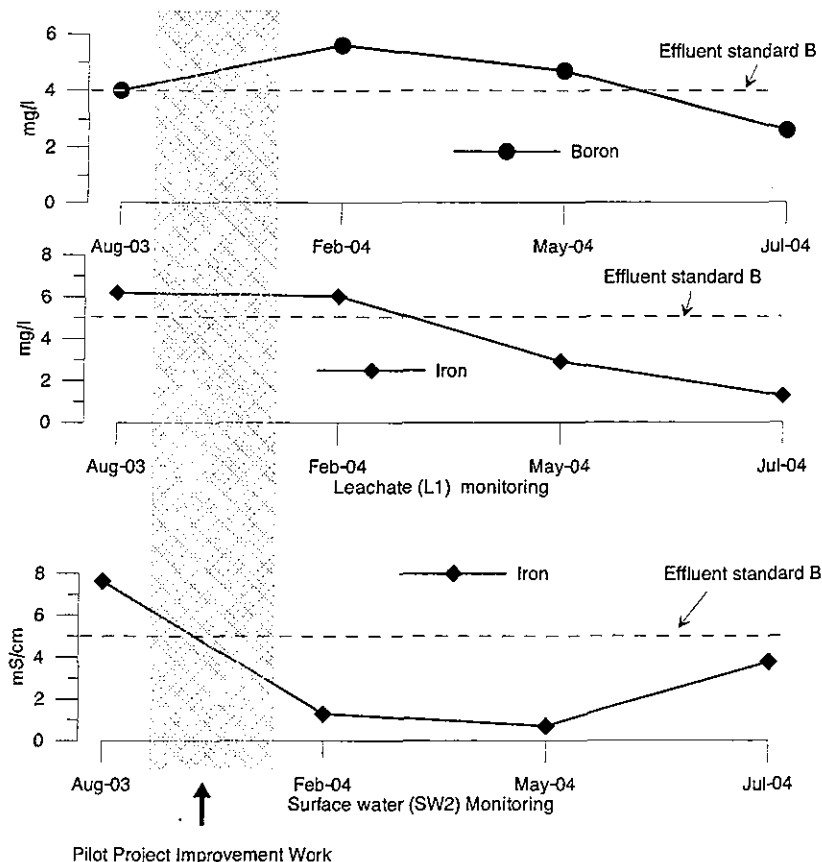
**Figure 9.2.3 Ampang Jajar Leachate (L1) and Surface Water (SW2) Monitoring : Boron and Iron Data**

The Boron and Iron values for AJ-L1 and SW2 were plotted in **Figure 9.2.3**. These values also exceeded the Effluent Standard B limits during the baseline survey in August 2003. After the PP works, the results for the Boron and Iron tended to decrease and at the recent monitoring in July, 2004, their values were all below the Standard B limits.

These are considered as positive effects of the PP improvement works.

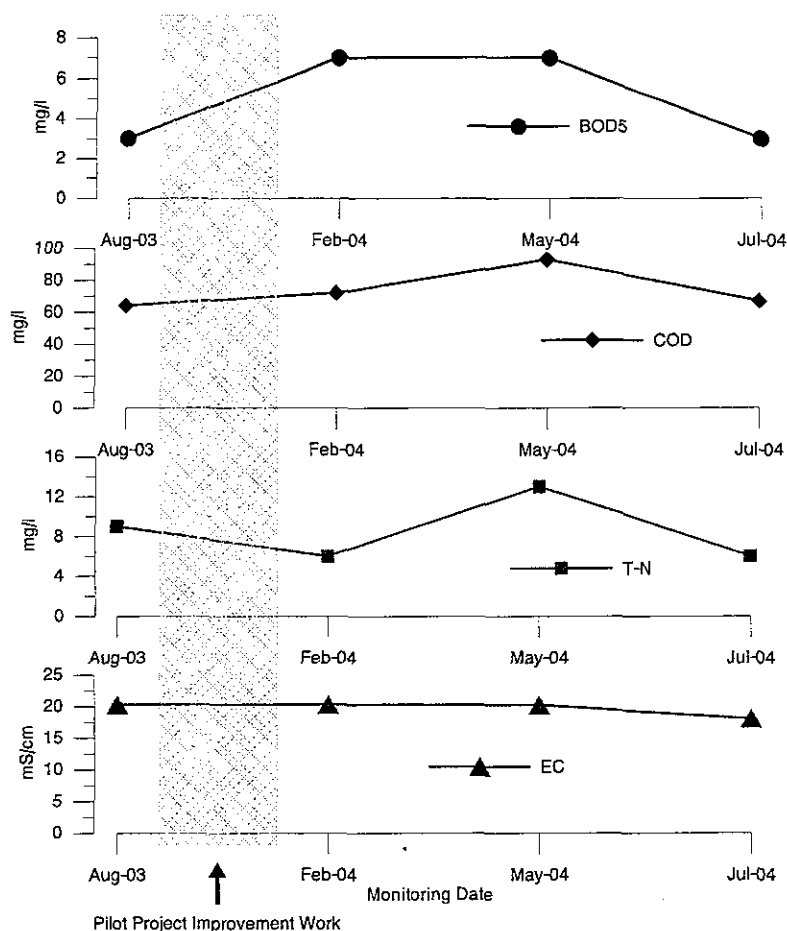
**Figure 9.2.4 Ampang Jajar Groundwater (W3) Monitoring Results**

**Figure 9.2.4** shows the results of the monitoring for BOD<sub>5</sub>, COD, total-nitrogen (T-N) and electric conductivity of AJ-W3. It should be noted that W3 is a groundwater well south (downstream direction of groundwater flow) of the PP improved area. As previously discussed in Chapter 6, the groundwater flow of the area is expected to be about 2.0-20 m/year. Obviously, any changes in the water quality at the landfill area will take years before it reaches and affects the water quality at AJ-W3. In this view, the results as appeared in **Figure 9.2.4** seemed to be reasonable.

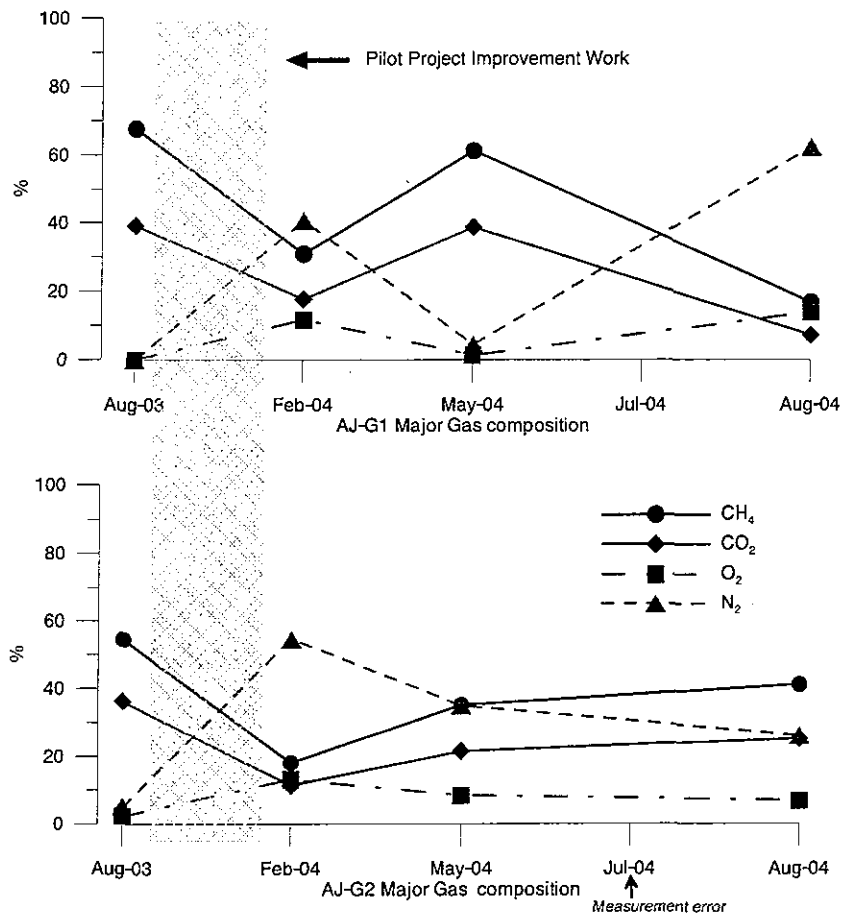
**Figure 9.2.5 Ampang Jajar Landfill Gas Monitoring Results**

Figure 9.2.5 shows the results of the monitoring for CH<sub>4</sub>, CO<sub>2</sub>, O<sub>2</sub> and N<sub>2</sub> of AJ-G1 and AJ-G2. It was found that the measurements taken in July, 2004 were not entirely correct due to some measurement error and therefore new measurements were taken in August, 2004.

The results for AJ-G1 showed fluctuated data for all the parameters. It seemed that the landfill gas generated by the organic decay, namely CH<sub>4</sub> and CO<sub>2</sub> tend to decrease after the PP works. The results for AJ-G2 also showed similar trends. It is premature at this early stage to conclude about the long-term effects of the PP improvement from the limited current data.

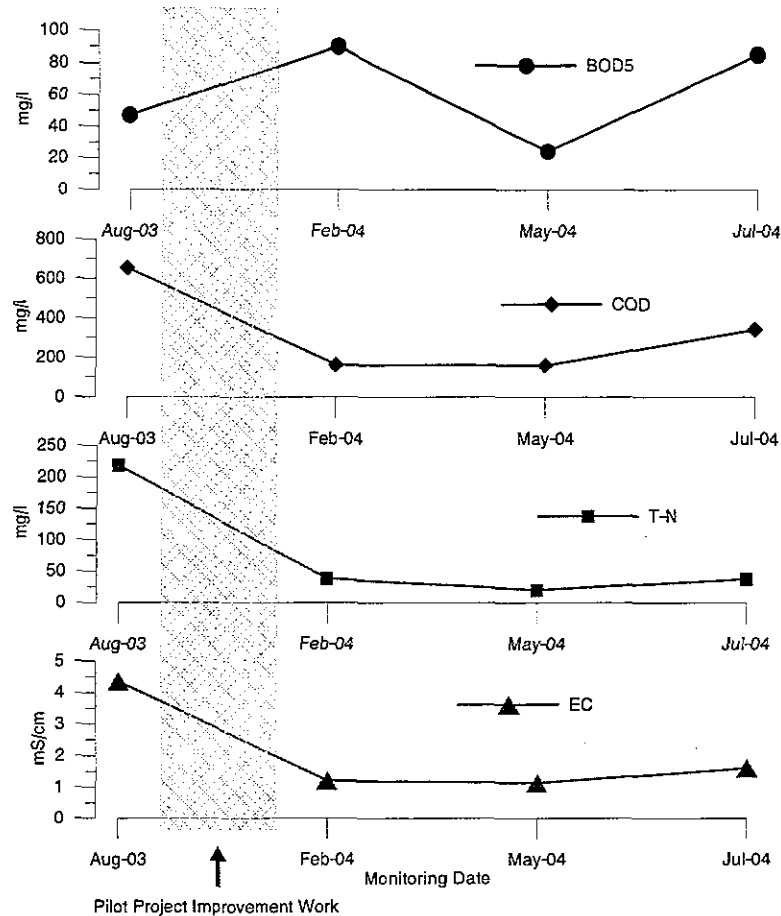
**Figure 9.2.6 Pekan Nenasi Leachate (L1) Monitoring Results**

Figure 9.2.6 shows the results of the monitoring for BOD<sub>5</sub>, COD, total-nitrogen (T-N) and electric conductivity of PN-L1. The COD, T-N and electric conductivity showed decreasing tendency after the PP works. The results for BOD<sub>5</sub> seemed they were not changed by the PP works.

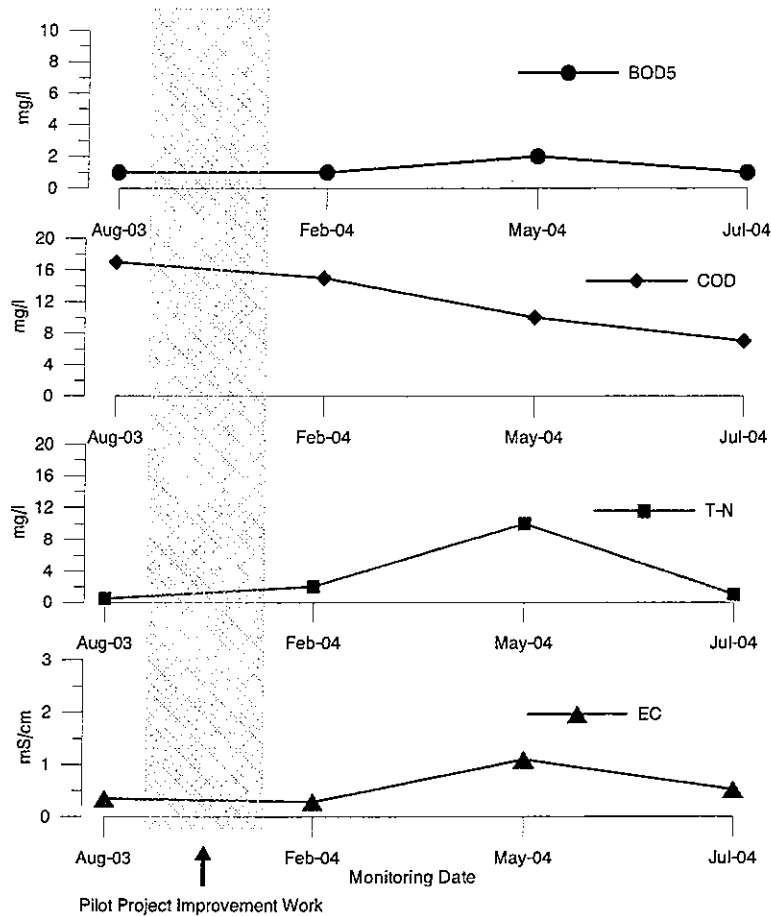
**Figure 9.2.7 Pekan Nenasi Surface Water (SW2) Monitoring Results**

Figure 9.2.7 shows the results of the monitoring for BOD<sub>5</sub>, COD, total-nitrogen (T-N) and electric conductivity of PN-SW2. In general, the surface water around the site was stagnated. The concentrations of the above same parameters at SW2 were all at very low levels. It seemed that SW2 was not contaminated by the leachate from the site.

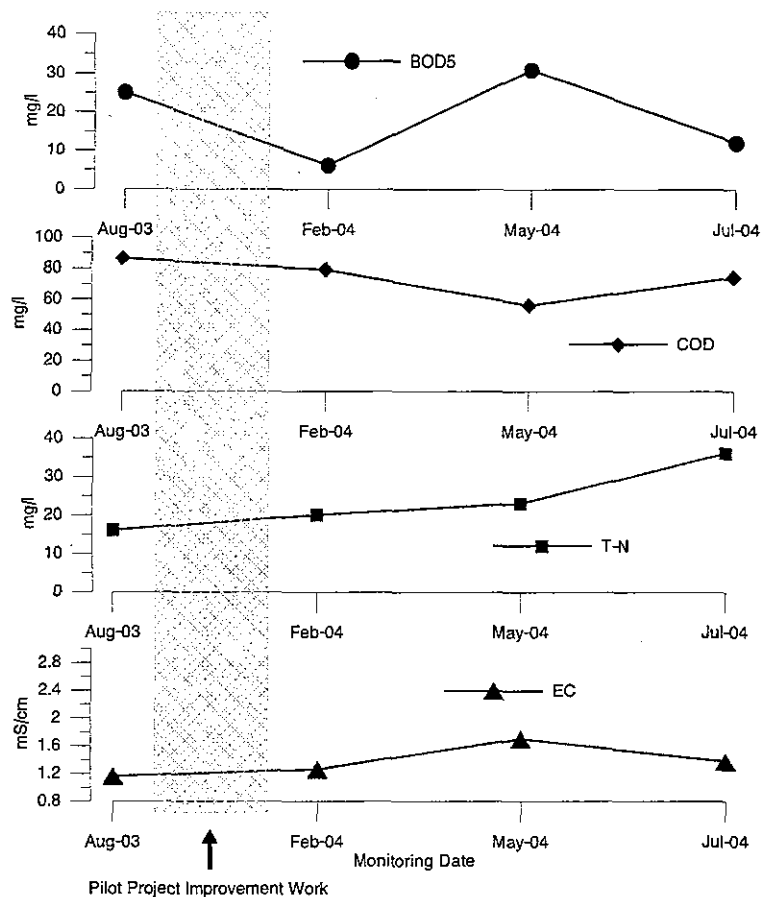
**Figure 9.2.8 Pekan Nenasi Groundwater (W2) Monitoring Results**

**Figure 9.2.8** shows the results of the monitoring for BOD<sub>5</sub>, COD, total-nitrogen (T-N) and electric conductivity of PN-W2. The W2 is a groundwater well at the middle of the site and just southeast of the PP improved area. There was no clear tendency of change in the water quality parameters. This was considered reasonable considering the slow groundwater flow and the presence of the sewage sludge disposal area adjacent to the site.

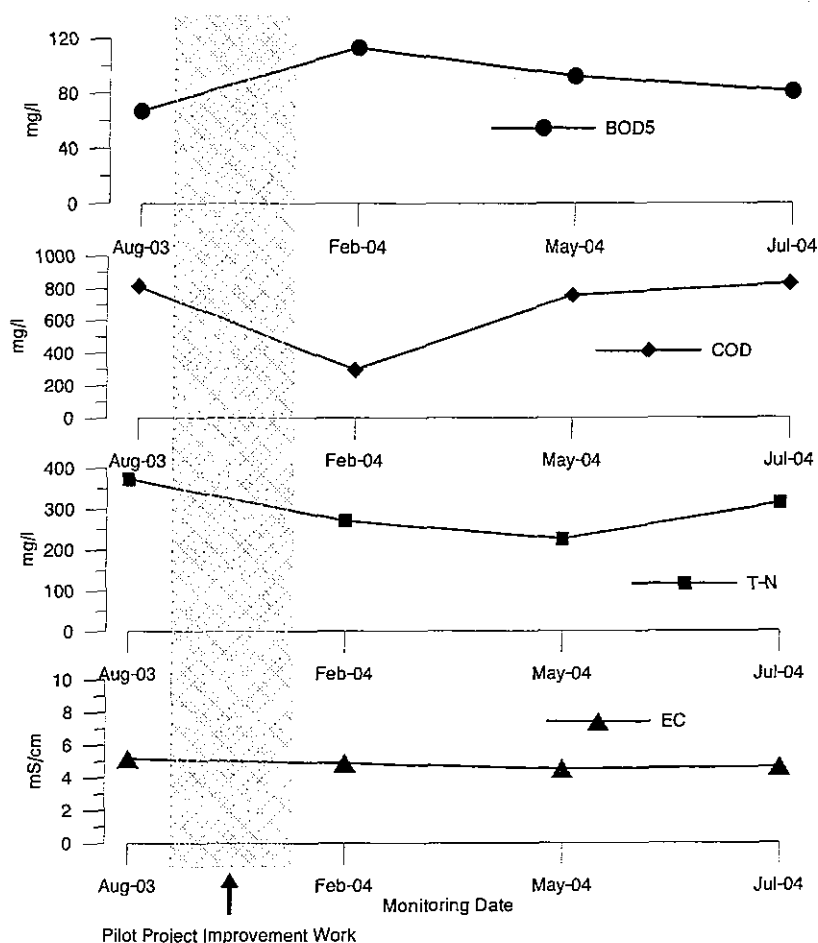
**Figure 9.2.9 Ampang Jaya Leachate (L1) Monitoring Results**

Figure 9.2.9 and Figure 9.2.10 show the results of the monitorings for BOD<sub>5</sub>, COD, total-nitrogen (T-N) and electric conductivity of AM-L1 and AM-L2, respectively. The PP works at the site included the leachate collection system but without the leachate circulation or leachate treatment. Therefore, the leachate quality was not

expected to improve much. **Figure 9.2.9** shows almost constant leachate quality for the AM-L1 samples taken at the discharge of the leachate pond. The AM-L2 samples, as shown in **Figure 9.2.10**, indicated improving quality for the COD, T-N and electric conductivity after February, 2004. The PP works resulted in the leachate being collected and thus minimise the penetration of the leachate into the ground and discharge to the waterways downstream. The monitoring of AM-L2 was taken here. Also as the result of the PP works, the leachate is now discharged straight to the surface water drains from the pond, which also reduce the leachate quantity at the AM-L2 location.

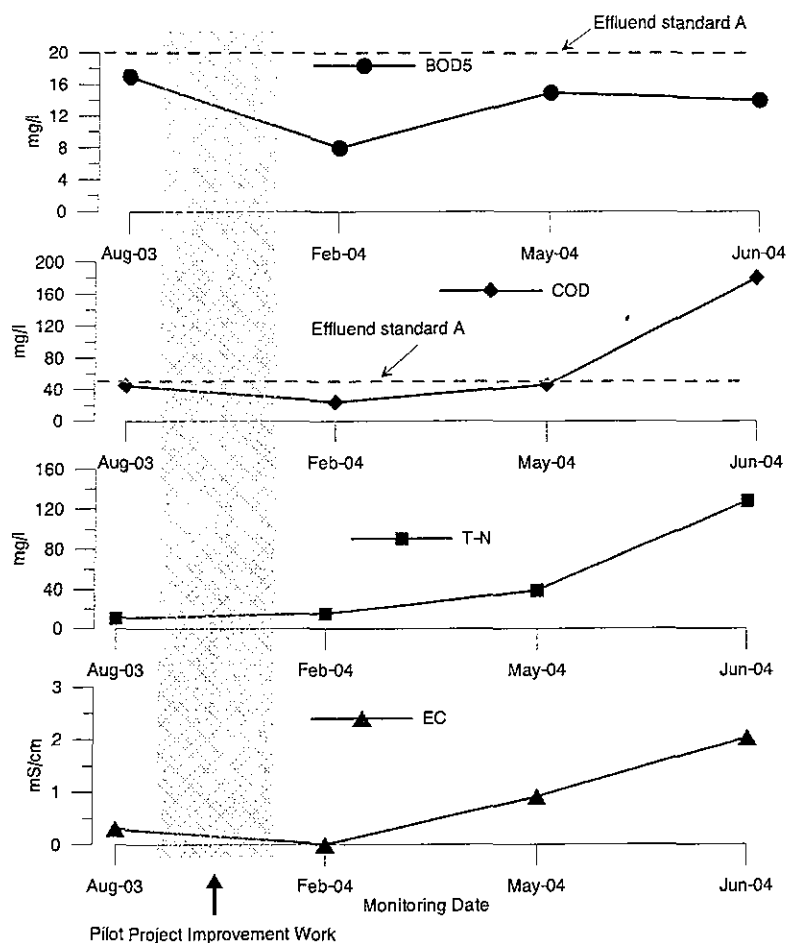
**Figure 9.2.11 Ampang Jaya Surface Water (SW2) Monitoring Results**

Figure 9.2.11 shows the results of AM-SW2. The COD, T-N and electric conductivity showed increased tendency after the PP works. This was considered reasonable as more leachate were collected by collection system and directly discharged to the waterway. It was noted that the COD values exceeded the Effluent Standard A limits.

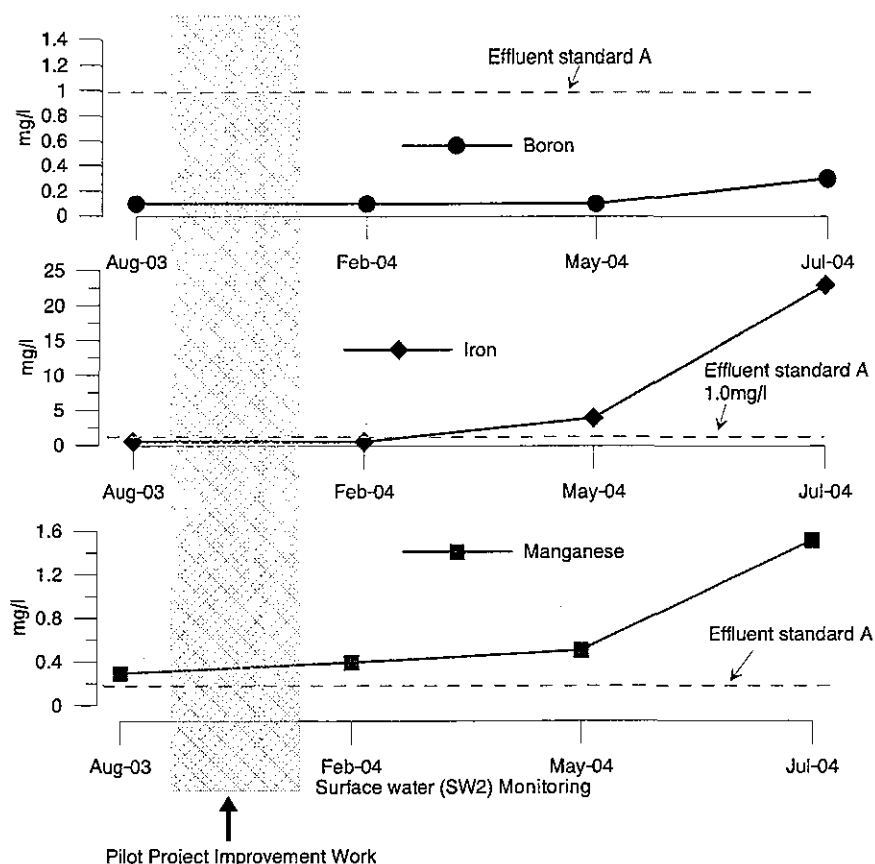
**Figure 9.2.12 Ampang Jaya Surface Water (SW2) Monitoring: Boron, Iron and Manganese Data**

It was observed during the baseline survey that concentrations of Boron, Iron and Manganese were high in the leachate. **Figure 9.2.12** was prepared to confirm the condition of the 3 parameters at AM-SW2. The Boron is well below the Effluent Standard A, but Iron and Manganese have exceeded the limits. They also exhibited the tendency to increase upwards.

It is strongly recommended that the leachate treatment system should be provided, as there is a water intake point downstream of the site.

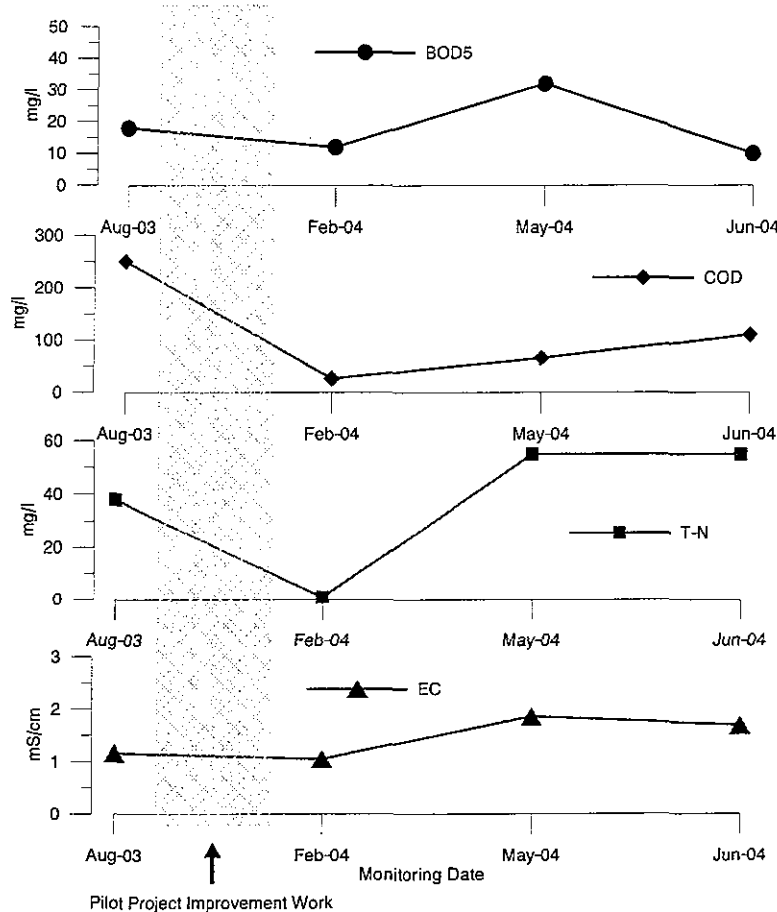
**Figure 9.2.13 Ampang Jaya Groundwater (W2) Monitoring Results**

Figure 9.2.13 shows the monitoring results of AM-W2. Since the PP works provided the better leachate collection to reduce the ground penetration, the groundwater quality should improve in the long-term. However within the present monitoring period of the pilot project, the changes cannot be observed.

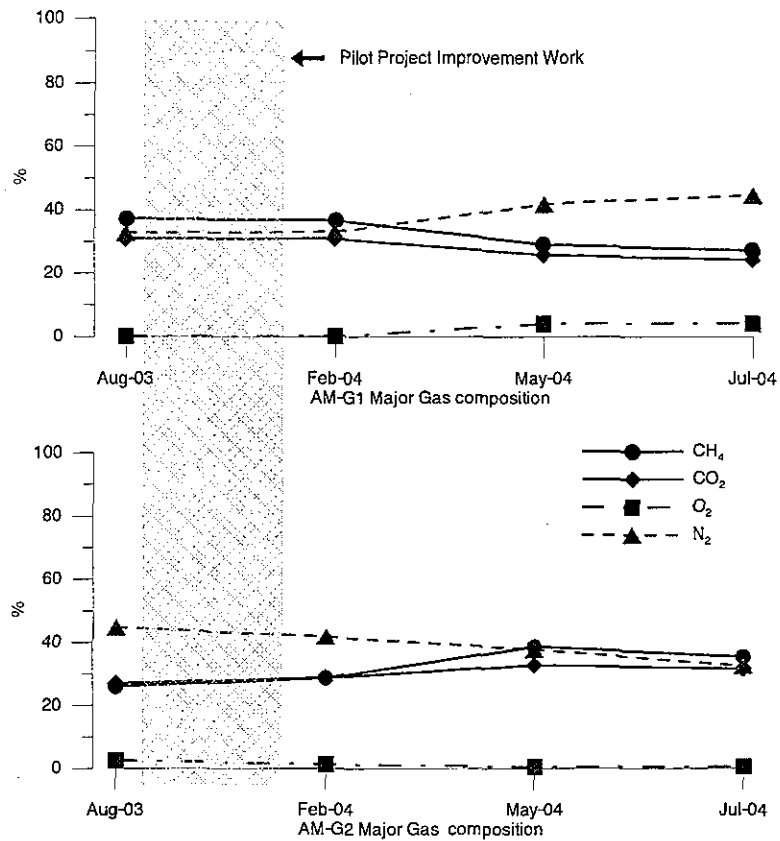
**Figure 9.2.14 Ampang Jaya Landfill Gas Monitoring Results**

Figure 9.2.14 shows the monitoring results of the landfill gas at AM-G1 and AM-G2. AM-G1 showed slight decrease in CH<sub>4</sub> and CO<sub>2</sub> and increase in N<sub>2</sub>. This may indicate better air circulation into the waste layers. On the other hand, AM-G2 showed the opposite tendency with slight increase in CH<sub>4</sub> and CO<sub>2</sub> and decrease in N<sub>2</sub>. In both points, the changes were not so significant and cannot be related definitely to the PP improvement works.
