State	N.Sembilan
		No.	NS-01
Basic Information			
Name of LA	MP Nilai		
Name of Landfill	Pajam		
Location of the Landfill	Kg. Gebok, Pajam		
Status of Landfill	operation	(Remaining Life Span : 15 years)	
Year Start Operation	1996	Year Cease Operation	2018
Managed by	Private Company		
Land ownership	Local Authority		
Gazetted	yes		
Area	69 acres	Waste Disposed daily	180
Reasons for closure	-		
Remarks			
Environmental Impact Conditions			
Landfill Level	Level 1		
Site Condition	swampy		
Waste Covered	Yes	(Frequency : 2 times /week)	
Type of Vegetation	no vegetation		
Landslide	no		
Soil Subsidence	not noticeable		
Vector and animals	medium (flies)		
Odor, gas and smoke	no		
Leachate Quantity	no		
Location of Intake Point	no		
Distance from Intake Pt	- km)		
Drinking Water Well	no		
Geological Condition	alluvial		
No of complaints (/year)	nil		
dist. from Residential	5 km (Kg. Gebuk)		
Remarks			
Land Utilisation after closure

No	NS-01
Local Authority	MP Nilai		
Name	Pajam		
Survey date	10-Mar-03		
Comments

State	N.Sembilan
		No.	NS-02
Basic Information			
Name of LA	MP Nilai		
Name of Landfill	Kuala Sawah		
Location of the Landfill	Jln Kg Stesyen, Rantau		
Status of Landfill	close

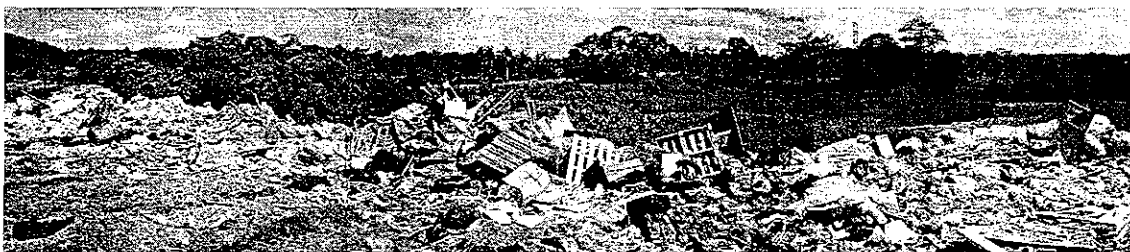
Landscape of eastside of the site. Site area is till trees.

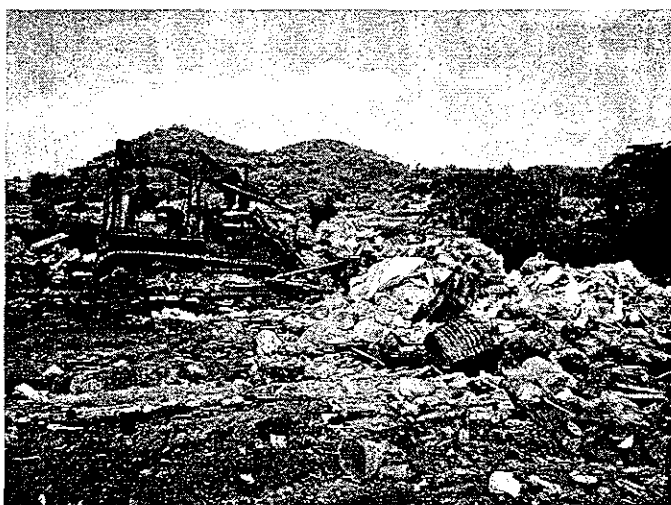
Waste is push down to the swanpy area.

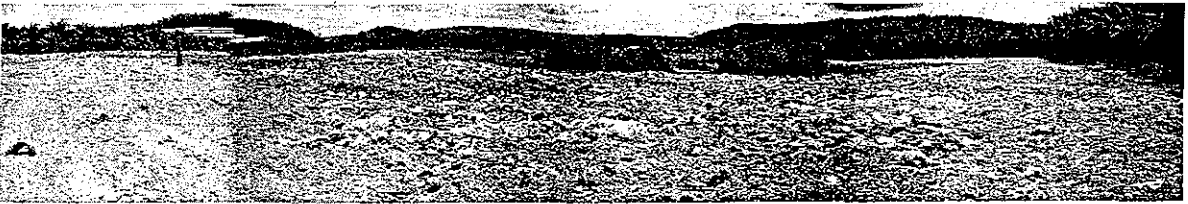
No		NS-02
Local Authority	MP Nilai	
Name	Kuala Sawah	
Survey date	10-Mar-03	
Comments		
<div style="border: 1px solid black; padding: 2px; display: inline-block;">Photos</div>		
<p>Landscape from the gate. Center of the site is swamp.</p>

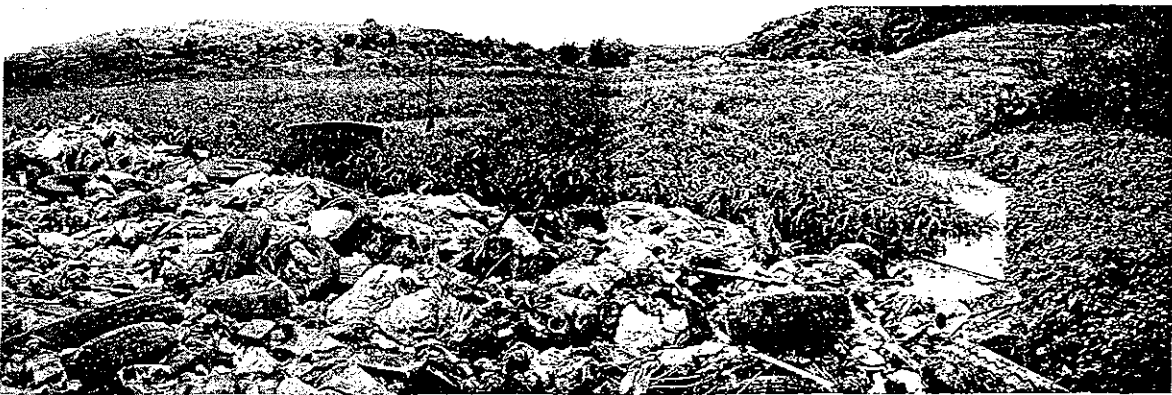
<p>Swamp of the nothside. (swamp is inside the area of site)</p>

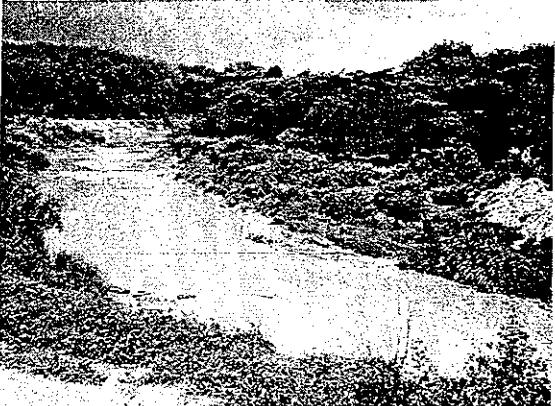
<div style="display: flex; justify-content: space-around;"> <div style="width: 45%;"> <p>River (S.Linggi) adjoins the site.</p>

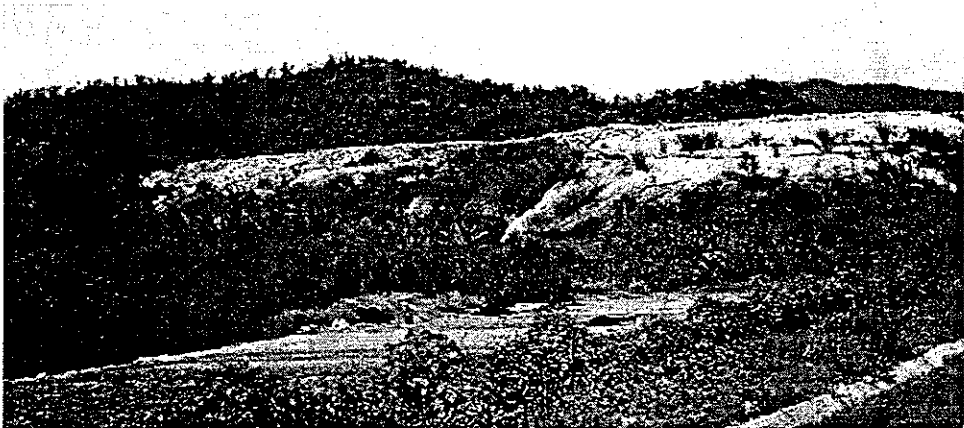
No	NS-03
Local Authority	MP Seremban	
Name	Sikamat	
Survey date	10-Mar-03	
Comments		
Photos	<p>Landscape from the road. The hight is approx. 10m.</p>

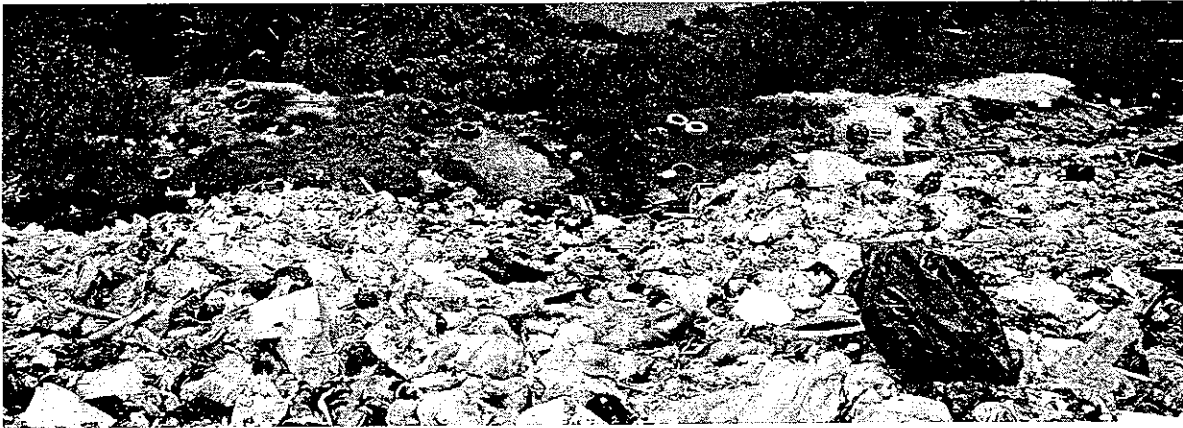
<p>Leachate flows down to the fish pond.</p>

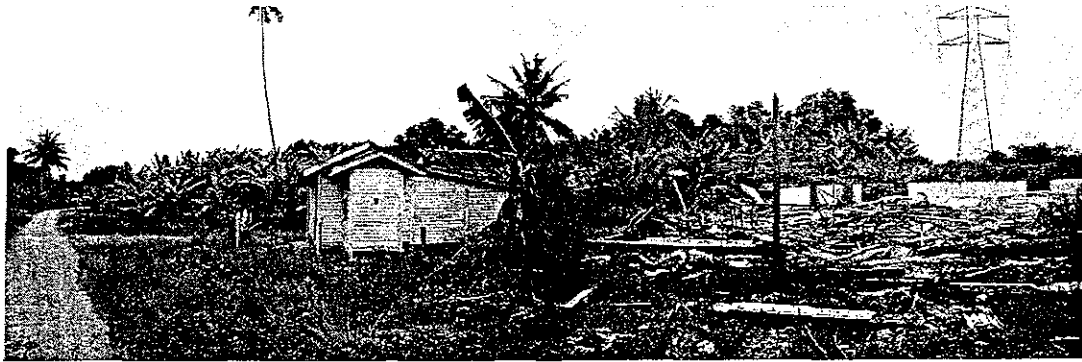
No	NS-04
Local Authority	MP Port Dickson		
Name	Quarters MPPD		
Survey date	11-Mar-03		
Comments	<p>TNB means "buffer zone of power line".</p> <p>The area of dumping is unknown.</p> <p>Landfilled solid waste is incineration ash.</p> <p>There is scarcely useful records about this site.</p>		
Photos	<p>Administrative building and power line. The back forest is landfill site.</p>

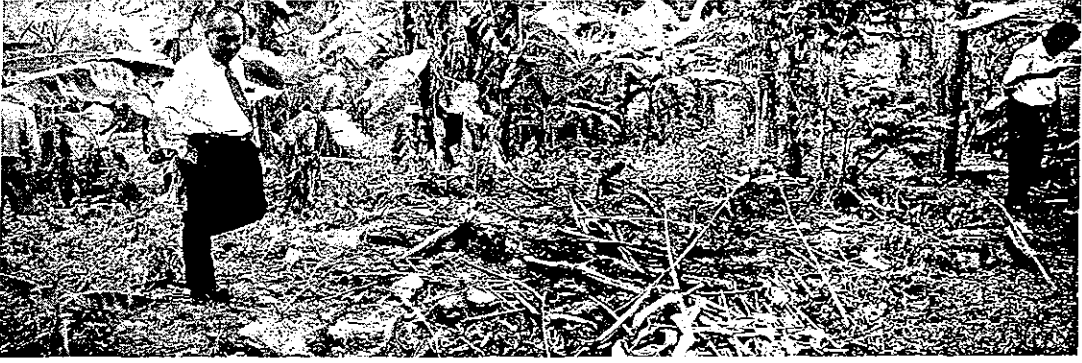
<p>Trace of incinerator. The incineration ash was dumped surrounding area.</p>

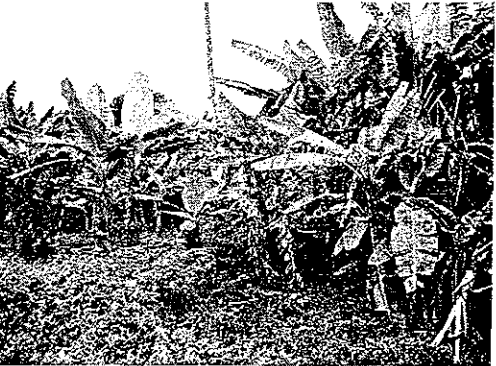
<p>Many trees grow thick on the surface.</p>

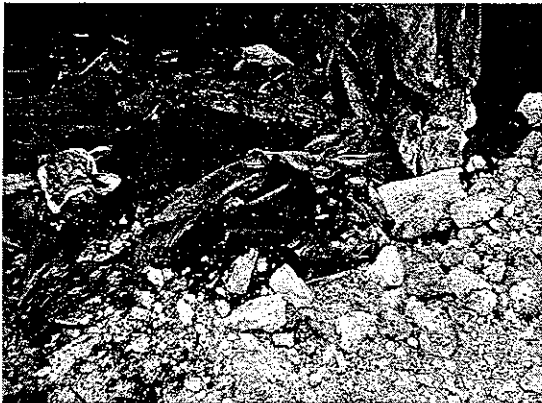
<div style="display: flex; justify-content: space-around;"> <div style="text-align: center;"> <p>Lots of activate carbon is dumped from oil refinery.</p>

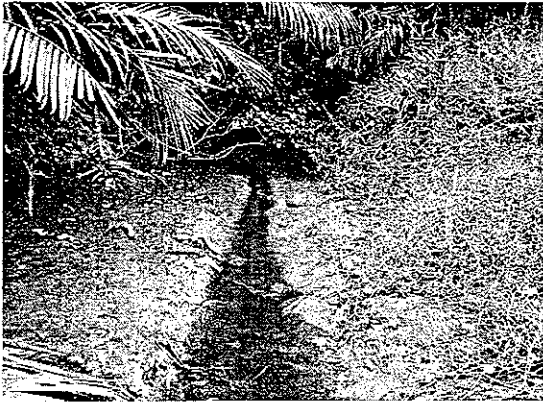
</div> <div style="text-align: center;"> <p>Leachate from landfill site</p>

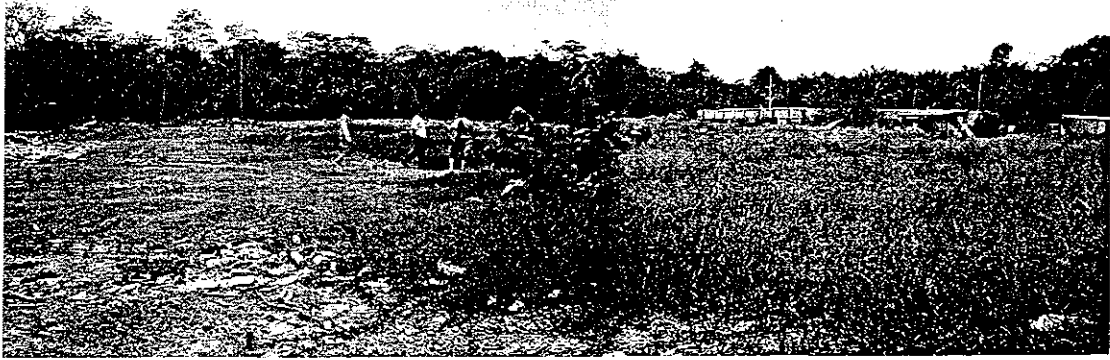
No	NS-06
Local Authority	MP Port Dickson	
Name	Pangkalan Kempas	
Survey date	11-Mar-03	
Comments	<p>For availability of river contamination by leachate, DOE made to close the site at 2002.</p>	
Photos	<p>Landscape from north end of the site. Blue fence is west side bounder.</p>

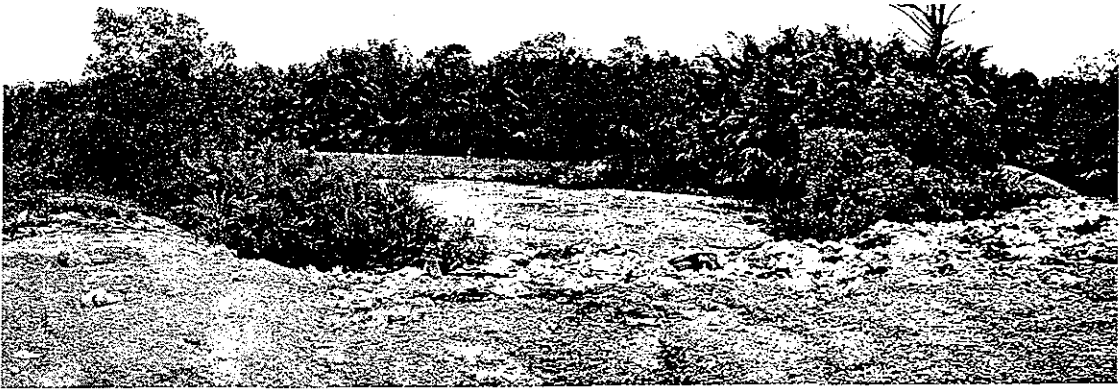
<p>East end of the site. It bounds to the river. There are leachate in the both side bush.</p>

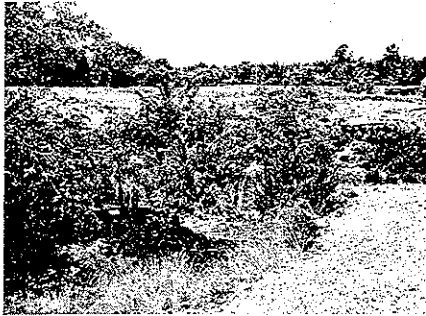
<div style="display: flex; justify-content: space-around;"> <div style="width: 45%;"> <p>Leachate stagnate in a small pond.</p>

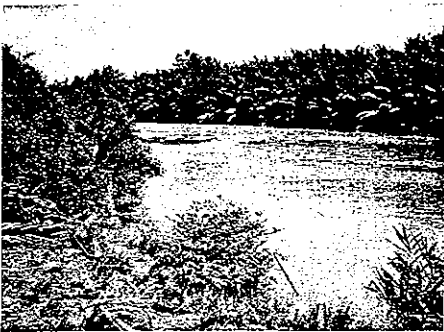
</div> <div style="width: 45%;"> <p>It is supposed that leachate flows down the river.</p>

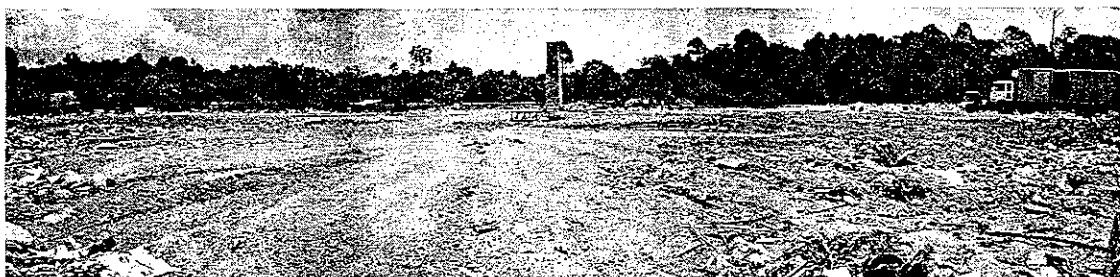
Landscape (from southwest end of the site).

The center chimney is past incinerator. The blue fence is bounder.

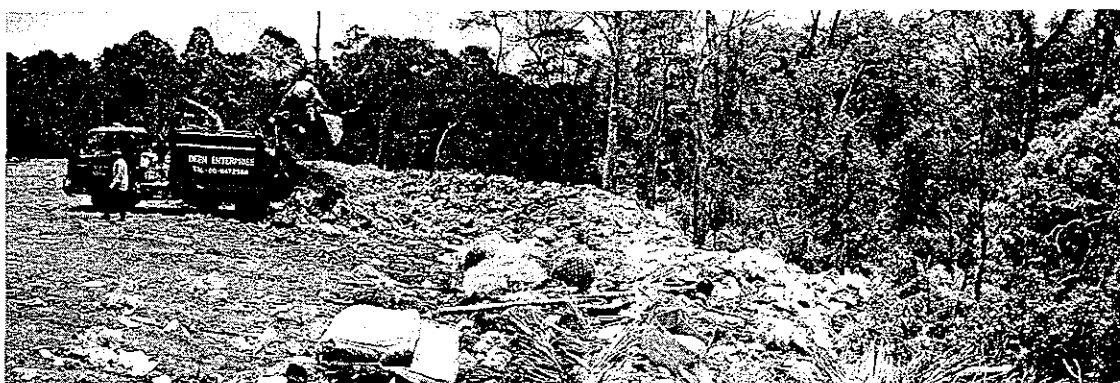
No	NS-07
Local Authority	MP Port Dickson		
Name	Jalan Sua Betong		
Survey date	11-Mar-03		
Comments	<p>The center part is made cover soil, but cover soil is made occasionally. It seems that leachate flows down to the south valley.</p>

The waste is pushed down toward the south small valley. (The hight of waste is approximately 5m)

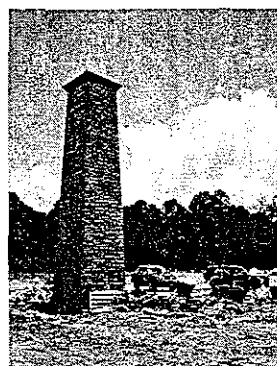
Chimney of the past incinerator.

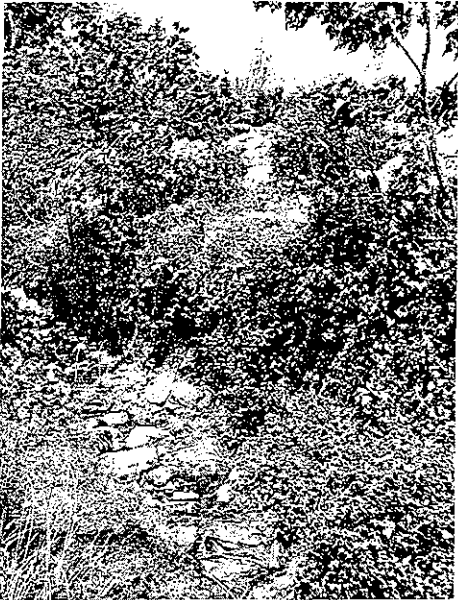
No	ML-01
Local Authority	MD Alor Gajah		
Name	Air Molek		
Survey date	12-Mar-03		
Comments	<p>Earth trenches have been dug for surface water drainage. The water is trapped and not flowing in the trenches.</p>		
Photos	<p>View from the eastern end of the site.</p>

<p>View of the trenches as seen from the oil palm plantation at the southern side of the site.</p>

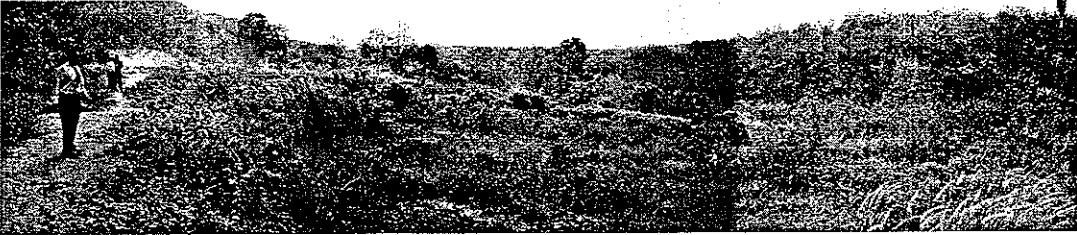
No	ML-02
Local Authority	MD Alor Gajah		
Name	Pulau Sebang		
Survey date	12-Mar-03		
Comments	<p>Smoke was observed and small fire are also observed.</p> <p>Cracks on the ground were observed. There is constant danger of landslide.</p> <p>If the landslide occurs, serious damage to the south river is expected.</p>		
Photos	<p>View from the entrance to the site. Smoke is observed around the site</p>

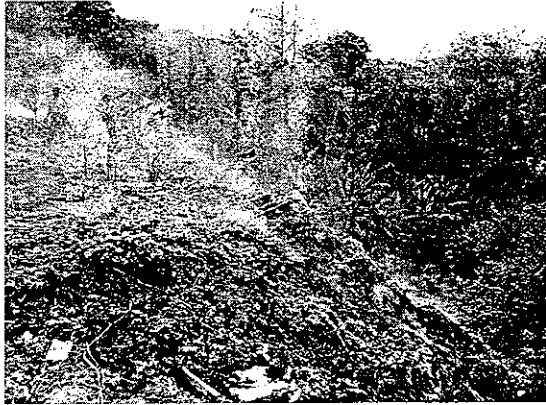
<div style="display: flex; justify-content: space-around; margin-top: 20px;"> <div style="width: 45%;"> <p>Smoke is observed from the steep slopes.</p>

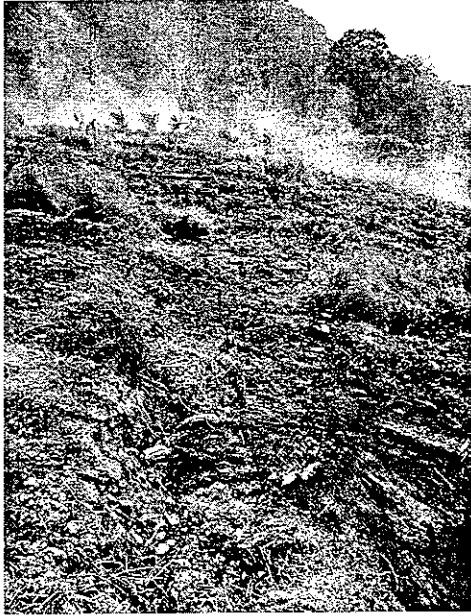
</div> <div style="width: 45%;"> <p>Uneven settlement exhibiting cracks. The difference in levels upto 300mm.</p>

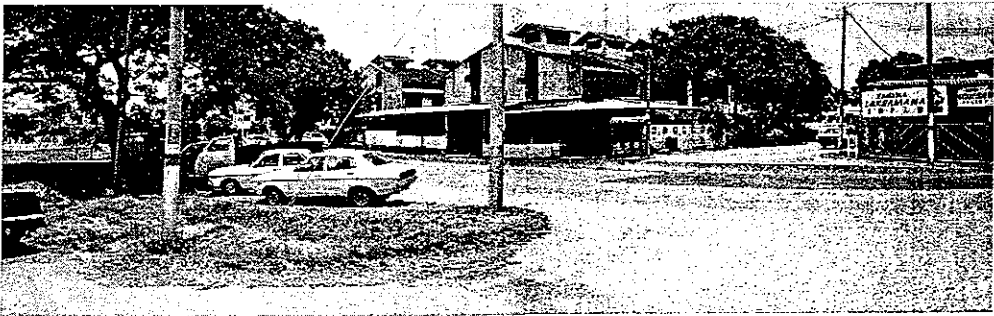
No	ML-05
Local Authority	MB Melaka	
Name	Kota Laksamana	
Survey date	13-Mar-03	
Comments	<p>The closed site is now used as a residential area.</p> <p>Countermeasure for post closure of the site was not provided.</p> <p>Cracks have been reported due to ground settlement.</p> <p>The site is close to the sea and the waste was dumped toward the sea.</p>	
Photos	<p>Land is now used for commercial and residential development.</p>

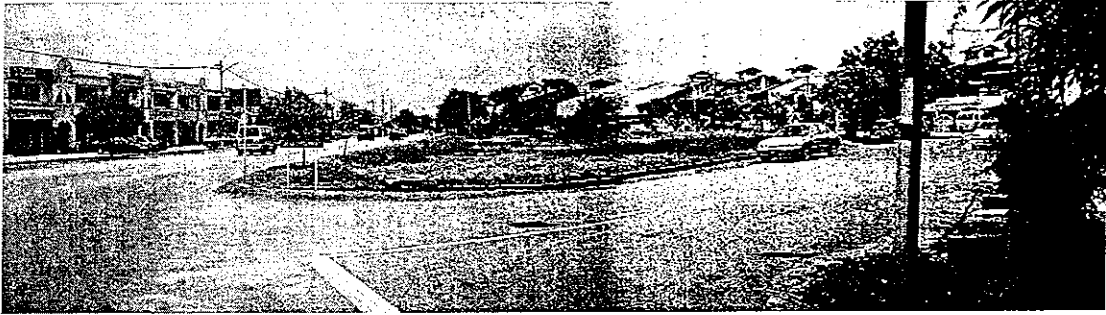
<p>Residential development at the right side of the road.</p>
