**THE STUDY ON MEKONG RIVERBANK PROTECTION
AROUND VIENTIANE MUNICIPALITY
IN THE LAO PEOPLE’S DEMOCRATIC REPUBLIC**

**FINAL REPORT
VOLUME 4
-SUPPORTING REPORT-**

SECTOR F

MONITORING OF PILOT WORKS

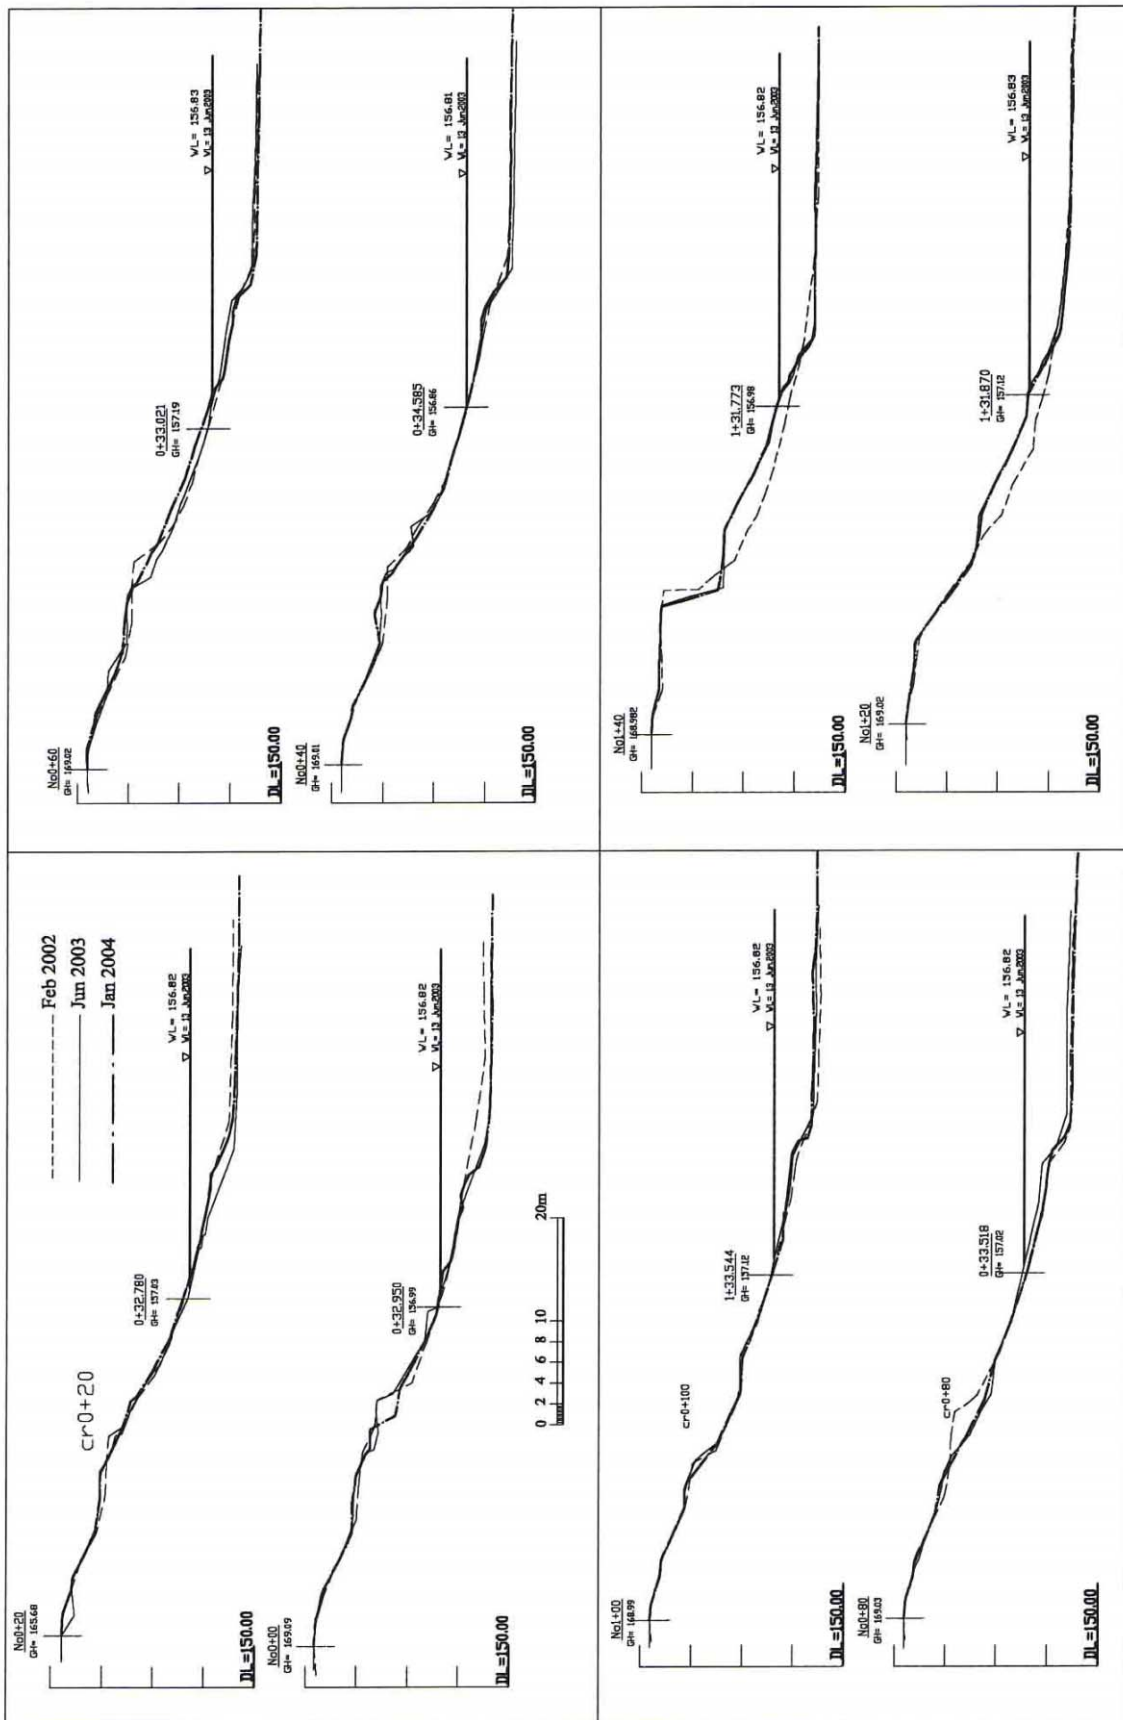
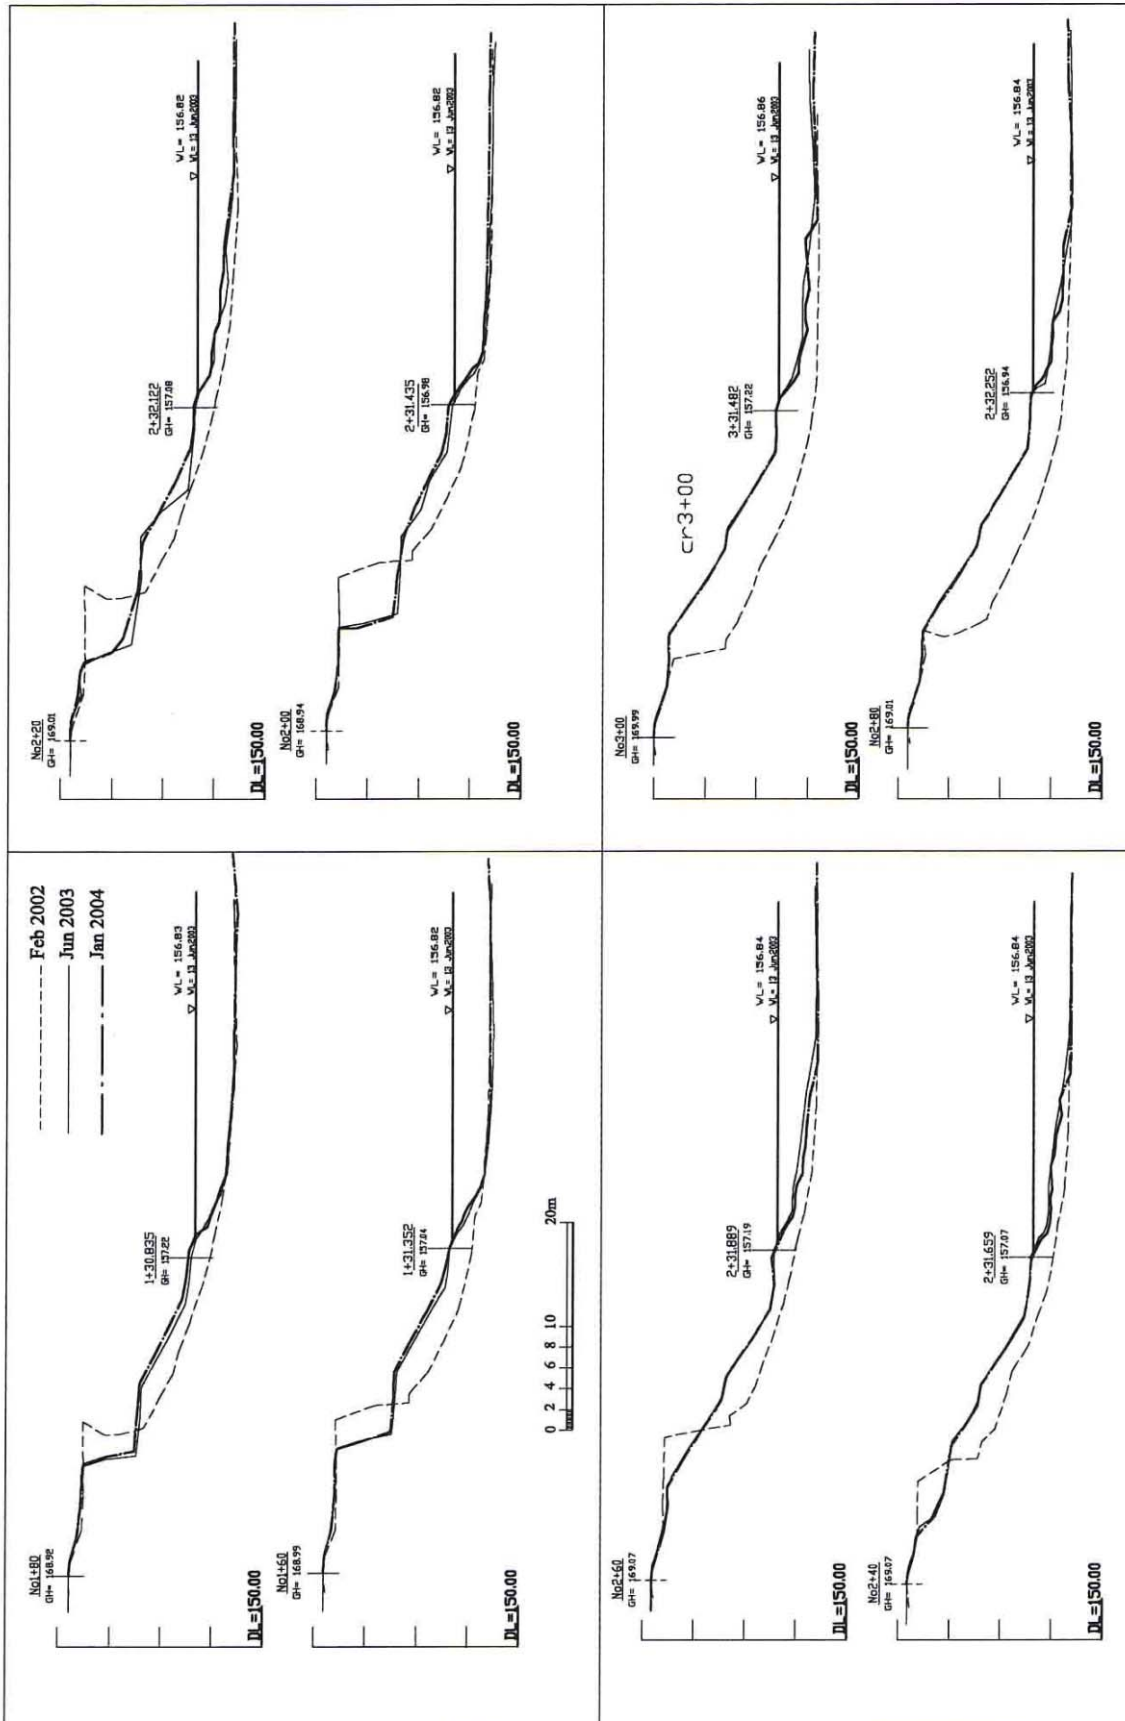
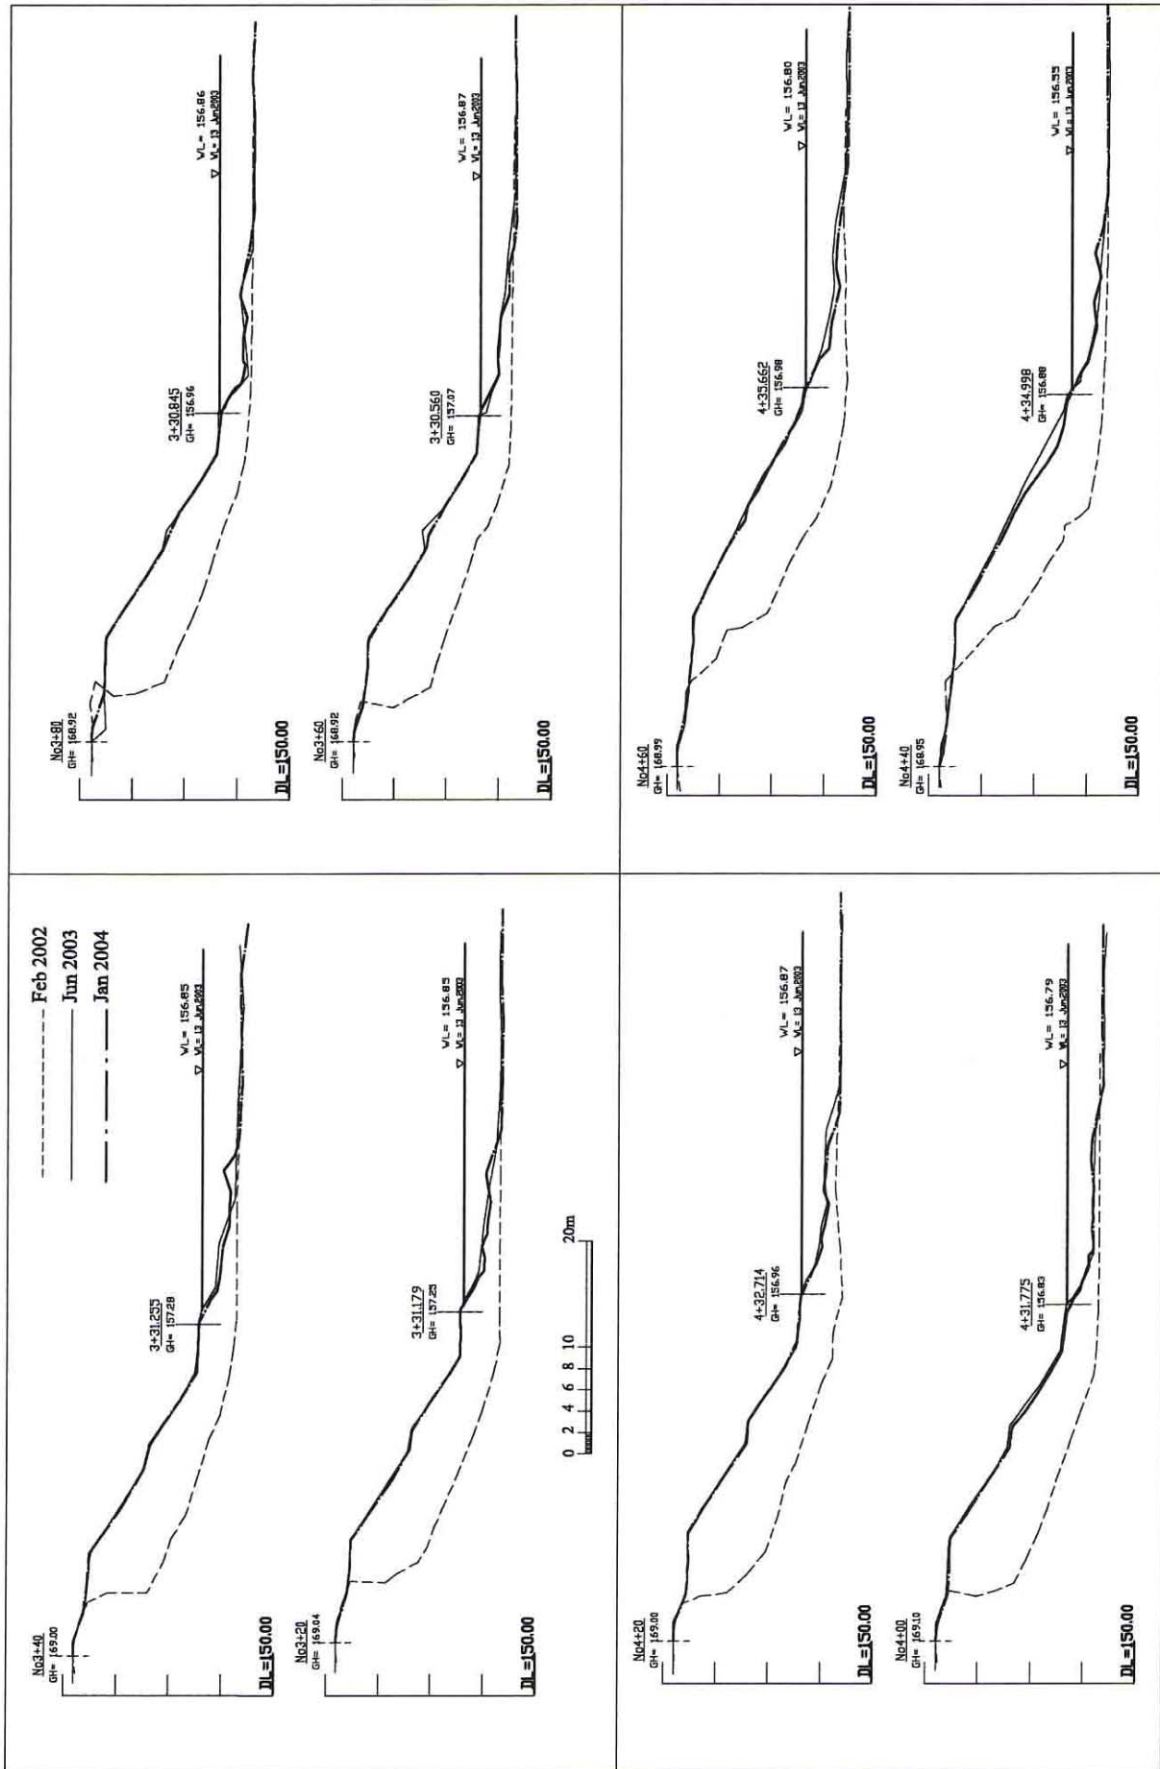
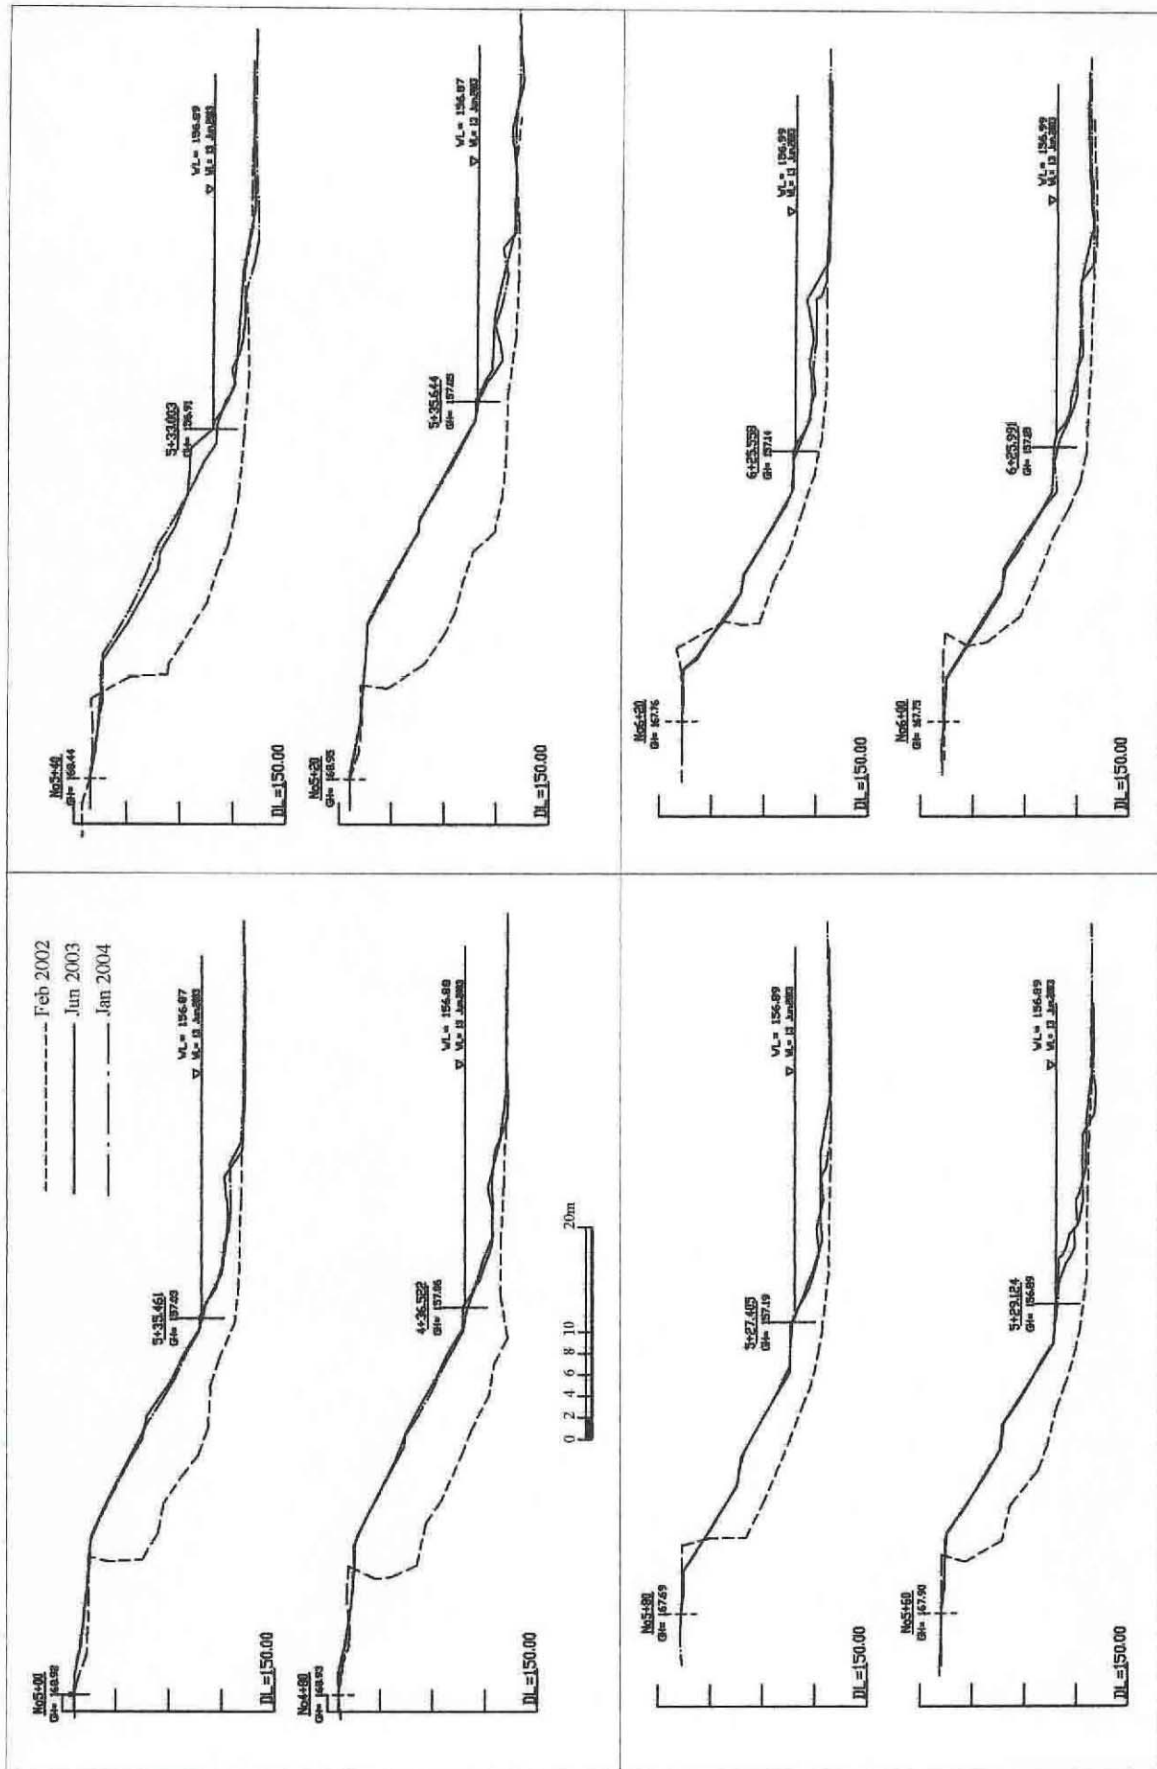
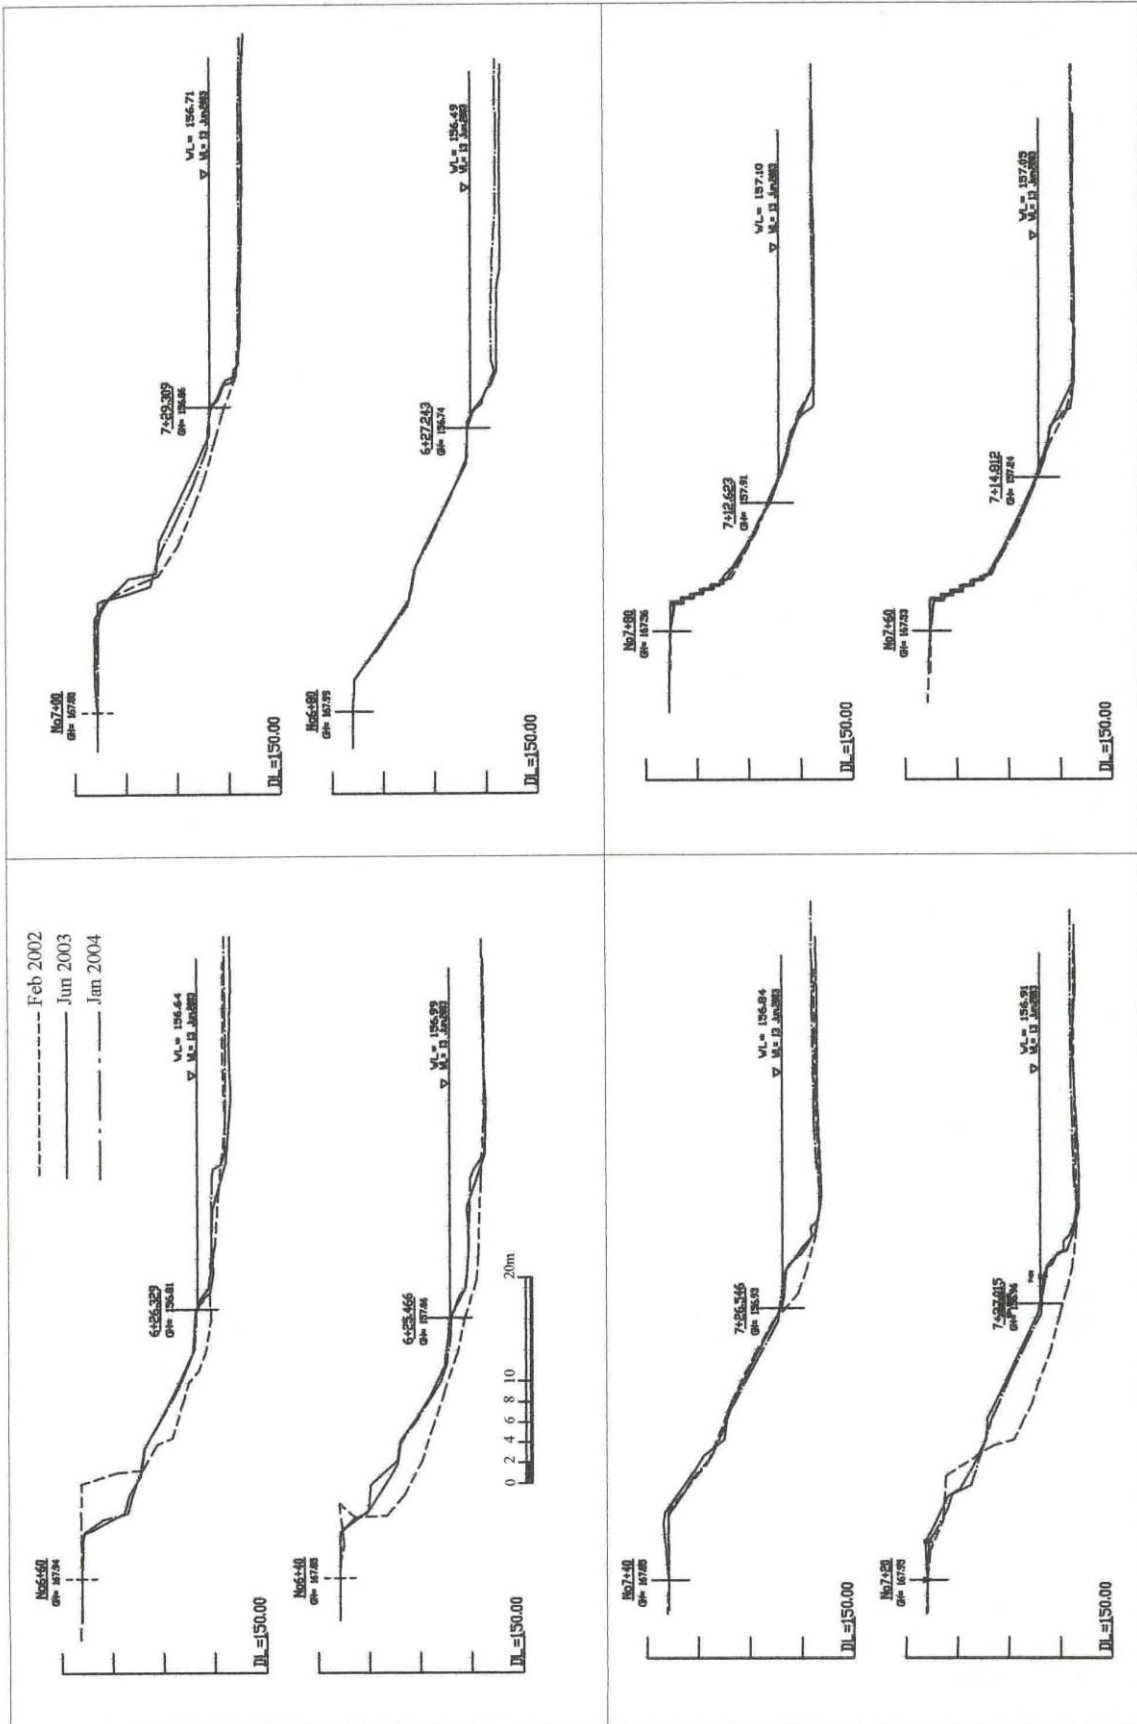
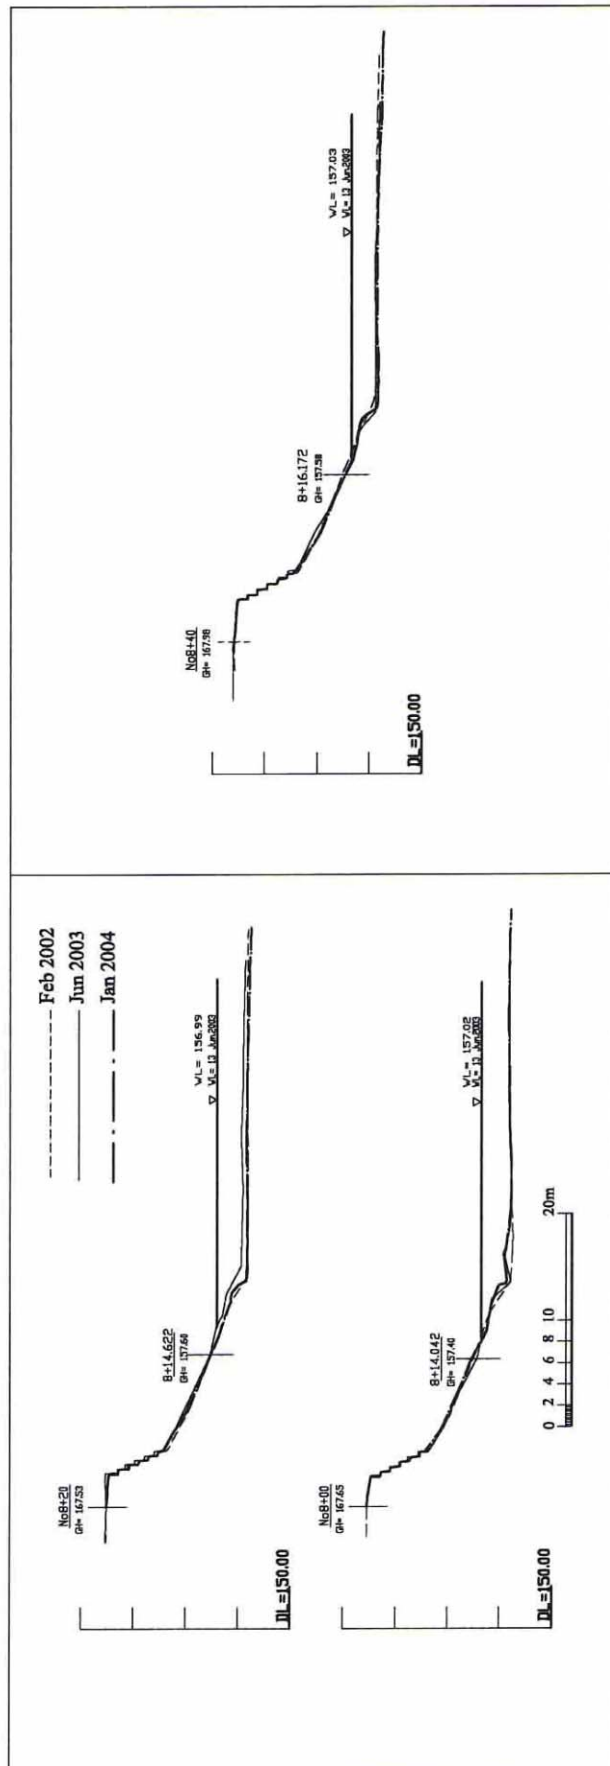
Along each cross sectional line, the profiles of riverbank and riverbed near the bank are compared in the same line as shown in Figure 1.2(1/6)-(6/6). By comparing the cross sectional profiles in different time, monitoring results on the variation of riverbank protection work and riverbank and riverbed are summarized as shown in Table 1.1.

Location	Riverbank Structure	Monitoring Results
Line No.0+00 – No. 1+00	Existing riverbank protection work for the Friendship Bridge	Slightly small variation of profile is found, presumably small scale of local sedimentation and scoring.
Line No.1+20 – No. 2+00	Cobble stone with Willow Branch work + Riprap foundation work	No remarkable changes after the construction work are found.
Line No.2+20 – No. 4+20	Cobble stone with Willow Branch work + Riprap foundation work + SODA Mattress	No remarkable changes on the slope and the foundation part are found. Slightly small variation of the profile on the foot protection work are found, presumably due to un-even surface of SODA Mattress covered by ripraps.
Line No.4+40 – No. 5+60	Cobble stone with Willow Branch work + Riprap foundation work + SODA Mattress + Covering Stones	Covering riprap part is reduced on Line No.4+40 and increased on Line No.5+40. Front slopes of foundation along lines No.5+00, 5+60 are seemed to subside following the SODA mattress before.

Line No.5+80 – No. 6+60	Cobble stone with Willow Branch work + Riprap foundation work + SODA Mattress	Toe of the slope is slightly scored on Line No.6+00. At the foot protection part, riprap seems to be lost along lines of No.6+00, 6+20 and 6+60.
Line No.6+80 – No. 7+40	Cobble stone with Willow Branch work + Riprap foundation work	Slopes along Line No.7+00 – No.7+20 slightly subsided, especially on Line No.7+20. Foundation part is kept as the original profile.
Line No.7+60 – No. 8+40	Existing riverbank protection work in front of Culture Park	Toe of the slopes has subsided with a steep angle along lines of No.7+60 – No.7+80.

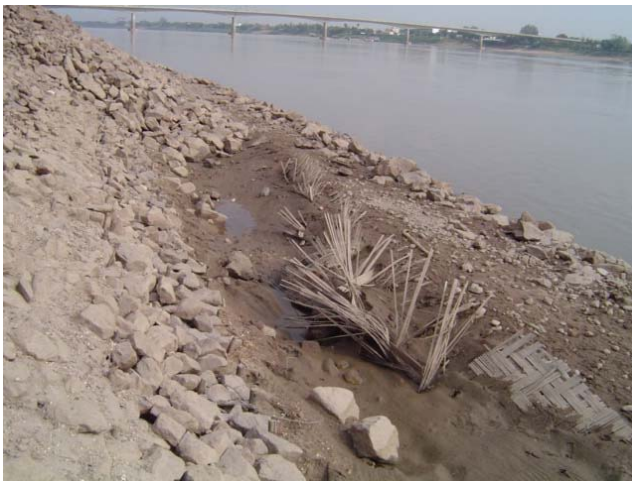
Cobble Stone with Willow Branch Work as a slope protection work and riprap foundation work have kept almost their original formation, except slightly small scale of riprap stone movement on the slope around the whole area and local scoring at the toe of the slope along Line No.5+40 – No.5+52 with depth of approximately 0.4m and width and length of approximately 2m and 12m, respectively as shown in Figure 1.3. The latter part falls in the transition of cross sectional profile with slight weakness against erosion presumably due to increase of gap between the toe of the slope protection work and the riprap foundation work around the area.

Figure 1.3 Local Scoring at the toe of Slope Protection Work

- Connection part between the toe of the slope protection work and the foundation work could be weak against local erosion in the flood season. To avoid this, enforcement with ripraps on the part will be effective.
- As for the foot protection work, supply of ripraps will be effective if further deformation of the foundation work is detected through successive monitoring works.

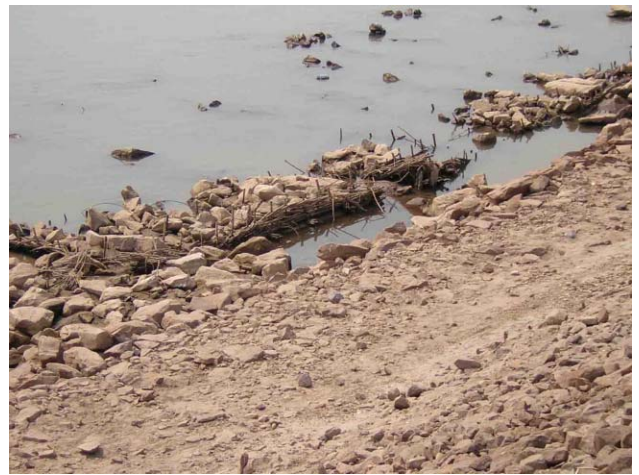
As for the foot protection work, part of SODA mattress exposes its naked wooden basket frame in the low water as shown in Figure 1.4. Gaps between SODA mattress and the riprap foundation work are found, that could lessen the function of foot protection work.

Figure 1.4 Ripraps on SODA Mattress Work

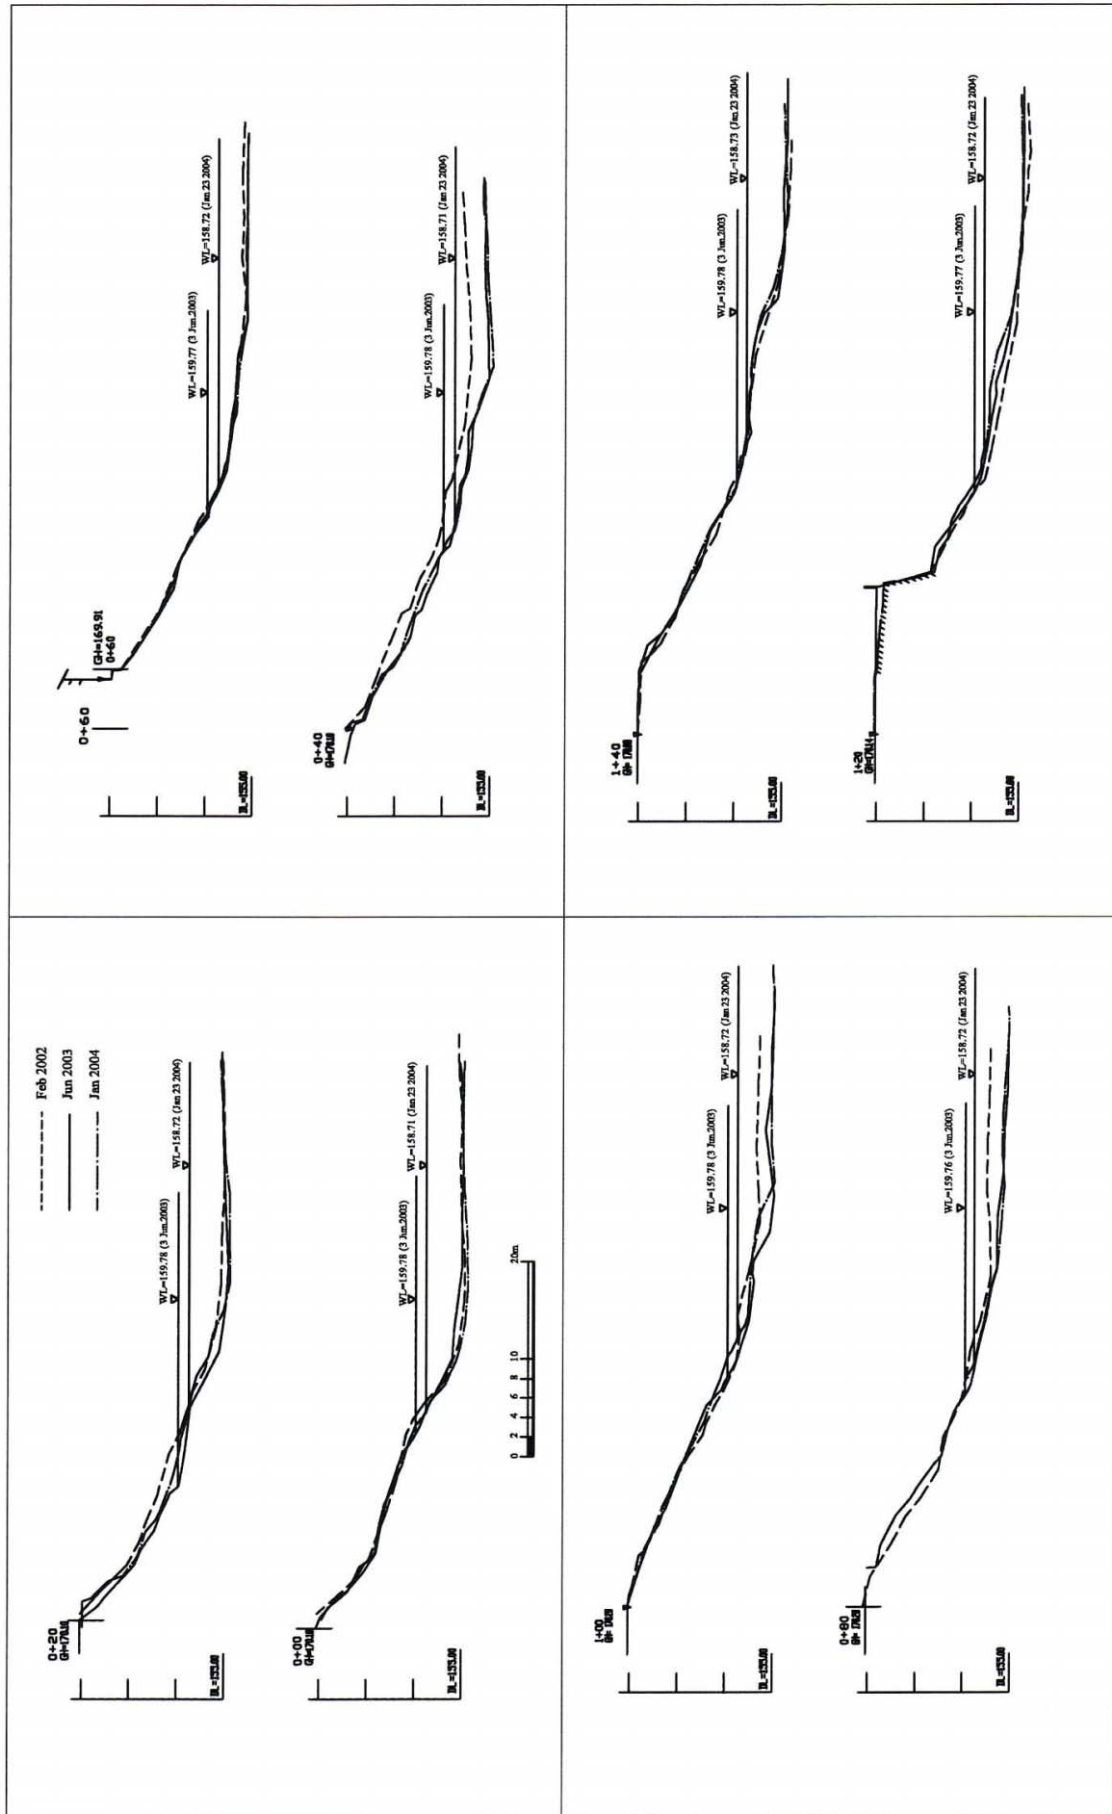
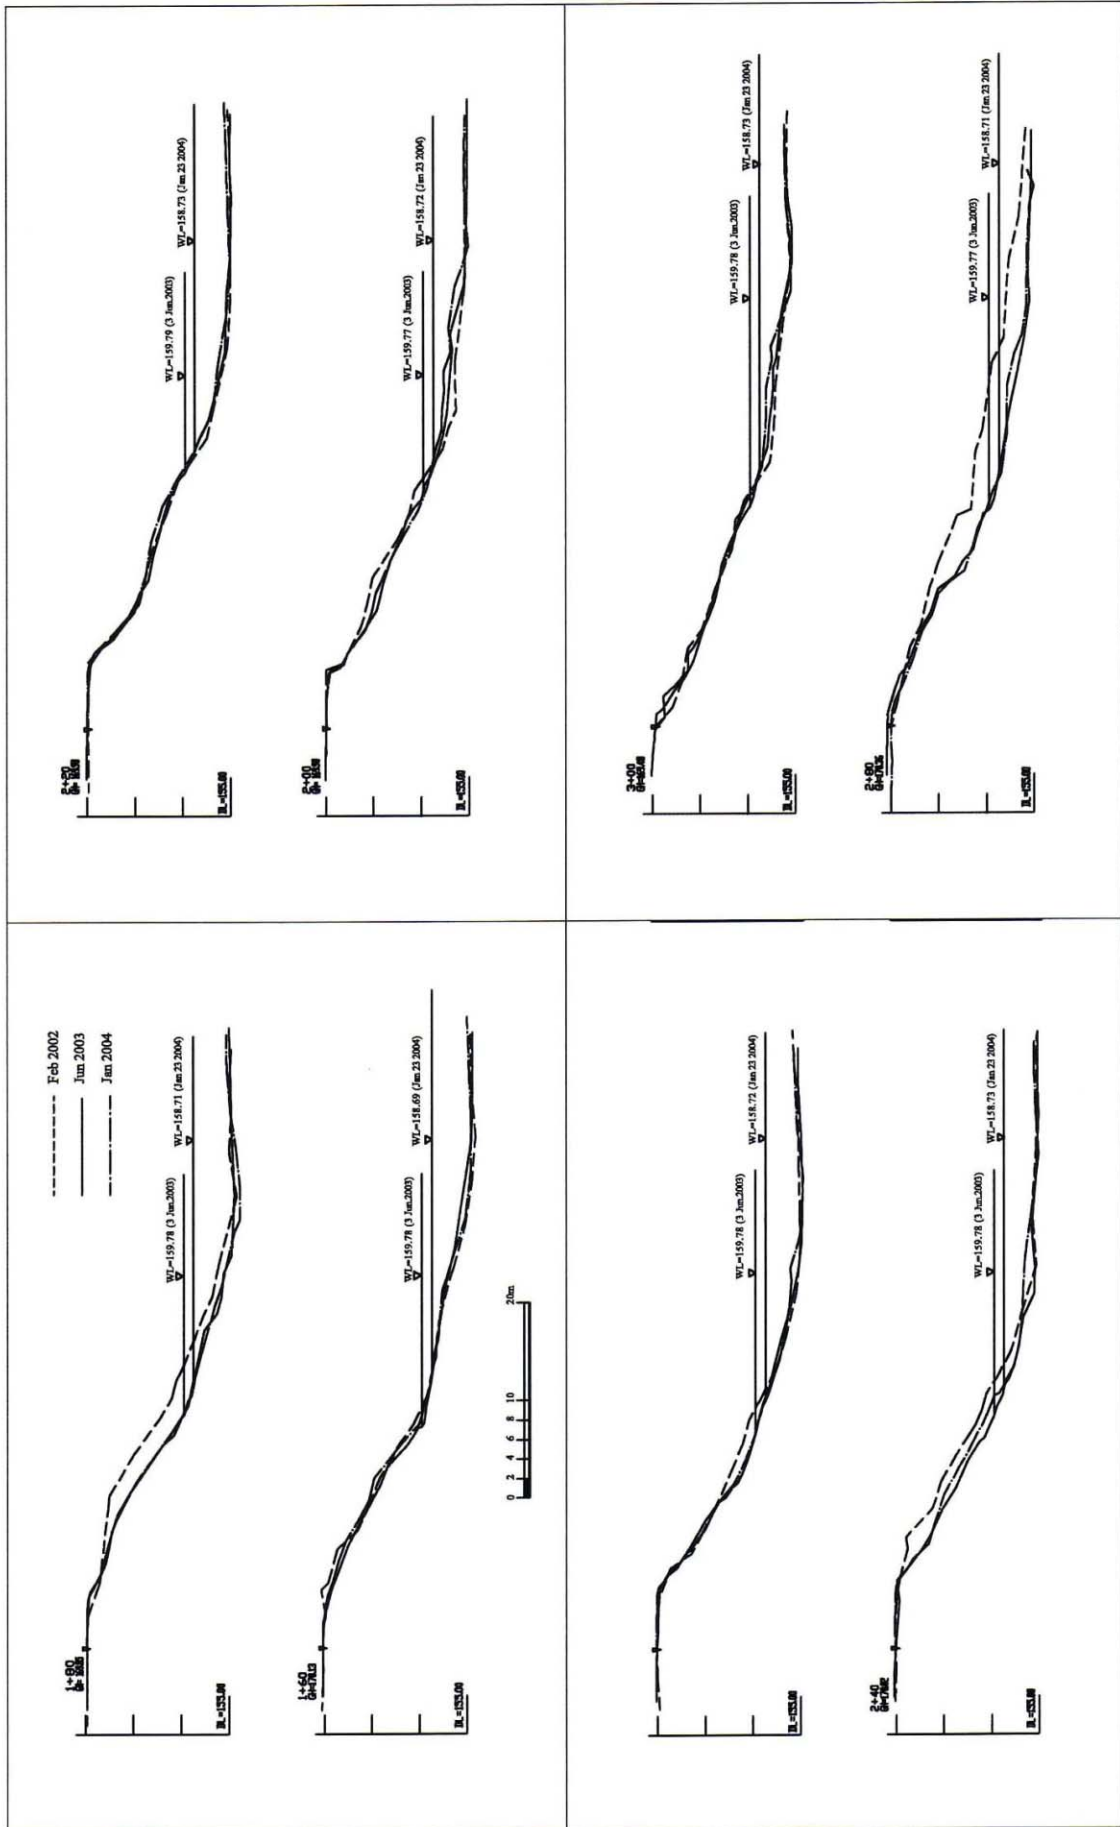
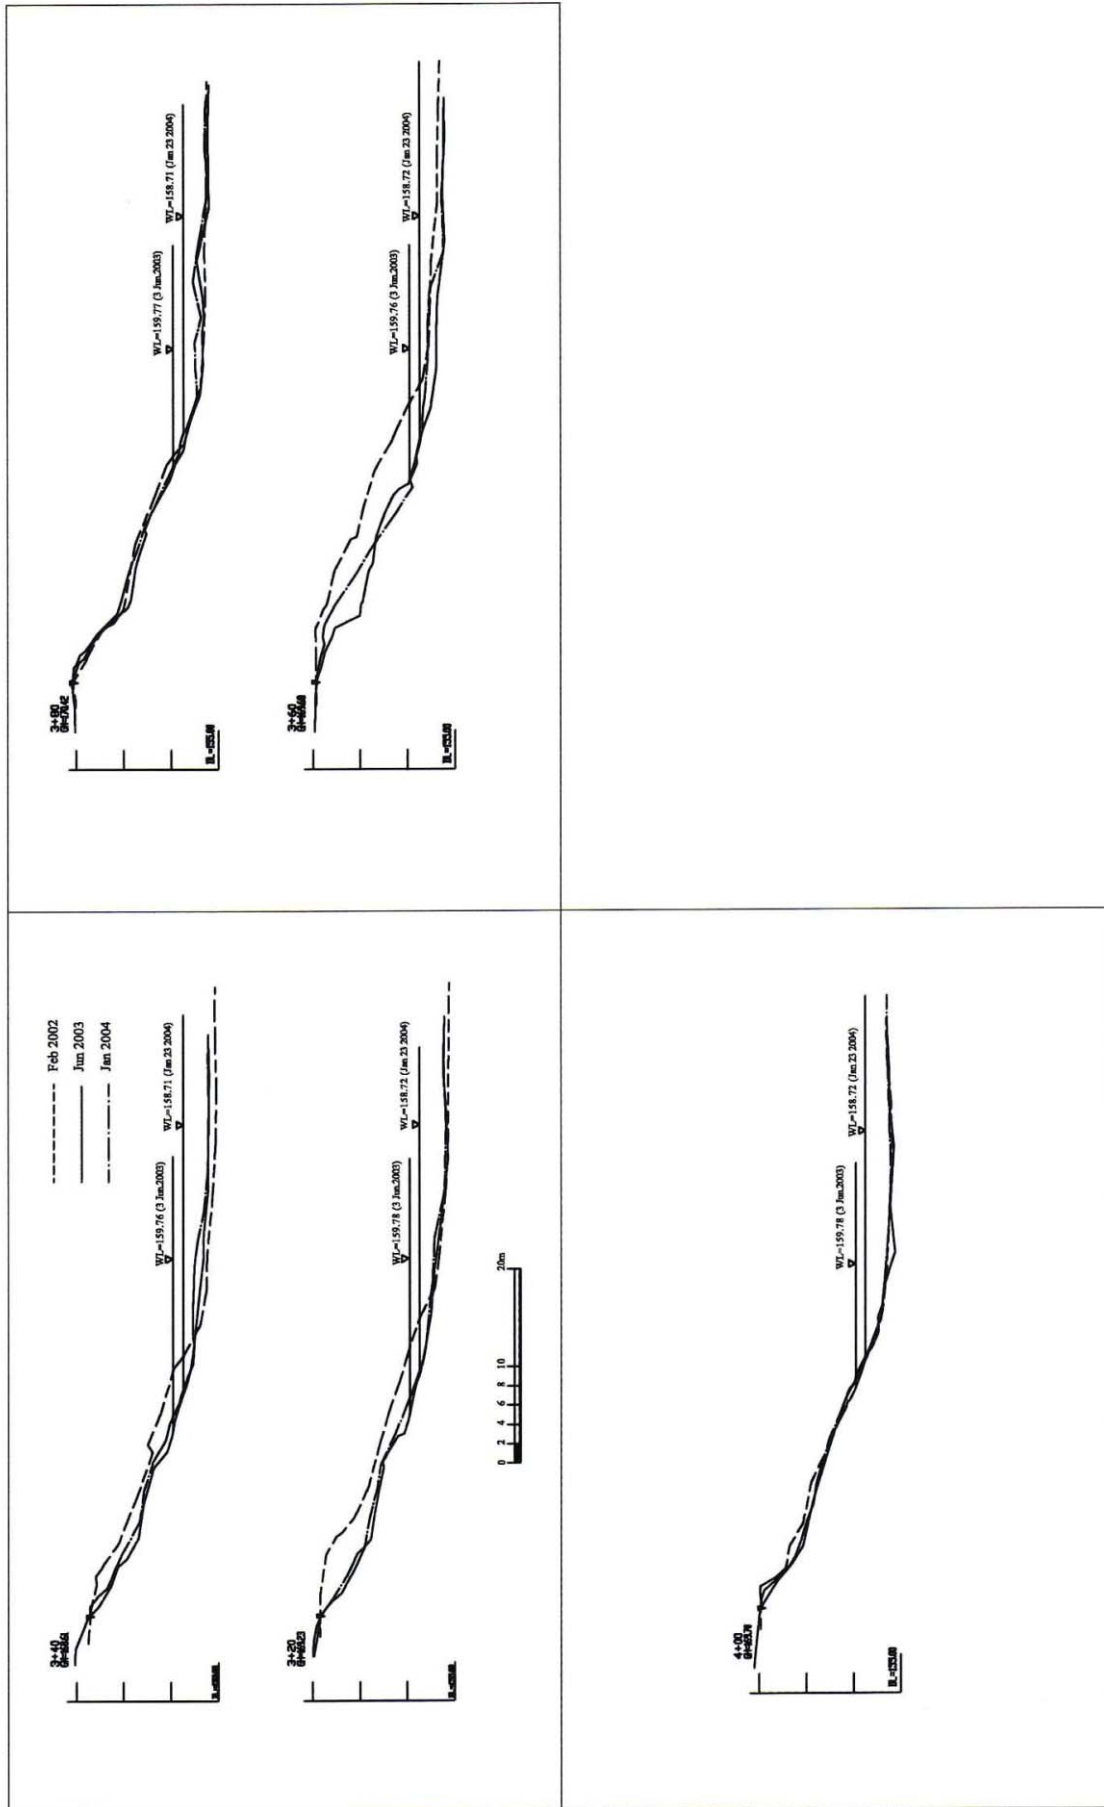
Along each cross sectional line, the profiles of riverbank and riverbed near the bank are compared in the same figure as shown in Figure 1.6(1/3)-(3/3). By comparing the cross sectional profiles in different time, monitoring results on the variation of riverbank protection work and riverbank and riverbed are summarized as shown in Table 1.2.

Location	Riverbank Structure	Monitoring Results
Line No.0+00	None	No remarkable variation of the riverbank profiles is found on the slope, but scoring of approximately 0.7 - 1.0m deep is at the foot part of the slope.
Line No.0+20	None	Accretion of approximately 0.5m thick is found on the slope, but slight scoring is at the foot of it.
Line No.0+40	None	Accretion of approximately 0.5m thick is found on the slope, but slight scoring is at the foot of it.
Line No.0+60	None	No remarkable variation of the profiles is found.
Line No.0+80	None	Accretion of approximately 0.5m thick is found on the slope, but slight scoring is at the foot of it.
Line No.1+00 – No.1+20	None	Accretion of approximately 0.6 – 0.8m thick is found at the foot of the slope.
Line No.1+40	Wooden Pile Dike Groyne	No remarkable variation of the profiles is found after completion of the work, except a slight accretion at the toe of the slope with approximately 0.5 – 1.0m thick.

Line No.1+60	None	Slight accretion on the whole slopes and scoring of approximately 0.4 – 0.6m deep at the foot of the slope are found.
Line No.1+80	None	No remarkable variation of the profiles is found after completion of the work, except a slight accretion at the toe of the slope with approximately 0.6m thick.
Line No.2+00	Wooden Pile Dike Groyne + SODA Mattress	Accretion and subsidence are found on the upper part of slope and middle part of slope, respectively. At the foot of the slope, wide range of sedimentation is found with approximately 0.6 – 0.8m thick.
Line No.2+20	None	On the middle part and the foot part of the slope is found accretion of approximately 0.4 – 0.6m thick.
Line No.2+40	None	On the middle part and the foot part of the slope is found accretion of approximately 0.6 – 1.1m thick.

Location	Riverbank Structure	Monitoring Results
Line No.2+60	Wooden Pile Dike Groyne	Accretion approximately 0.5 – 0.7m thick at the foot of the slope is found.
Line No.2+80	None	Ditto.
Line No.3+00	Wooden Pile Dike Groyne + SODA Mattress	Approximately 0.5 – 0.7m thick accretions is found at the lower part of the slope. Tip of SODA Mattress seems to subside approximately 0.5m.
Line No.3+20	None	Wide range of accretion is found on the upper part and lower part of the slope.
Line No.3+40	Wooden Pile Dike Groyne	Ditto.
Line No.3+60	None	Much amount of sedimentation at lower part of the slope is found with thickness of approximately 1.0m. Upper part of the slope seems to change its profile slightly uniform slope through the previous flood season.
Line No.3+80	Wooden Pile Dike Groyne + SODA Mattress	Accretions at the foot and upper part of the slope are found with thickness of approximately 0.5 – 1.0m.

Line No.4+00	None	Natural riverbank slope variation is found without effect of Wooden Pile Dike Groyne Works. Variation ranges approximately 0.5 – 0.8m.

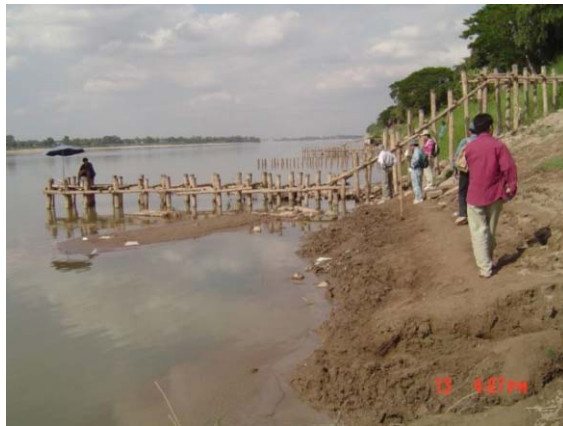
Amount of soil sedimentation is found between wooden pile groynes as shown in Figure 1.7. Especially the sedimentation occurs just downstream of the groyne works. No remarkable changes of the wooden piles are observed with respect to; a) Deformation of wooden piles, b) Deterioration of wood pile not only with tin-plate cap, but also without cap. Slight inclination of wooden piles presumably due to soil mass movement induced by drained water are found at Line No.3+40 as shown in Figure 1.8.

Figure 1.7 Sedimentation between Wooden Pile Dike Groyne Works

- Wooden Pile Dike Groyne Work is effective at the site where accretion almost balances to degradation through a flood period and riverbed consists of sand and silt material.
- Appropriate interval of groynes will be 3 times of groyne length for the site.

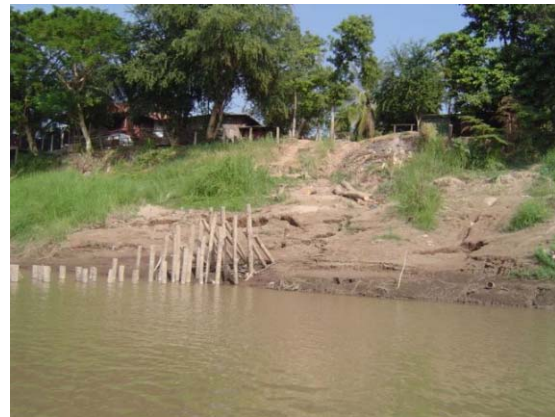
Figure 1.8 Inclination of Wooden Piles at Line No.3+40
