**THE STUDY ON MEKONG RIVERBANK PROTECTION
AROUND VIENTIANE MUNICIPALITY
IN THE LAO PEOPLE’S DEMOCRATIC REPUBLIC**

**FINAL REPORT
VOLUME 4
-SUPPORTING REPORT-**

SECTOR F

MONITORING OF PILOT WORKS

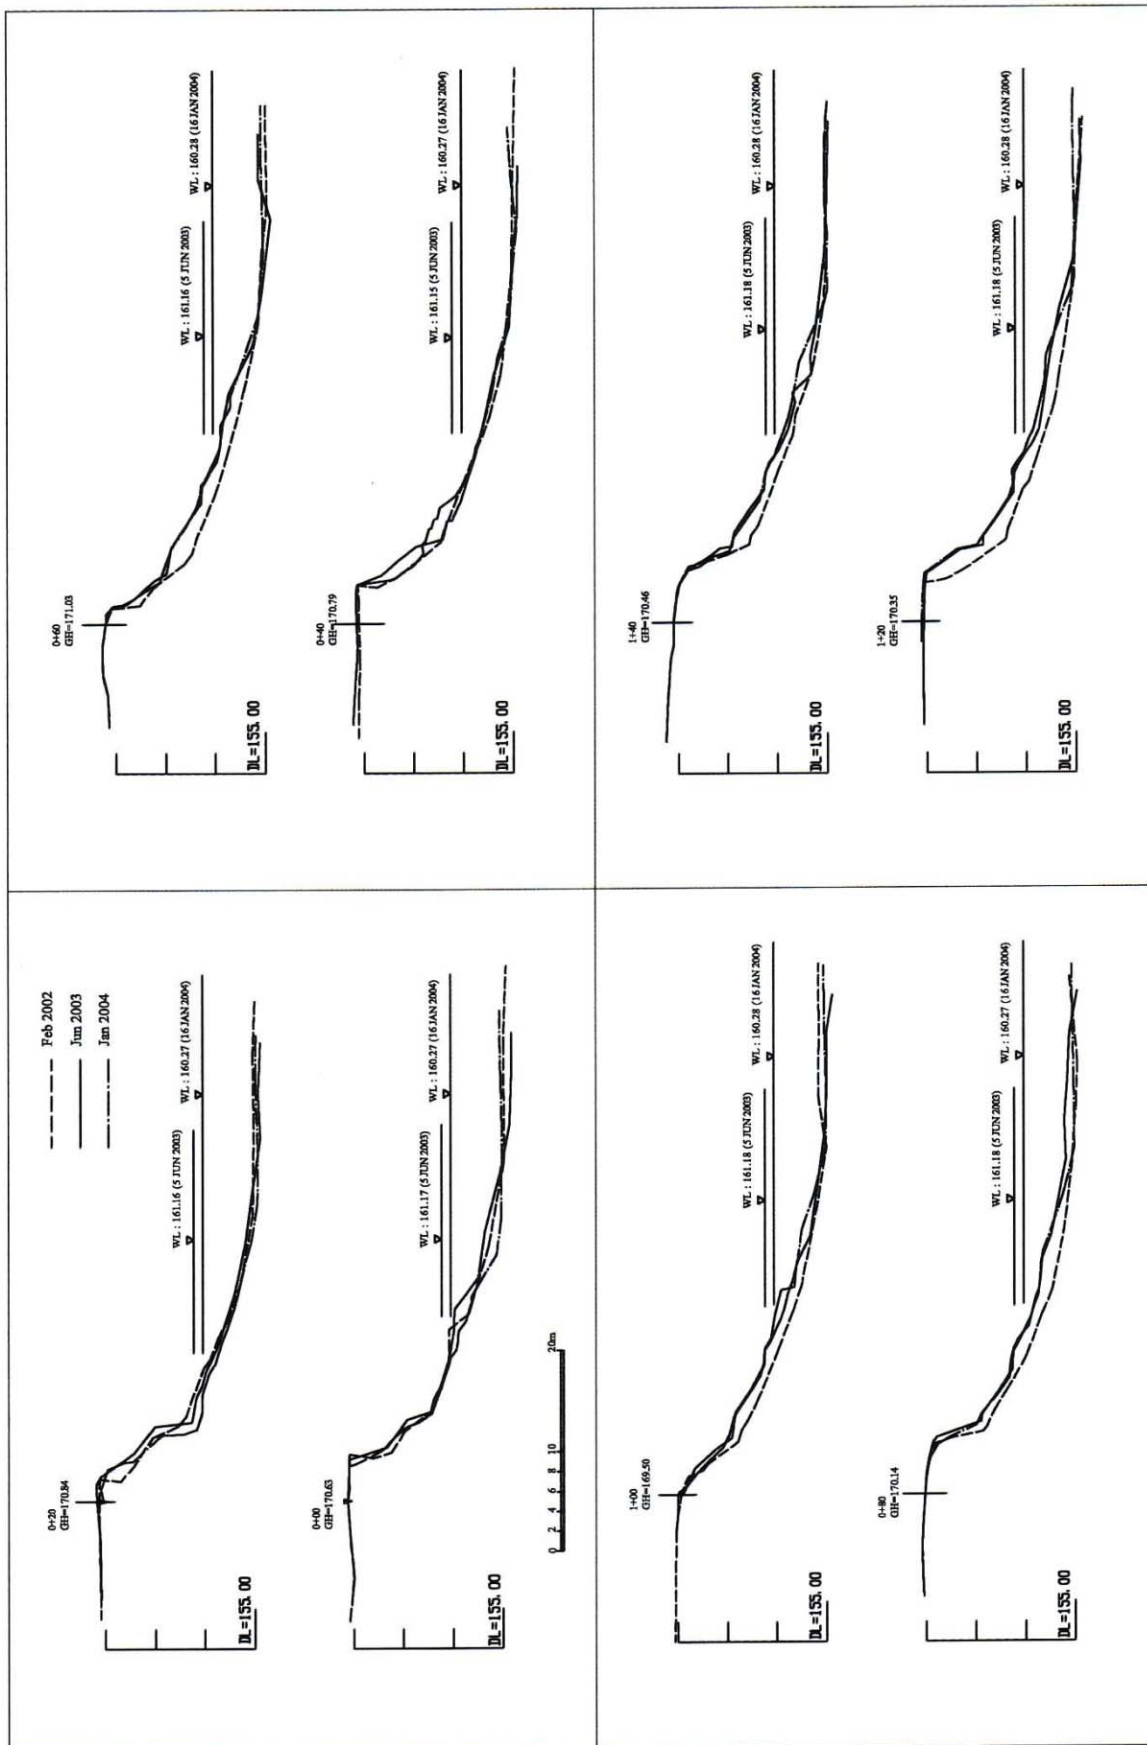
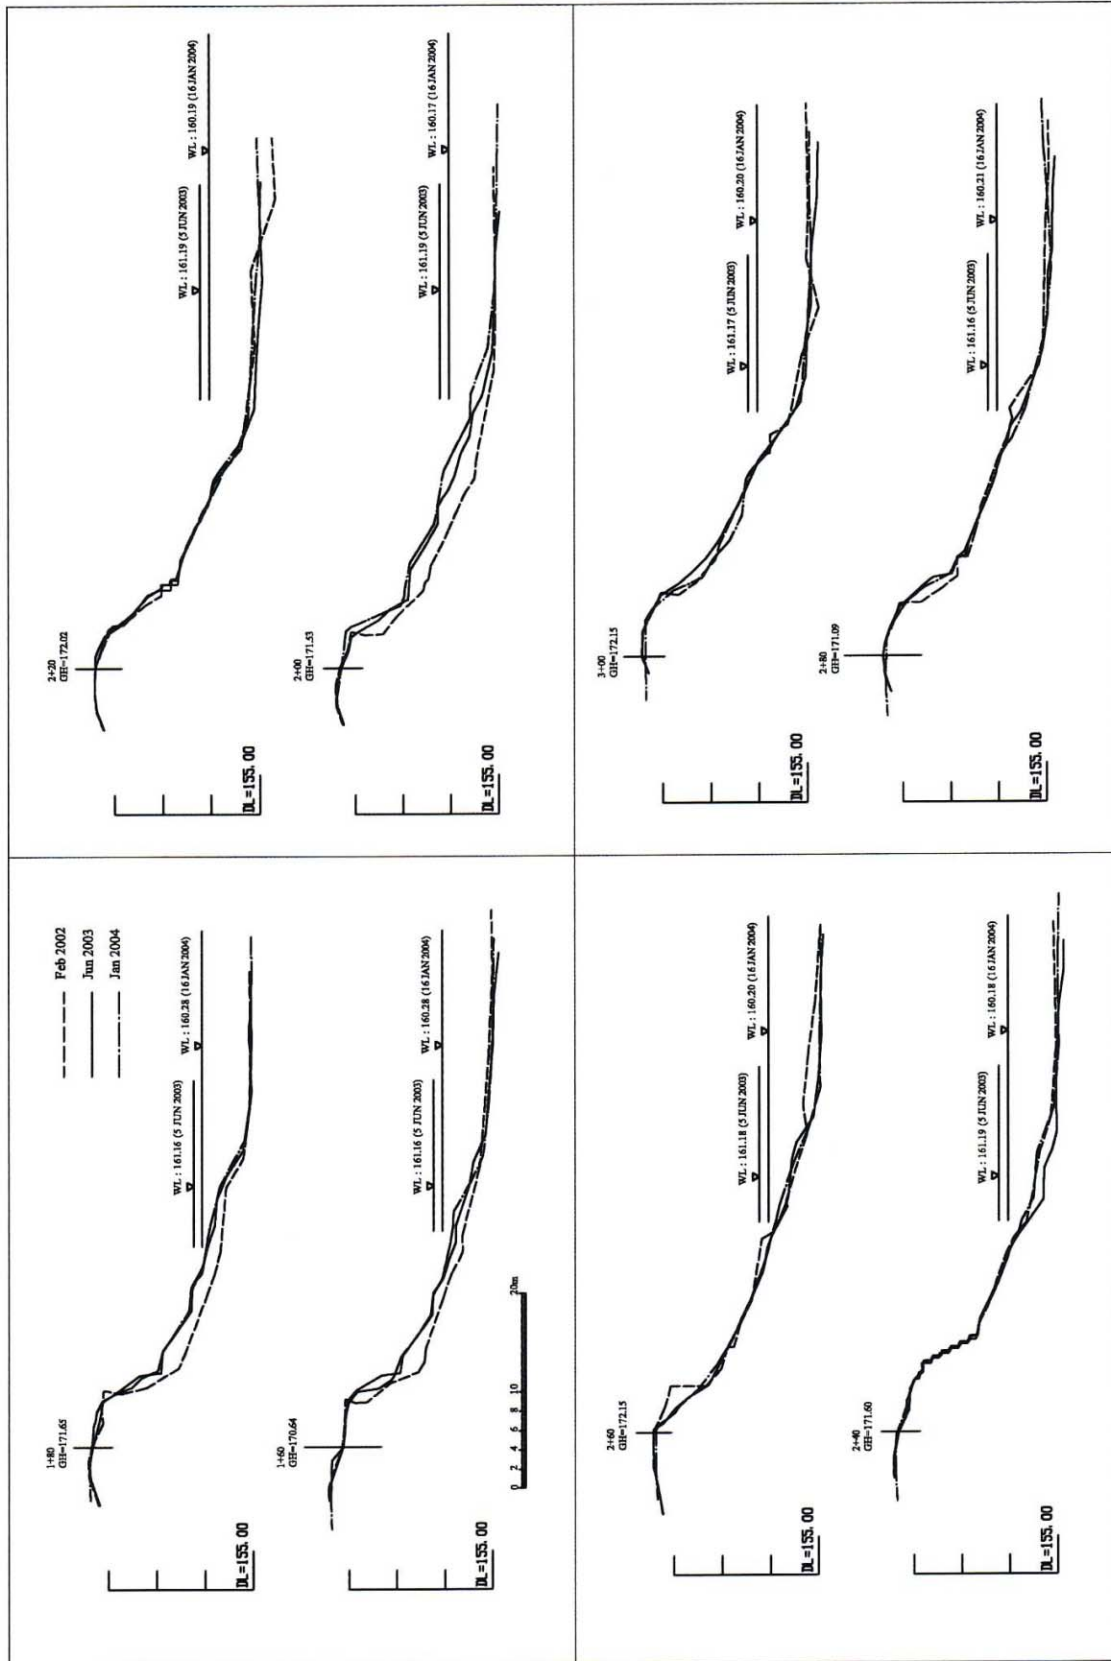
Along each cross sectional line, the profiles of riverbank and riverbed near the bank are compared in the same figure as shown in Figure 1.10(1/3)-(3/3). By comparing the cross sectional profiles in different time, the variation of riverbank protection work and riverbank and riverbed are derived as shown in Table 1.4.

Location	Riverbank Structure	Monitoring Results
Line No.0+00	None	Slightly large recession at the lower part of slope is found.
Line No.0+20	None	Recession of steep slope is found.
Line No.0+40	None	Recession of steep slope and accretion at the foot of slope are found.
Line No.0+60	Cobble Stone with Willow	No remarkable change is found.
Line No.0+80	Branch Work + Log Hurdle Work + SODA	Recession of upper part of steep slope is found. Tip of the foot protection work is seemed to subside.
LineNo.1+00 – No.1+20	Mattress	Accretion at the foot of foundation is found. Tip of the foot protection work is seemed to subside.
Line No.1+40		Recession of steep slope and accretion at the foot of slope are found. And tip of the foot protection work is seemed to subside.
Line No.1+60		Ditto.
Line No.1+80		No remarkable change in the profiles is found.
Line No.2+00		Amount of sediment is found at the lower part of slope.

LineNo.2+20 – No.3+00	Riverbank protection work done by IDI Japan.	Riverbank slope is almost stable in the range of riverbank protection work, except on Line No.2+60, where upper part of slope collapsed in flood season of 2003

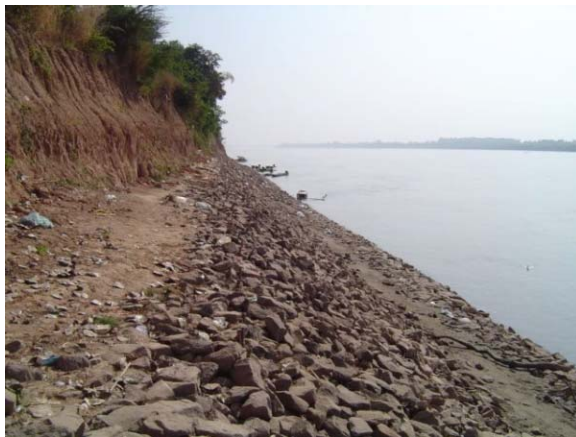
Amount of soil sedimentation is found on the flat top of slope covering work and also flat foundation work as shown in Figure 1.11. Between riprap stones fine sediment materials are found as shown in Figure 1.12.

Figure 1.11 Downstream View at Sibounheuang Site

- Protecting the lower part of the steep slope will be effective around the site to mitigate the setbacks of the cliffy riverbank caused by successive erosion during flood period.
- Width of foot protection work is to be adjusted in accompanying the deformation / subsidence of SODA mattress through successive monitoring works.

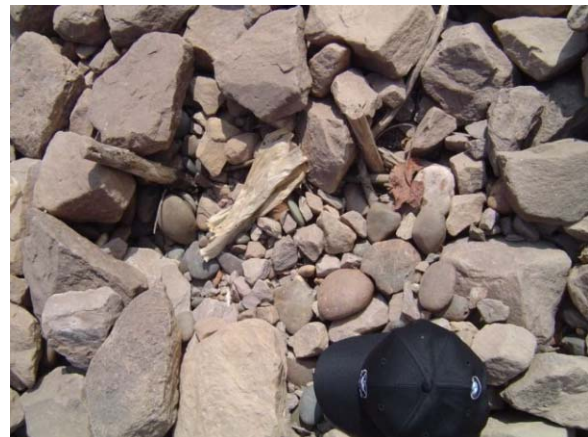
Figure 1.12 Sediment Material under the Slope Covering Riprap at Sibounheuang Site

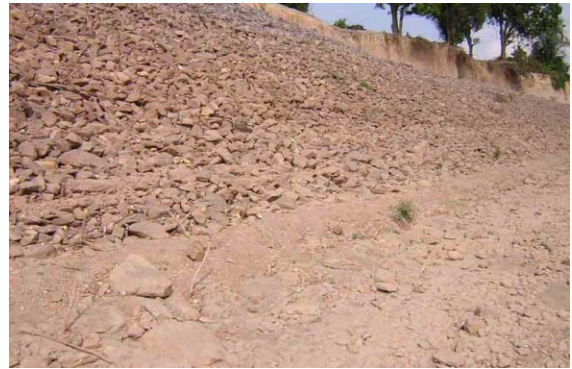
For the stump directly planting, 250 stumps were planted, in which there were only 6 survived (2.4%). The too low percentage is presumably due to the site condition of the slope with the stone, that is hardly to keep the moisture leading to the stump drying up and death.

Situation of willow survived (Stump directly planting) Dec/2003

- It is necessary for stump directly planting to keep moisture by watering every day. However, the site condition of the slope was with stones and it was difficult to keep moisture.
- The time of seed sowing was at the end of March. It was only two months before flood, too short for the seed to mature in order to make the young seedling grow against flood. If the seed was sown more deeply under the stones or soil, the seed and the young seedling could be alive.
- The monitoring period is short. There is possibility that the willow included in Shikisoda will germinate in two or three years after construction.

According to the monitoring result, it is better to plant willow by seedling on the cobble stone works. However, there is a fair possibility of success by another planting method. Based on the finding of the test planting and experience, recommendations for the further vegetation riverbank protection works are thereby made as below:

- Using vertical willow branch (TATE-SODA) to plant deeply instead of stump directory planting.
- Sowing seed under Siki-Soda and using germinated seed before sowing.
- Planting by seedling should be promoted for the construction site.
- It is necessary to continue monitoring for three to five years.
