**TECHNICAL NOTE**  
**on the Basic Design Study**  
**on the Project for Rehabilitation of Betio Port**  
**in the Republic of Kiribati**

**Minutes of Discussions  
on the Basic Design Study  
on the Project for Rehabilitation of Betio Port  
in the Republic of Kiribati  
(Explanation of Draft Final Report)**

## 資料-6 事業事前計画表(基本設計時)

### A-1 現地損傷状況調査内容

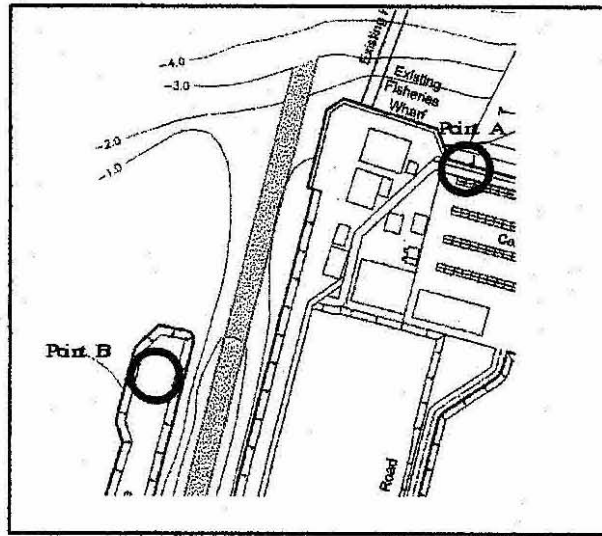
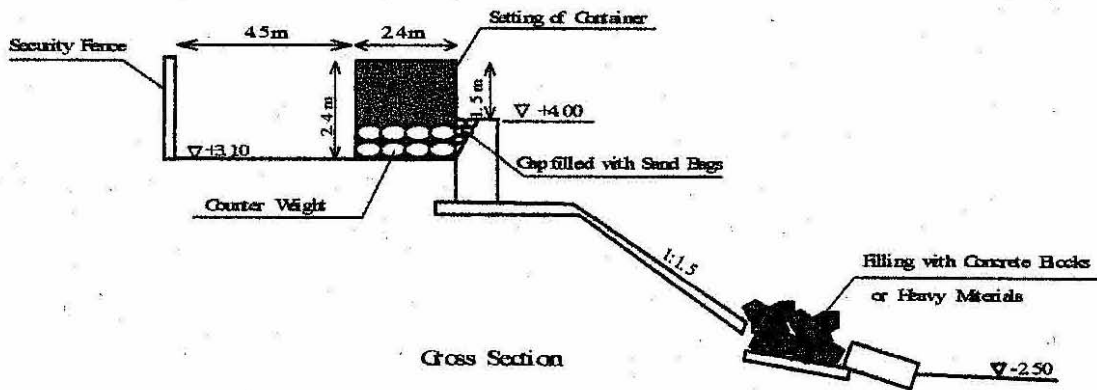
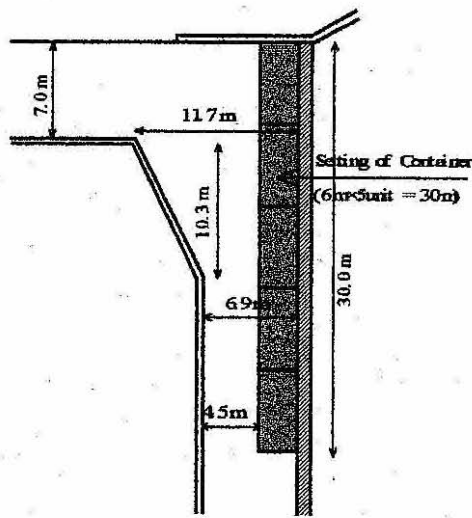
Point A (New Wharf Revetment)

At the west end of the New Wharf Revetment, it is experienced frequent overtopping waves causing damages to top surface including apron concrete slab. To prevent further damage by overtopping waves, it is proposed to install containers along the parapet wall temporarily.

For the openings of fabric mat damaged by the wave action, it is proposed to fill with heavy materials like used concrete curb stones or similar temporarily.

In order to stabilize the present revetment structure, it is suggested to reinforce said revetment by bagged concrete and sand bags as shown in Attachment A.

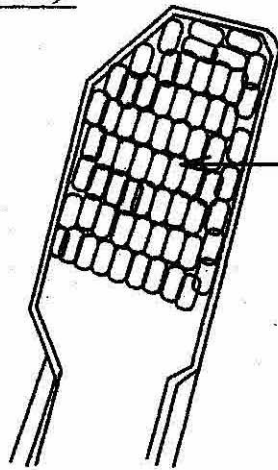
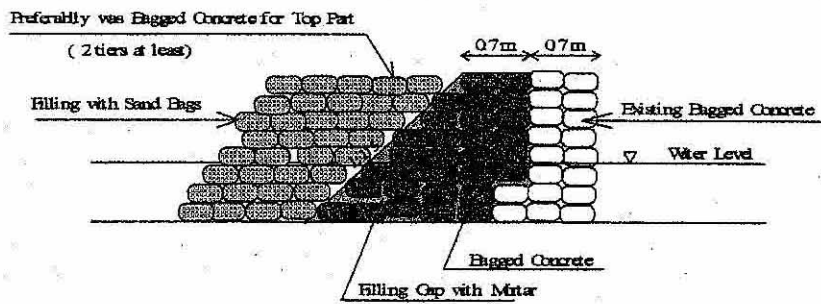
Point B (West Mile Revetment)

The West Mole Revetment is being damaged continuously due to its unstable structure. Also the filled sand inside the revetment is frequently washed out by overtopping waves. This section of the revetment at West Mole is very important to prevent large damage to the container yard and other facilities located in East Mole since it is functioned as breakwater.

Filling with Bagged Concrete and Sand Bags  
(Total 1,000 m<sup>3</sup>)

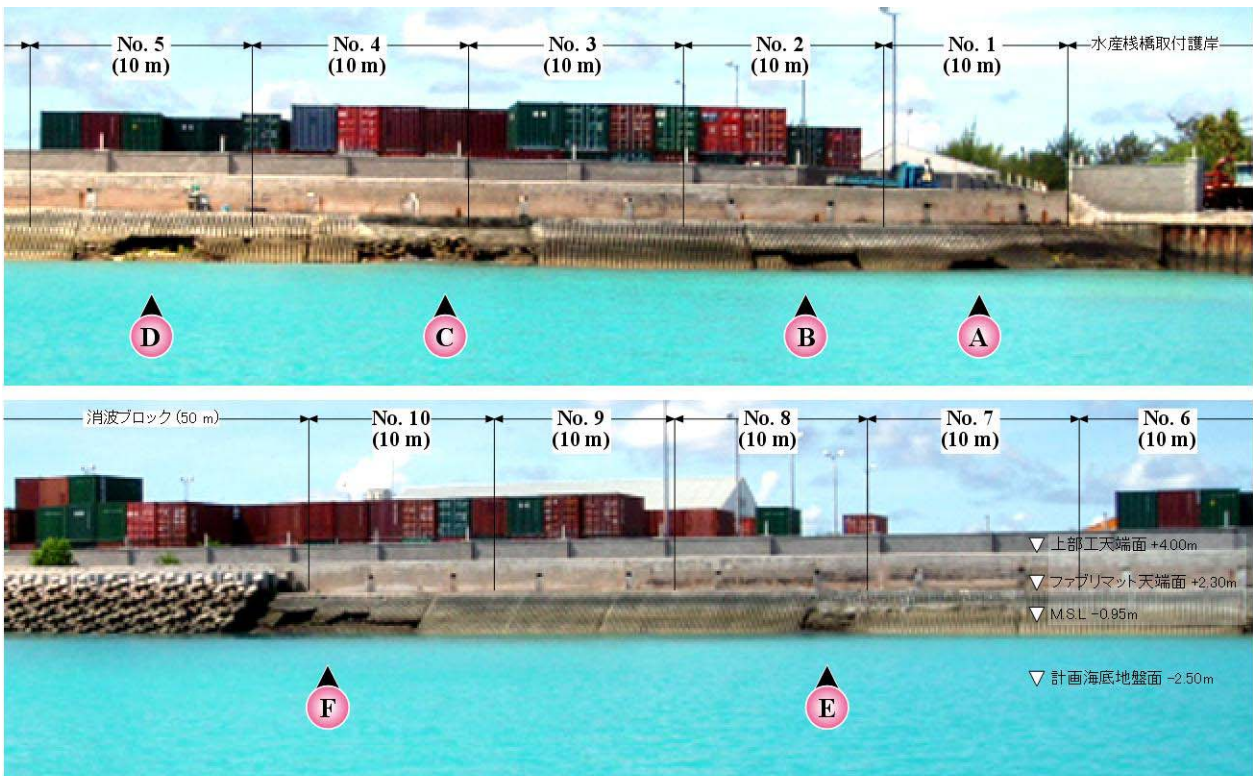
図 A-2-1 ファブリマット護岸部の損傷状況

1996－2000 年の無償資金協力事業により実施した新港護岸部と共に、事業対象外の水産棧橋取付護岸、東防波堤護岸、旧港側の西防波堤護岸についても目視調査を実施した。これらの被災状況をまとめたものを図 A-2-1～A-2-3 に示す。図 A-2-1 は、新港護岸部のうちのファブリマット護岸における損傷状況、図 A-2-2 は水産棧橋及び東防波堤護岸部周辺の損傷状況、図 A-2-3 は西防波堤護岸部周辺の損傷状況を示す。

- a) ファブリマット形式の護岸の内、コンクリートマットの崩壊・剥離まで生じている損傷の激しいスパンは、No.1～2、No.4～5、No.7、及び No.10 である。ここでは、平均水面付近から下側にコンクリートマットの崩壊、剥離が生じている。また、裏込材のサンゴ塊及び補修対策として用いられた袋詰めコンクリートが、前面の海底に散乱している(写真 A-2-1 ①参照)。
- b) ファブリマット法肩部では、ほぼ全域にわたって亀裂が生じている(写真 A-2-1 ②参照)。法肩部の亀裂については、少なくとも大規模な崩壊(2002年11月)の1年前から認められたことが、港湾局からのヒアリング結果より得られた。
- c) 潜水調査の結果、この崩壊面の内側には裏込材のサンゴ塊流出に伴い、奥行 1m～3m 程度の空洞が生じていることを確認した(写真 A-2-1 ③参照)。崩壊部では、裏込材が常に波浪に曝されているため、裏込石及びその背後の土砂は、現在も引き続きの流出しているものと推測される。
- d) 法尻部では根固用布団籠が散乱し、一部の布団籠の下側に高さ 30～50 cm 程度の隙間が生じていた。

- To place unused curb stones and concrete debris to the openings of damaged fabric mat at the location A, B, C, D, E and F shown in Figure A-2-1 of Appendix A, Draft Final Report.

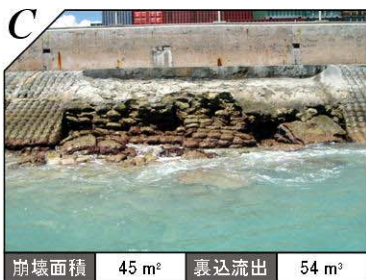
- ・ 大量の裏込石(サンゴ塊)および袋詰めコンクリートの流出
- ・ 根固用布団籠の散乱
- ・ 布団籠下の洗掘による空洞

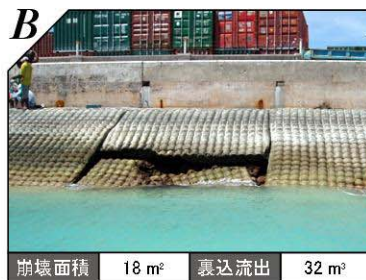
- ・ 裏込石(サンゴ塊)の流出
- ・ 根固用布団籠の散乱

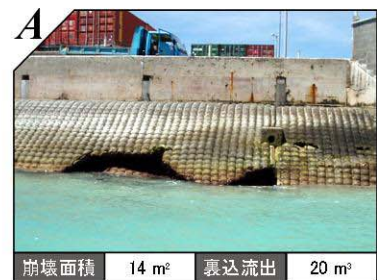
- ・ 法尻付近は砂で覆われている
- ・ 砂地盤は反射波の影響による顕著な砂れんが形成

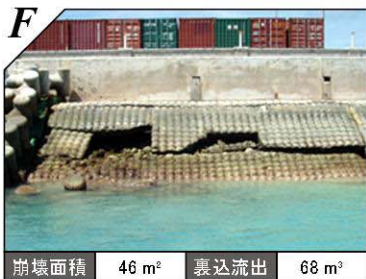
- ・ 裏込石(サンゴ塊)の流出
- ・ 根固用布団籠の散乱

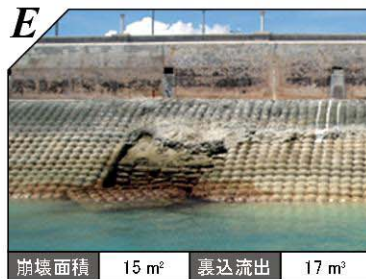
- ・ 裏込石(サンゴ塊)の流出
- ・ 根固用布団籠の散乱

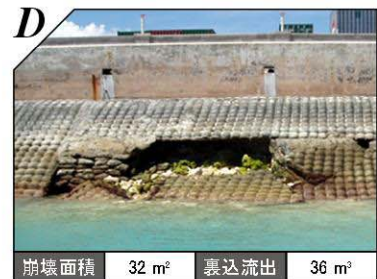
- ・ 大量の裏込石(サンゴ塊)および袋詰めコンクリートの流出
- ・ 根固用布団籠の散乱
- ・ 布団籠下の洗掘による空洞

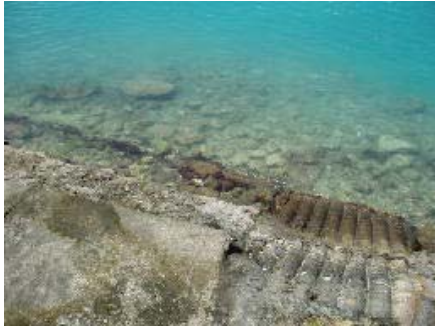
① 裏込石散乱状況 (No.4 付近)

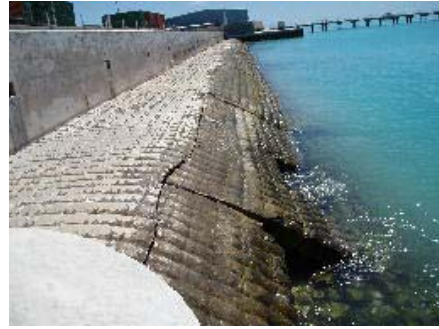
② 法肩部の亀裂 (No.10 付近)

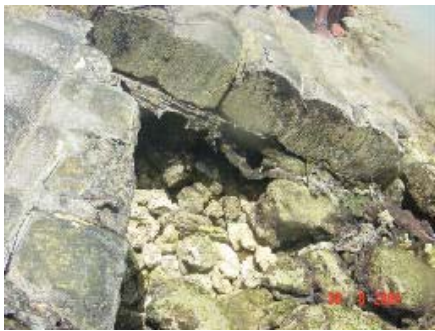
③ 裏込石流出状況

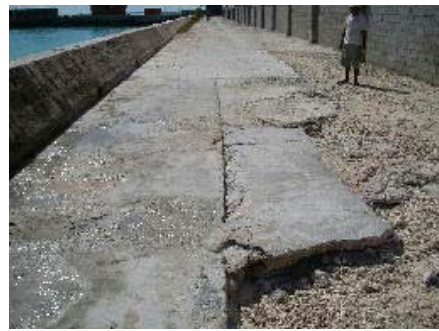
④ 道路の補修 (No.1~3 付近)

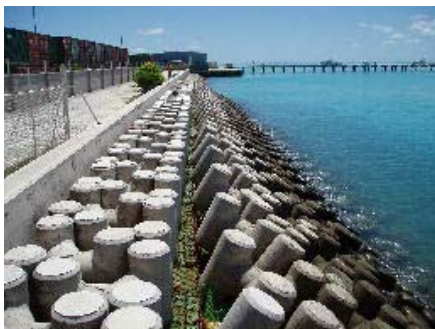
- g) 消波ブロック形式護岸の No.11～15 測点では、特に消波ブロックの損傷及び沈下等は見られない。潜水観測において、法尻部の根固め用布団籠に多少の変動が認められたが、ブロックはほぼ移動していない事が確認された(写真 A-2-1 ⑤参照)。この事実から判断し、消波ブロック護岸部では、極端な海底地形の変動や、洗掘の可能性は少ないといえる。

⑤ 消波ブロック形状護岸

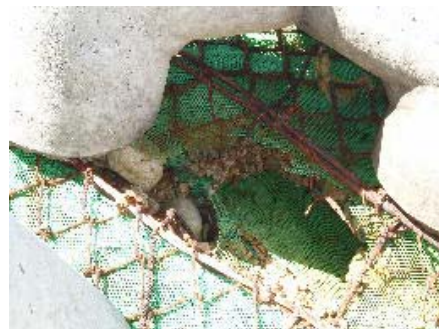
- h) 消波ブロックには特に損傷は見られないが、法肩部のブロック下層に用いられている布団籠の一部に、表面の金網及び防砂シートの一部破損、それに伴う中詰材のサンゴ塊の一部流出が見られた(写真 A-2-1 ⑥参照)。また全体として、布団籠の枠材として用いている鋼材の腐食が顕著である。そのため、今後数年の内には更なる金網、ネットの破損、それに伴う中詰材の流出が生じ、これによる構造全体の変形が生じる可能性が高いと考えられる。

⑥ ブロック下の布団籠損傷状況

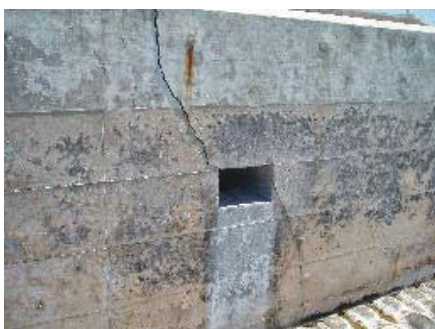
- i) パラペットコンクリートは、10m 毎のスパンで打設されているが、ファブリマツ護岸区間では、すべてのスパンで中央部の水抜き孔付近にひび割れが生じている(写真 A-2-1 ⑦⑧参照)。このひび割れは、その形状から判断し、曲げ破壊により生じたものと推定される。最も顕著なひび割れは No.2 から No.3 付近で生じており、そのひび割れ幅は 10mm 程度である。これらの顕著なひび割れと、前面ファブリマツの損傷箇所とが位置的にほぼ一致していることから、護岸崩壊による裏込材の流出に伴う局所的な沈下と、それにより発生した応力集中によるものと考えられる。尚、現地ヒアリング結果より、このひび割れ状況は徐々に拡大している。

⑦ パラペットひび割れ状況 (陸側)

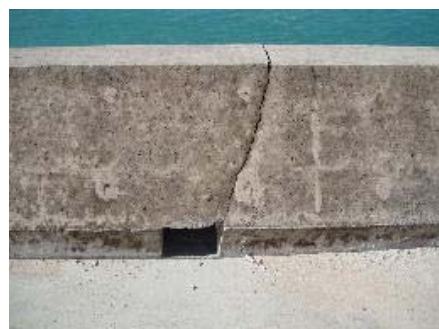
⑧ パラペットひび割れ状況 (海側)

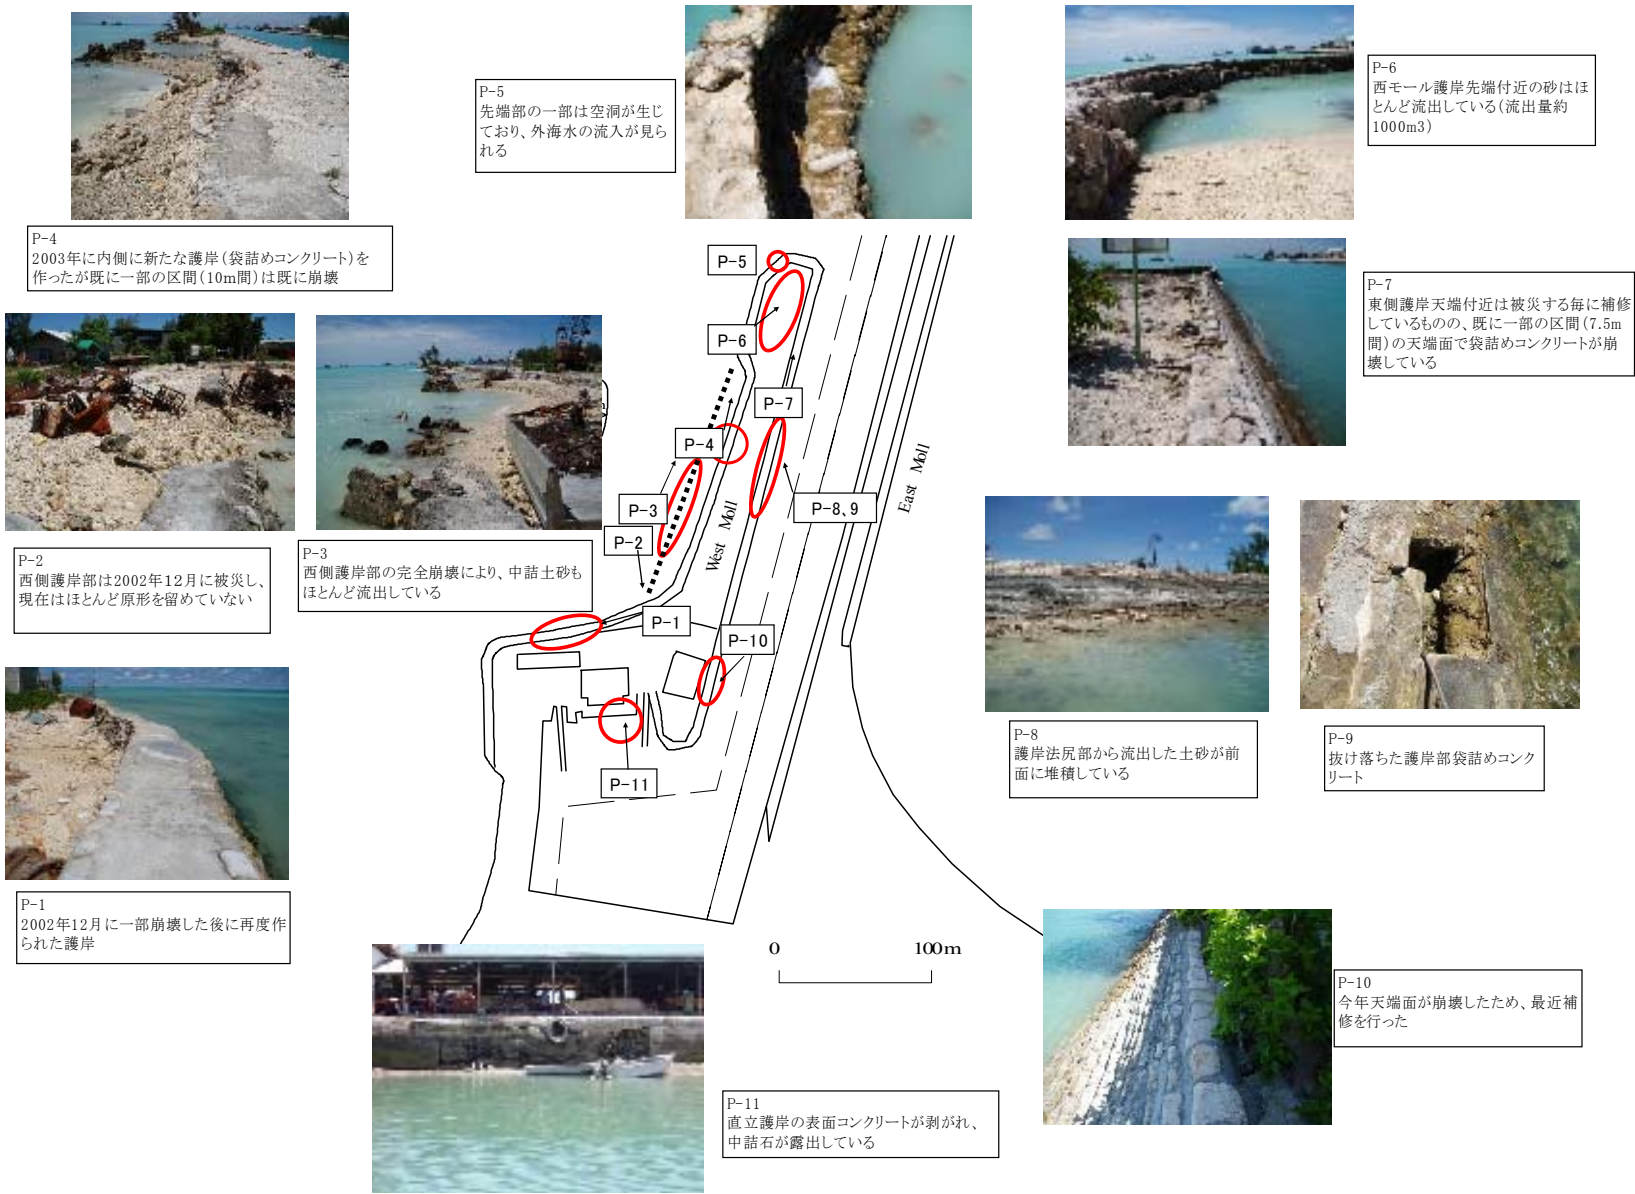
図 A-2-3 旧港西防波堤護岸部における被災状況

西防波堤護岸の被災は際だっており、特に西側面での損傷が激しい。被災の状況を、下記に詳述する。

- a) 沖側の西側面の護岸は、そのほとんどが原型を留めることができないほど崩壊している。なお、2003 年 12 月の予備調査時との写真比較から、この半年間でさらに崩壊が進んだ様子が見られる。
- b) 西側面の旧護岸内側に作られた護岸（サンゴ塊をセメントで固めたもの）も、これまでに度々被災を受けていたため、2003～2004 年にかけて修復を行った。しかし、既に一部の区間（長さ 8m 程度）で崩壊が生じている。
- c) 護岸内側の土砂の流出も激しく、特に西防波堤護岸前面部の約 30m 区間では、中詰め土砂のほとんどは既に流出し、袋詰めコンクリート 2 列による直立護岸壁がかろうじて存在している状態である。この中詰め砂の大量流出は、ファブリマツ護岸被災時と同じ 2002 年 12 月に生じたが、予備調査時の 2003 年 12 月時点の写真から判断すると、その後も流出が続いた結果、現在はほとんど消失している。先端部を取り巻く直立護岸も、既に 3 ヶ所程度で空洞が見られ、背後への海水の流入が生じている。
- d) 西防波堤護岸東側（旧港航路側）においても、東防波堤護岸と同様、袋詰めコンクリートの一部離脱、下層部からの土砂流出、天端付近での崩壊が生じている。ここでも、港湾公社により度々補修が行われている。

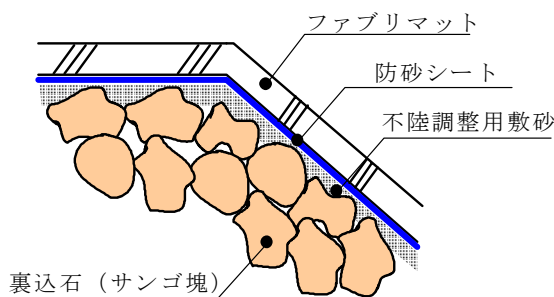
図 A-3-1 ファブリマツ下の構成材（新港護岸部）

- a) ファブリマツ下側は、図A-3-1に示すように表層から、ファブリマツ → 防砂シート → 不陸調整用敷砂 → 裏込石（5～20kg/個のサンゴ塊）で構成されている。尚、背後の取付道路護岸部では裏込材として袋セメントを用いている。不陸調整用敷砂は、裏込石の凹凸による防砂シート及びファブリマツの損傷を防ぐために、施工上用いられた。
- b) 被災した新港護岸部では、削孔部すべての箇所では敷砂は流出しており、防砂シートの直下には、裏込材のサンゴ塊が見られた。

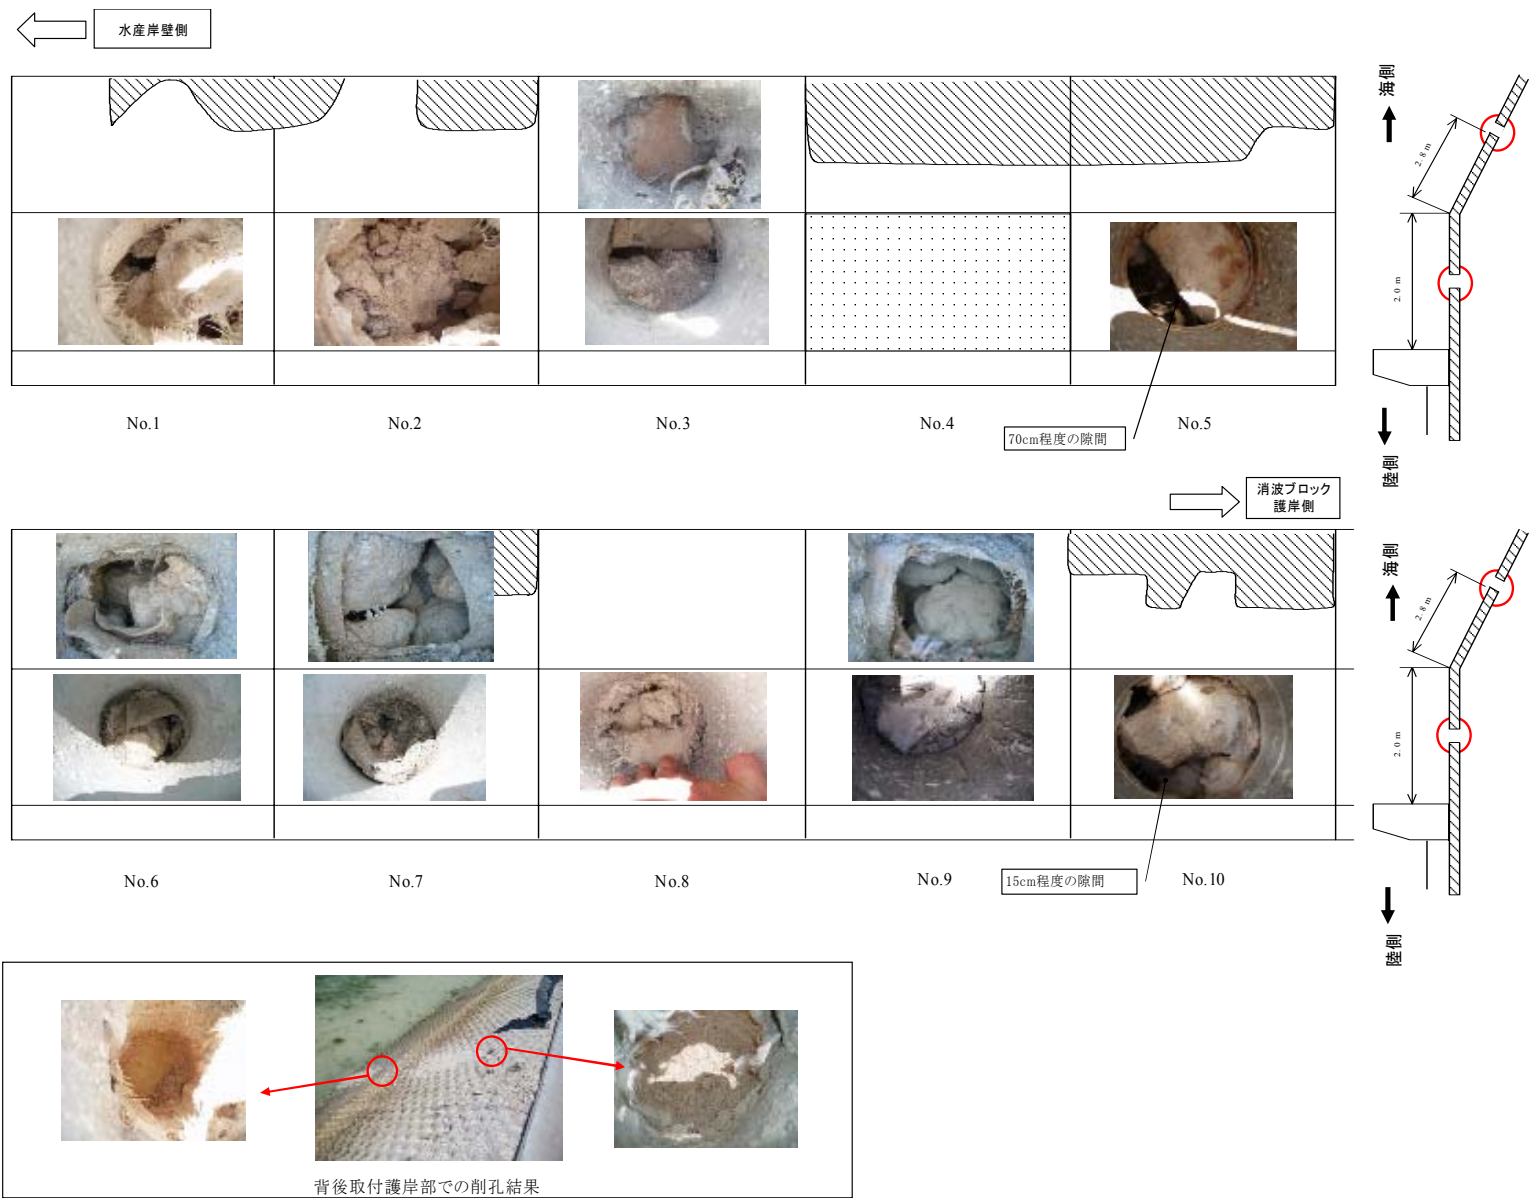
図 A-3-2 ファブリック護岸削孔調査結果

- c) このサンゴ塊は様々な形状を有するため、各個別の石の間には空隙が存在する。マツの崩壊が生じていない箇所ではサンゴ塊はマツの下層面にほぼ接して詰まっており、特に流出している様子は見られなかった。一方、前面でマツが崩壊している箇所では、明らかにサンゴ塊が流出した結果と見られる顕著な隙間が生じている箇所が見られた。特に、最も顕著な被災が生じたNo.5では、天端上の孔においても、奥行70cm程度の間隙が生じていた。
- d) 削孔後の孔では、前面の水位変動に応じて激しい空気の噴出入が生じていた。また、HWL時にはこの孔から激しく海水が吹き上げていた。観測結果から、マツの有無にかかわらず、ファブリマツ裏側においても前面側の水位変動が伝達していること判明した。
- e) 特に問題の生じていない東側取付護岸部では、2ヶ所とも法肩及び法尻付近の双方でマツの下には調整用敷砂が存在し、さらに下側20cm程度では、裏込材の袋セメントが現れた。

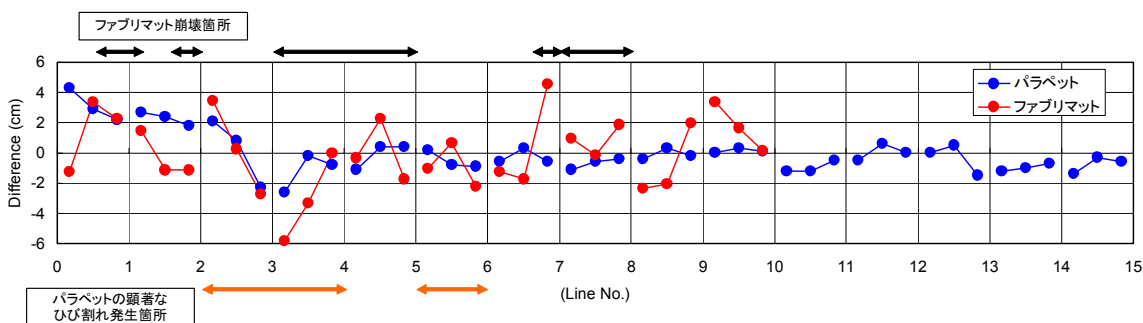
図 A-3-1 レベル測量結果 (ファブリマツ天端面及びパラペット天端面)

図 A-4-1 は、パラペット天端面及びファブリマツ護岸天端面の各スパン間での相対的な高さの違いを示す。レベル測量は各スパン間で、両端部及び中央部の計 3 ヶ所で計測した。縦軸は、それぞれのレベルの平均値からの差を示す。この結果から、ファブリマツの天端高の変動と崩壊箇所とは相関関係が見られ、崩壊箇所では顕著な変動を示している。特に崩壊の顕著な No.3~4 付近では、極端な高さの違いが見られ、その境界付近では明らかな沈下傾向が見られる。パラペット部については、ファブリマツに見られるほどの顕著な変化はないものの、No.3~4 付近ではファブリマツとほぼ対応する変動を示している。詳細な沈下状況の推定は難しいが、マツの崩壊に伴うマツ天端高が変動していること、及び No.3~4 付近では明らかに沈下傾向であることが示された。

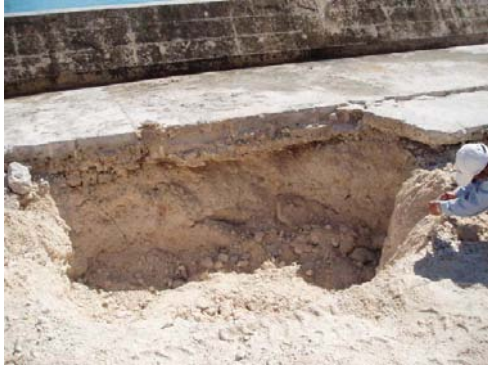
最も道路部での土砂流出が顕著なところであるため、港湾公社が路面をコンクリートにより(No.1～No.3)補強工事を行った箇所である。コンクリートの下端面と裏込土砂との間に、1～2cm 程度の隙間が生じているとともに、裏込石の間にある空隙が確認された。

掘削状況

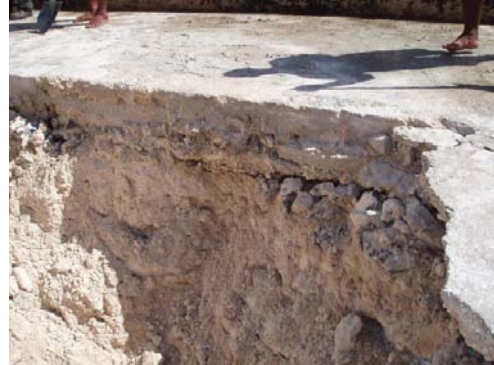
コンクリート下面での隙間

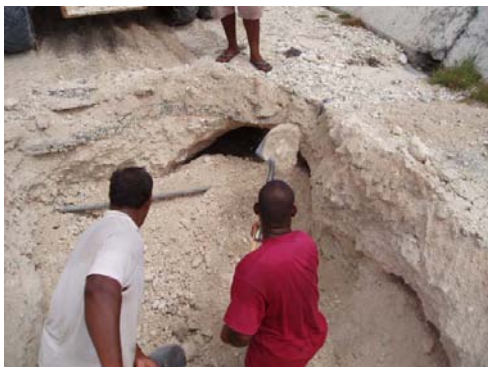
表面の一部に薄いコンクリートが見られる。そのコンクリート面の下側で、ファブリマツ端部付近に大きな空洞が観察された。この空洞の大きさは、高さ 50cm 程度、幅 1m 程度、奥行 1m 程度である。

付近の状況

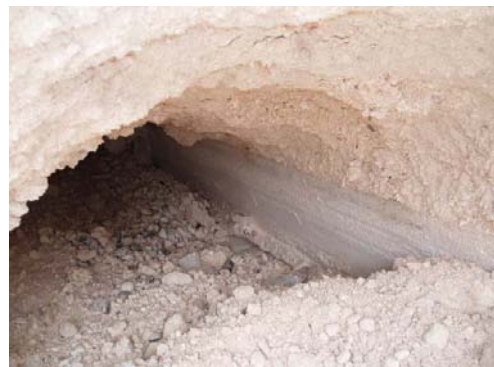
パラペット際の空洞

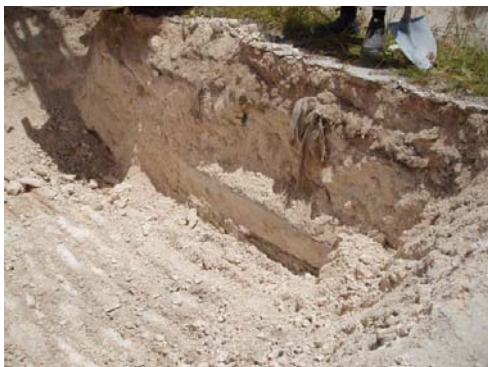
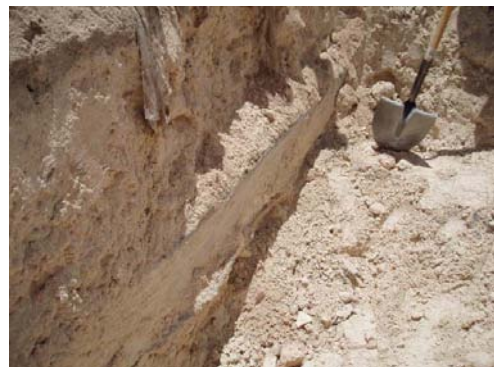
写真 A-5-3 No. 7 調査状況

この区間では、特に空洞・空隙は観察されなかった。

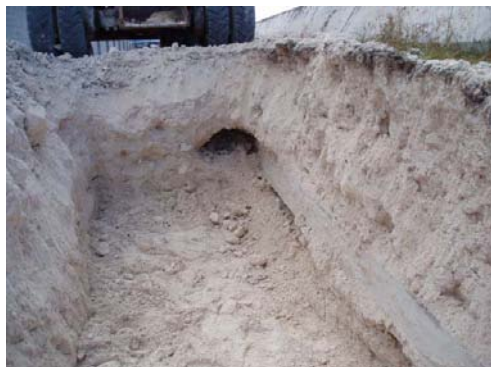
パラペット際に、顕著な空洞が存在する。空洞の大きさは、高さ 30cm 程度、幅 50cm 程度、奥行 1m 程度であった。この空洞の直上にはパラペットの排水孔が存在する。また、空洞脇のファブリマツ端部の下面には、10cm 程度の間隙が存在する。

付近の空洞

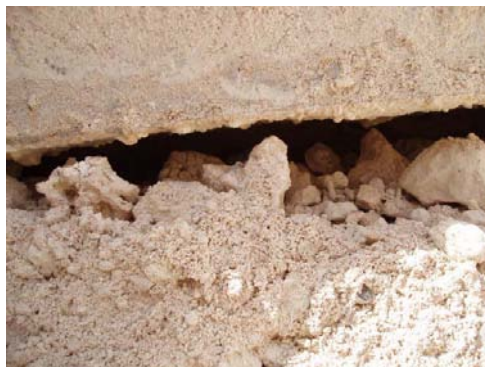
ファブリマツ下面での隙間

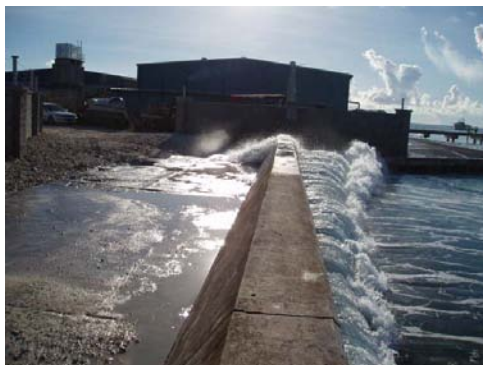
① 越波状況 (No.1 付近)

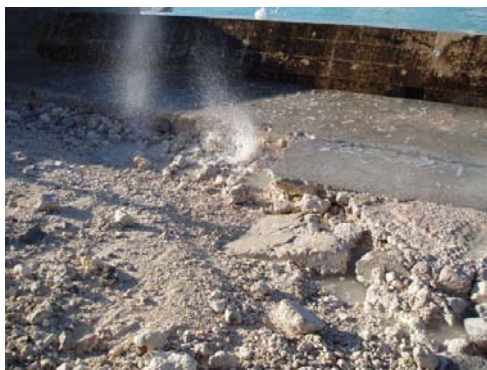
②はその付近の様子であるが、コンクリート補修部と未舗装部との境からは、波の位相変動に応じて海水が噴出しており、コンクリート舗装部下面での裏込め石の空隙を介し、背後まで海水が進入していることが確認された。

② 道路部からの海水の噴出 (No.1 付近)

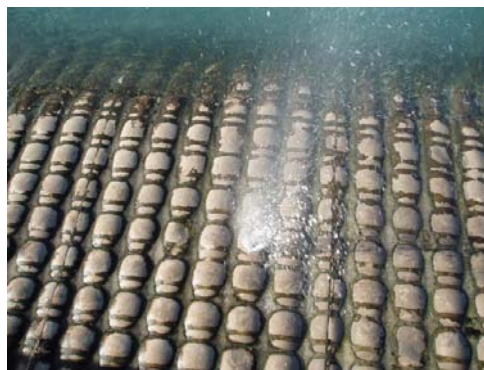
③は、今回の削孔部の様子を示したものである。すべての削孔部で波の位相変動に対応し、海水の噴出が認められた。ただし、その噴出状況には違いが見られ、崩壊面の存在する測点での削孔部からの噴出高は、崩壊していない測点での削孔部からの噴出高に比べて著しかった。これより、前面が崩壊している箇所は、崩壊していない箇所に比べ、背面側に直接的に波が進入していることがわかる。

③ 削孔部からの海水の噴出

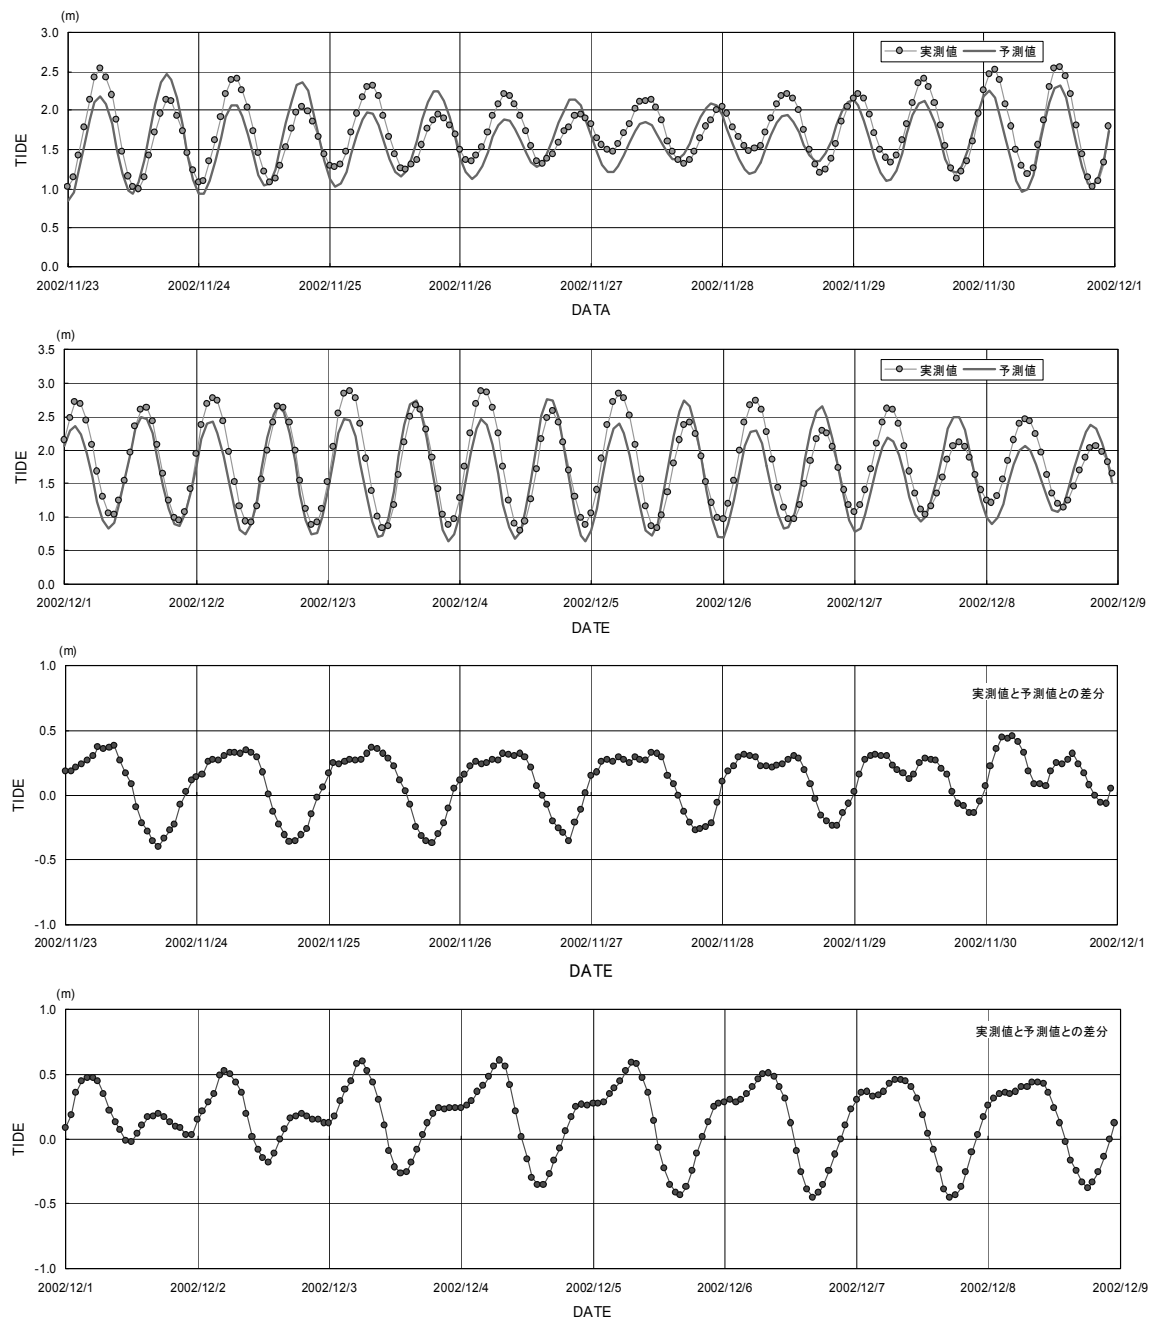
図 B-1-1 被災時前後の潮位の実測値と予測値および両者の差

図B-1-1は、被災時前後の予測と実測の水位変化及び両者の差を示したものである。西寄りの強風が生じた11月29日から12月6日にかけては、ラグーン内での吹き寄せ等の影響によるものと考えられる水位値の上昇が見られる。この間の最高水位は、12月3日に記録した+2.88 mであった。
