TECHNICAL NOTE
on the Basic Design Study
on the Project for Rehabilitation of Betio Port
in the Republic of Kiribati

**Minutes of Discussions
on the Basic Design Study
on the Project for Rehabilitation of Betio Port
in the Republic of Kiribati
(Explanation of Draft Final Report)**

APPENDIX 6.A FIELD INVESTIGATIONS ON DAMAGED FACILITIES

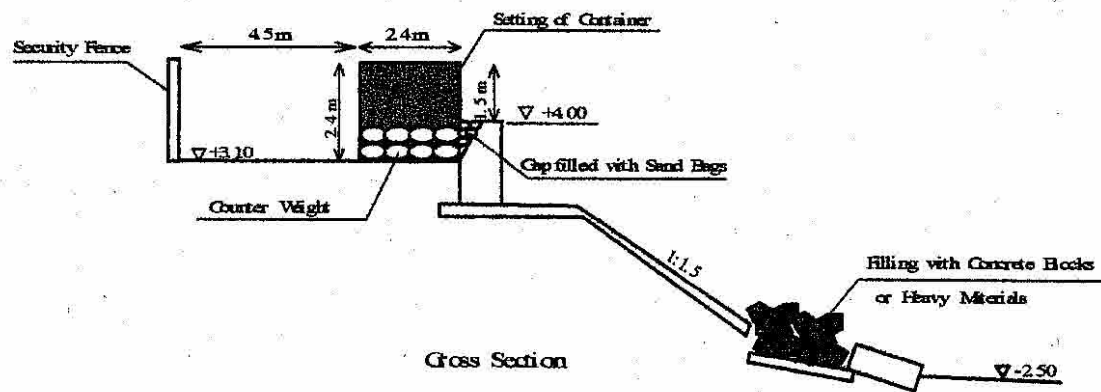
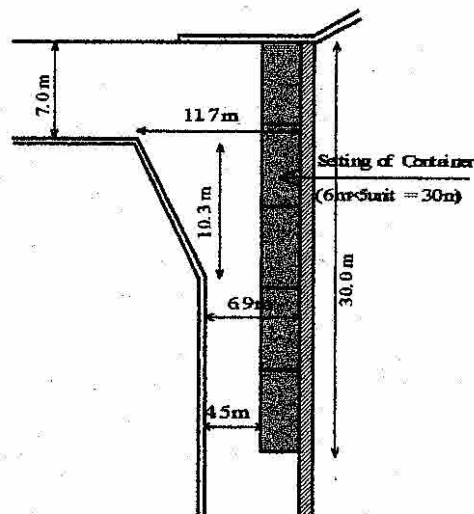
Point A (New Wharf Revetment)

At the west end of the New Wharf Revetment, it is experienced frequent overtopping waves causing damages to top surface including apron concrete slab. To prevent further damage by overtopping waves, it is proposed to install containers along the parapet wall temporarily.

For the openings of fabric mat damaged by the wave action, it is proposed to fill with heavy materials like used concrete curb stones or similar temporarily.

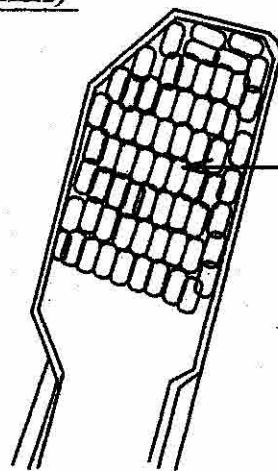
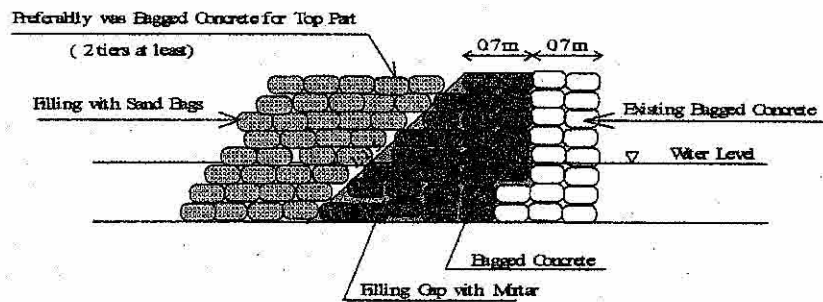
Point B (West Mile Revetment)

The West Mole Revetment is being damaged continuously due to its unstable structure. Also the filled sand inside the revetment is frequently washed out by overtopping waves. This section of the revetment at West Mole is very important to prevent large damage to the container yard and other facilities located in East Mole since it is functioned as breakwater.

In order to stabilize the present revetment structure, it is suggested to reinforce said revetment by bagged concrete and sand bags as shown in Attachment A.

Filling with Bagged Concrete and Sand Bags

(Total 1,000 m³)

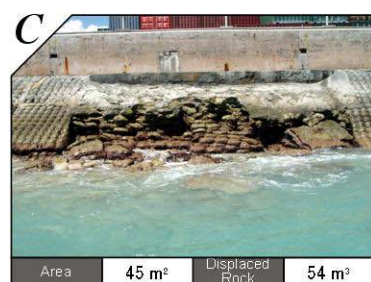
- Considerable amount of rock and bagged concrete displaced.
- Toe protection gabion scattered.
- Opening under gabion due to scouring.

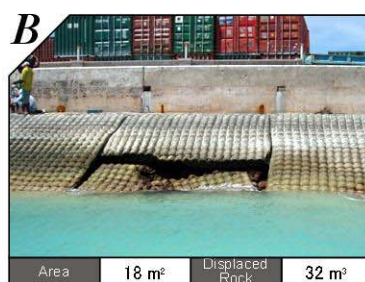
- Coral rock displaced.
- Toe protection gabion scattered.

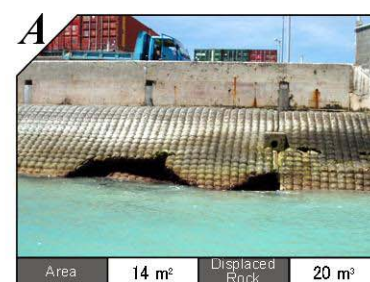
- Seabed at toe part covered by sand.
- Sand ripple due to wave reflection observed at seabed.

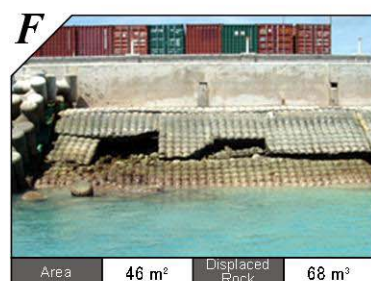
- Coral rock displaced.
- Toe protection gabion scattered.

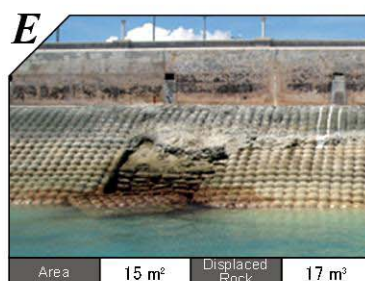
- Coral rock displaced.
- Toe protection gabion scattered.

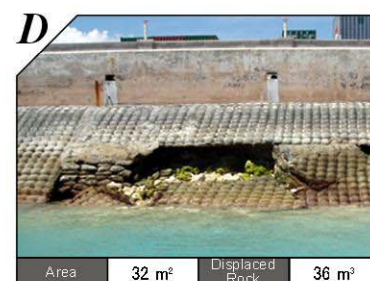
- Considerable amount of rock and bagged concrete displaced.
- Toe protection gabion scattered.
- Opening under gabion due to scouring.

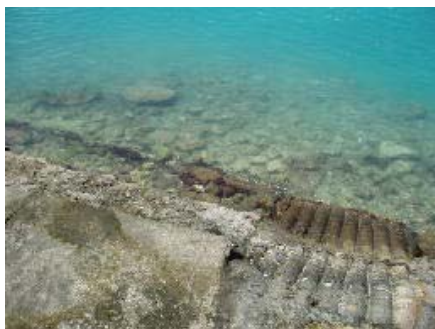
- a) The most severe damages of mat are observed at Sections No.1~2, No.4~5, No.7 and No.10 of fabric mat type revetment. At these Sections the damages are caused at the lower part below LWL. The bagged concrete used for urgent repair on the damaged parts were scattered on the seabed. (see Photo A-2-1 ①)

① Coral rocks scattered (vicinity of No.4)

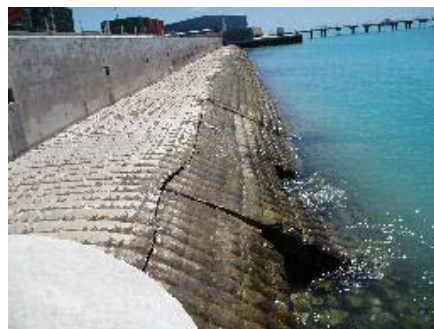
- b) Cracks appear at the shoulder part of fabric mat type revetment along whole section. (see Photo A-2-1 ②) According to the hearing from KPA, the cracks at the shoulder had been observed about one year ahead of the large damage caused in November 2002.

② Cracks at shoulder of fabric mat (vicinity of No.10)

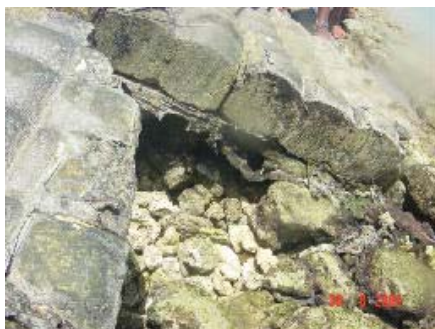
- c) From the ocular inspection by diving operation to observe inside of the damaged part, opening depth of 1 to 3 m has been observed due to displacement of coral rocks. (see Photo A-2-1 ③) Damaged parts are currently facing to the continuous wave action and backfill coral rocks and it is supposed that the reclaimed sand have being displaced continuously.

③ Displacement of coral rocks

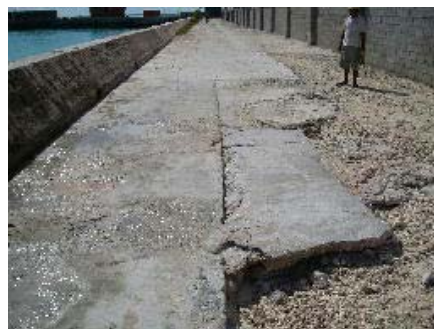
④ Repair done for apron/road (vicinity of No.1~3)

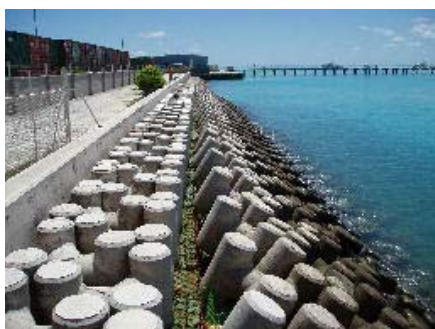
- g) At Section Nos. 11 to 15 for concrete block type revetment, it was not observed any crack or damage to the concrete blocks. It was observed slight movement of gabions at toe part by diving inspection, but no movement of blocks was observed. (see Photo A-2-1 ⑤) Judging from these facts, no significant change of seabed and scouring along the concrete block type revetment.

⑤ Situation of concrete block type revetment

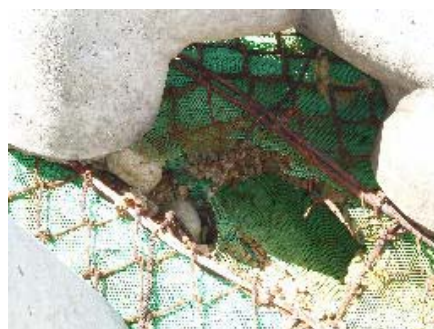
- h) No damage to concrete blocks was observed, but wire and geo-textile sheet of gabion were damaged appearing opening where coral rocks were dislocated. (see Photo A-2-1 ⑥) As a whole, rust of frame of gabion is severe. It is supposed the rust will progress and opening of wire/net will be enlarged resulted in scattering of more coral rocks and it is high possibility of collapse of whole structure in the near future.

⑥ Damage of gabion under concrete blocks

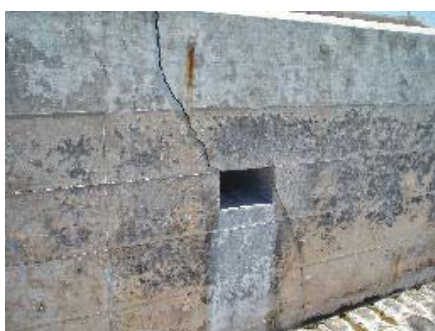
- i) Parapet concrete was constructed with joint every 10m and cracks appear every location of drain holes provided in parapet wall. (see Photo A-2-1 ⑦⑧) The cracks has been caused by bending force judged from its feature. The most significant cracks were seen at Section Nos. 2 to 3 where the gaps of cracks were about 10mm. Since the cracks and damages to the fabric mat coincide at the similar location, it is assumed that leakage of backfill due to damage of fabric mat caused concentration of external force acting to the parapet wall. According to the hearing obtained from KPA, the gaps of cracks are growing.

⑦ Cracks appeared at parapet wall (land side)

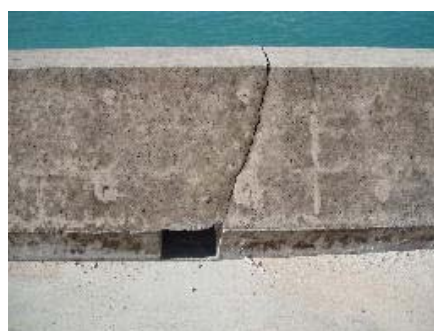
⑧ Cracks appeared at parapet wall (sea side)

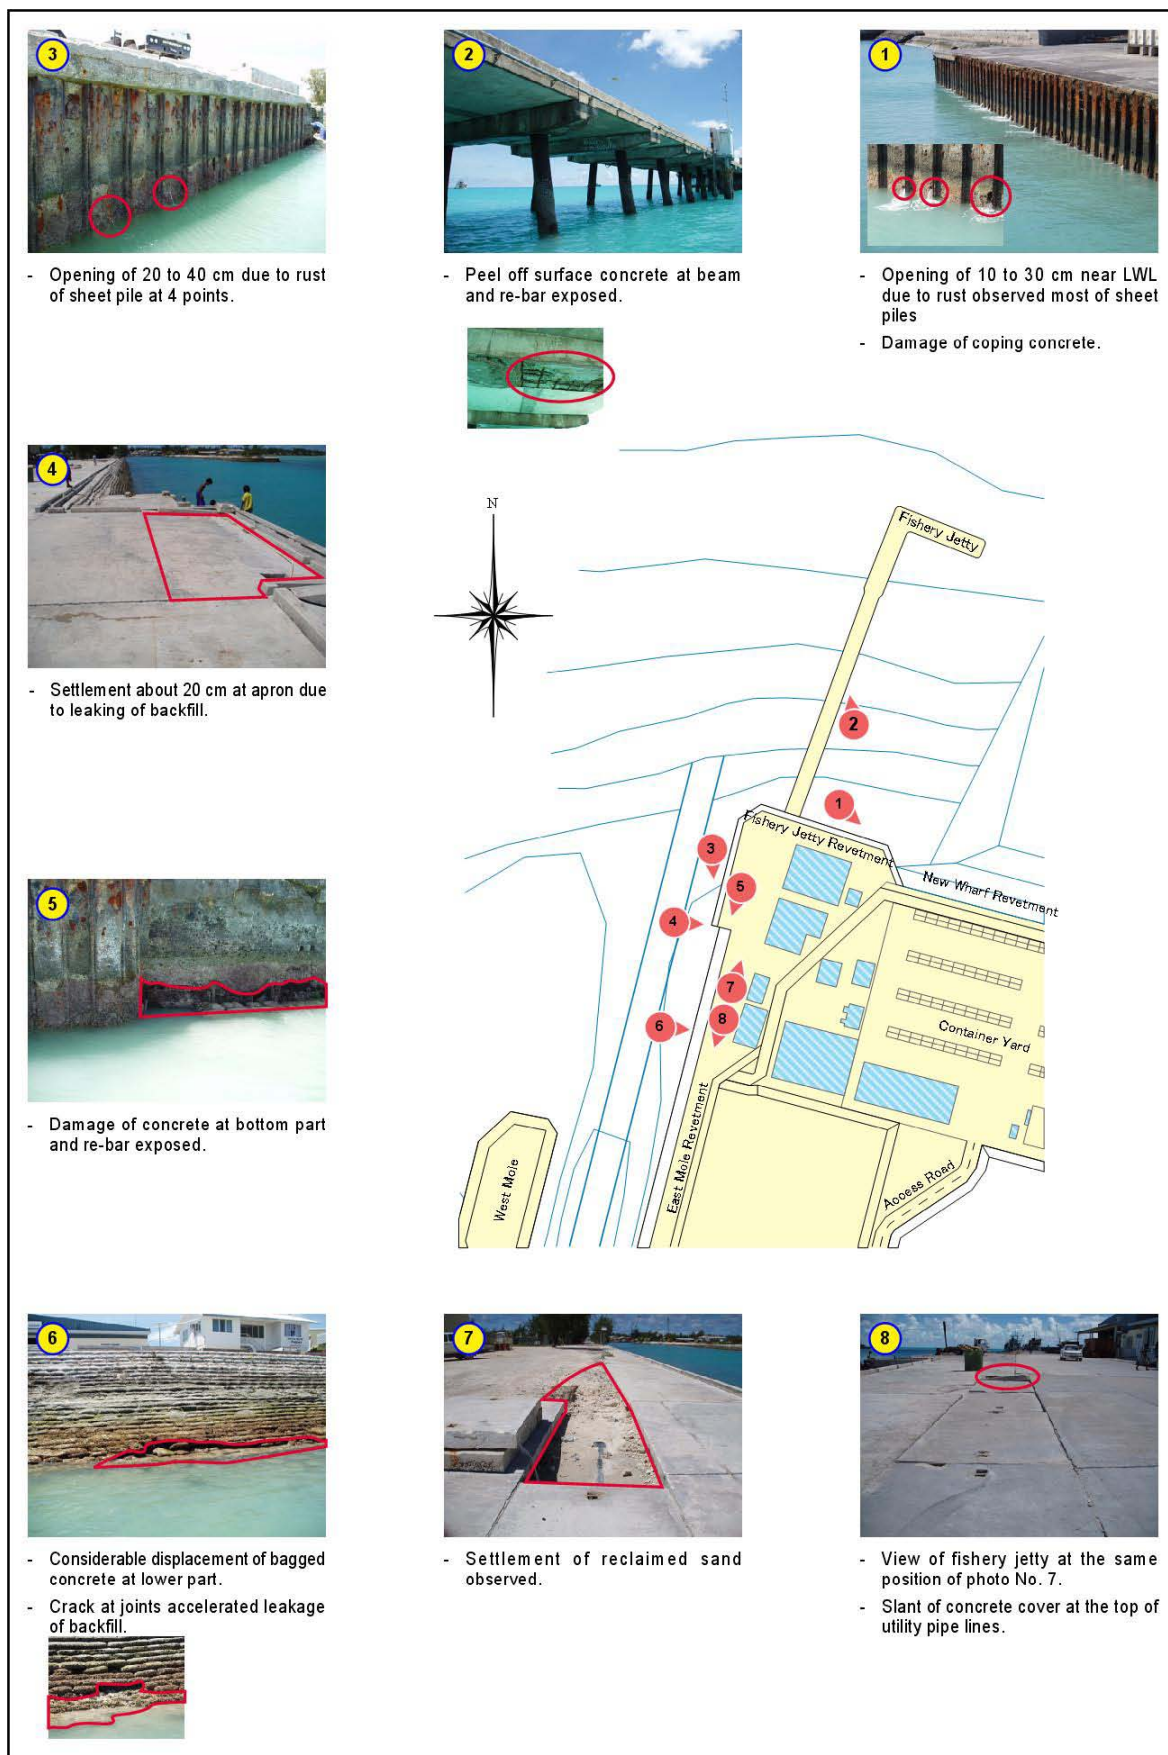
Figure A-2-2 Situation of Fishery Jetty Revetment and East Mole Revetment

- a) The most of the Steel sheet piles of Fishery Jetty Revetment facing to the North have 10 to 30 cm holes caused by rusting near the elevation of LWL and backfill material with residual sea water get in and come out causing settlement of apron concrete.

- b) About 70 to 80 % of coping concrete at the top of sheet piles were fallen down.
- c) At the western part of Fishery Jetty Revetment, 20 to 40 cm holes were observed at four locations. At the gravity type revetment by concrete block (constructed in 1970s) located between Fishery Jetty Revetment and East Mole Revetment, concrete peel off and re-bar exposed at lower part of the structure.

- d) Concrete pavement has been provided by the Betio Fish Port Complex Project (completed in 2000), but a settlement of approximately 20cm caused due to leakage of backfill materials. This settlement was not recognized during the Preparatory Study of the project in December 2003. Such settlement has been observed in other part of the revetment.

- e) The East Mole Revetment having total length of 610m is initially constructed in 1960s by the sloped revetment type with bagged concrete. Leakage of backfill materials was observed several locations where the bagged concrete is dislocated.

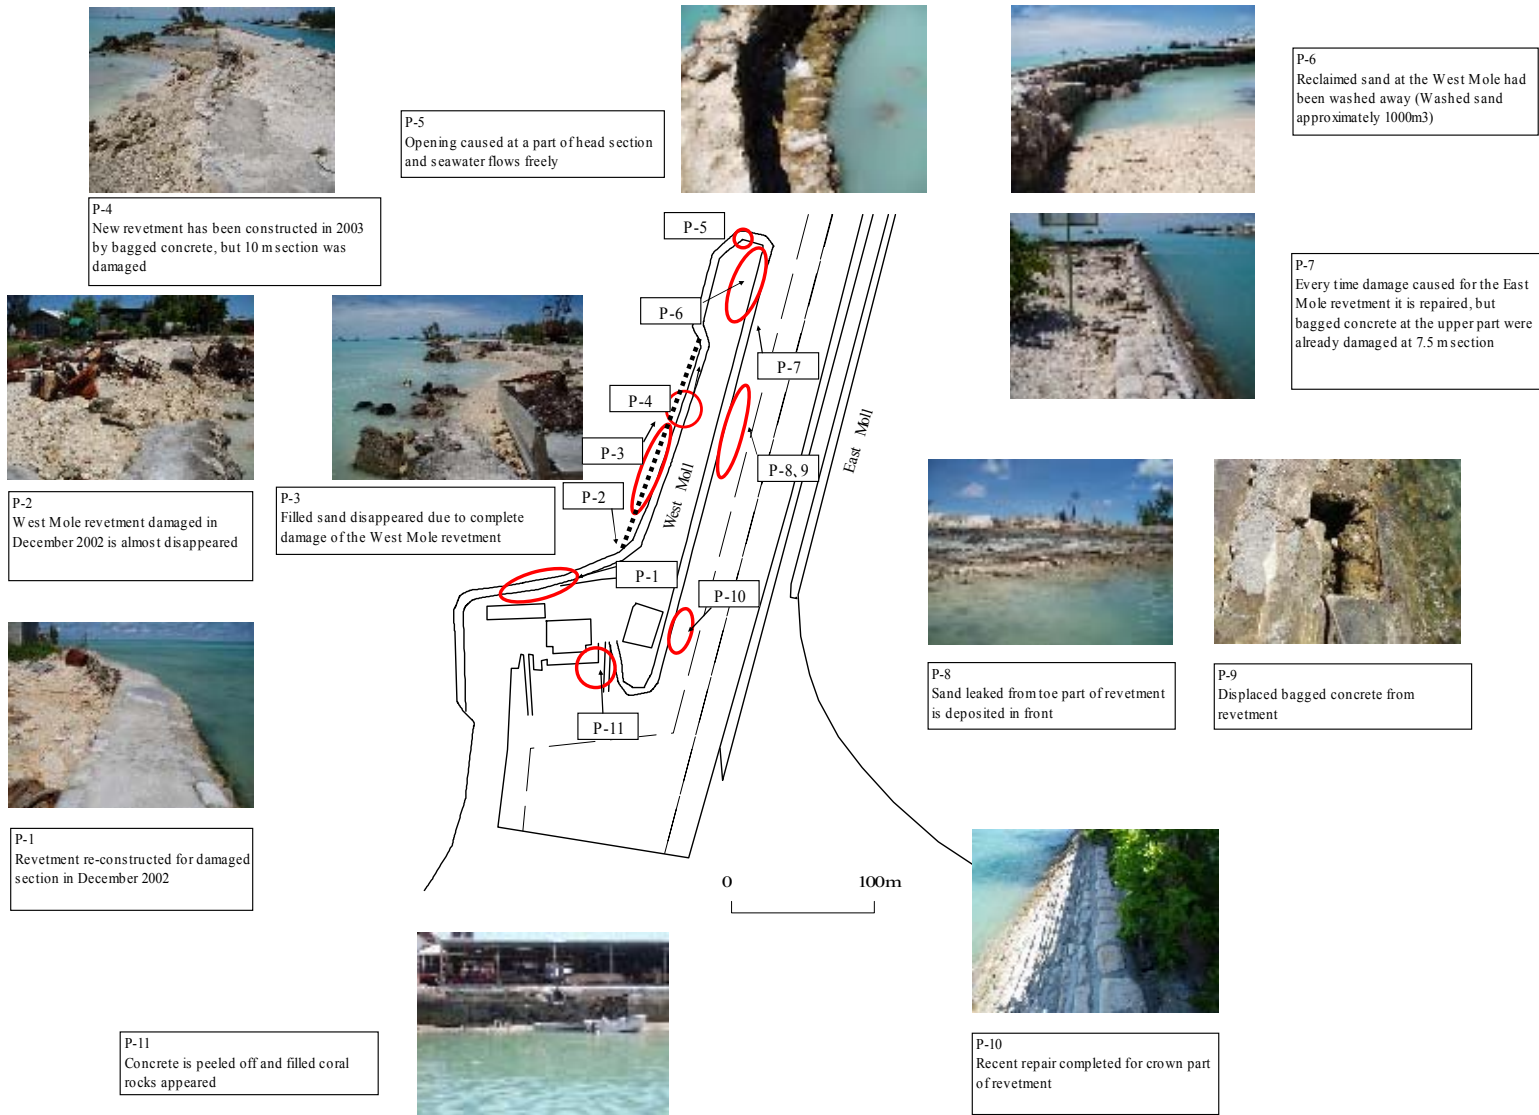
Figure A-2-3 Situation of West Mole Revetment

- a) The section of the revetment at the western part and offshore side is totally damaged and disappeared. When the situation of damages examined by photos taken in December 2003 by the Preparatory Study and taken by the Basic Design Study of the project in September 2004, it is recognized some progress of damages.

- b) A revetment constructed inside of the original revetment at the western section (coral rocks cemented) has been damaged many times, the it was repaired in 2003 – 2004. But the part of the section (about 8m) is collapsed again.

- c) Leakage of backfill materials from inner part of the revetment is significant and it is markedly damaged at the offshore side (about 30m section) where filled materials were dislocated totally and only vertical structure by bagged concrete remains. This large scale leakage has been caused along with damages caused for fabric mat in December 2002 and it progressed after that time. At the three locations at vertical structure of offshore section, sea water move freely through the opening of revetment.

- d) At the eastern section of the West Mole Revetment (facing to the approach channel to the Old Port), damages of dislocating bagged concrete, leakage of filled materials and collapse at the top part. KPA repairs repeatedly at this section.

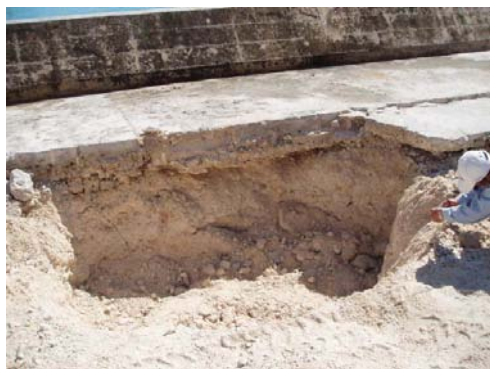
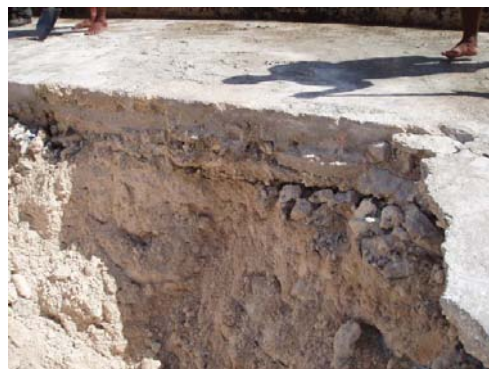
Photo A-1-3 Section No.1

This section causes significant leakage and wash out of backfill soil, then KPA had provided concrete pavement at Section Nos. 1 to 3. Under the concrete pavement, gaps of 1 to 2 cm have been observed.

Opening underneath of concrete

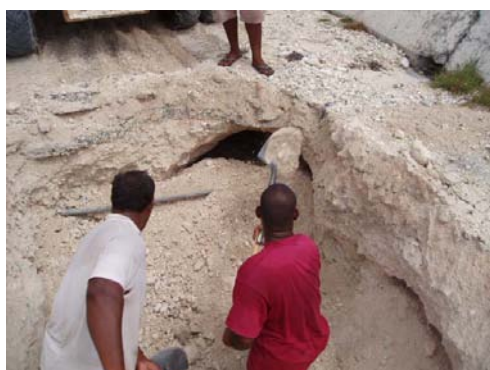
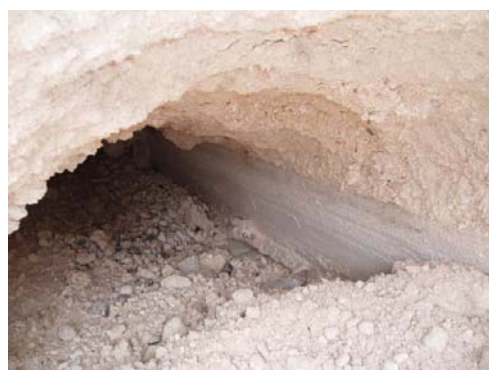
Photo A-5-2 Section No.5

Near the end of fabric mat, a large opening of 50cm high, 1 m wide and 1 m long has been observed.

Gap under parapet

- Large openings have been found at Section Nos. 5 and 9 where damages of fabric mat have been observed. At both locations, drainage holes were located nearby. Therefore, it is supposed that leakage of backfill soil is being experienced through water course created between top soil and toe part.

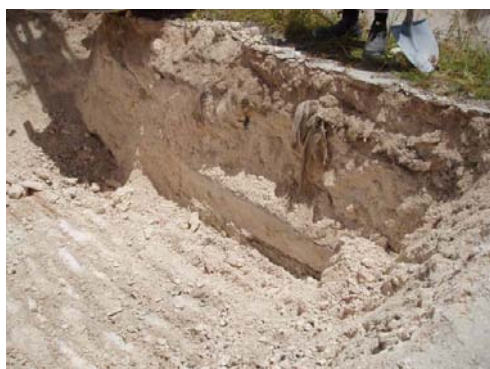
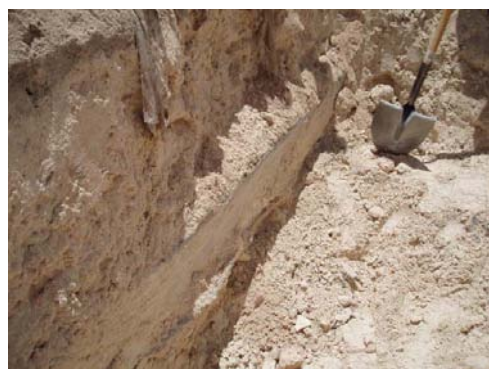
Photo A-5-3 Section No.7

Noticeable opening or gap has not been observed at this section.

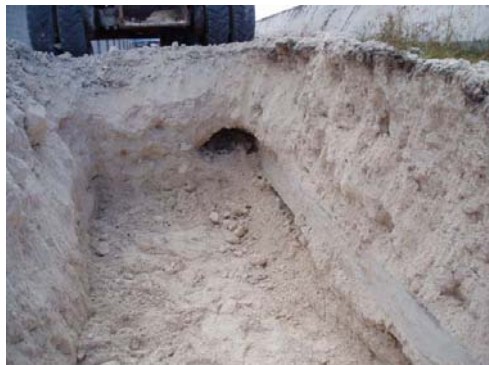
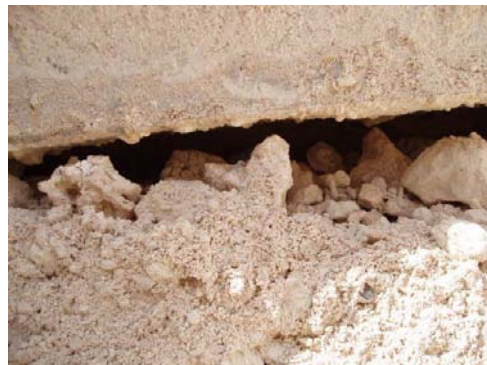
Photo A-5-4 Section No.9

Near the parapet wall, significant openings have been observed. The size of opening was 30 cm high, 50 cm wide and 1 m long. A drainage hole of parapet wall was located near this opening. Also gap of about 10 cm has been seen under the fabric mat.

Gap below fabric mat

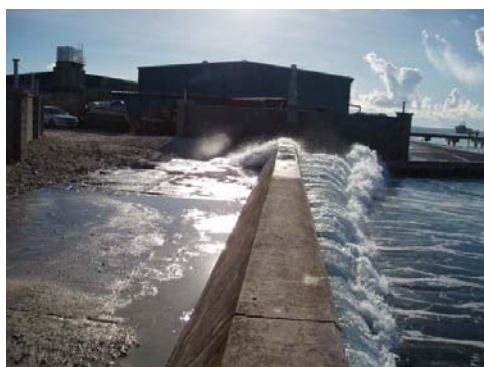
Photo ① shows situation of wave overtopping at Section No. 1. The tidal elevation at that time was lower than the highest higher water level recorded (+2.97 m) in March 1997 by 36 cm. The wave condition was not particularly rough, but significant overtopping waves were caused. It was appeared only at the location near Section Nos. 1 and 2 and overtopped waves were soaked into the top soil at the road.

① Situation of Overtopping Waves (Section No.1)

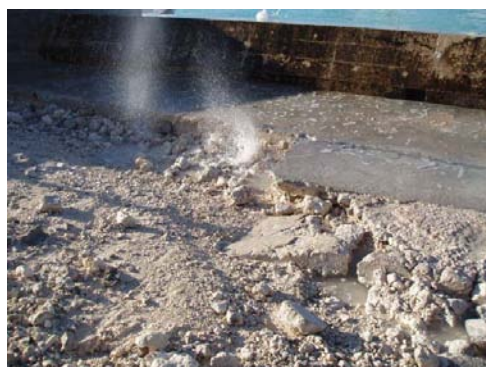
Photo ② shows situation around the area and sea water spurt out from the boarder between paved and unpaved areas due to the phase difference of waves, thus it was confirmed sea water transmit between the backfill rocks and toe part of the revetment.

② Spurting of sea water at road (Section No.1)

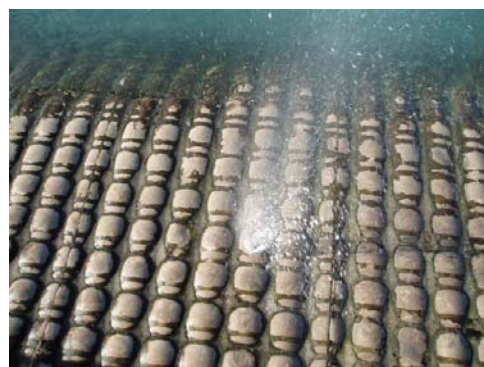
Photo ③ shows situation of core holes during HWL. It was observed sea water has spurted up from whole core holes and spurt height at those holes where damages are significant was higher. It reveals that transmission of sea water at damaged parts is much significant in compared with undamaged part.

③ Spurting of sea water at cored holes
