THE BASIC DESIGN STUDY ON CONSTRUCTION OF EASTERN ARTERIAL ROAD IN MONGOLIA

JAPAN INTERNATIONAL COOPERATION AGENCY (JICA)

PACIFIC CONSULTANTS INTERNATIONAL
JAPAN OVERSEAS CONSULTANTS

D-53

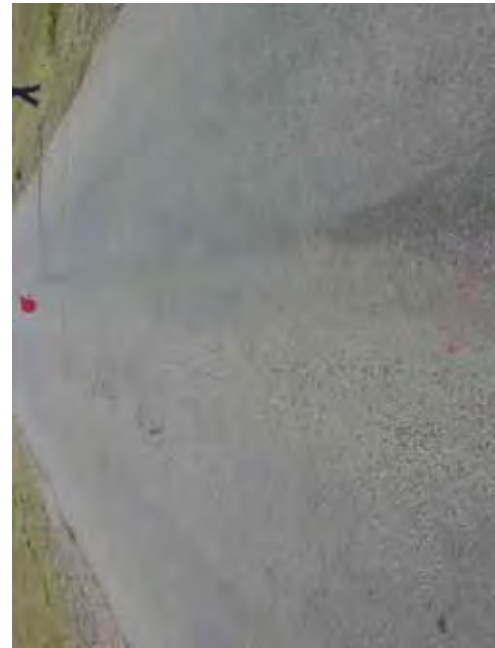
DSC00818

COMMENT	Volume of crackle: less Width of crackle: 05-10mm 165 / 2800 * 100 = 5.89%	Volume of crackle: less Width of crackle: 05-10mm 249 / 2800 * 100 = 8.89%	Volume of crackle: less Width of crackle: 05-10mm 274 / 2800 * 100 = 9.79%	Volume of crackle: less Width of crackle: 05-10mm 317 / 2800 * 100 = 11.32%
SUBJECTIVE EVALUATION	3	3	3	3
OBJECTIVE EVALUATION	b	b	b	b
TYPE OF PAVEMENT REHABILITATION	B	B	B	B

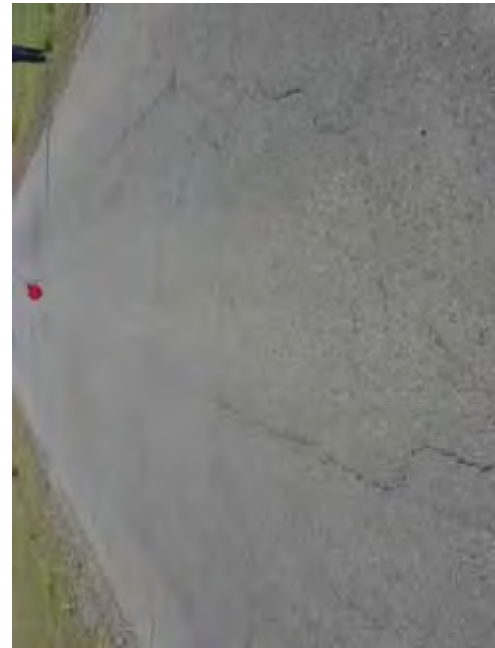
DSC00822

COMMENT	Volume of crackle: less Width of crackle: 05-10mm 356 / 2800 * 100 = 12.71%	Volume of crackle: less Width of crackle: 05-10mm 220 / 2800 * 100 = 7.86%	Volume of crackle: medium Width of crackle: 05-30mm 350 / 2800 * 100 = 12.50%	Volume of crackle: medium Width of crackle: 05-15mm 333 / 2800 * 100 = 11.89%
SUBJECTIVE EVALUATION	3	3	4	3
OBJECTIVE EVALUATION	b	b	b	b
TYPE OF PAVEMENT REHABILITATION	B	B	B	B

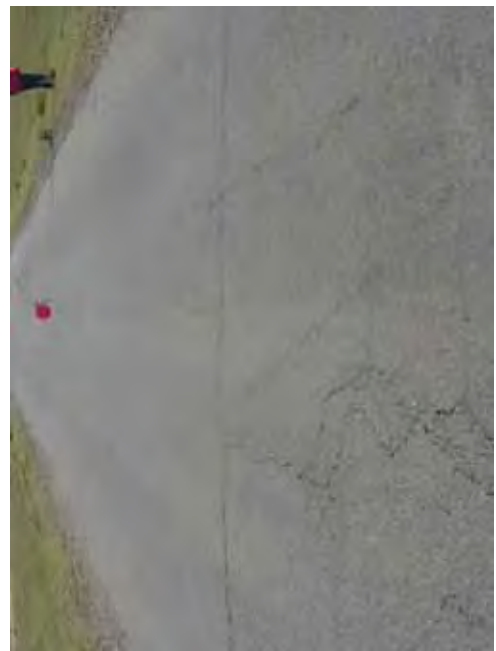
DSC00826

COMMENT	Volume of crackle: less Width of crackle: 05-10mm 212 / 2800 * 100 = 7.57%	Volume of crackle: less Width of crackle: 05-10mm 221 / 2800 * 100 = 7.89%	Volume of crackle: less Width of crackle: 05-15mm 322 / 2800 * 100 = 11.50%	Volume of crackle: medium Width of crackle: 05-20mm There is a pothole in + 5792 metre. (200*300*60mm) 294 / 2800 * 100 = 10.50%
SUBJECTIVE EVALUATION	3	3	3	3
OBJECTIVE EVALUATION	b	b	b	b, c
TYPE OF PAVEMENT REHABILITATION	B	B	B	B

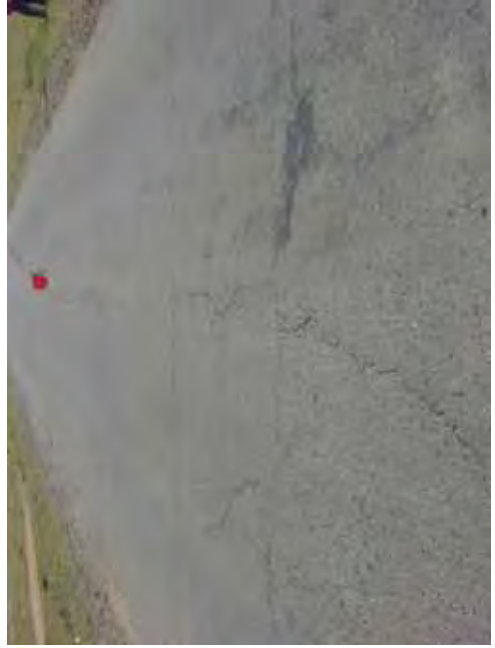
DSC00831

5+700	Volume of crackle: less Width of crackle: 05-10mm 208 / 2800 * 100 = 7.43%	Volume of crackle: medium Width of crackle: 05-15mm There is a pothole in + 5844 metre. (70*150*50mm) 239 / 2800 * 100 = 8.54%	Volume of crackle: medium Width of crackle: 05-20mm 233 / 2800 * 100 = 8.32%	Volume of crackle: medium Width of crackle: 05-25mm 236 / 2800 * 100 = 8.43%
COMMENT				
SUBJECTIVE EVALUATION	3	3	3	3
OBJECTIVE EVALUATION	b	b, c	b	b
TYPE OF PAVEMENT REHABILITATION	B	B	B	B

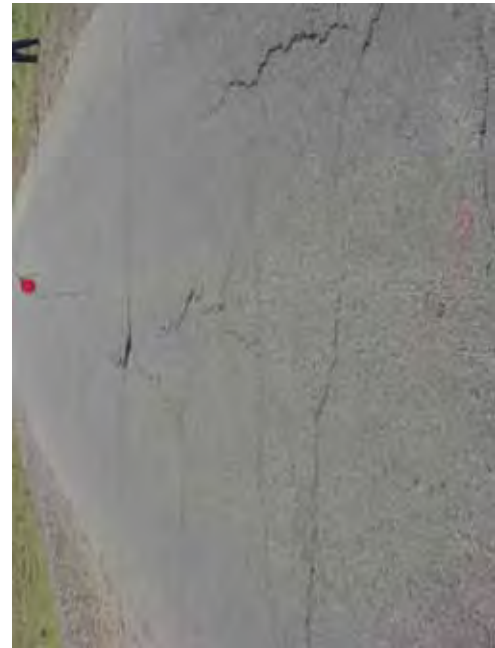
DSC00835

COMMENT	Volume of crackle: medium Width of crackle: 05-20mm 289 / 2800 * 100 = 10.32%	Volume of crackle: medium Width of crackle: 05-30mm 261 / 2800 * 100 = 9.32%	Volume of crackle: medium Width of crackle: 05-20mm 363 / 2800 * 100 = 12.96%	Volume of crackle: medium Width of crackle: 05-30mm 327 / 2800 * 100 = 11.68% There is a pothole in + 5912 metre. (40*200*60mm)
SUBJECTIVE EVALUATION	3	3	3	3
OBJECTIVE EVALUATION	b	b	b	b, c
TYPE OF PAVEMENT REHABILITATION	B	B	B	B
