# THE COMPREHENSIVE MASTER PLAN STUDY ON URBAN SEISMIC DISASTER PREVENTION AND MANAGEMENT FOR THE GREATER TEHRAN AREA IN THE ISLAMIC REPUBLIC OF IRAN

## FINAL REPORT - THE STUDY ON RECONSTRUCTION PLAN FOR BAM WATER SUPPLY SYSTEM-

March 2005

Japan International Cooperation Agency (JICA)  
Tehran Disaster Mitigation and Management Center (TDMMC)

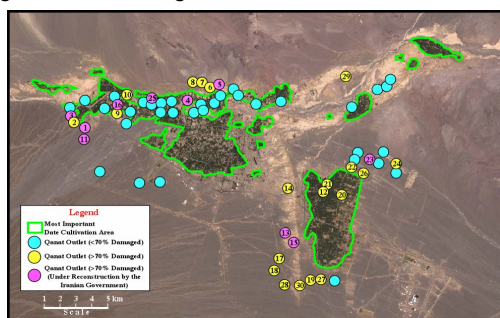
**Figure 4 Damaged Qanat Distribution Map**

The earthquake damaged 64 of the 374 qanats in the region. Of the 64 damaged qanats, 30 are heavily damaged and need urgent restoration.

The most damaged qanats are pointed in yellow and pink. The outlets shown in pink are those that the Bam government is working to restore at the moment. The Baravat area is the area that has the highest concentration of qanats with high damage level.

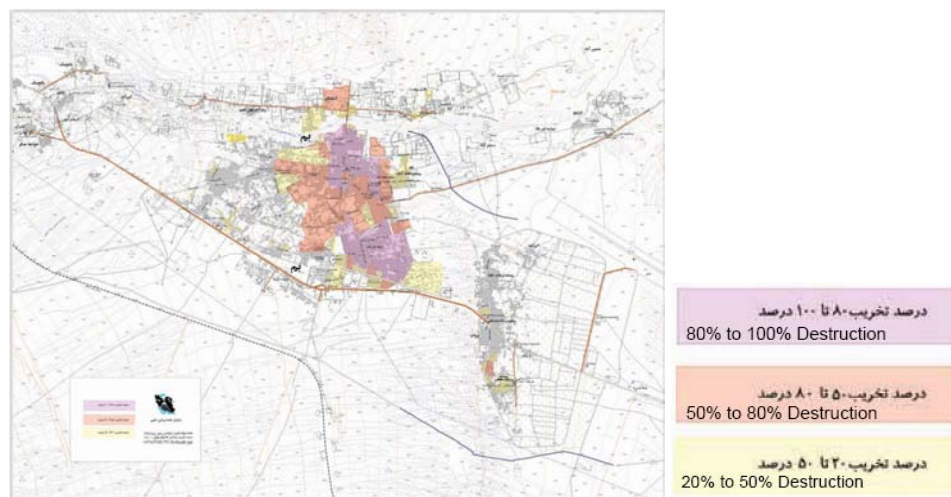
**Figure 2.2.2 Destroyed Building Ratio in Bam**

First of all, the damage ratio of the buildings is the most reliable factor to indicate the scale of disaster. The damage ratio of the buildings estimated by the JICA study is shown in Figure 2.2.1 and that in Bam is shown in Figure 2.2.2.

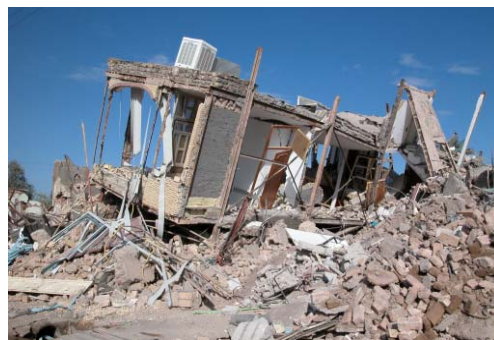
**Figure 2.2.3 Example of a Totally Collapsed Building of Steel Frame**

The next aspect is the earthquake resistance of each different building type. There can be a misconception that modern buildings, constructed by construction methods other than adobe, can resist against this scale of earthquake. It is because some examples can be found, in which some buildings made by RC or “confined masonry” in the west part of Bam and Argejadit were not so heavily damaged. However, the buildings in the central part of Bam made by RC or “confined masonry” received catastrophic damage. Especially, steel frame buildings received damage of total collapse (see Figure 2.2.3).

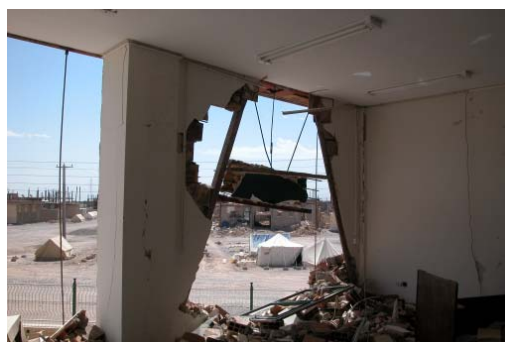
**Figure 2.2.4 Destroyed Public Buildings, which may have been Constructed with Considerable Inspection**

Even in the public buildings, which may have been constructed with considerable inspection, brick infill walls blew off into the out of plane direction. It is thought that human lives may be lost if the disaster occurred in noontime (see Figure 2.2.4)

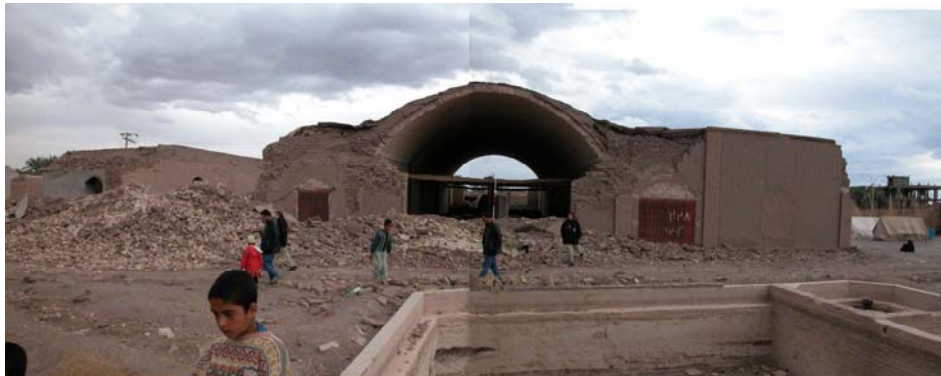
Steel frame building is increasing in Tehran. But the idea that the main cause of the Bam disaster was the use of adobe for building construction is a misconception. Moreover, the idea that the Bam disaster may be minimized if adobe is not the predominant building type in Bam is also not true. Even the buildings made by the building type other than adobe cannot prevent collapse if those are constructed without sufficient consideration based on engineering. On the other hand, there were some buildings that did not totally collapse even though they were made by adobe. A typical example can be seen in Figure 2.2.5.

Material of this building is sun-burned brick

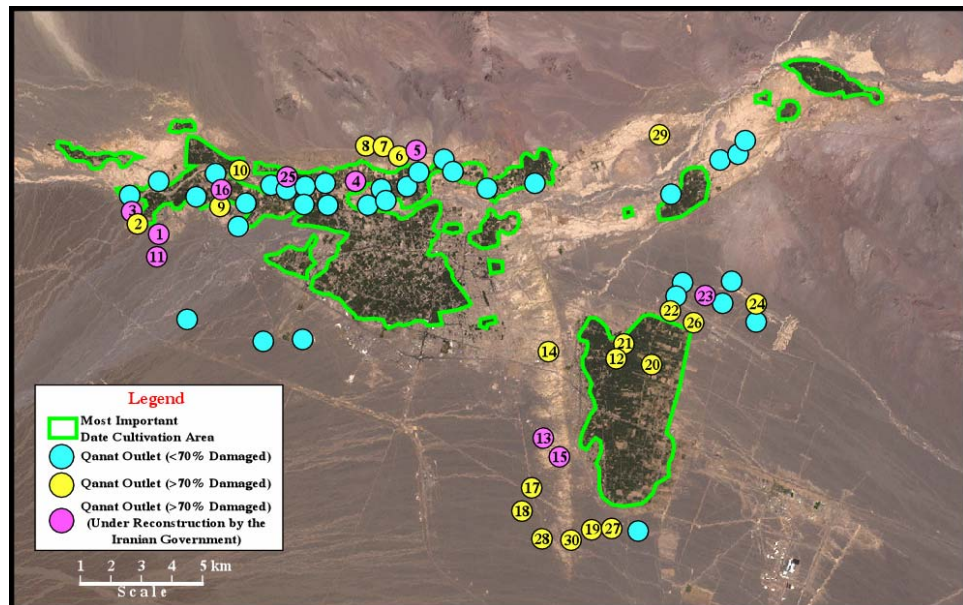
**Figure 3.2.3 Damaged Qanat Distribution Map**

The earthquake damaged 64 of the 374 qanats in the region. Of the 64 damaged qanats, 30 are heavily damaged and need urgent restoration.
